**The Road Inventory  
of  
George Rogers Clark National Historical  
Park  
GERO – 6402**

**Road Inventory Program**

Prepared By:  
Federal Highway Administration  
Eastern Federal Lands Highway Division  
Cycle 3

# George Rogers Clark National Historical in Indiana

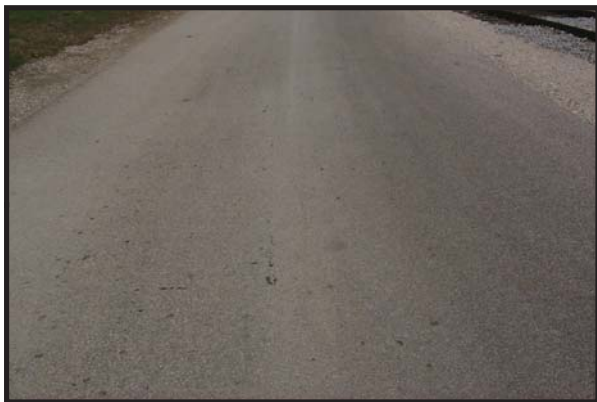
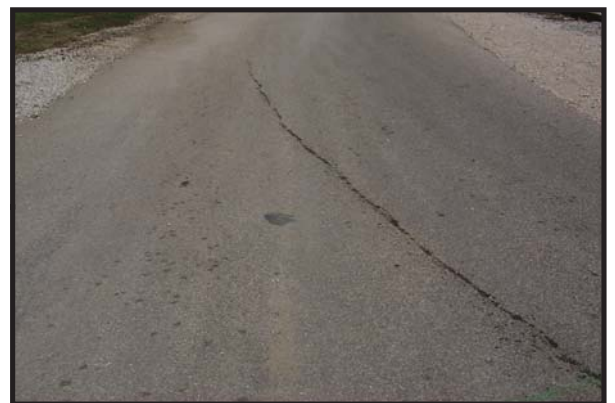
## Route 0100

Pearl Drive

From Willow Street

Route	Length (mi)	Width (ft)	Area (sq ft)	Lane Miles *	Condition / PCR	Surface Type
0100	0.03	16.50	2614	0.05	GOOD / 90	AS

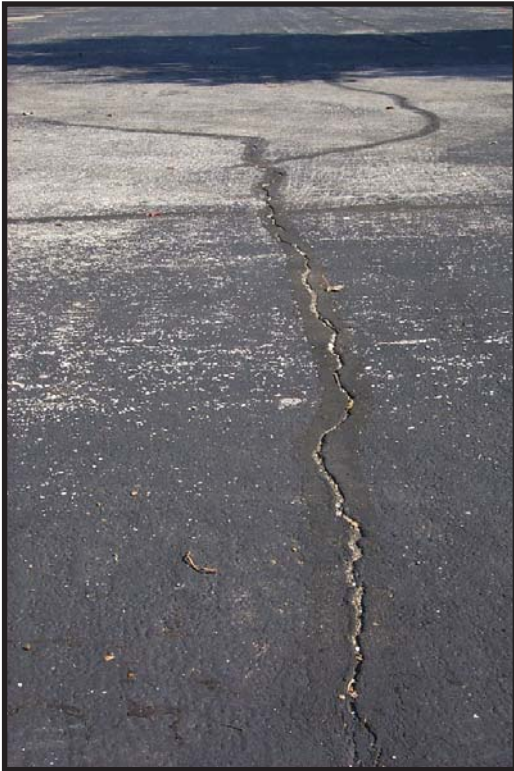
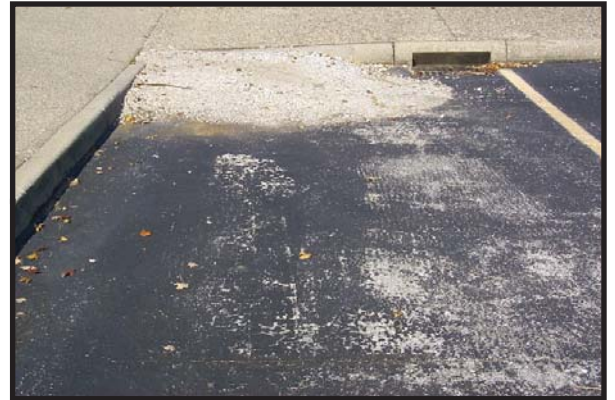
## Route 0900

### VISITOR CENTER PARKING

From South 2nd Street

Route	Public / NonPublic	Date Visited	Area (sq ft)	Lane Miles *	Surface Type	Condition / PCR
0900	Public	10/24/2002	39398	0.68	AS	POOR / 45

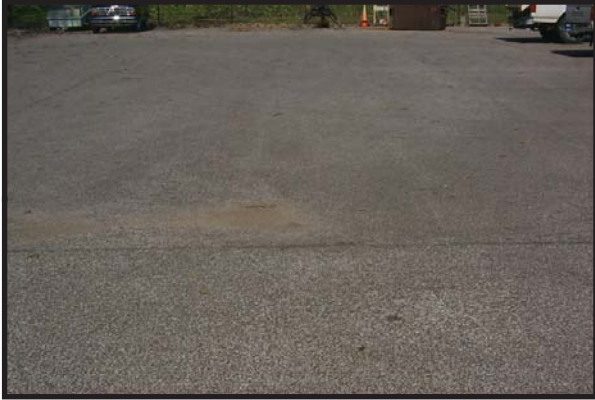
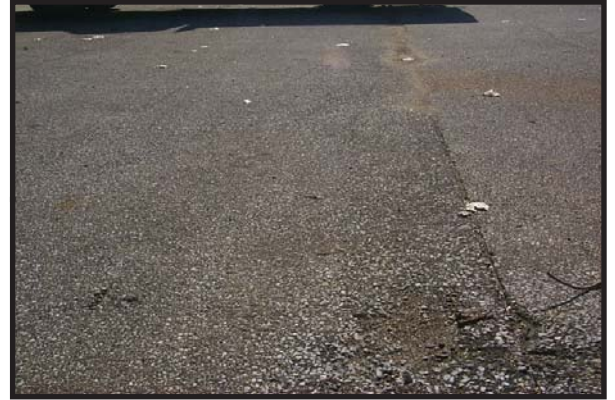
## Route 0901

MAINTENANCE AREA  
From Frisz Boulevard

Route	Public / NonPublic	Date Visited	Area (sq ft)	Lane Miles *	Surface Type	Condition / PCR
0901	NonPublic	10/24/2002	11761	0.20	AS	GOOD / 90

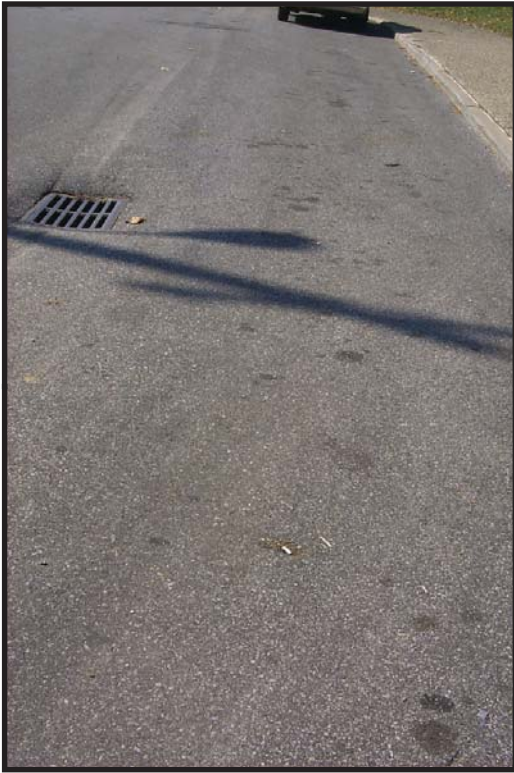
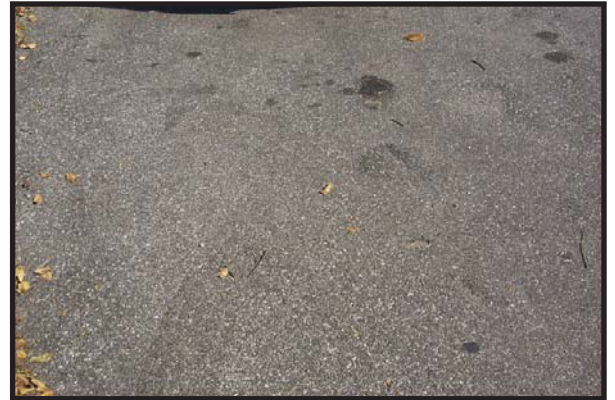
## Route 0902

### VISITOR CENTER PULL-OUT

From South 2nd Street

Route	Public / NonPublic	Date Visited	Area (sq ft)	Lane Miles *	Surface Type	Condition / PCR
0902	Public	10/24/2002	932	0.02	AS	GOOD / 90
