# The Road Inventory of Gettysburg National Military Park GETT – 4400

## Road Inventory Program

Prepared By:  
Federal Highway Administration  
Eastern Federal Lands Highway Division  
Cycle 3

# Gettysburg National Military Park in Pennsylvania

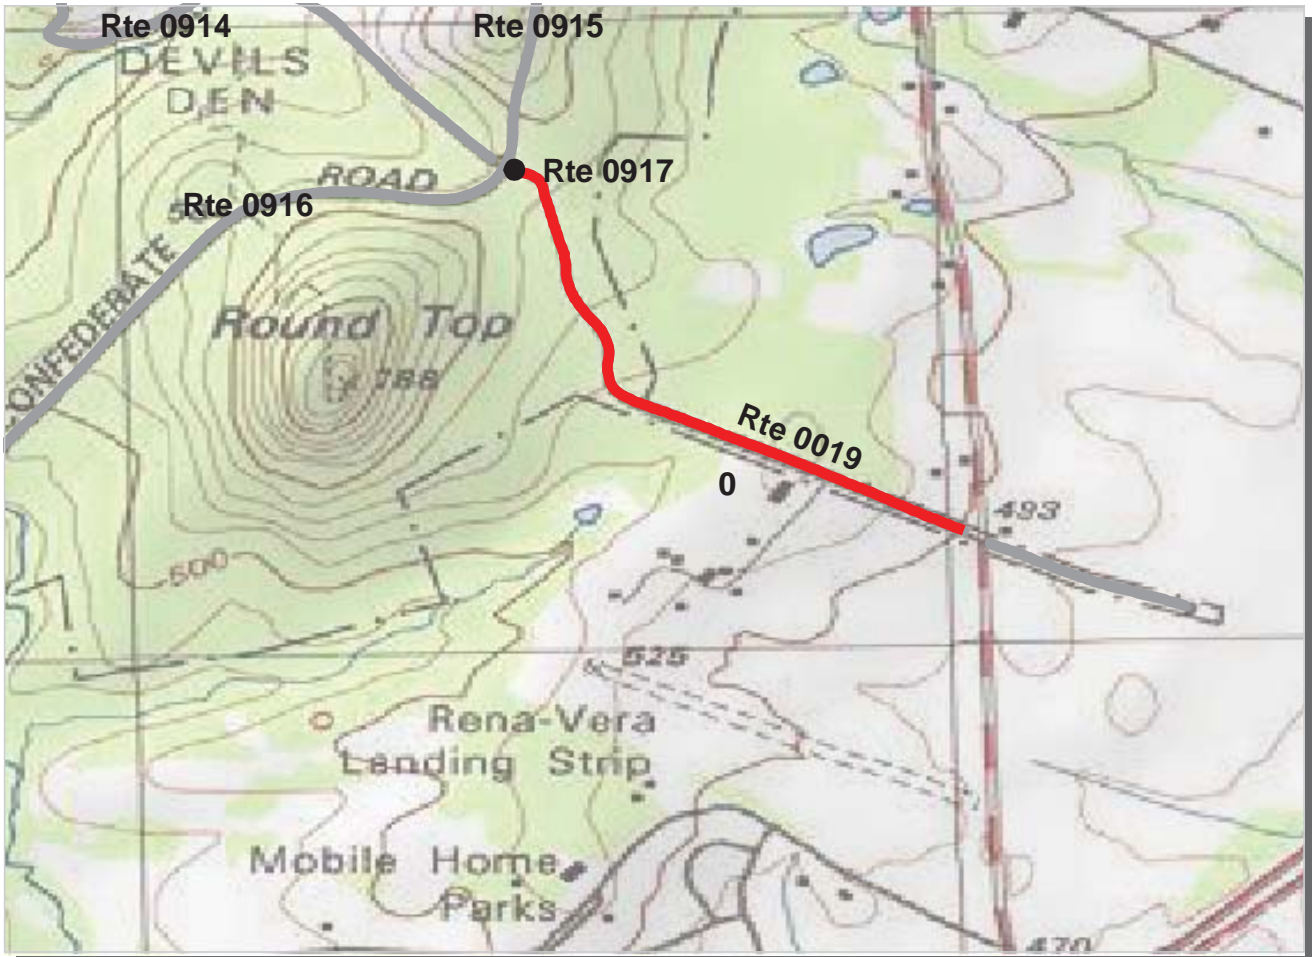
**ROUTE: 0018 West Confederate Avenue**

Section Number	0	1	2		
Section Length (mi)	1.00	1.00	0.81		
AADT	**				
SADT	**				
ADT Date	**				
<b>Cross Section Information</b>					
Number of Lanes	2	2	2		
Paved Width (ft)	19	22	22		
Lane Width (ft)	10	22	22		
Shoulder Width (ft)	0	0	0		
<b>Roadway Condition Information</b>					
PCR (Pavement Condition Rating)	62	69	74		
RCI (Roughness Condition Index)	71	73	82		
SCR (Surface Condition Rating)	57	66	72		
Alligator Cracking Index	97	95	100		
Rutting Index	66	76	76		
Patching Index	98	98	98		
Transverse Cracking Index	98	98	99		
Longitudinal Cracking Index	95	96	98		
Shoulder Condition Rating	N/A	N/A	N/A		
Drainage Condition Rating	GOOD	GOOD	GOOD
