**The Road Inventory
of
George Washington Birthplace
National Monument
GEWA - 4380**

Road Inventory Program

Prepared By:
Federal Highway Administration
Eastern Federal Lands Highway Division
Cycle 3

George Washington Birthplace National Monument in Virginia

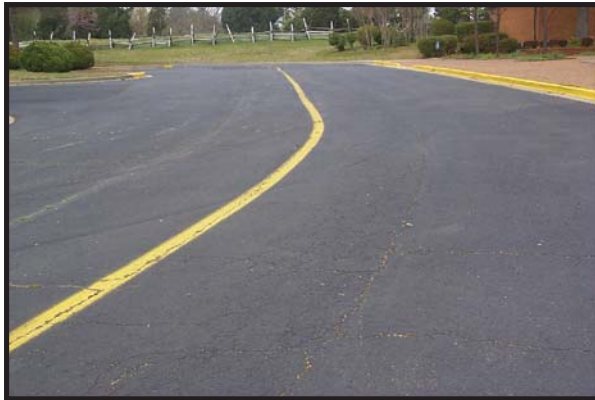
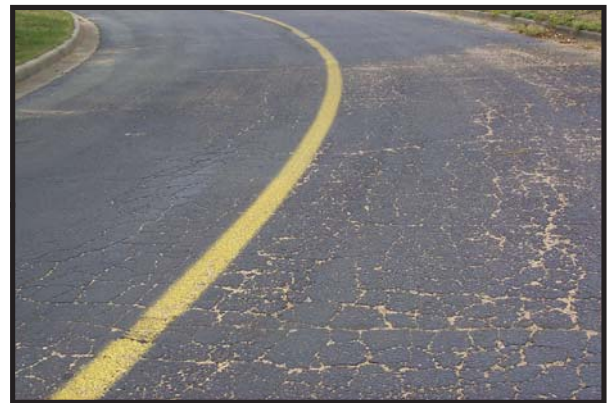
Route	Public / NonPublic	Date Visited	Area (sq ft)	Lane Miles *	Surface Type	Condition / PCR
0900	Public	4/13/2002	32475	0.56	AS	FAIR / 73

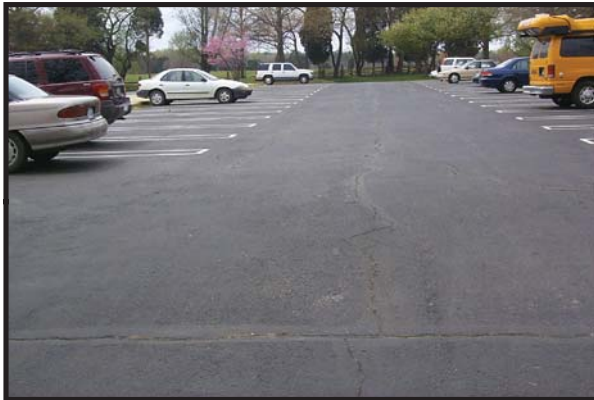
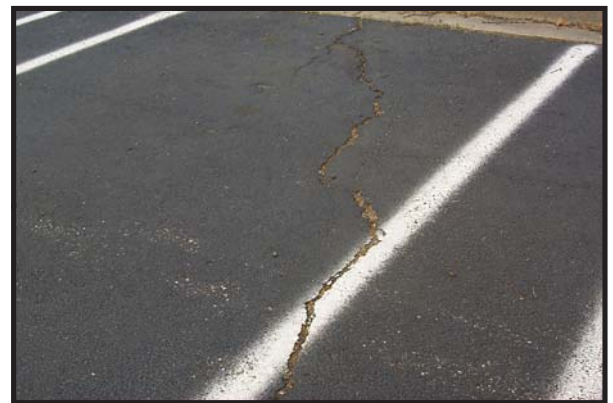
Route 0901

Route	Public / NonPublic	Date Visited	Area (sq ft)	Lane Miles *	Surface Type	Condition / PCR
0901	Public	4/13/2002	45142	0.78	AS	FAIR / 73

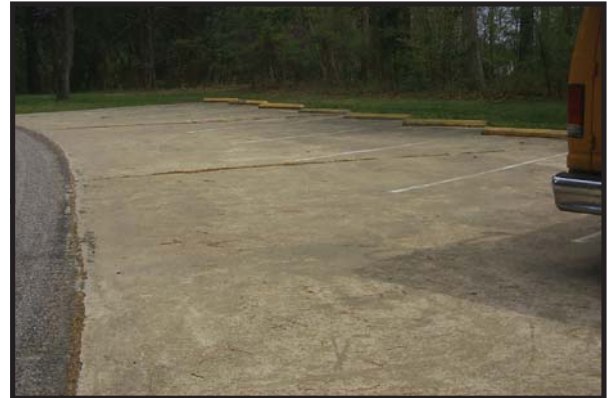
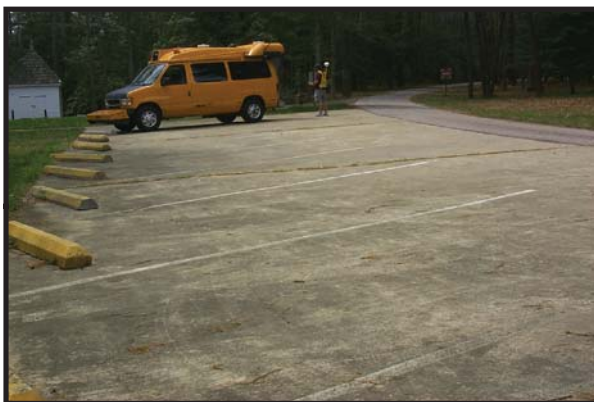
Route 0902

Route	Public / NonPublic	Date Visited	Area (sq ft)	Lane Miles *	Surface Type	Condition / PCR
0902	Public	4/13/2002	3175	0.05	CO	GOOD / 90

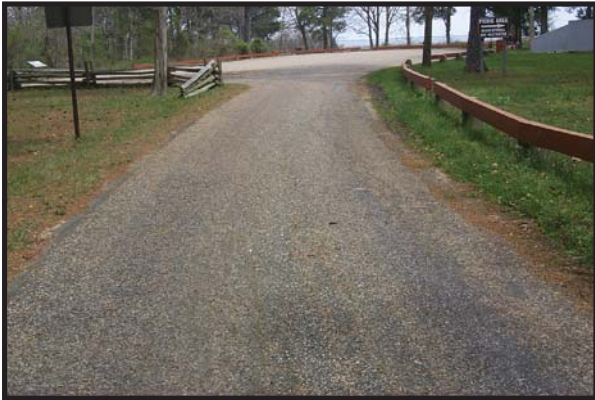
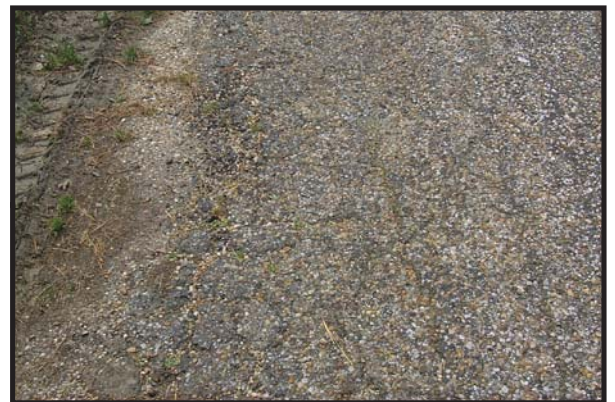
Route 0903

Route	Public / NonPublic	Date Visited	Area (sq ft)	Lane Miles *	Surface Type	Condition / PCR
0903	Public	4/13/2002	15864	0.27	OC	POOR / 45

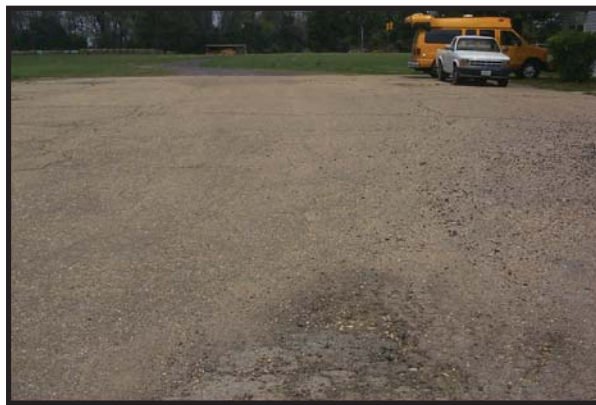
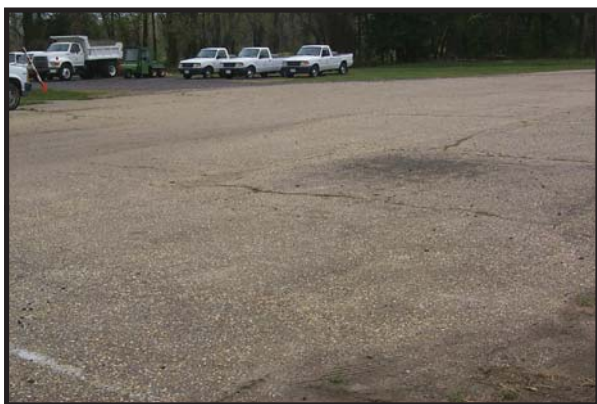
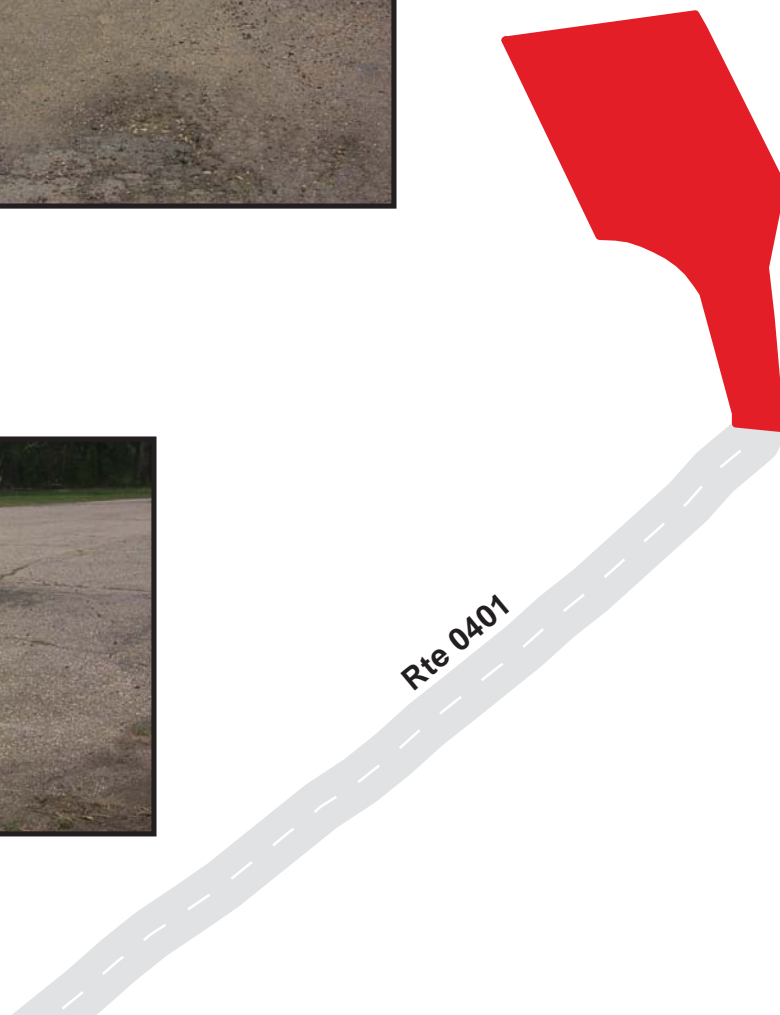
Route 0904

Route	Public / NonPublic	Date Visited	Area (sq ft)	Lane Miles *	Surface Type	Condition / PCR
0904	NonPublic	4/13/2002	7729	0.13	OC	POOR / 45

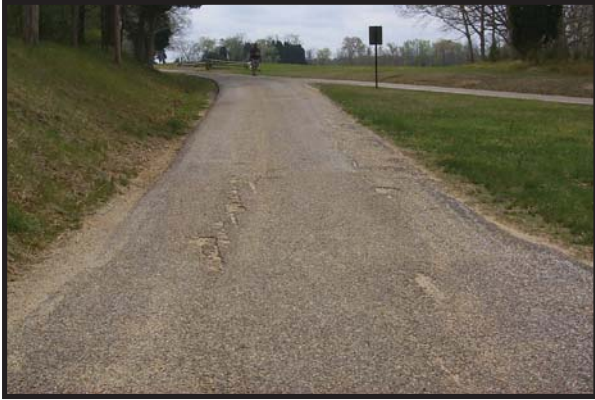
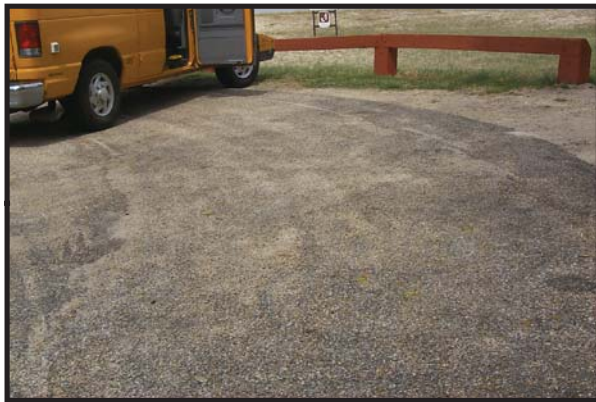
Route 0906

Route	Public / NonPublic	Date Visited	Area (sq ft)	Lane Miles *	Surface Type	Condition / PCR
0906	Public	4/13/2002	6939	0.12	OC	FAIR / 73
