The Road Inventory of Gila Cliff Dwellings National Monument GICL - 7250

Road Inventory Program

Prepared By:
Federal Highway Administration
Eastern Federal Lands Highway Division
Cycle 3

Gila Cliff Dwellings National Monument in New Mexico

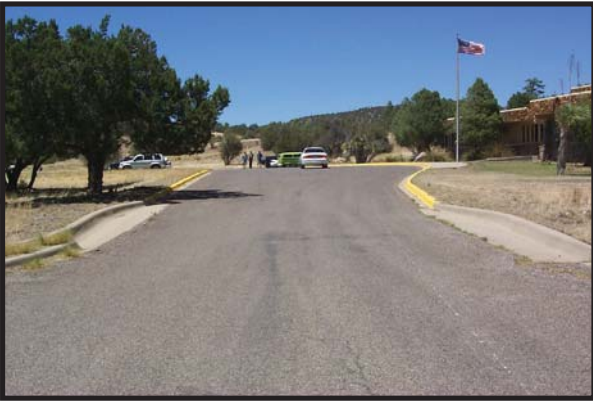
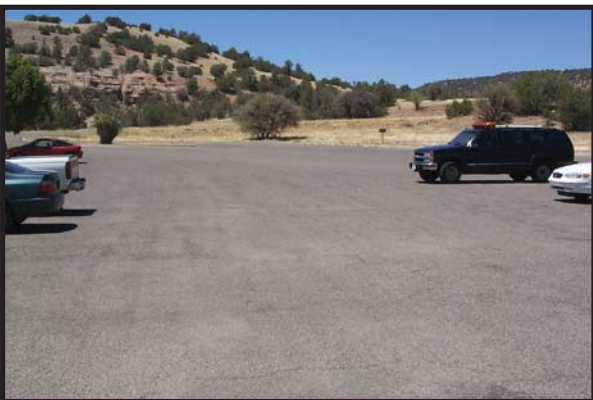
Route	Public / NonPublic	Date Visited	Area (sq ft)	Lane Miles *	Surface Type	Condition / PCR
0900	Public	5/21/2002	54064	0.93	OC	GOOD / 90

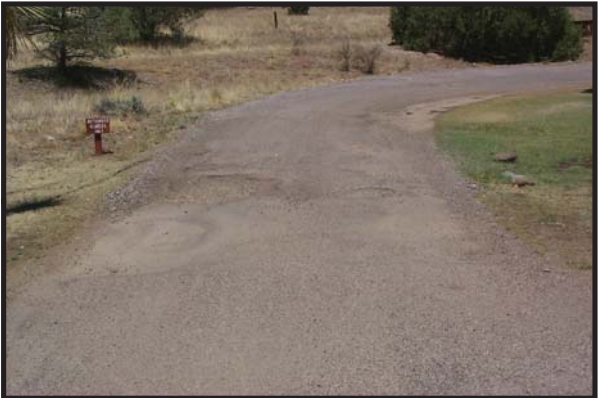
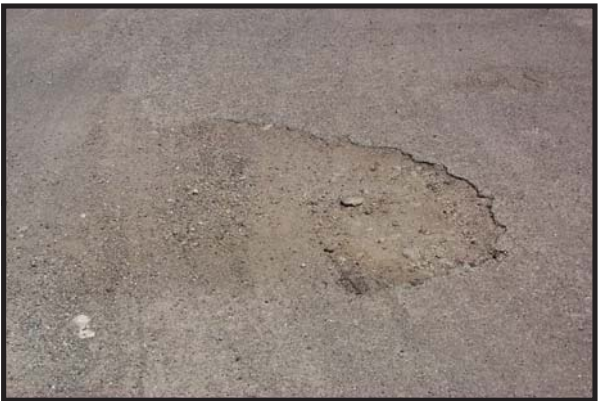
Route 0901

Route	Public / NonPublic	Date Visited	Area (sq ft)	Lane Miles *	Surface Type	Condition / PCR
0901	NonPublic	5/21/2002	3938	0.07	OC	FAIR / 73

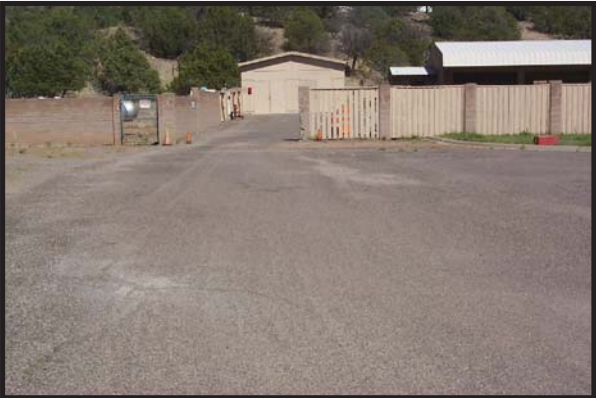
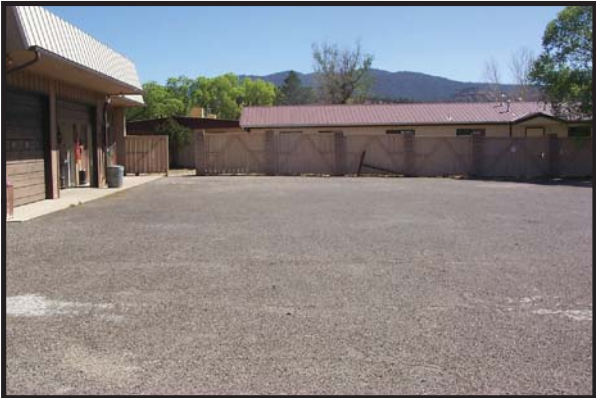
Route 0903

Route	Public / NonPublic	Date Visited	Area (sq ft)	Lane Miles *	Surface Type	Condition / PCR
0903	NonPublic	5/21/2002	16751	0.29	OC	POOR / 45

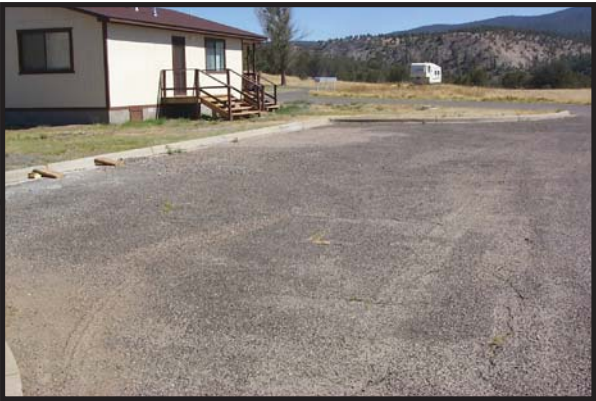
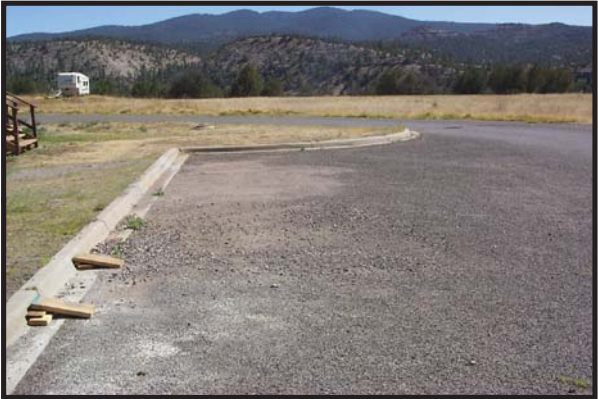
Route 0904A

Route	Public / NonPublic	Date Visited	Area (sq ft)	Lane Miles *	Surface Type	Condition / PCR
0904A	NonPublic	5/21/2002	1787	0.03	OC	FAIR / 73

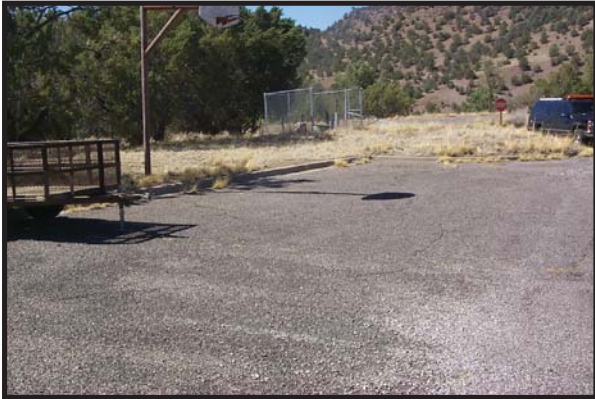
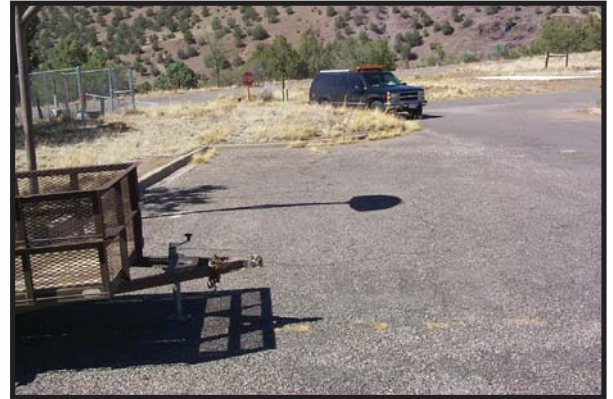
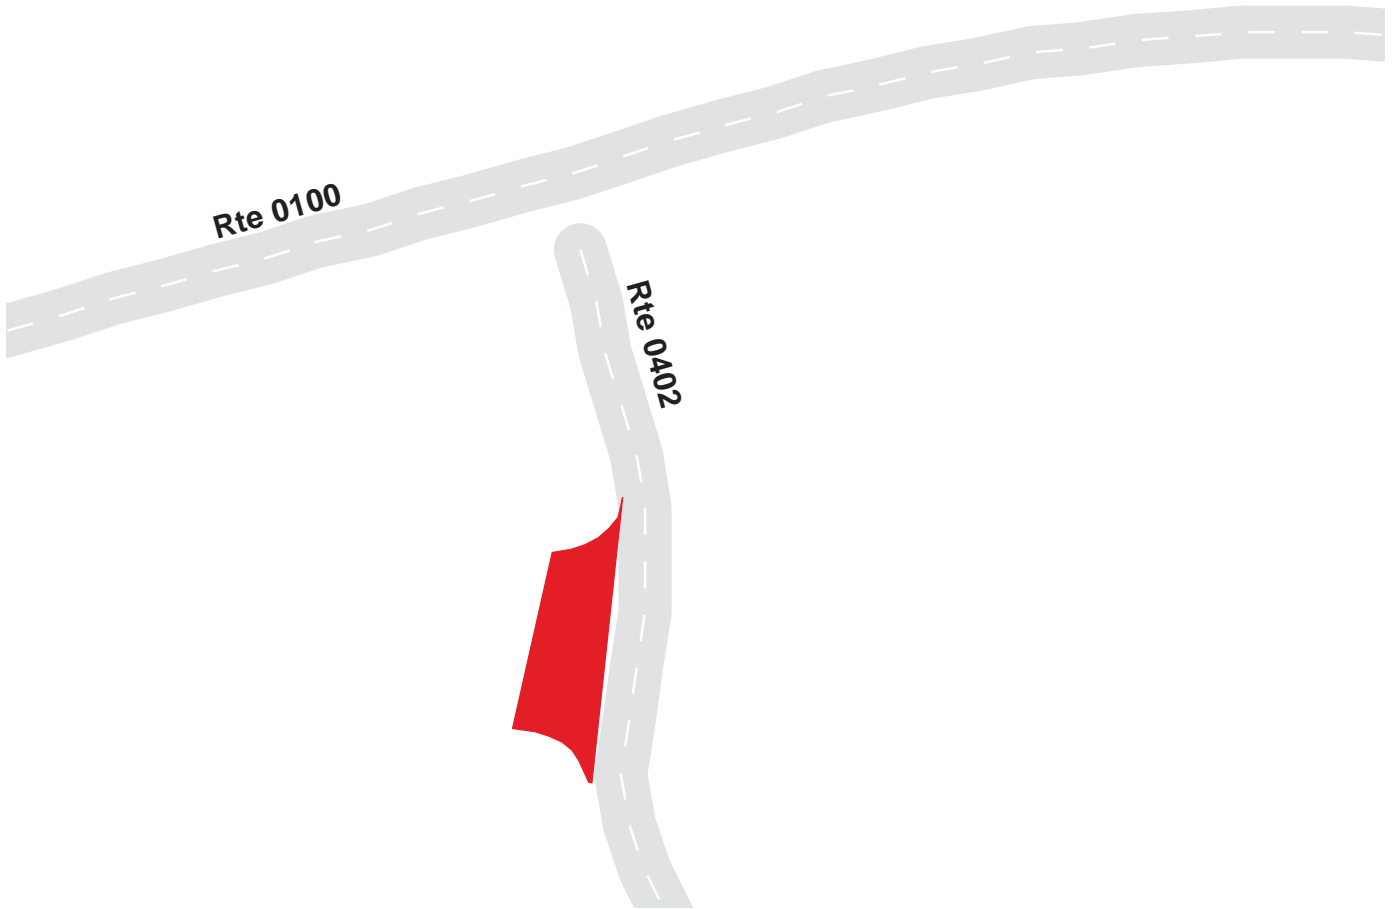
Route 0904B

Route	Public / NonPublic	Date Visited	Area (sq ft)	Lane Miles *	Surface Type	Condition / PCR
0904B	NonPublic	5/21/2002	1526	0.03	OC	FAIR / 73

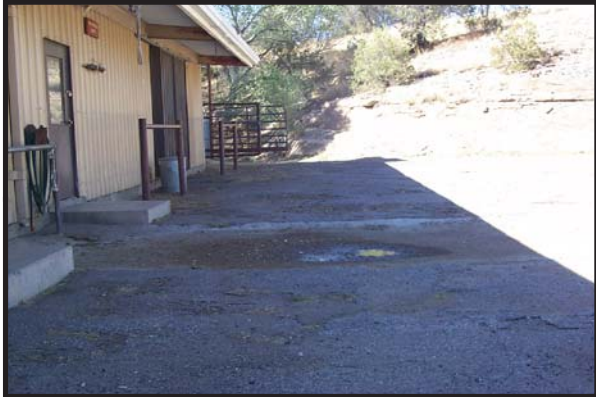
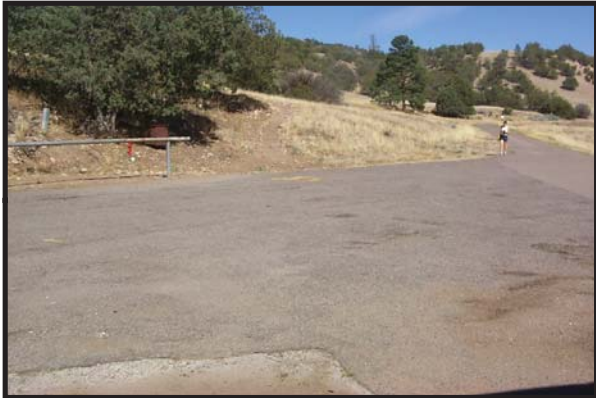
Route 0908

Route	Public / NonPublic	Date Visited	Area (sq ft)	Lane Miles *	Surface Type	Condition / PCR
0908	NonPublic	5/21/2002	5806	0.10	OC	FAIR / 73

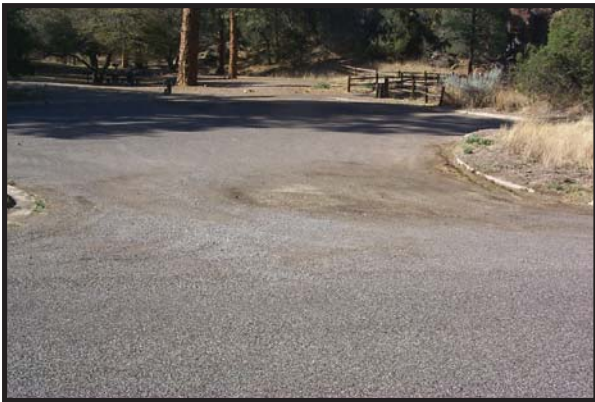
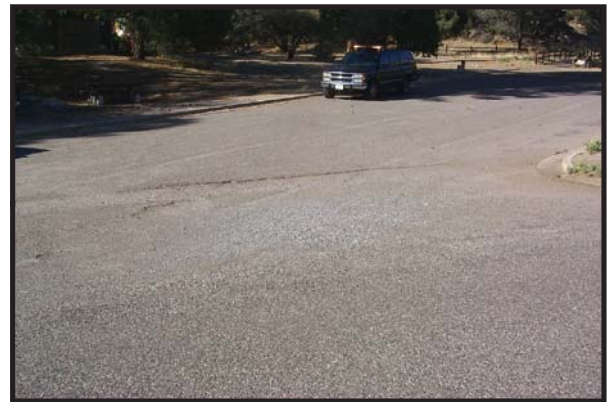
Route 0912

Route	Public / NonPublic	Date Visited	Area (sq ft)	Lane Miles *	Surface Type	Condition / PCR
0912	Public	5/21/2002	11476	0.20	OC	POOR / 45

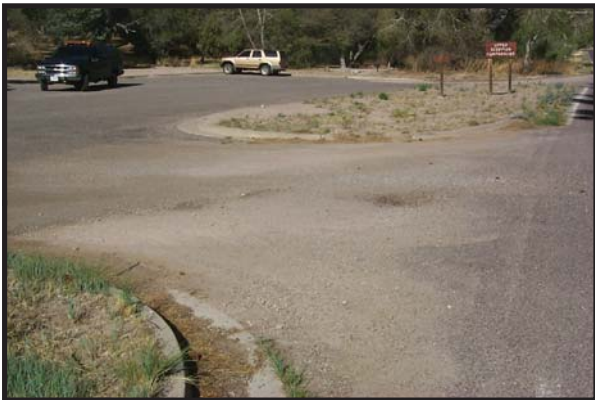
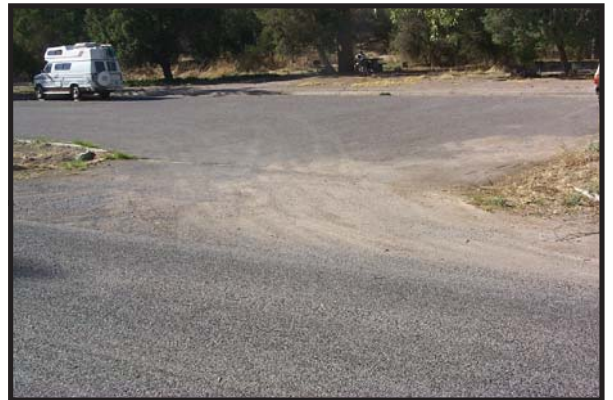
Route	Public / NonPublic	Date Visited	Area (sq ft)	Lane Miles *	Surface Type	Condition / PCR
0913	Public	5/21/2002	17701	0.30	OC	GOOD / 90

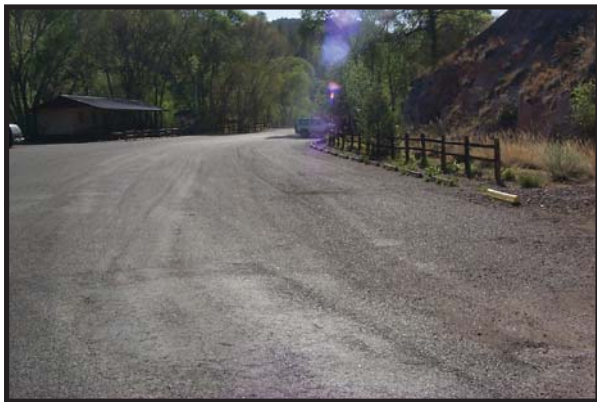
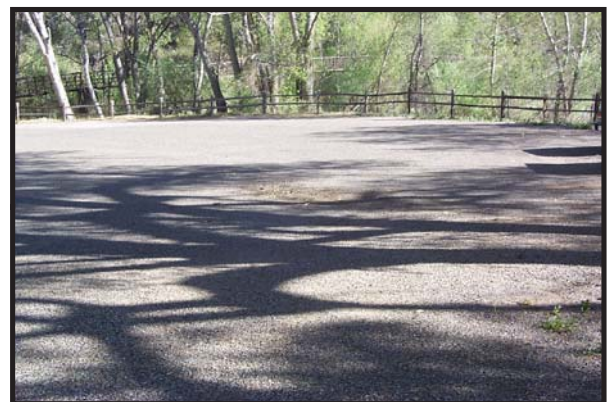
Route 0914

Route	Public / NonPublic	Date Visited	Area (sq ft)	Lane Miles *	Surface Type	Condition / PCR
0914	Public	5/21/2002	38007	0.65	OC	GOOD / 90
