The Road Inventory of Glacier National Park GLAC - 1430

Road Inventory Program

Prepared By:
Federal Highway Administration
Eastern Federal Lands Highway Division
Cycle 3

Glacier National Park in Montana

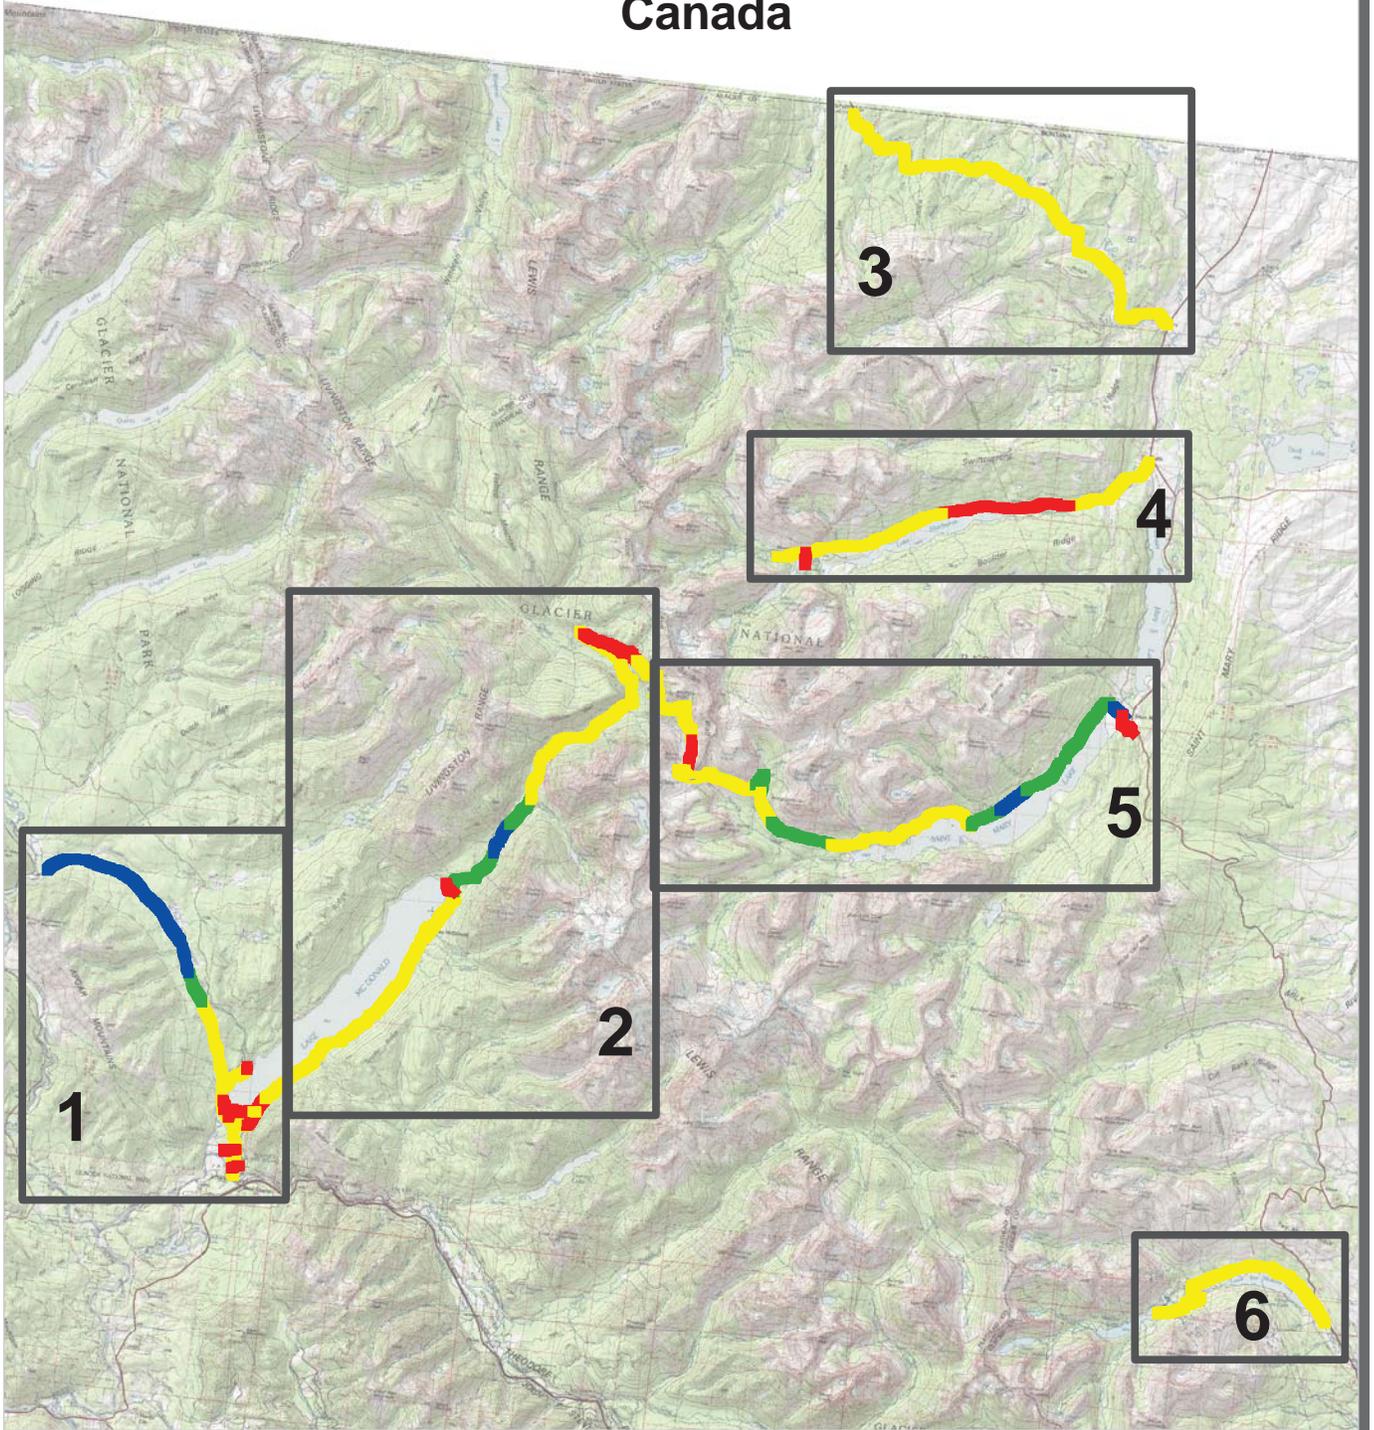
Glacier National Park Route Condition Key Map PCR - Mile by Mile

* If the PCR rating is not available for a section, the SCR rating will be displayed. See appendix for definitions and formulas.

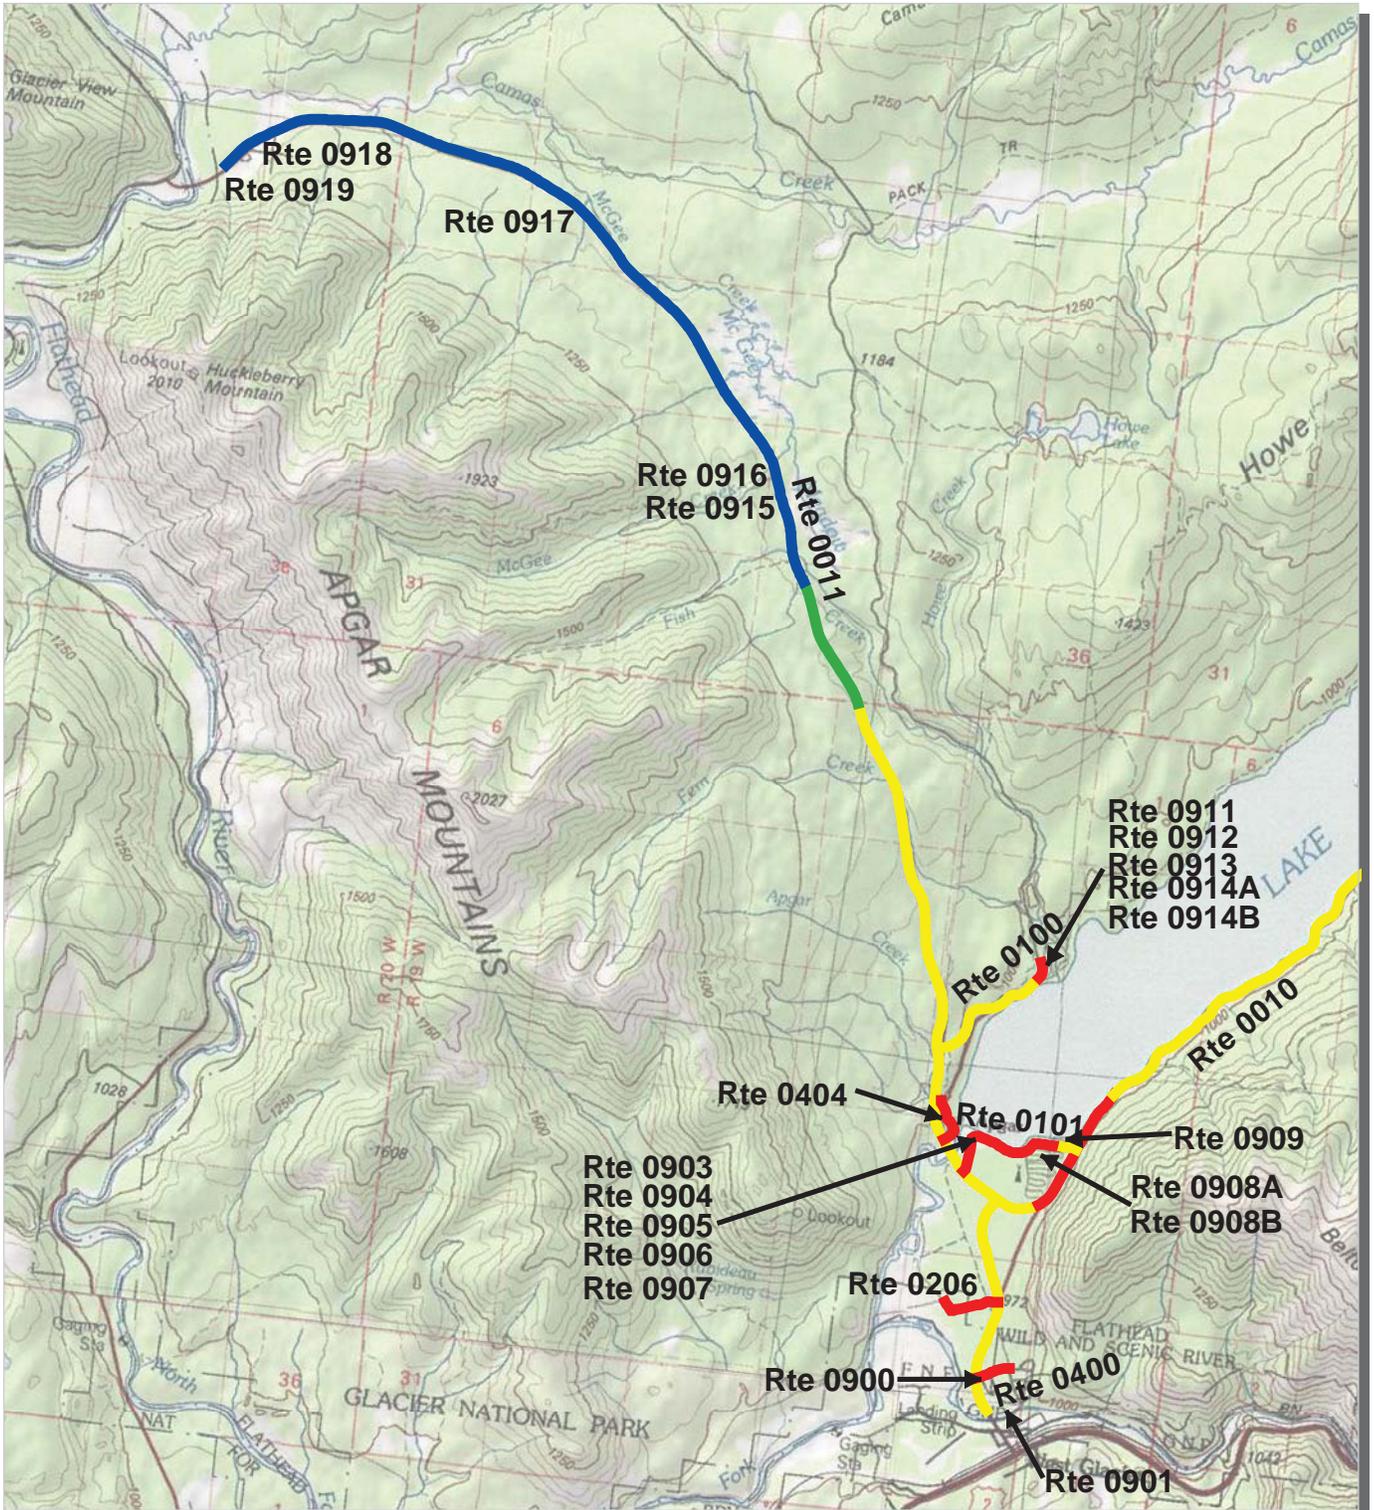
Glacier National Park Route Condition Area Map 1 PCR - Mile by Mile

PCR	Poor	Fair	Good	Excellent
	(≤60)	(61 - 84)	(85 - 94)	(95 - 100)

* If the PCR rating is not available for a section, the SCR rating will be displayed. See appendix for definitions and formulas.

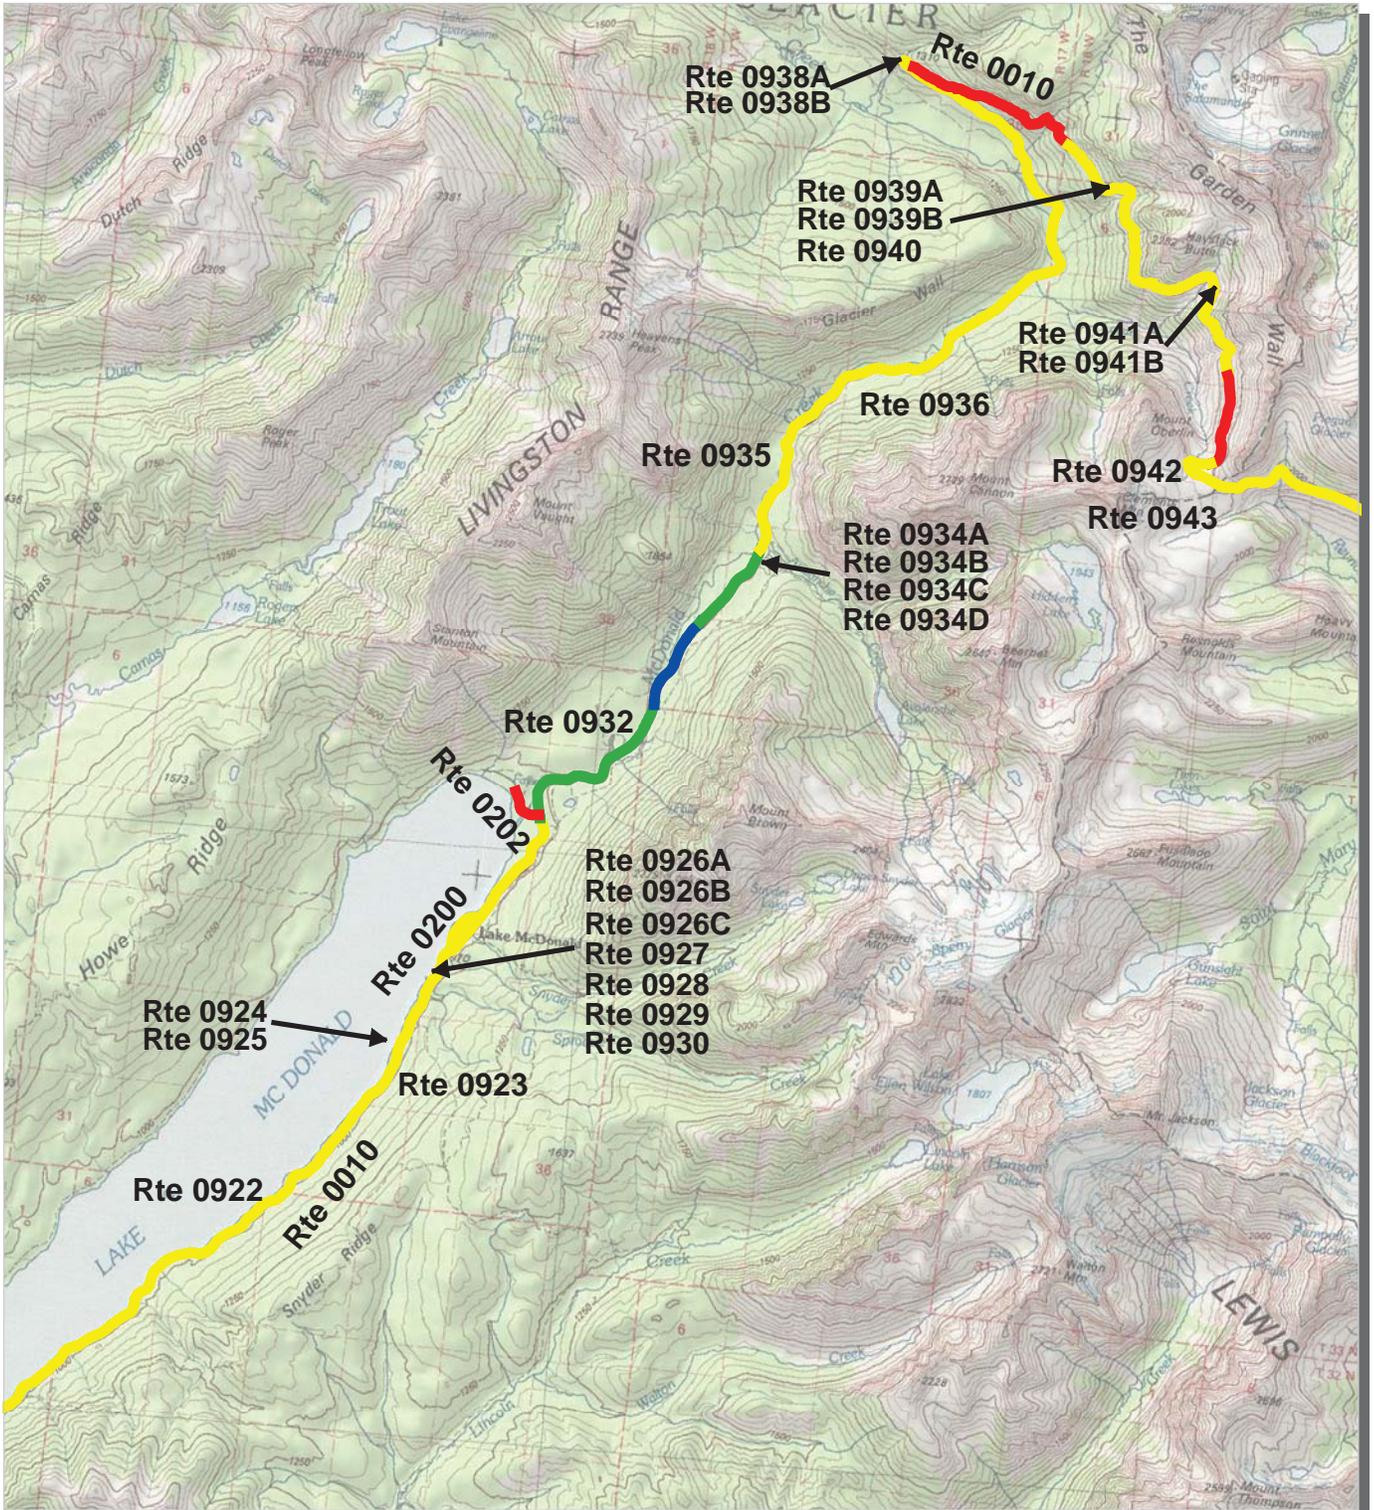
Glacier National Park Route Condition Area Map 2 PCR - Mile by Mile

PCR	Poor	Fair	Good	Excellent
	(≤60)	(61 - 84)	(85 - 94)	(95 - 100)

* If the PCR rating is not available for a section, the SCR rating will be displayed. See appendix for definitions and formulas.

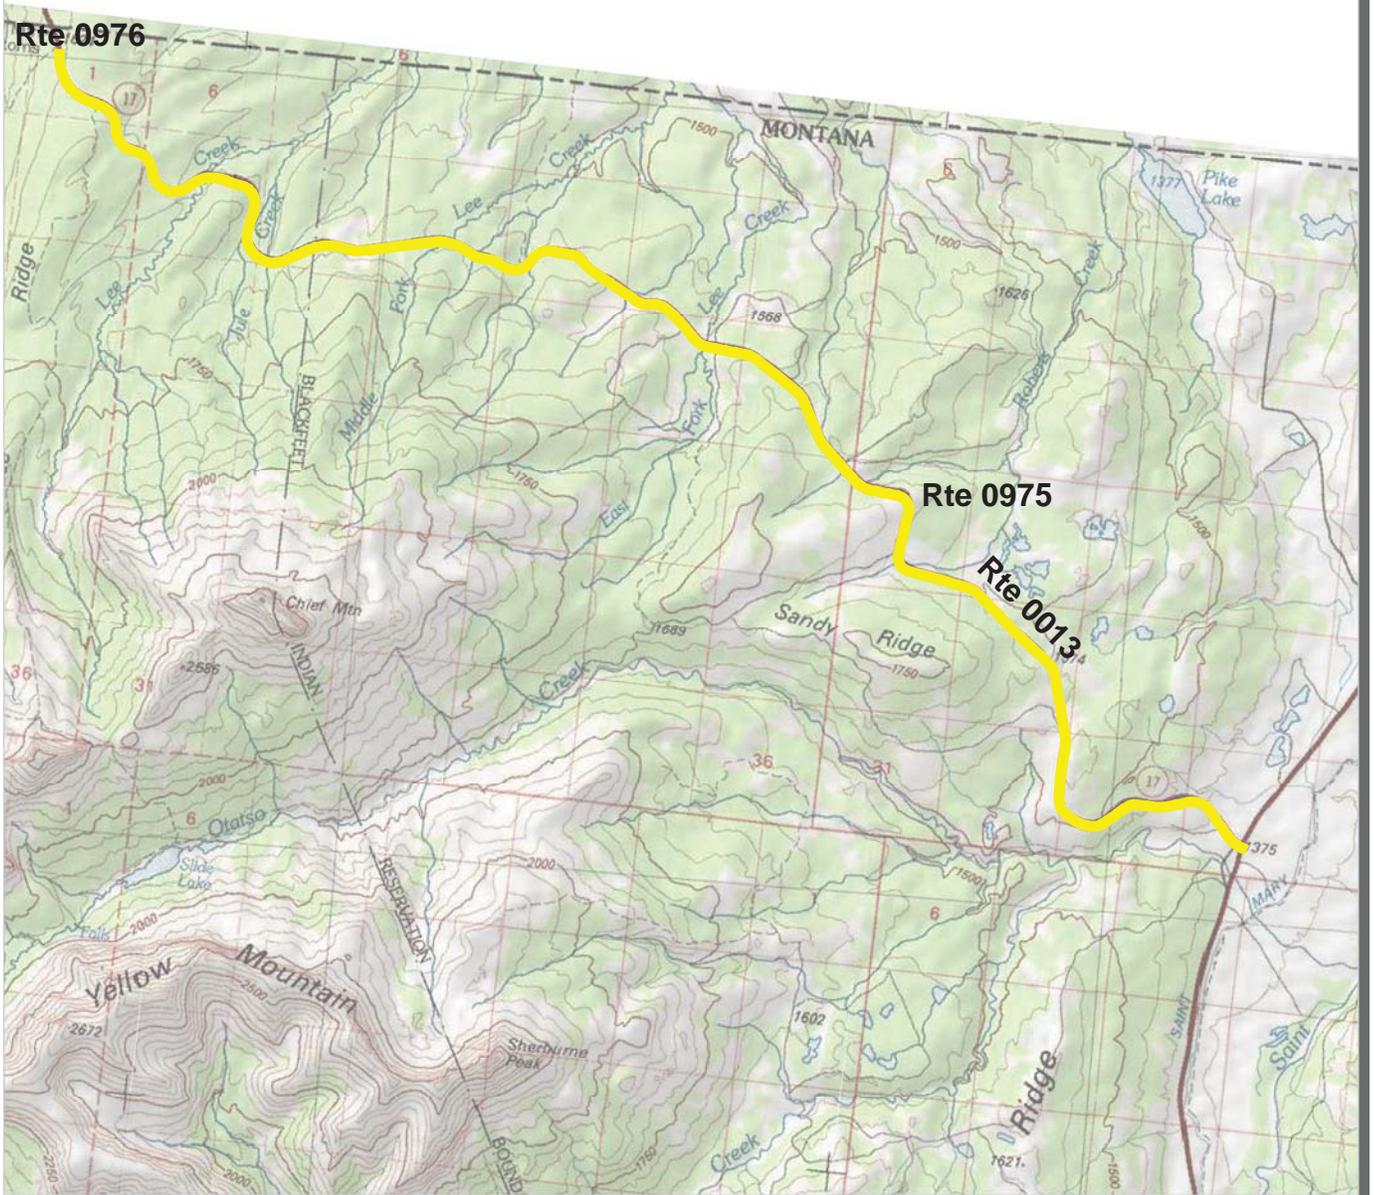
Glacier National Park Route Condition Area Map 3 PCR - Mile by Mile

PCR	Poor	Fair	Good	Excellent
	■	■	■	■
	(≤60)	(61 - 84)	(85 - 94)	(95 - 100)

* If the PCR rating is not available for a section, the SCR rating will be displayed. See appendix for definitions and formulas.

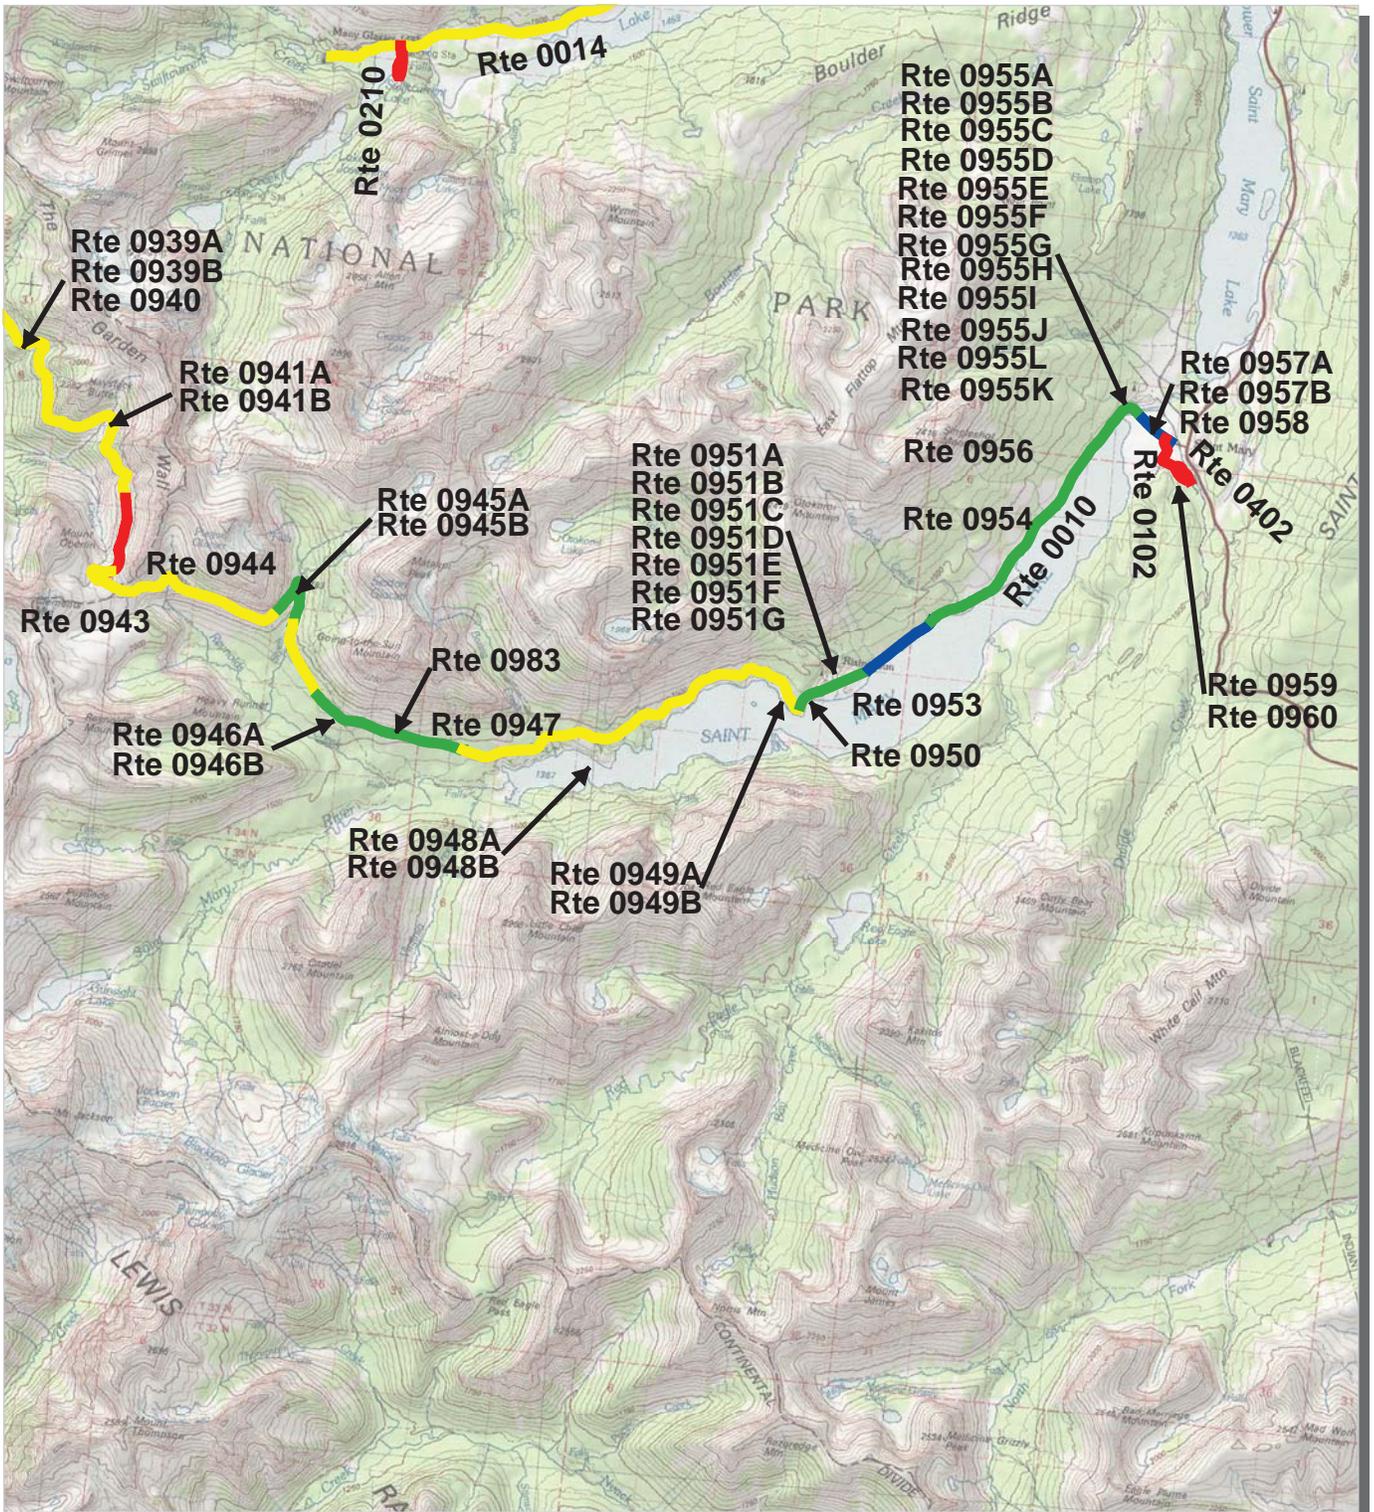
Glacier National Park Route Condition Area Map 5 PCR - Mile by Mile

PCR	Poor	■	Fair	■	Good	■	Excellent	■
		(<=60)		(61 - 84)		(85 - 94)		(95 - 100)

* If the PCR rating is not available for a section, the SCR rating will be displayed. See appendix for definitions and formulas.

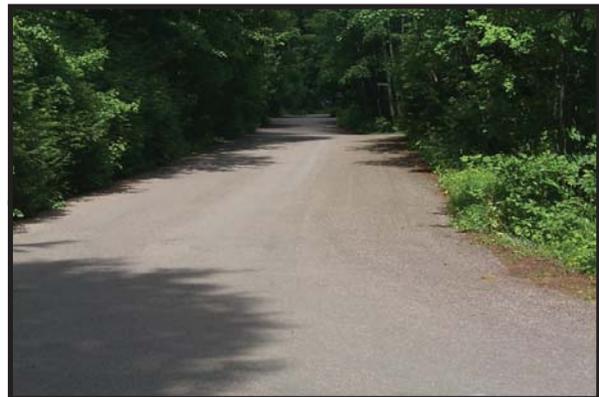
Glacier National Park
Route 0201A
Avalanche Campground Loop A
From Route 0201 at MP 0.20

Route	Length (mi)	Width (ft)	Area (sq ft)	Lane Miles *	Condition / PCR	Surface Type
0201A	0.37	11.00	21199	0.37	FAIR / 73	AS

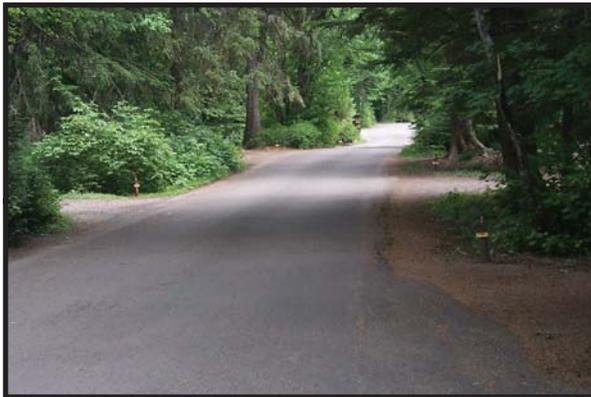
Glacier National Park
Route 0201B
Avalanche Campground Loop B
From End of Route 0201

Route	Length (mi)	Width (ft)	Area (sq ft)	Lane Miles *	Condition / PCR	Surface Type
0201B	0.28	11.00	16146	0.28	FAIR / 73	AS

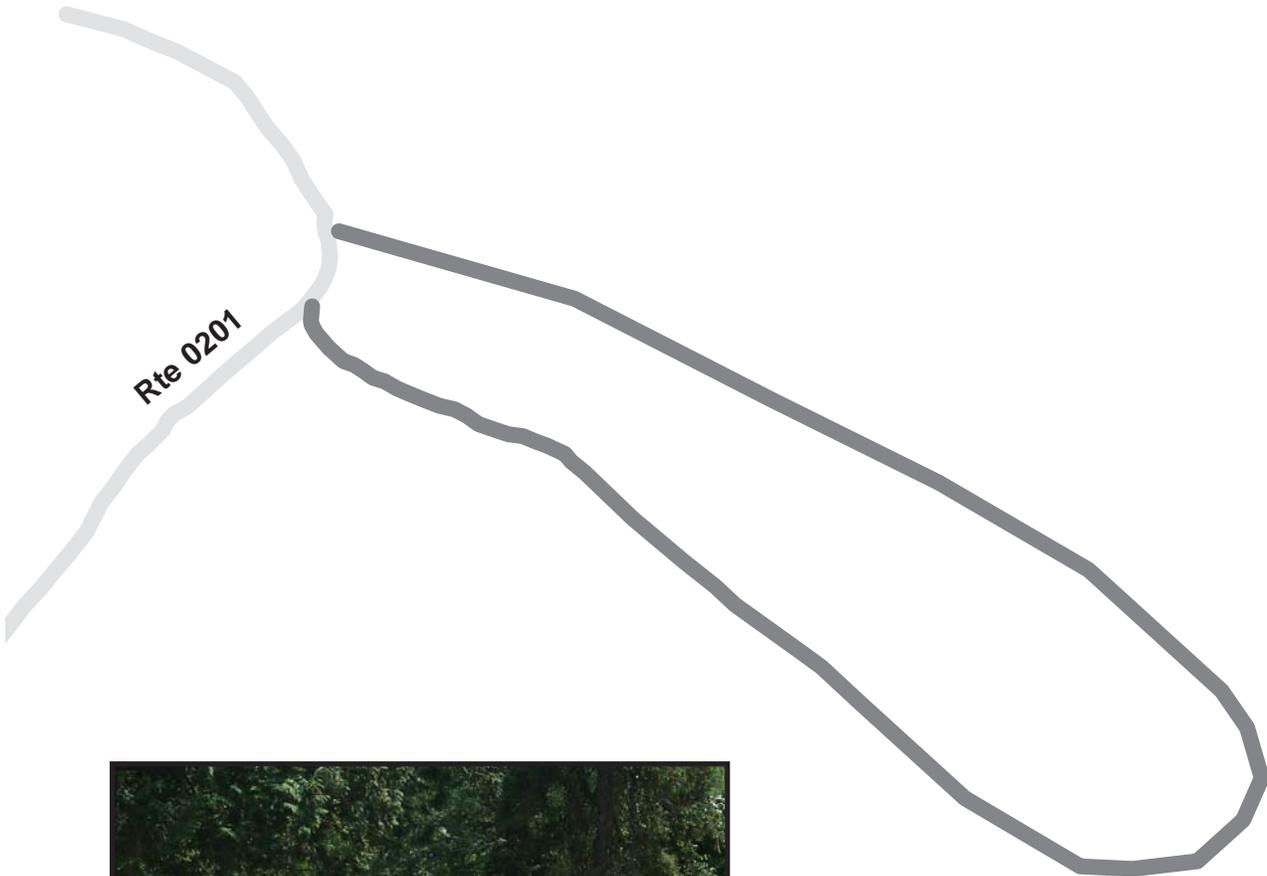
Glacier National Park
Route 0201C
Avalanche Campground Loop C
From Route 0201 at MP 0.10

Route	Length (mi)	Width (ft)	Area (sq ft)	Lane Miles *	Condition / PCR	Surface Type
0201C	0.48	11.00	27936	0.48	FAIR / 73	AS

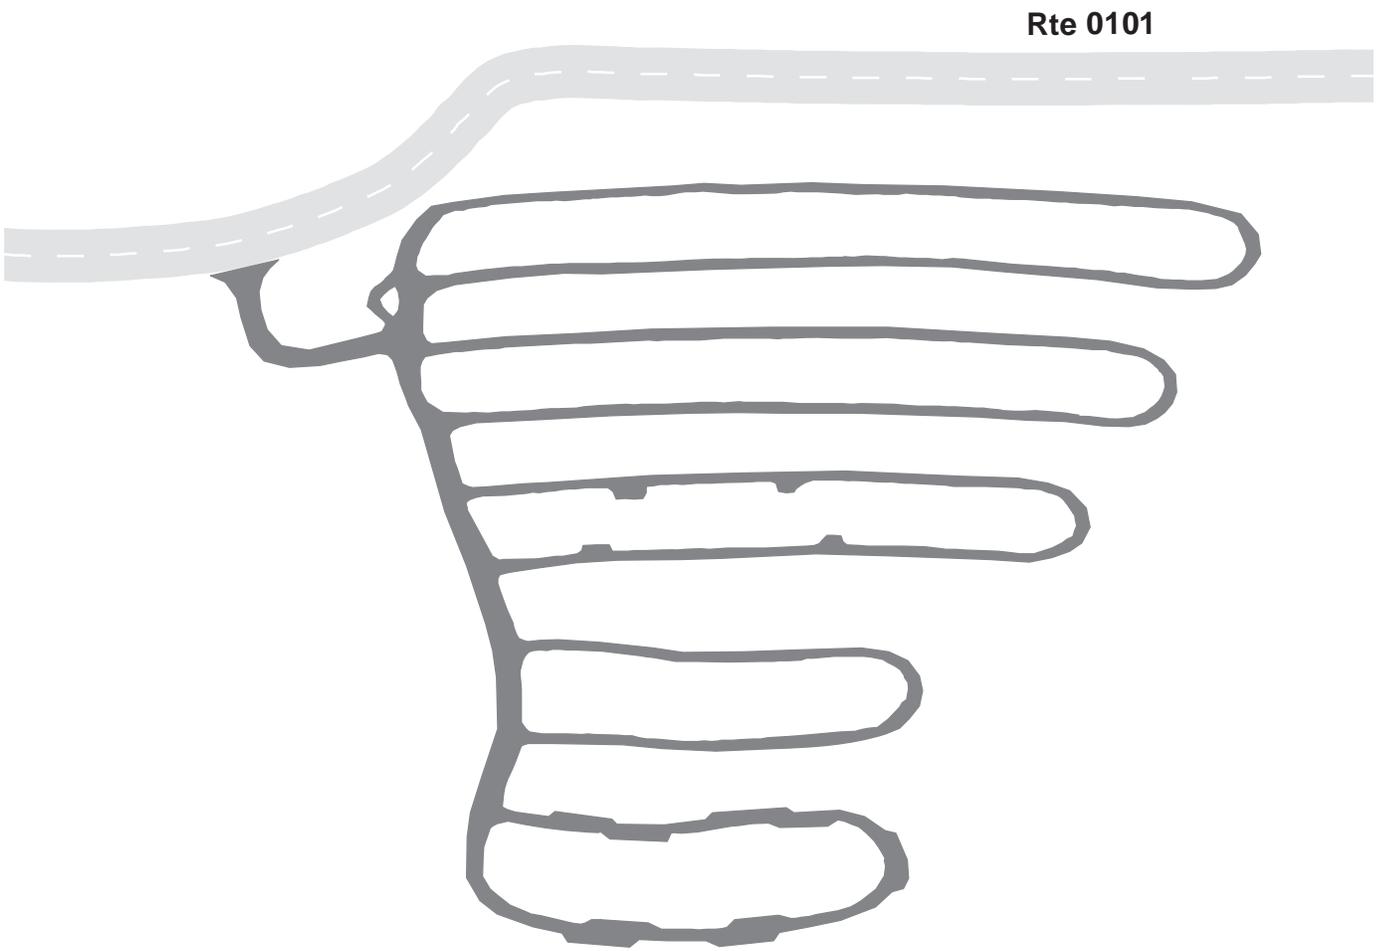
Glacier National Park
Route 0207
 Two Medicine Campground
 From Route 0012

Route	Length (mi)	Width (ft)	Area (sq ft)	Lane Miles *	Condition / PCR	Surface Type
0207	2.99	0.00	173540	2.99	FAIR / 73	OC

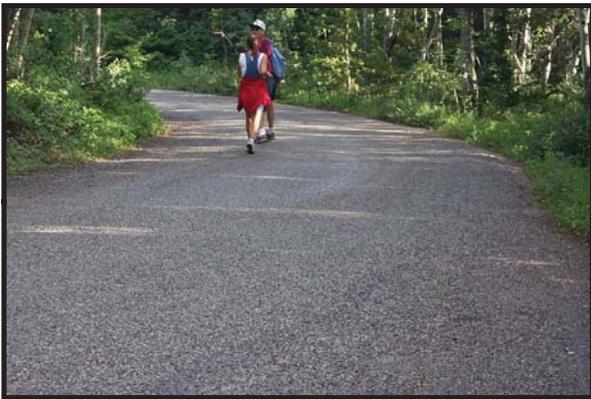
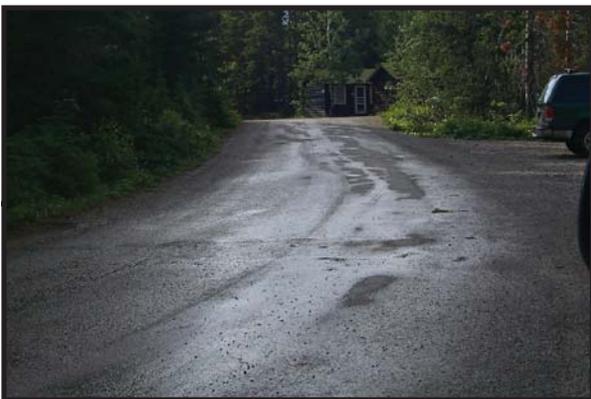
Glacier National Park
Route 0208B
Swift Current Cabins Cutoff Road
From Route 0208A

Route	Length (mi)	Width (ft)	Area (sq ft)	Lane Miles *	Condition / PCR	Surface Type
0208B	0.03	15.00	2218	0.04	FAIR / 73	OC

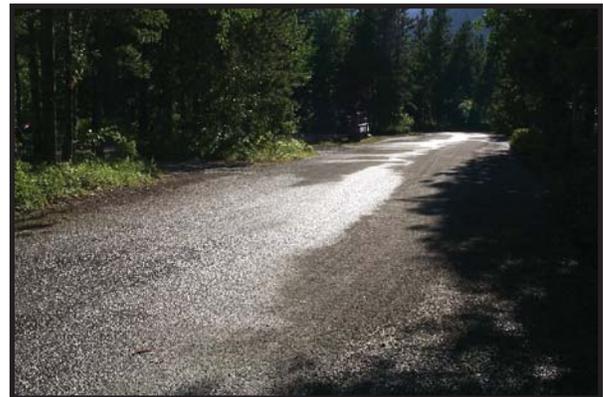
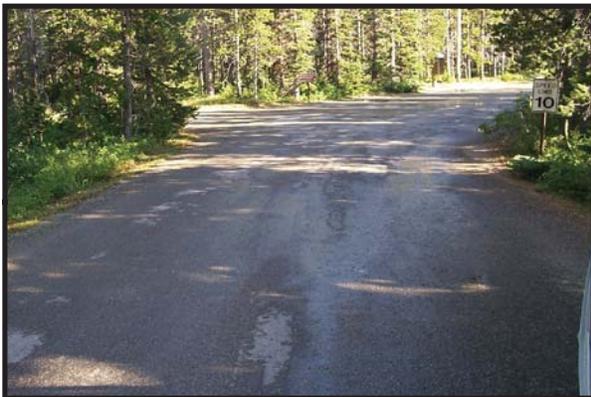
Glacier National Park
Route 0209B
Many Glacier Campground Loop B
From Route 0209A

Route	Length (mi)	Width (ft)	Area (sq ft)	Lane Miles *	Condition / PCR	Surface Type
0209B	0.23	11.00	13300	0.23	FAIR / 73	OC

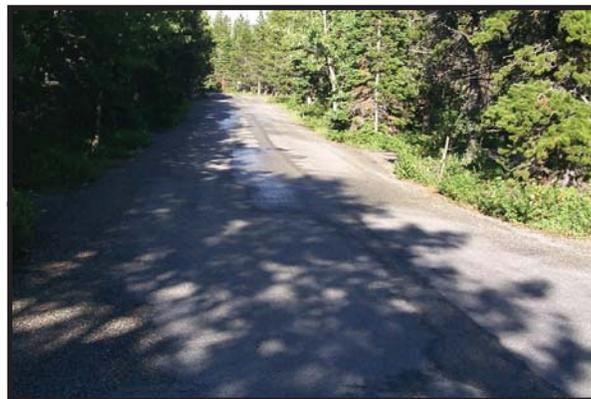
Glacier National Park
Route 0211
Sun Point Road
From Route 0010 at MP 39.7

Route	Length (mi)	Width (ft)	Area (sq ft)	Lane Miles *	Condition / PCR	Surface Type
0211	0.31	11.00	17947	0.31	FAIR / 73	AS

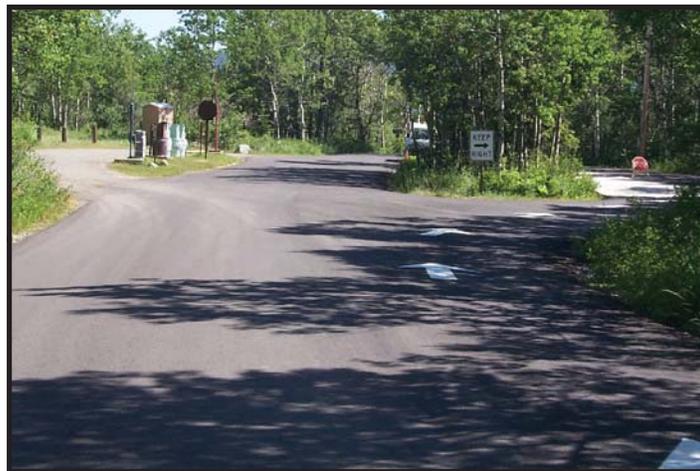
Glacier National Park
Route 0214A
St. Mary Campground Loop A
From End of Route 0214

Route	Length (mi)	Width (ft)	Area (sq ft)	Lane Miles *	Condition / PCR	Surface Type
0214A	0.47	12.00	29462	0.51	FAIR / 73	OC

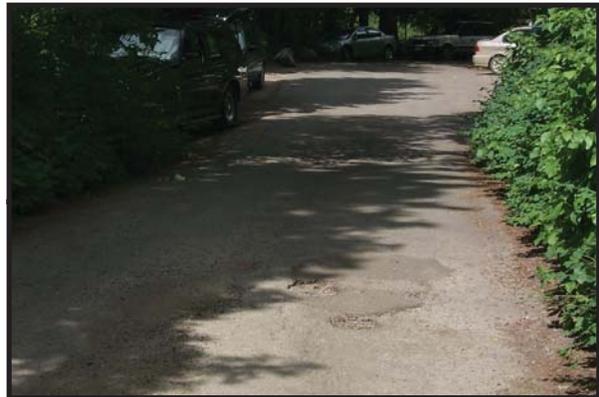
Glacier National Park
Route 0401
 Many Glacier Residence Area
 From Route 0209A

Route	Length (mi)	Width (ft)	Area (sq ft)	Lane Miles *	Condition / PCR	Surface Type
0401	0.25	0.00	40660	0.70	GOOD / 90	AS

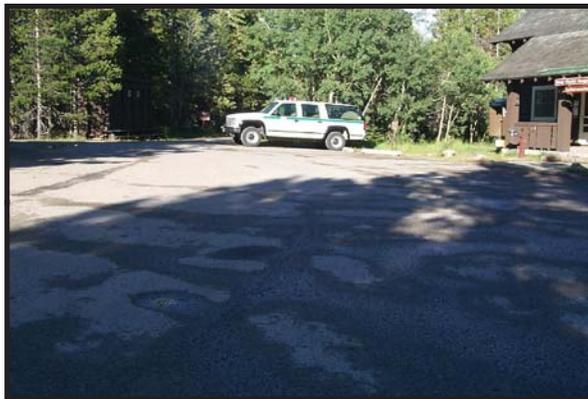
Glacier National Park
Route 0407
 Camel'S Hump Road
 From End of Route 0400 on Left

Route	Length (mi)	Width (ft)	Area (sq ft)	Lane Miles *	Condition / PCR	Surface Type
0407	0.27	0.00	15588	0.27	POOR / 45	OC

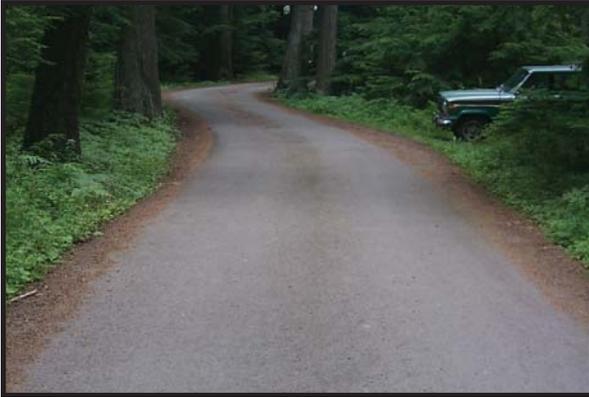
Glacier National Park
Route 0409
 Headquarters Residence Area Road
 From End of Route 0400

Route	Length (mi)	Width (ft)	Area (sq ft)	Lane Miles *	Condition / PCR	Surface Type
0409	2.17	0.00	252243	4.34	GOOD / 90	AS

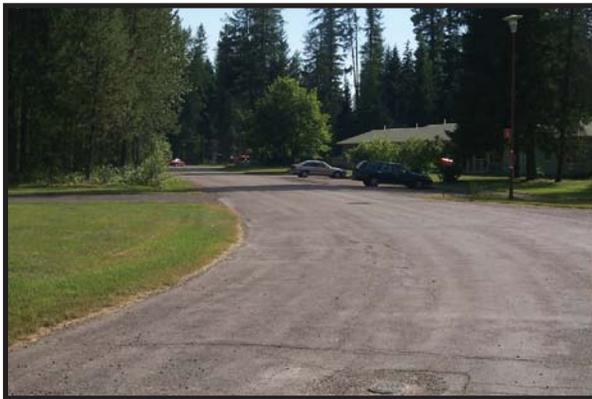
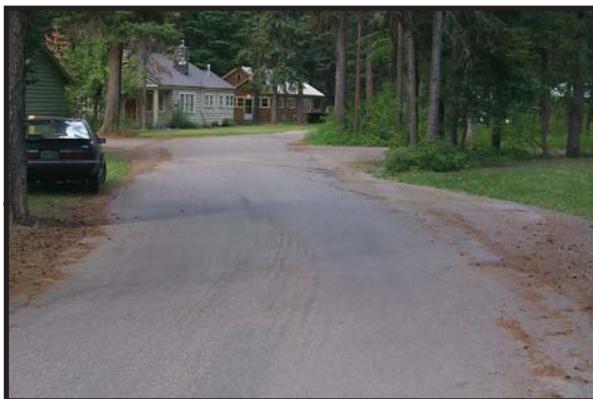
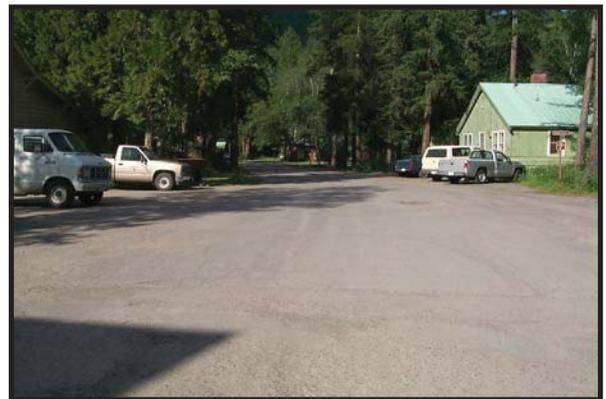
Glacier National Park Route 0900

Headquarters Visitor Parking
Adjacent to Route 0400

Route	Public / NonPublic	Date Visited	Area (sq ft)	Lane Miles *	Surface Type	Condition / PCR
0900	NonPublic	7/14/2001	12068	0.21	AS	FAIR / 73

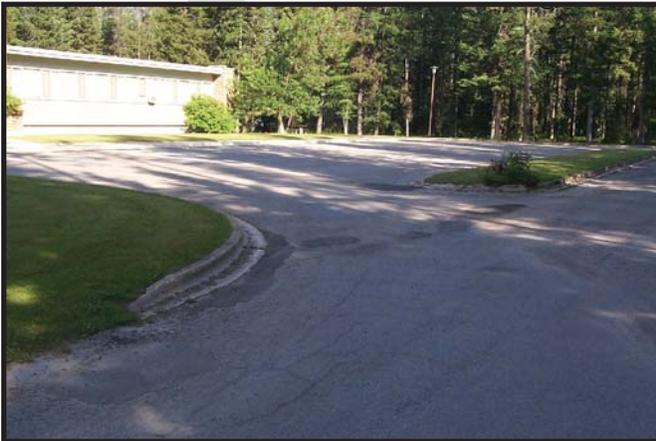
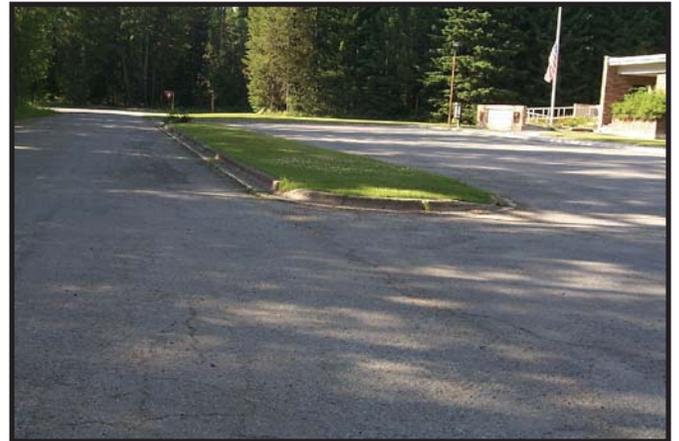
Route 0901

Route	Public / NonPublic	Date Visited	Area (sq ft)	Lane Miles *	Surface Type	Condition / PCR
0901	NonPublic	7/14/2001	197398	3.40	AS	POOR / 45

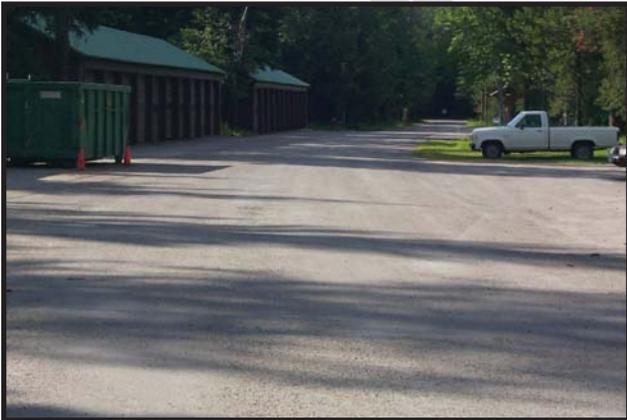
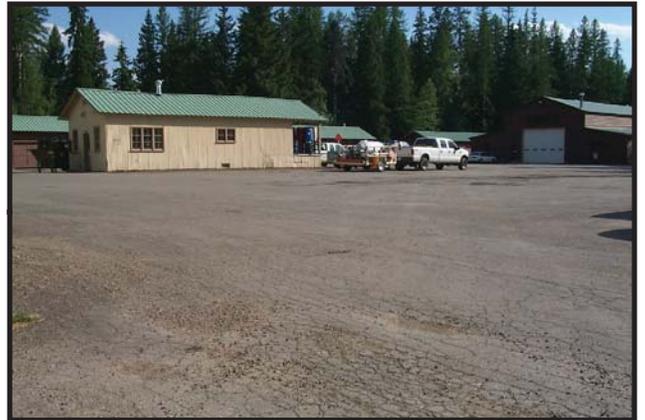
Route 0903

Route	Public / NonPublic	Date Visited	Area (sq ft)	Lane Miles *	Surface Type	Condition / PCR
0903	Public	7/14/2001	4683	0.08	AS	FAIR / 73

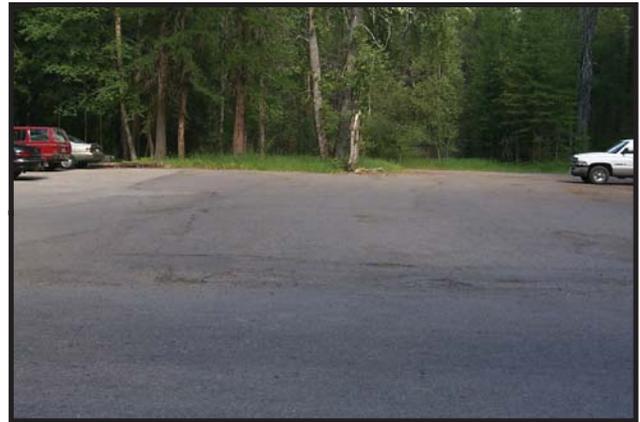
Route 0904

Route	Public / NonPublic	Date Visited	Area (sq ft)	Lane Miles *	Surface Type	Condition / PCR
0904	Public	7/14/2001	10599	0.18	AS	GOOD / 90

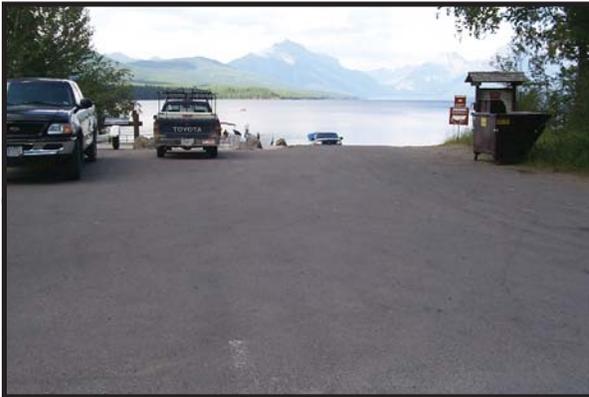
Route 0907

Route	Public / NonPublic	Date Visited	Area (sq ft)	Lane Miles *	Surface Type	Condition / PCR
0907	Public	7/14/2001	19686	0.34	AS	GOOD / 90

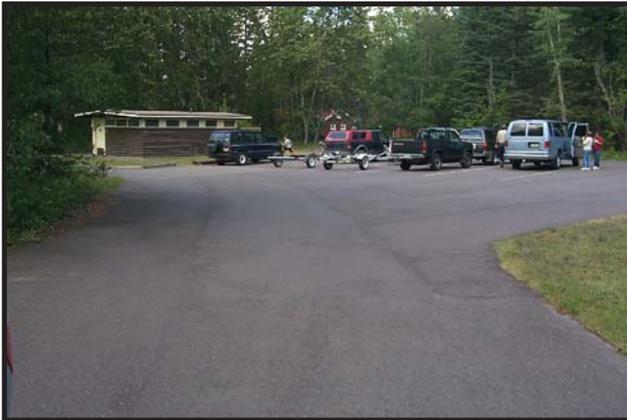
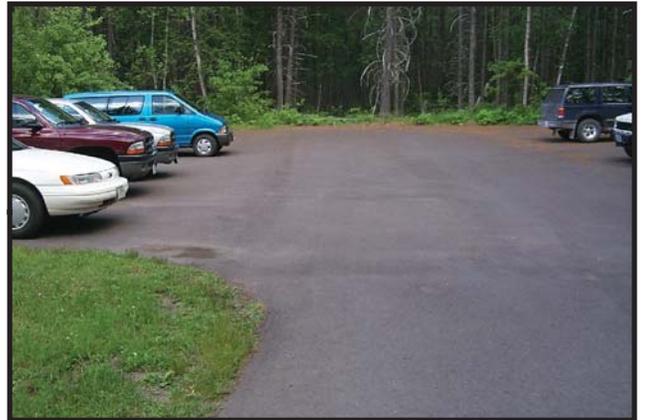
Route 0908A

Route	Public / NonPublic	Date Visited	Area (sq ft)	Lane Miles *	Surface Type	Condition / PCR
0908A	Public	7/14/2001	6309	0.11	AS	FAIR / 73

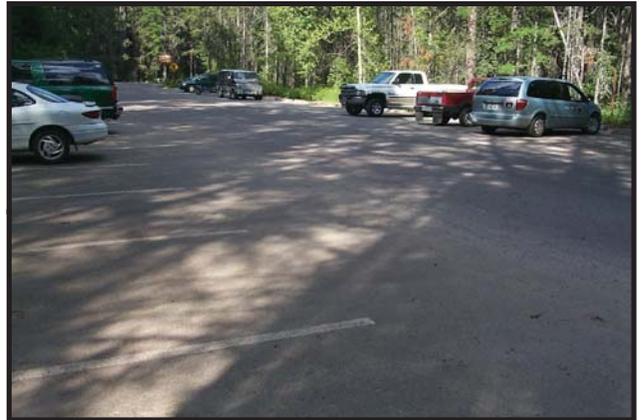
Route 0908B

Route	Public / NonPublic	Date Visited	Area (sq ft)	Lane Miles *	Surface Type	Condition / PCR
0908B	Public	7/14/2001	7709	0.13	AS	FAIR / 73

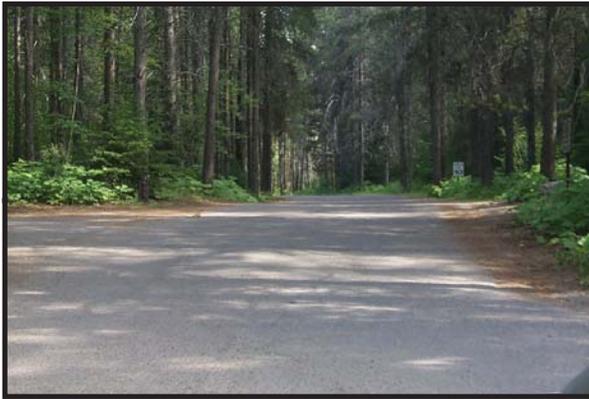
Route 0909

Route	Public / NonPublic	Date Visited	Area (sq ft)	Lane Miles *	Surface Type	Condition / PCR
0909	Public	7/14/2001	37088	0.64	AS	FAIR / 73

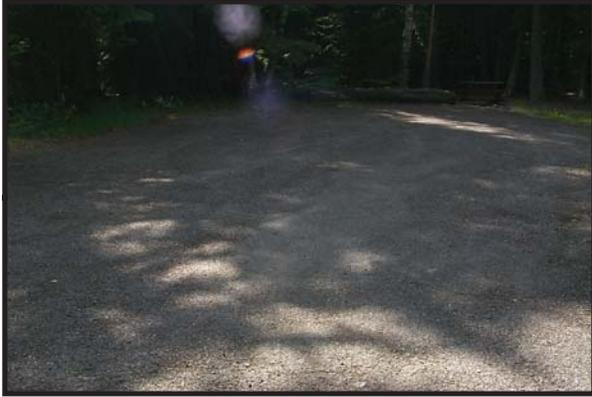
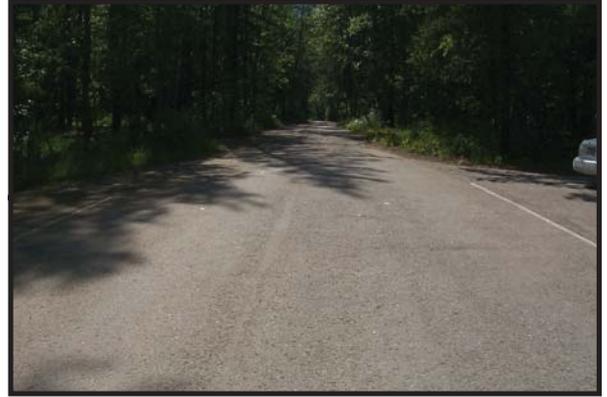
Route 0911

Route	Public / NonPublic	Date Visited	Area (sq ft)	Lane Miles *	Surface Type	Condition / PCR
0911	Public	7/14/2001	20005	0.34	AS	FAIR / 73

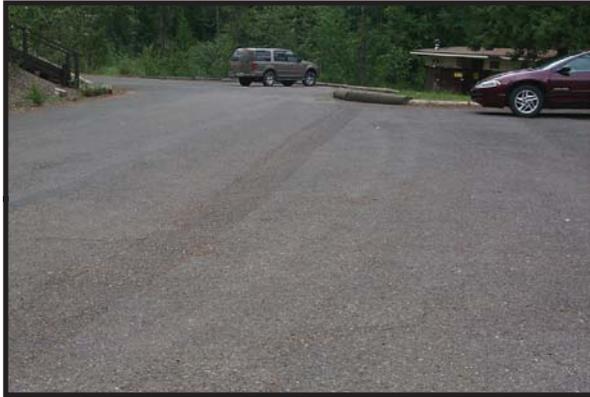
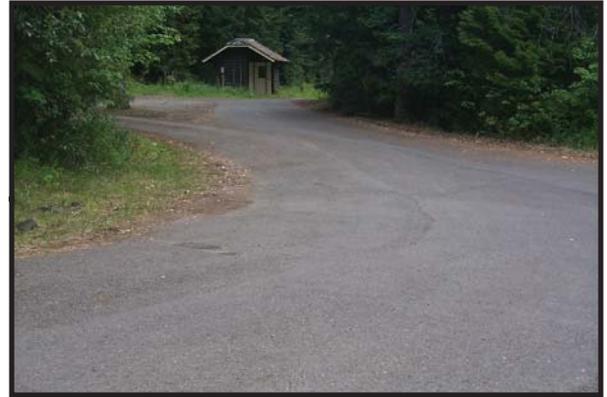
Route 0912

Route	Public / NonPublic	Date Visited	Area (sq ft)	Lane Miles *	Surface Type	Condition / PCR
0912	Public	7/14/2001	7944	0.14	AS	FAIR / 73

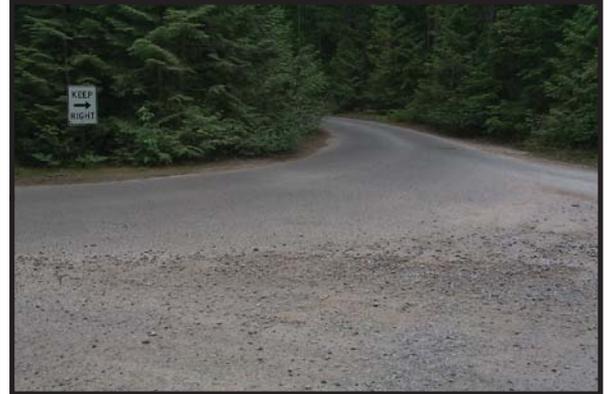
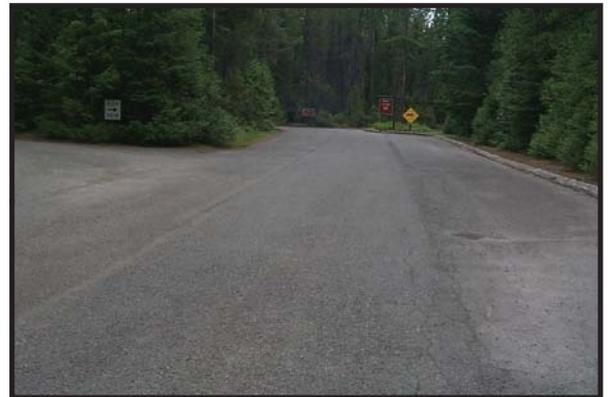
Route 0913

Route	Public / NonPublic	Date Visited	Area (sq ft)	Lane Miles *	Surface Type	Condition / PCR
0913	NonPublic	7/14/2001	7928	0.14	AS	FAIR / 73

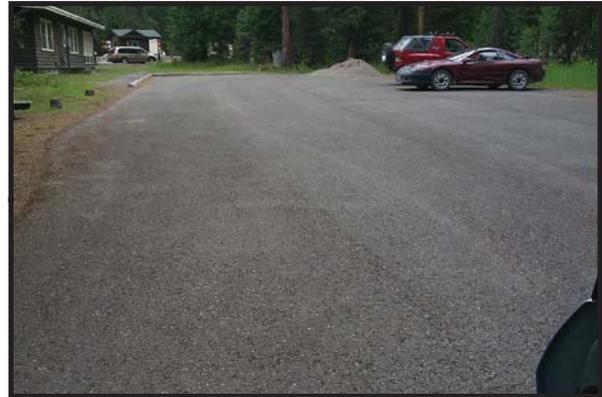
Route 0914A

Route	Public / NonPublic	Date Visited	Area (sq ft)	Lane Miles *	Surface Type	Condition / PCR
0914A	Public	7/14/2001	1891	0.03	AS	FAIR / 73

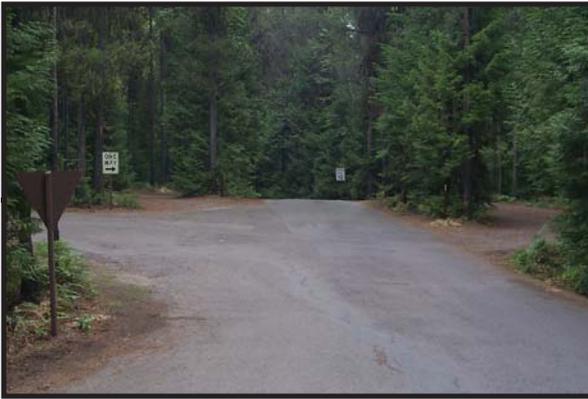
Route 0914B

Route	Public / NonPublic	Date Visited	Area (sq ft)	Lane Miles *	Surface Type	Condition / PCR
0914B	Public	7/14/2001	15065	0.26	AS	FAIR / 73

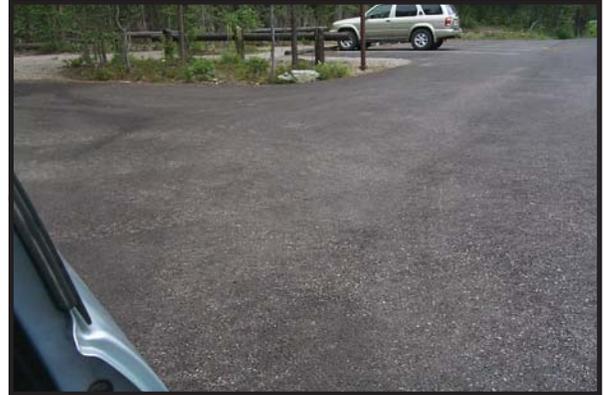
Route 0917

Route	Public / NonPublic	Date Visited	Area (sq ft)	Lane Miles *	Surface Type	Condition / PCR
0917	Public	7/14/2001	17072	0.29	AS	EXCELLENT / 97

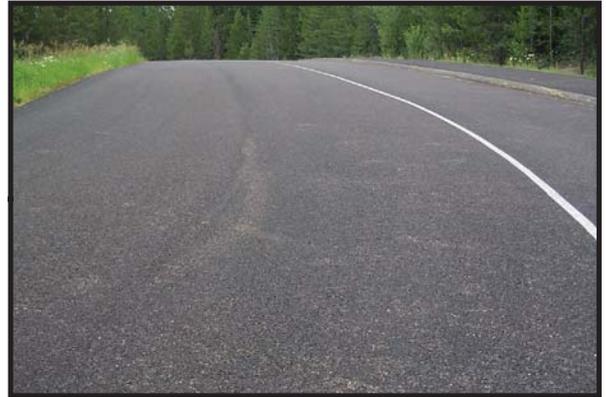
Route 0918

Route	Public / NonPublic	Date Visited	Area (sq ft)	Lane Miles *	Surface Type	Condition / PCR
0918	Public	7/14/2001	4822	0.08	AS	EXCELLENT / 97

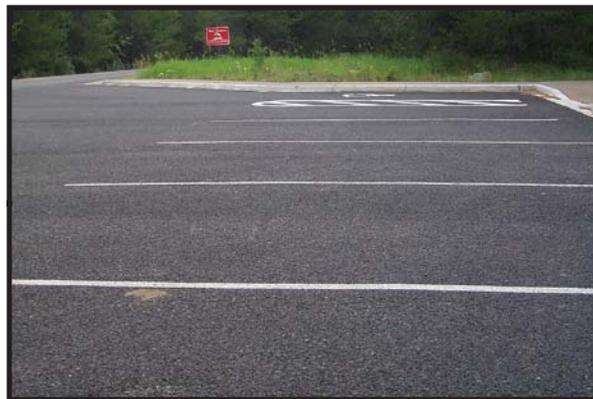
Route 0919

Route	Public / NonPublic	Date Visited	Area (sq ft)	Lane Miles *	Surface Type	Condition / PCR
0919	Public	7/14/2001	29152	0.50	AS	GOOD / 90

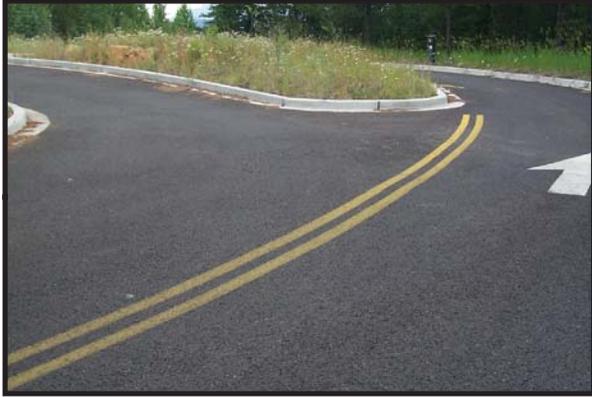
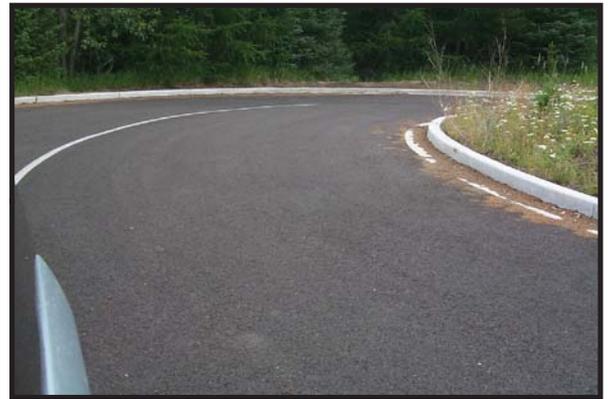
Route 0922

Route	Public / NonPublic	Date Visited	Area (sq ft)	Lane Miles *	Surface Type	Condition / PCR
0922	Public	7/14/2001	5894	0.10	OC	GOOD / 90
