The Road Inventory of Glacier National Park GLAC - 1430

Road Inventory Program

Prepared By:
Federal Highway Administration
Eastern Federal Lands Highway Division
Cycle 3

Glacier National Park in Montana

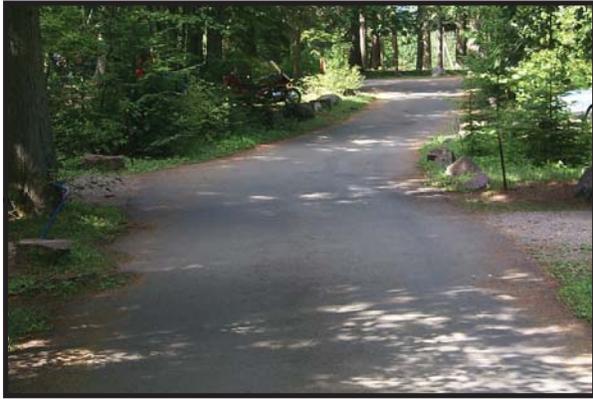
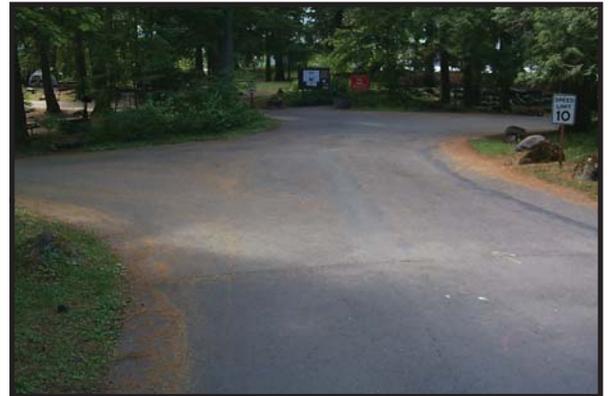
Route 0925

Route	Public / NonPublic	Date Visited	Area (sq ft)	Lane Miles *	Surface Type	Condition / PCR
0925	Public	7/14/2001	13316	0.23	AS	FAIR / 73

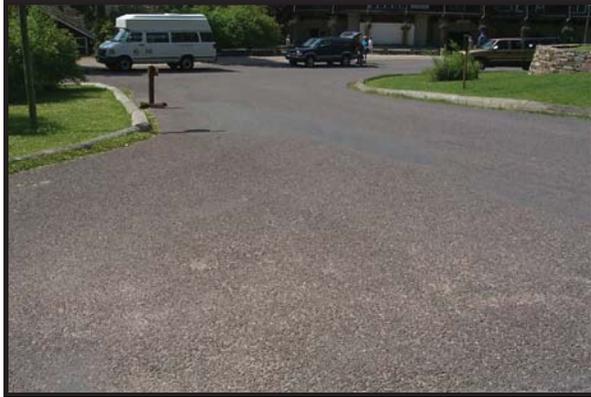
Route 0926B

Route	Public / NonPublic	Date Visited	Area (sq ft)	Lane Miles *	Surface Type	Condition / PCR
0926B	Public	7/14/2001	15183	0.26	AS	POOR / 45

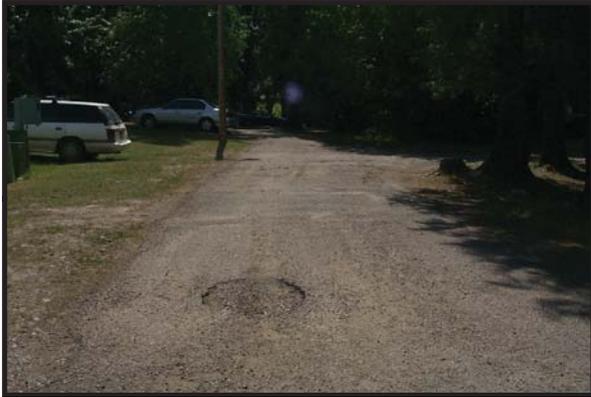
Route 0926C

Route	Public / NonPublic	Date Visited	Area (sq ft)	Lane Miles *	Surface Type	Condition / PCR
0926C	Public	7/14/2001	14679	0.25	AS	FAIR / 73

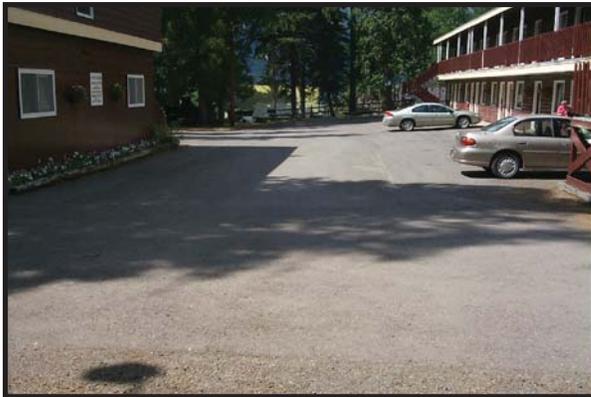
Route 0927

Route	Public / NonPublic	Date Visited	Area (sq ft)	Lane Miles *	Surface Type	Condition / PCR
0927	Public	7/14/2001	57807	1.00	AS	GOOD / 90

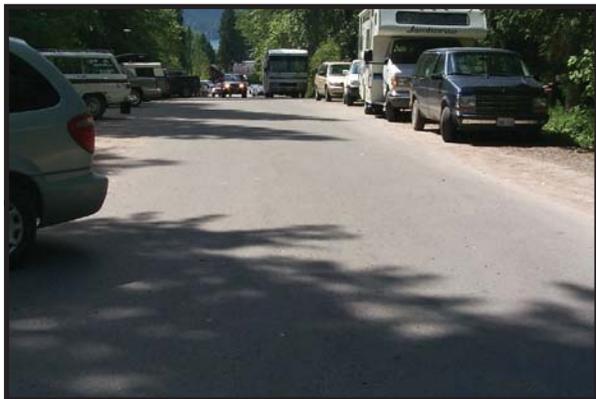
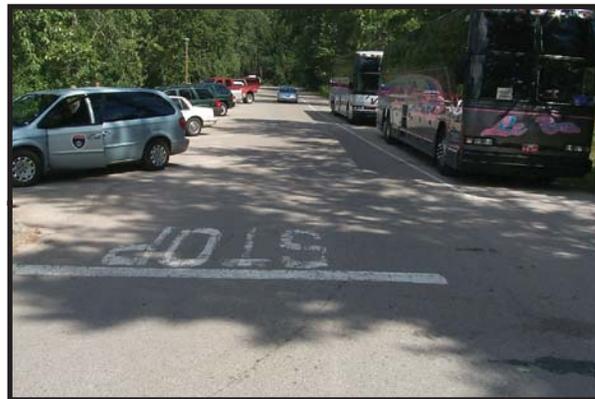
Route 0928

Route	Public / NonPublic	Date Visited	Area (sq ft)	Lane Miles *	Surface Type	Condition / PCR
0928	Public	7/14/2001	15145	0.26	AS	FAIR / 73

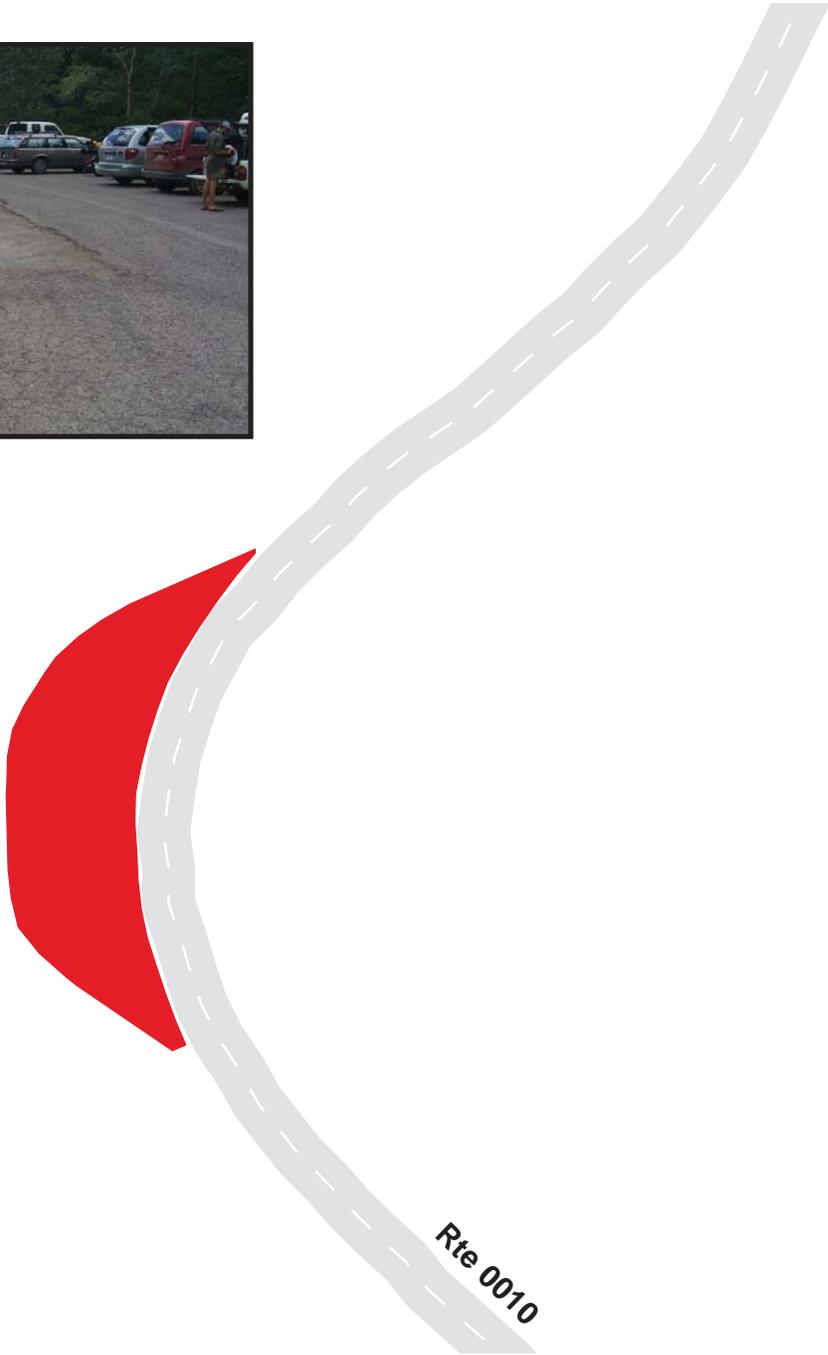
Glacier National Park
Route 0935
 Redrock Point Pulloff
 From Route 0010 at MP 17.2

Route	Public / NonPublic	Date Visited	Area (sq ft)	Lane Miles *	Surface Type	Condition / PCR
0935	Public	7/14/2001	8977	0.15	AS	POOR / 45

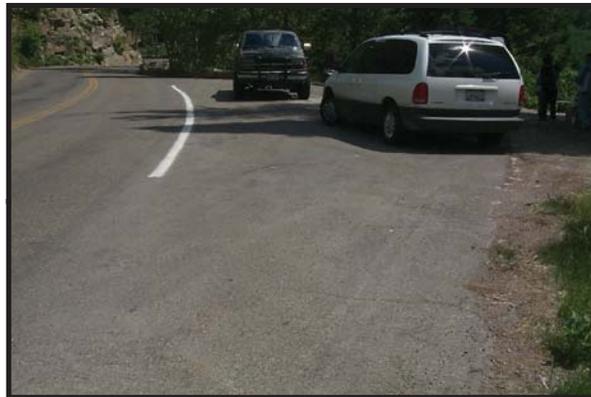
Route 0939B

Route	Public / NonPublic	Date Visited	Area (sq ft)	Lane Miles *	Surface Type	Condition / PCR
0939B	Public	7/14/2001	1833	0.03	AS	GOOD / 90

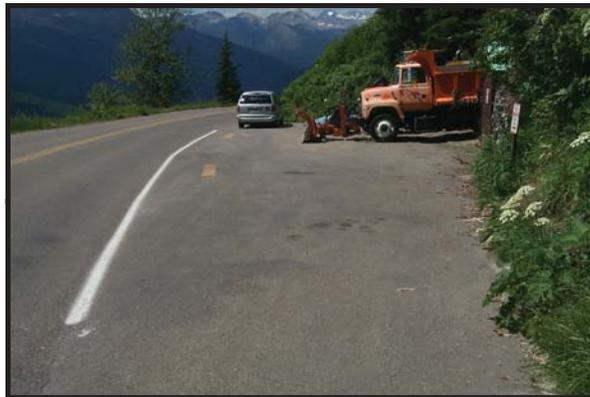
Glacier National Park
Route 0940
 Bird Woman Falls
 From Route 0010 at MP 26.7

Route	Public / NonPublic	Date Visited	Area (sq ft)	Lane Miles *	Surface Type	Condition / PCR
0940	Public	7/14/2001	3226	0.06	AS	GOOD / 90

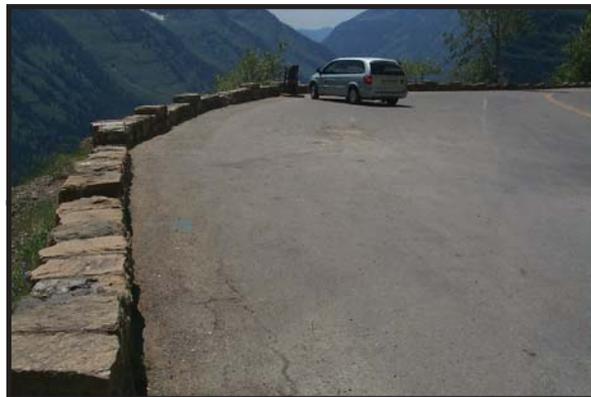
Route 0941A

Route	Public / NonPublic	Date Visited	Area (sq ft)	Lane Miles *	Surface Type	Condition / PCR
0941A	Public	7/14/2001	10598	0.18	AS	GOOD / 90

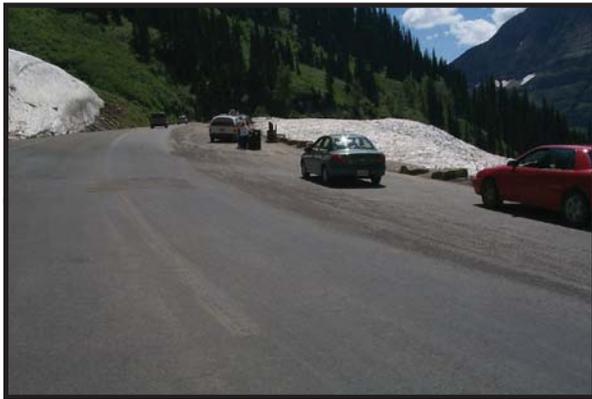
Route 0941B

Route	Public / NonPublic	Date Visited	Area (sq ft)	Lane Miles *	Surface Type	Condition / PCR
0941B	Public	7/14/2001	5538	0.10	AS	GOOD / 90

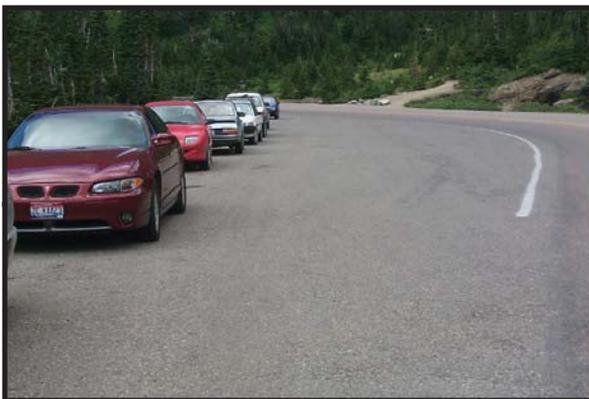
Glacier National Park
Route 0945A
 Siyeh Bend Parking A
 From Route 0010 at MP 34.4

Route	Public / NonPublic	Date Visited	Area (sq ft)	Lane Miles *	Surface Type	Condition / PCR
0945A	Public	7/14/2001	6942	0.12	AS	GOOD / 90

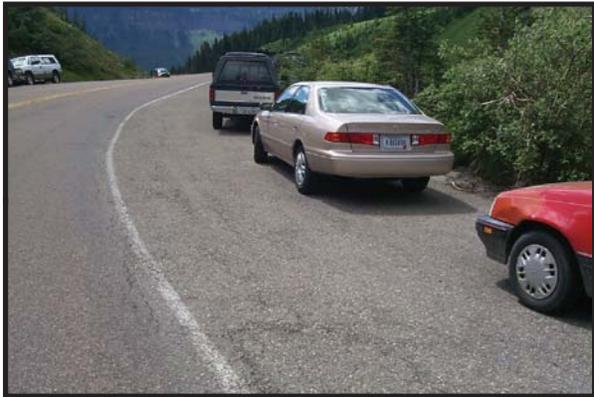
Glacier National Park
Route 0945B
 Siyeh Bend Parking B
 From Route 0010 at MP 34.5

Route	Public / NonPublic	Date Visited	Area (sq ft)	Lane Miles *	Surface Type	Condition / PCR
0945B	Public	7/14/2001	4110	0.07	AS	GOOD / 90

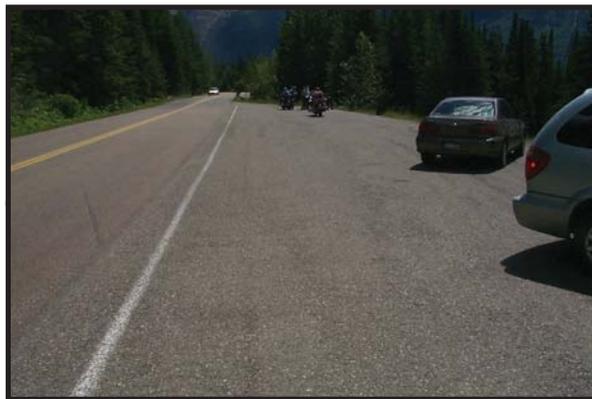
Route 0946B

Route	Public / NonPublic	Date Visited	Area (sq ft)	Lane Miles *	Surface Type	Condition / PCR
0946B	Public	7/14/2001	7898	0.14	AS	FAIR / 73

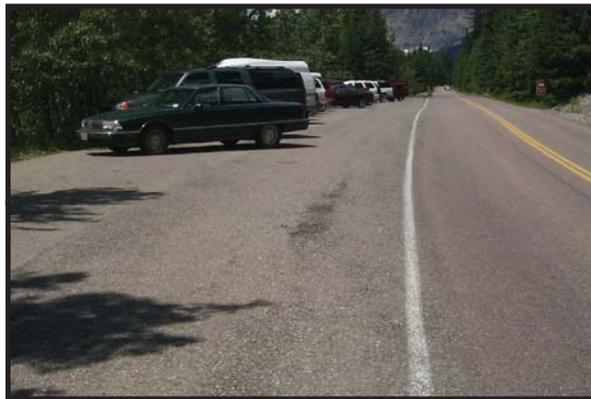
Route 0947

Route	Public / NonPublic	Date Visited	Area (sq ft)	Lane Miles *	Surface Type	Condition / PCR
0947	Public	7/14/2001	3316	0.06	OC	FAIR / 73

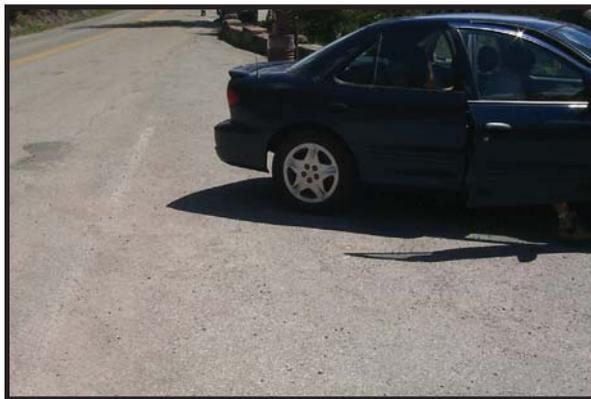
Route 0948A

Route	Public / NonPublic	Date Visited	Area (sq ft)	Lane Miles *	Surface Type	Condition / PCR
0948A	Public	7/14/2001	2271	0.04	OC	FAIR / 73

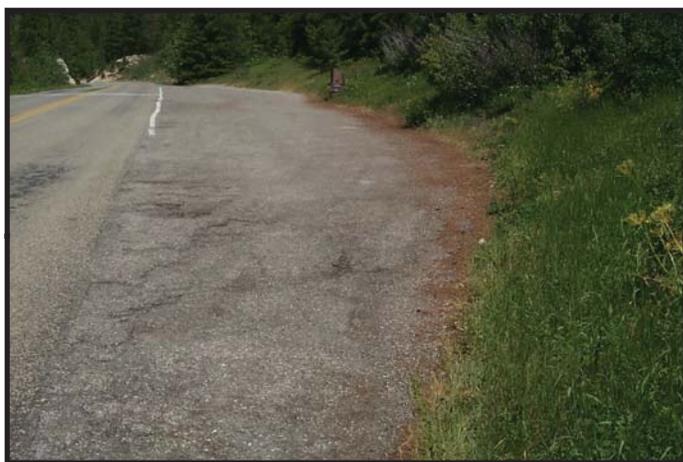
Route 0950

Route	Public / NonPublic	Date Visited	Area (sq ft)	Lane Miles *	Surface Type	Condition / PCR
0950	Public	7/14/2001	64040	1.10	AS	GOOD / 90

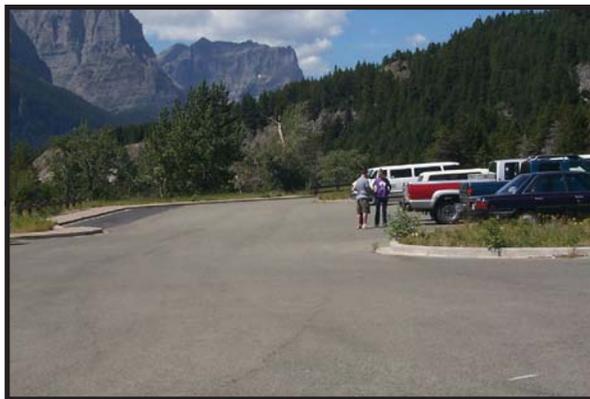
Route 0951C

Route	Public / NonPublic	Date Visited	Area (sq ft)	Lane Miles *	Surface Type	Condition / PCR
0951C	Public	7/14/2001	7331	0.13	AS	GOOD / 90

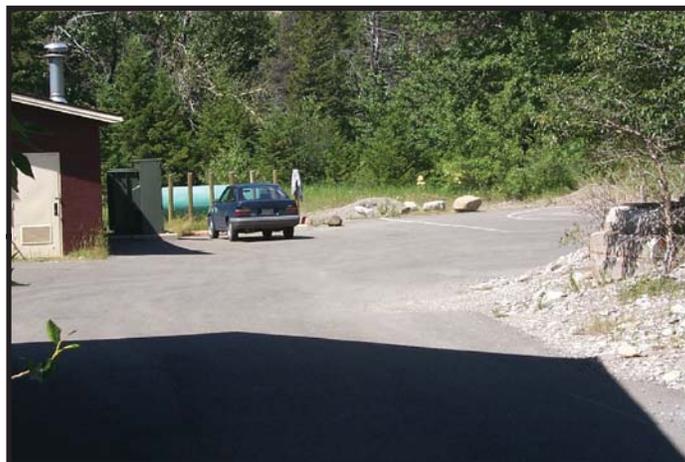
Route 0951D

Route	Public / NonPublic	Date Visited	Area (sq ft)	Lane Miles *	Surface Type	Condition / PCR
0951D	Public	7/14/2001	4603	0.08	OC	FAIR / 73

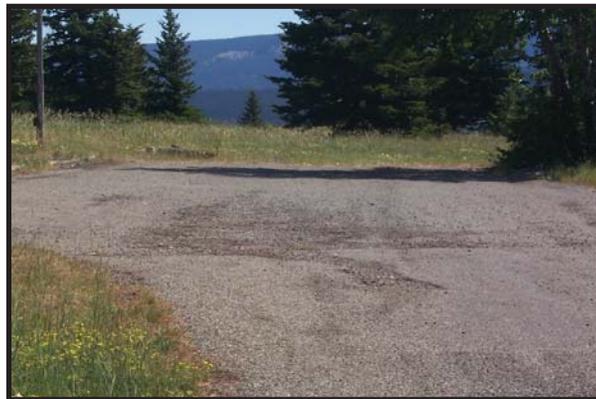
Route 0951E

Route	Public / NonPublic	Date Visited	Area (sq ft)	Lane Miles *	Surface Type	Condition / PCR
0951E	Public	7/14/2001	4137	0.07	OC	FAIR / 73

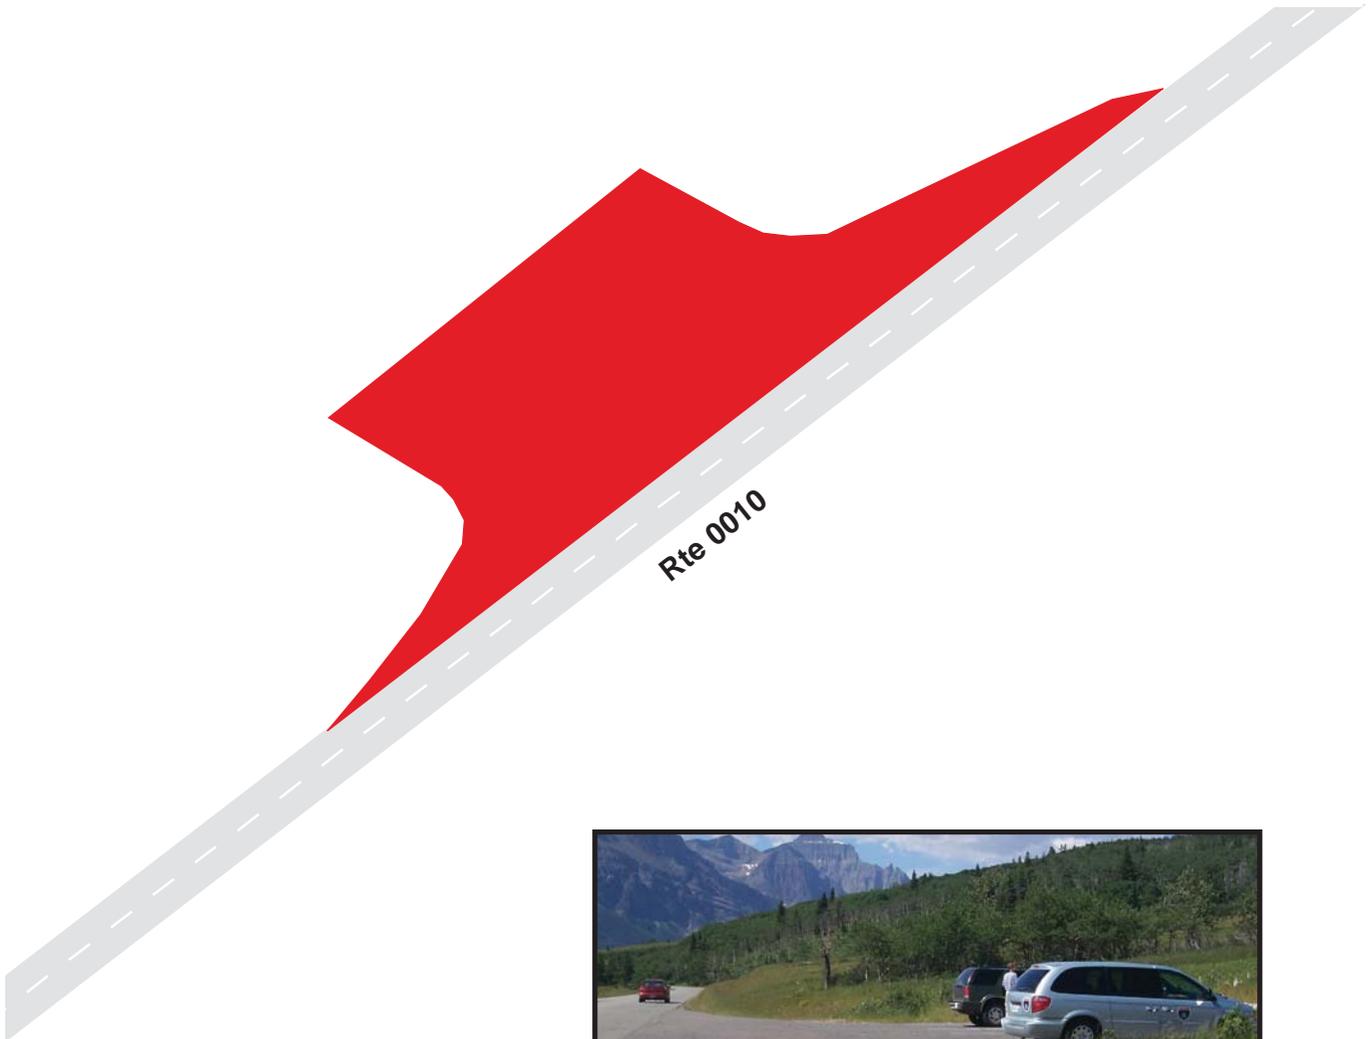
Glacier National Park
Route 0954
 Two Dog Flats
 From Route 0010 at MP 47.0

Route	Public / NonPublic	Date Visited	Area (sq ft)	Lane Miles *	Surface Type	Condition / PCR
0954	Public	7/14/2001	3234	0.06	AS	GOOD / 90

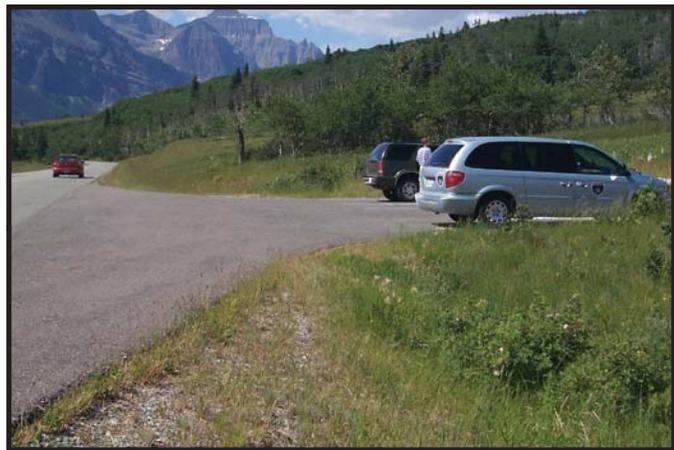
Route 0955A

Route	Public / NonPublic	Date Visited	Area (sq ft)	Lane Miles *	Surface Type	Condition / PCR
0955A	Public	7/14/2001	3133	0.05	OC	FAIR / 73

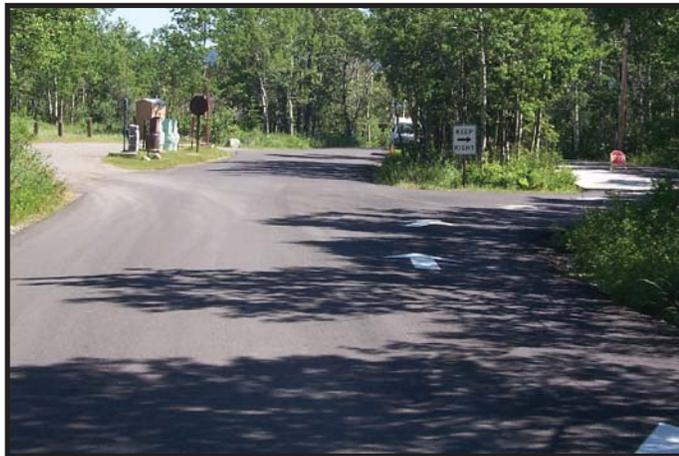
Route 0955B

Route	Public / NonPublic	Date Visited	Area (sq ft)	Lane Miles *	Surface Type	Condition / PCR
0955B	Public	7/14/2001	749	0.01	OC	FAIR / 73

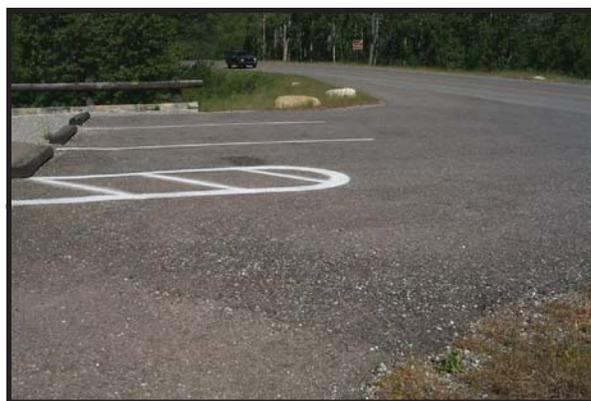
Route 0957A

Route	Public / NonPublic	Date Visited	Area (sq ft)	Lane Miles *	Surface Type	Condition / PCR
0957A	Public	7/14/2001	26703	0.46	OC	POOR / 45

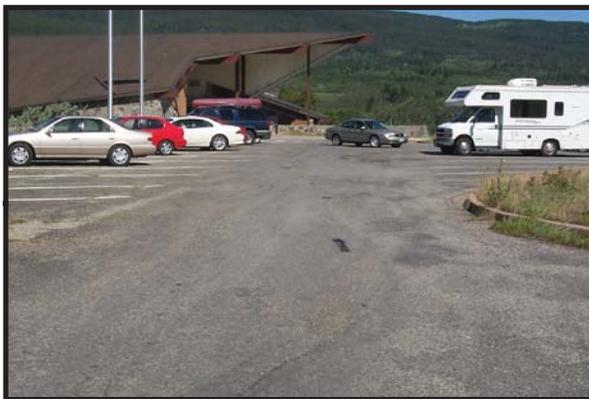
Route 0957B

Route	Public / NonPublic	Date Visited	Area (sq ft)	Lane Miles *	Surface Type	Condition / PCR
0957B	Public	7/14/2001	32574	0.56	OC	POOR / 45

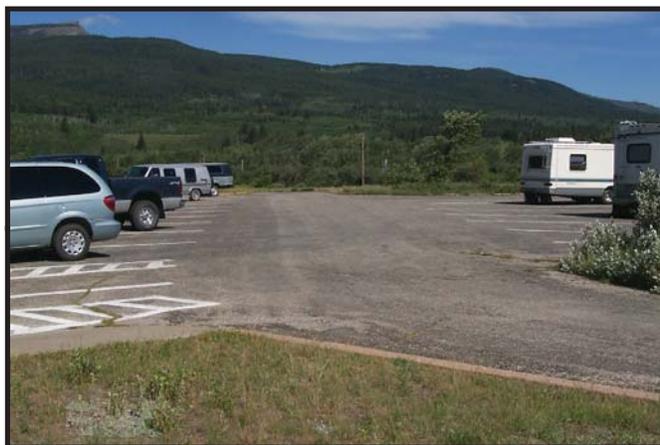
Route 0958

Route	Public / NonPublic	Date Visited	Area (sq ft)	Lane Miles *	Surface Type	Condition / PCR
0958	NonPublic	7/14/2001	4767	0.08	OC	FAIR / 73

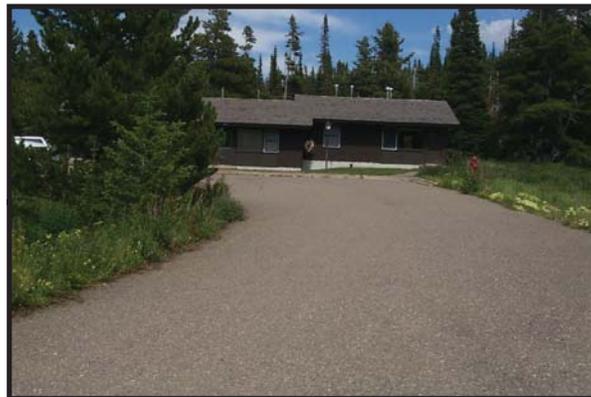
Glacier National Park
Route 0967
 Pola Lake Pullout
 From Route 0014 at MP 10.3

Route	Public / NonPublic	Date Visited	Area (sq ft)	Lane Miles *	Surface Type	Condition / PCR
0967	Public	7/14/2001	3709	0.06	OC	GOOD / 90

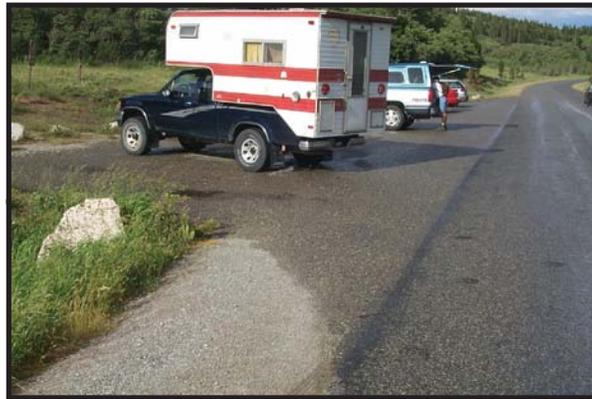
Route 0968

Route	Public / NonPublic	Date Visited	Area (sq ft)	Lane Miles *	Surface Type	Condition / PCR
0968	Public	7/14/2001	97516	1.68	OC	FAIR / 73

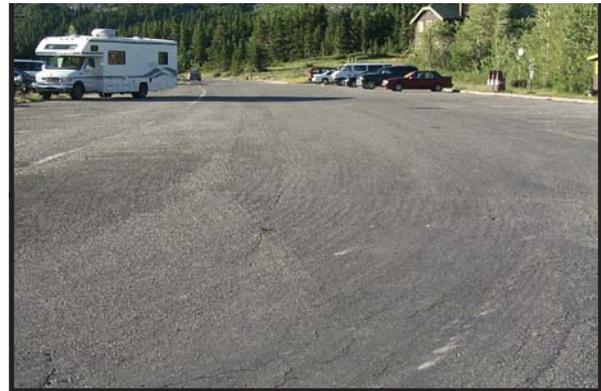
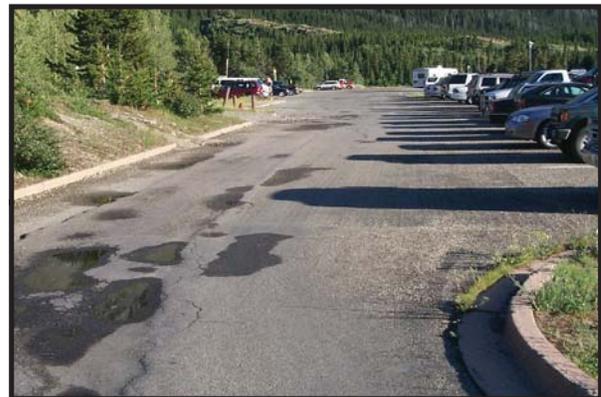
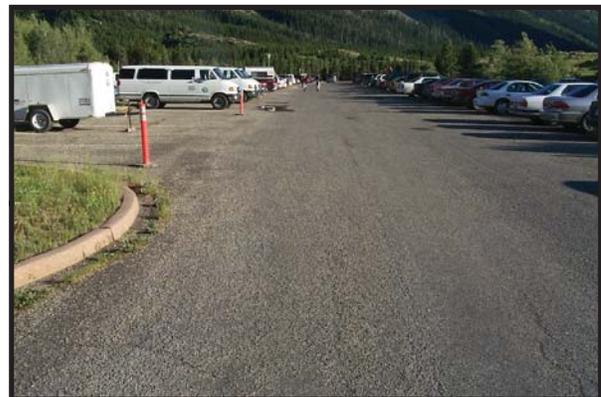
Route 0970

Route	Public / NonPublic	Date Visited	Area (sq ft)	Lane Miles *	Surface Type	Condition / PCR
0970	Public	7/14/2001	2487	0.04	AS	FAIR / 73

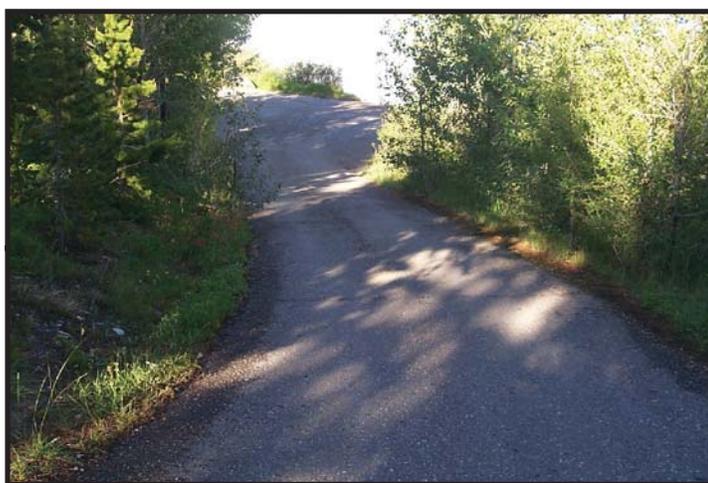
Route 0971

Route	Public / NonPublic	Date Visited	Area (sq ft)	Lane Miles *	Surface Type	Condition / PCR
0971	NonPublic	7/14/2001	9284	0.16	OC	FAIR / 73

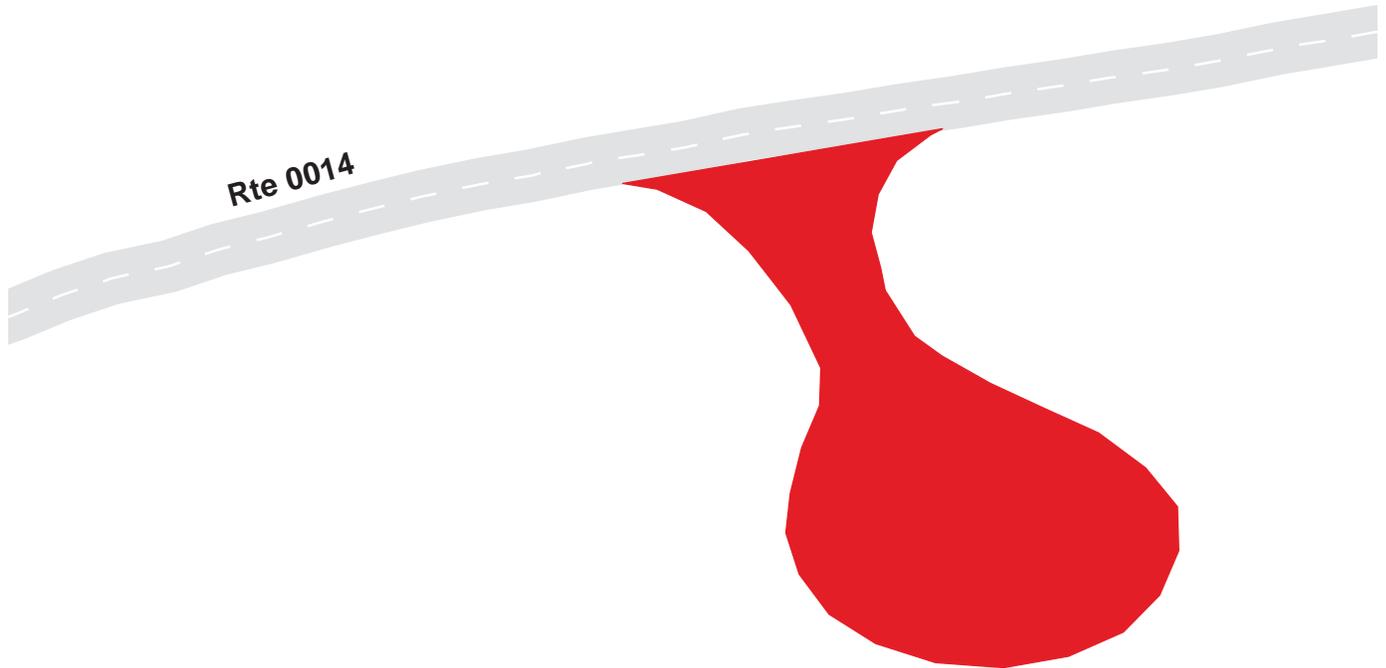
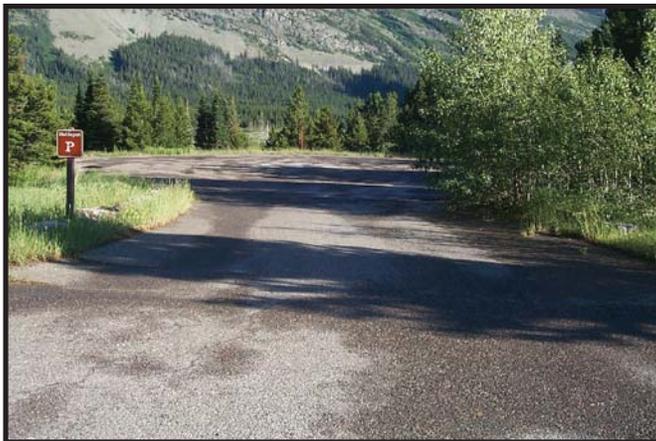
Route 0972

Route	Public / NonPublic	Date Visited	Area (sq ft)	Lane Miles *	Surface Type	Condition / PCR
0972	Public	7/14/2001	25198	0.43	OC	FAIR / 73

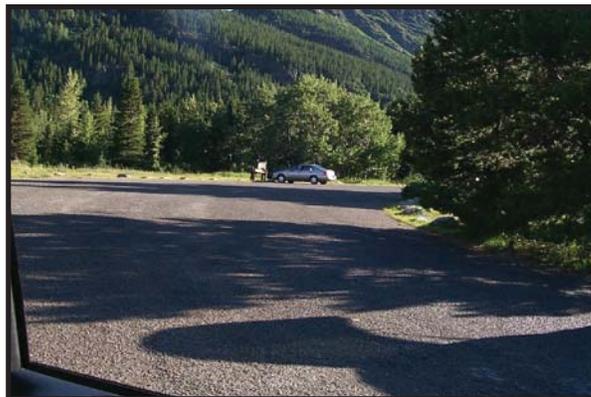
Route 0973A

Route	Public / NonPublic	Date Visited	Area (sq ft)	Lane Miles *	Surface Type	Condition / PCR
0973A	Public	7/14/2001	7504	0.13	OC	FAIR / 73

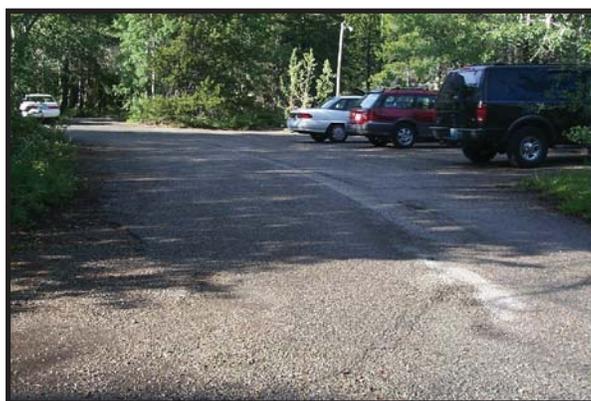
Route 0973B

Route	Public / NonPublic	Date Visited	Area (sq ft)	Lane Miles *	Surface Type	Condition / PCR
0973B	Public	7/14/2001	3754	0.06	OC	FAIR / 73

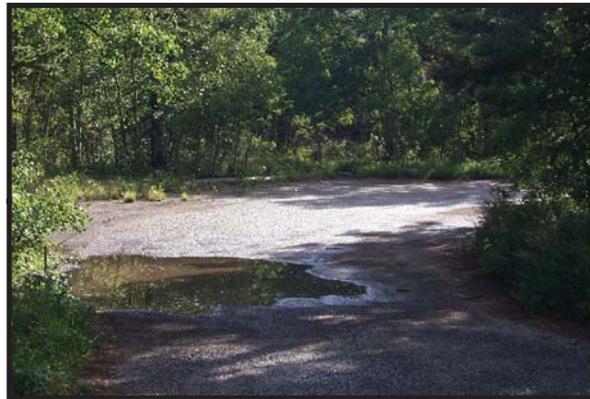
Route 0973E

Route	Public / NonPublic	Date Visited	Area (sq ft)	Lane Miles *	Surface Type	Condition / PCR
0973E	Public	7/14/2001	9753	0.17	OC	FAIR / 73

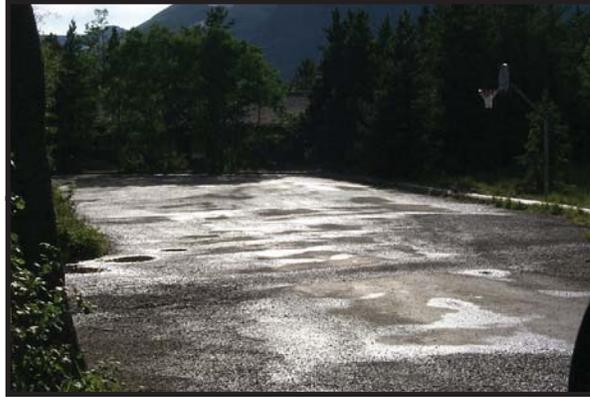
Route 0974

Route	Public / NonPublic	Date Visited	Area (sq ft)	Lane Miles *	Surface Type	Condition / PCR
0974	Public	7/14/2001	56300	0.97	OC	FAIR / 73

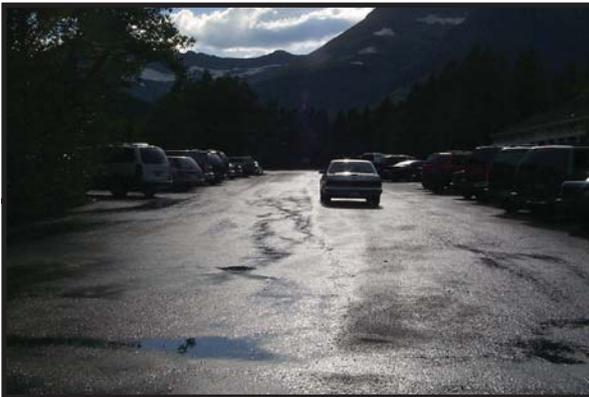
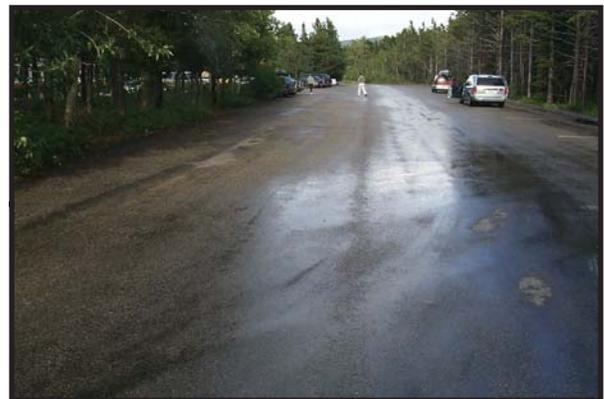
Glacier National Park
Route 0975
 Crusher Hill
 From Route 0013 at MP 4.84

Route	Public / NonPublic	Date Visited	Area (sq ft)	Lane Miles *	Surface Type	Condition / PCR
0975	Public	7/14/2001	38928	0.67	OC	FAIR / 73

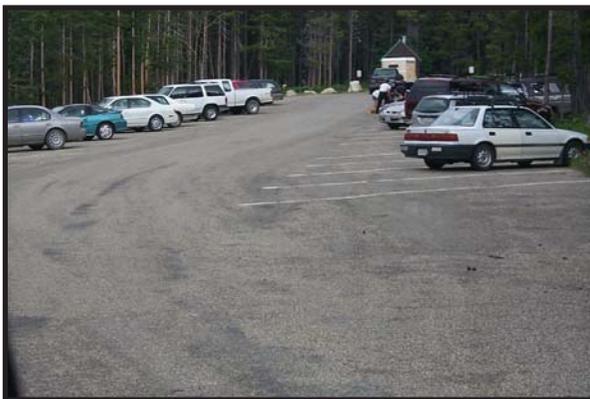
Route 0983

Route	Public / NonPublic	Date Visited	Area (sq ft)	Lane Miles *	Surface Type	Condition / PCR
0983	Public	7/14/2001	17164	0.30	AS	FAIR / 73
