**The Road Inventory
of
Glacier Bay National Park and Preserve
GLBA – 9815**

Road Inventory Program

Prepared By:
Federal Highway Administration
Eastern Federal Lands Highway Division
Cycle 3

Glacier Bay National Park in Alaska

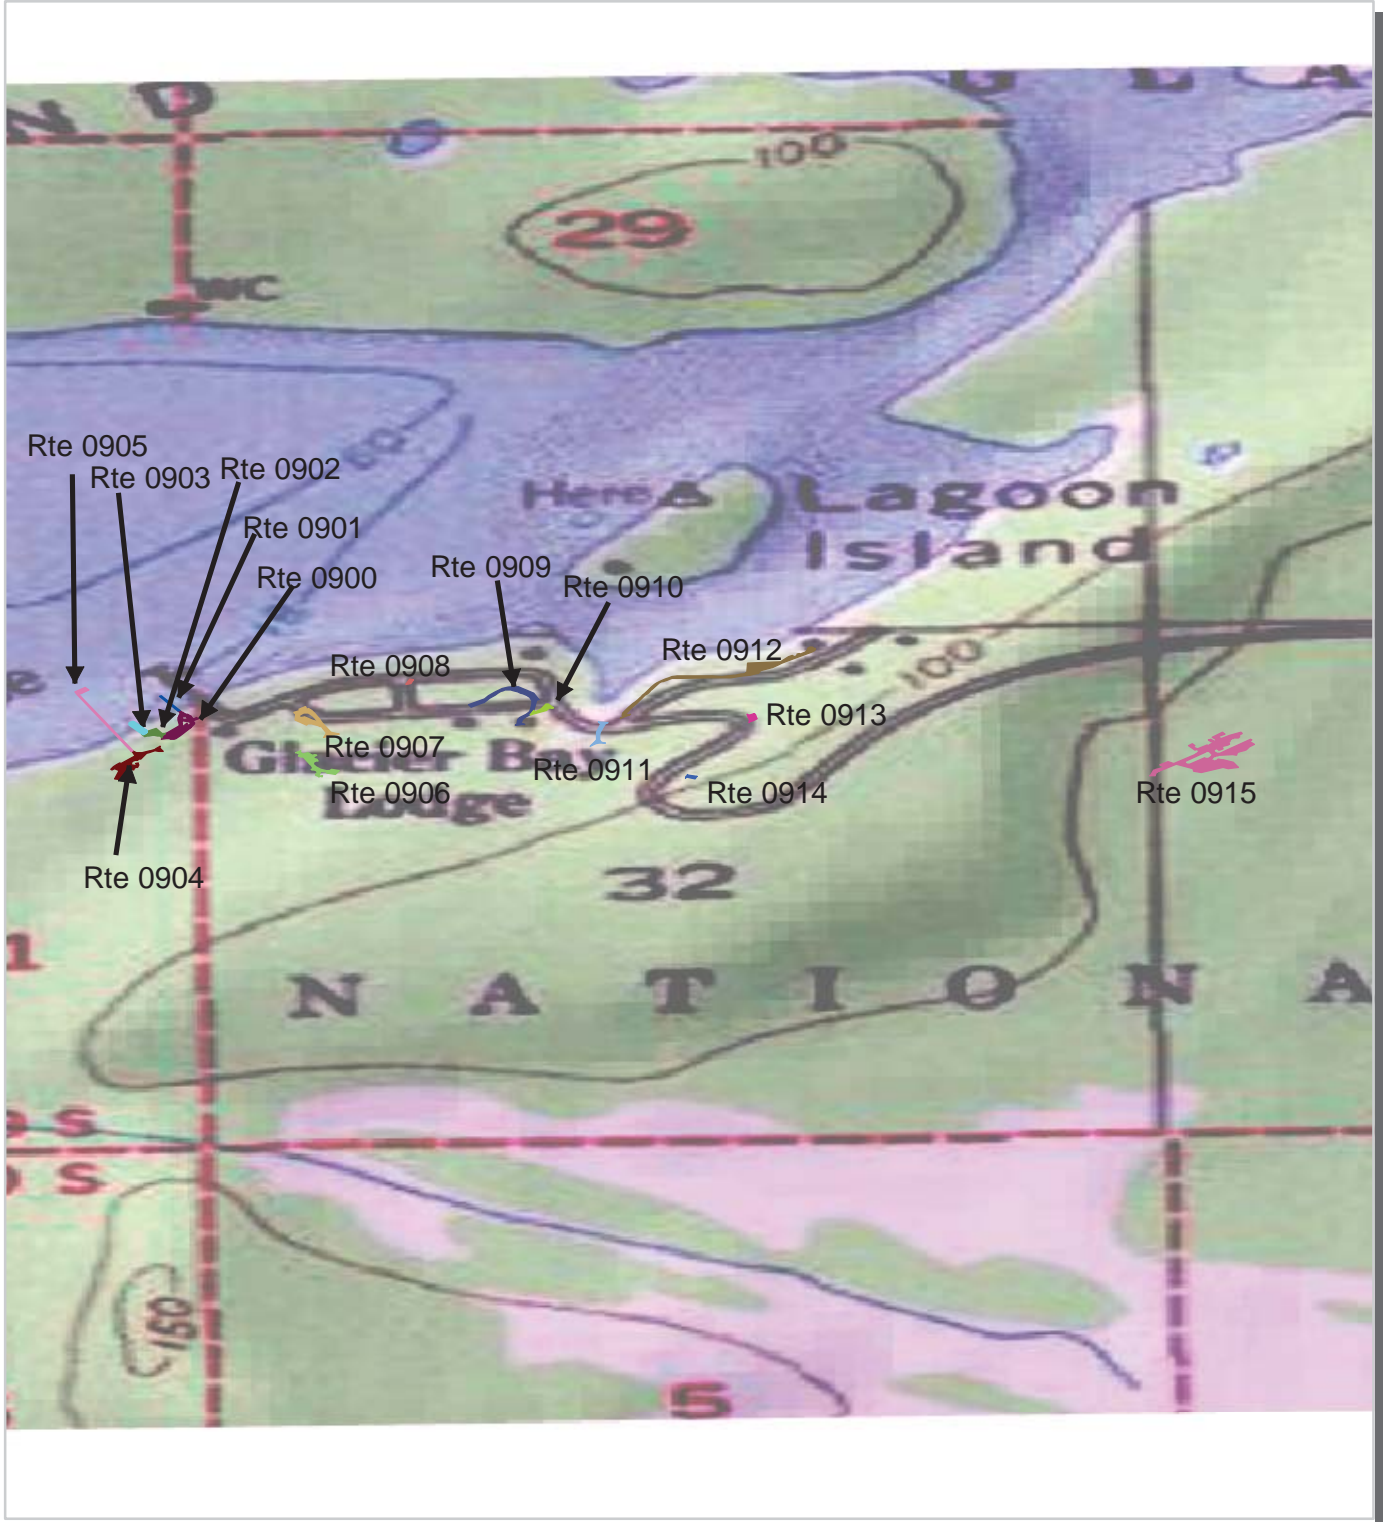
Glacier Bay National Park and Preserve Route Condition Key Map PCR - Mile by Mile

PCR	Poor		Fair		Good		Excellent	
		(<=60)		(61 - 84)		(85 - 94)		(95 - 100)

* If the PCR rating is not available for a section, the SCR rating will be displayed. See appendix for definitions and formulas.

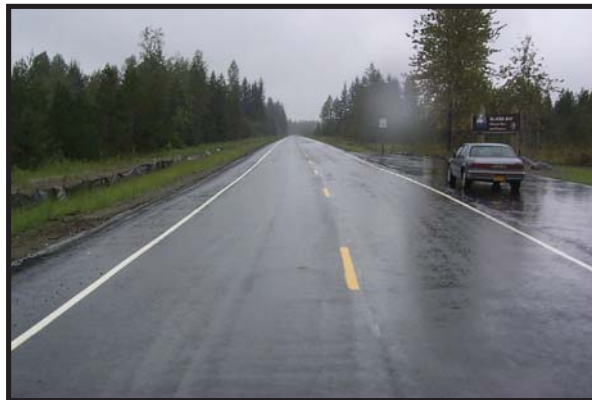
Route 0010

Route	Length (mi)	Width (ft)	Area (sq ft)	Lane Miles *	Condition / PCR	Surface Type
0010	4.40	21.00	487872	8.40	EXCELLENT / 97	AS

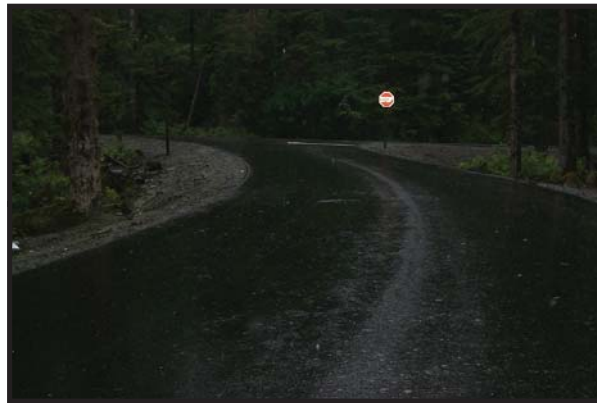
Route 0401

Route	Length (mi)	Width (ft)	Area (sq ft)	Lane Miles *	Condition / PCR	Surface Type
0401	0.07	21.00	7762	0.13	GOOD / 90	AS

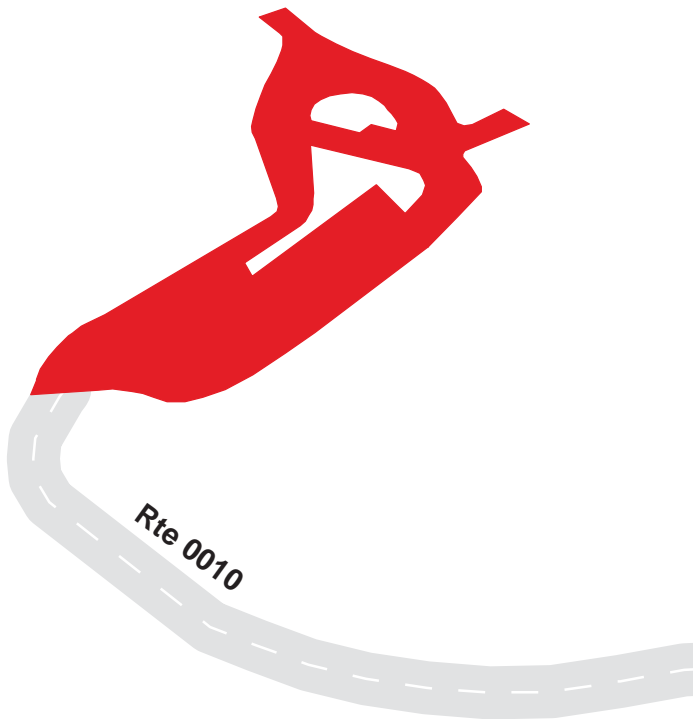
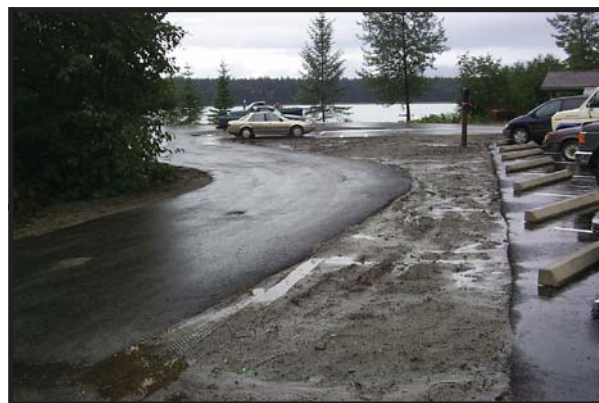
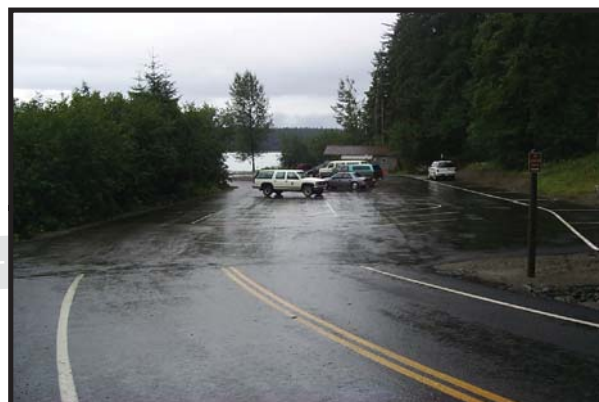
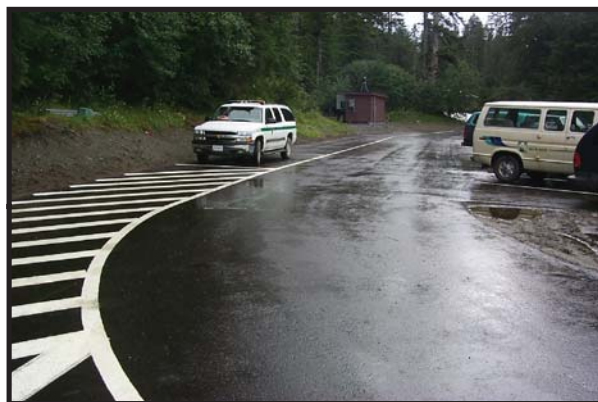
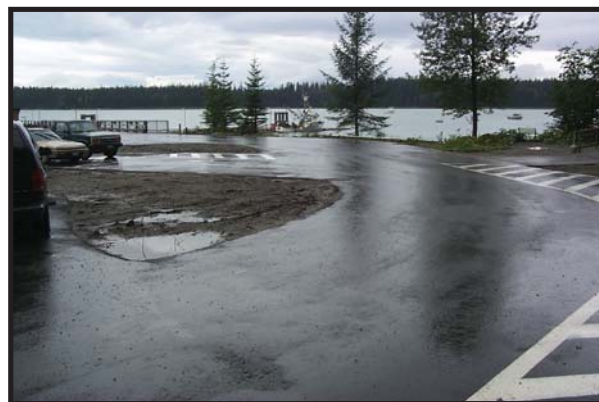
Route 0900

Route	Public / NonPublic	Date Visited	Area (sq ft)	Lane Miles *	Surface Type	Condition / PCR
0900	Public	8/21/2002	21314	0.37	AS	EXCELLENT / 97

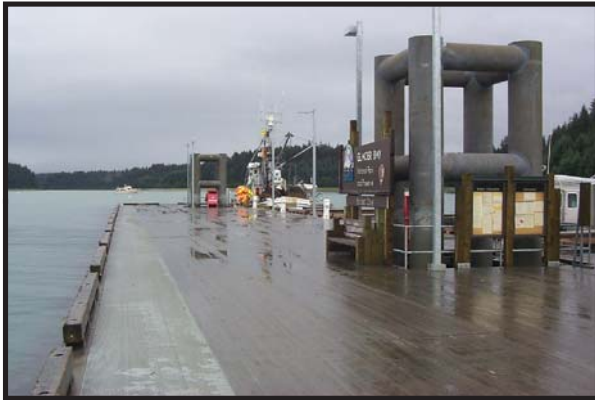
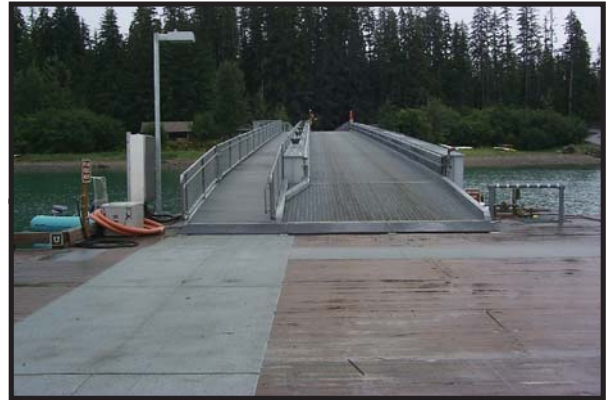
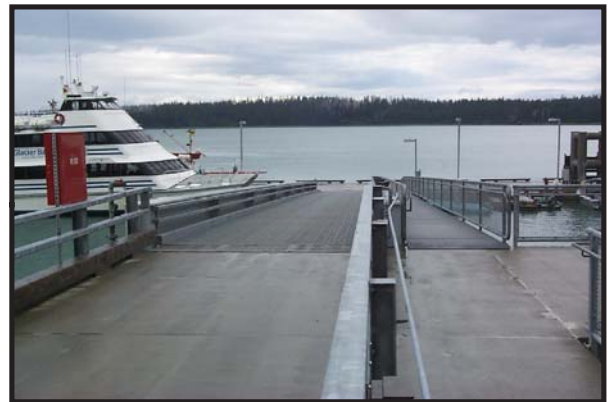
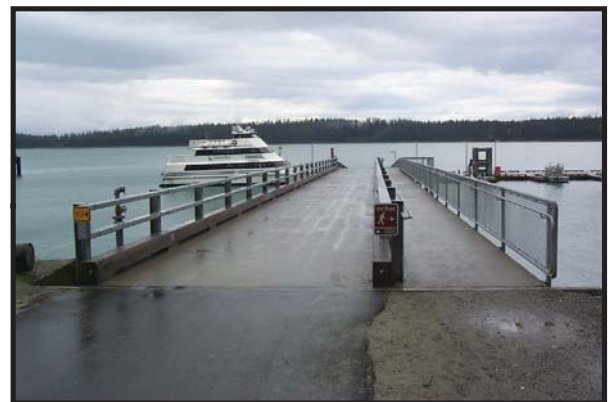
Route 0901

Route	Public / NonPublic	Date Visited	Area (sq ft)	Lane Miles *	Surface Type	Condition / PCR
0901	Public	8/21/2002	2356	0.04	CO	EXCELLENT / 97

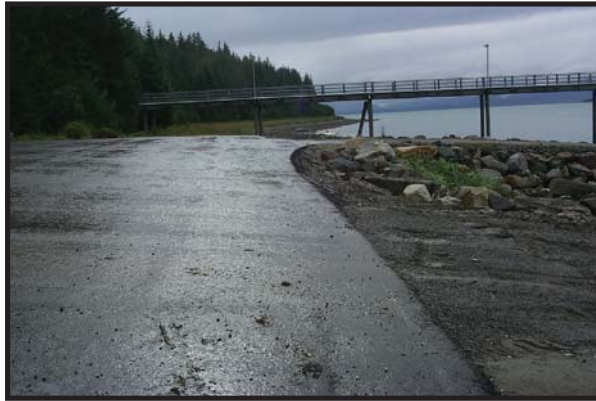
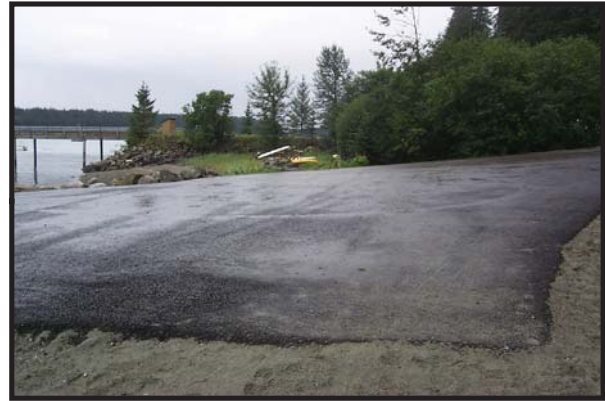
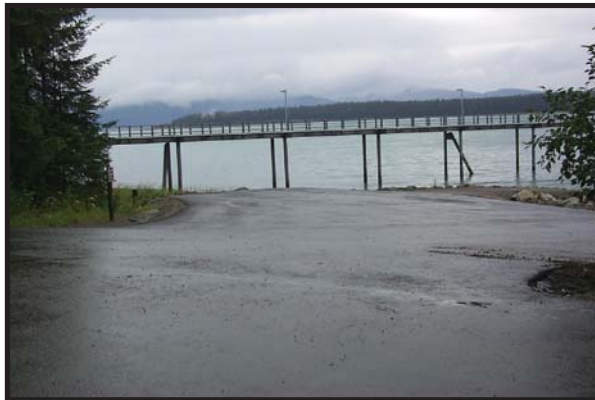
Route 0902

Route	Public / NonPublic	Date Visited	Area (sq ft)	Lane Miles *	Surface Type	Condition / PCR
0902	Public	8/21/2002	6534	0.11	AS	EXCELLENT / 97

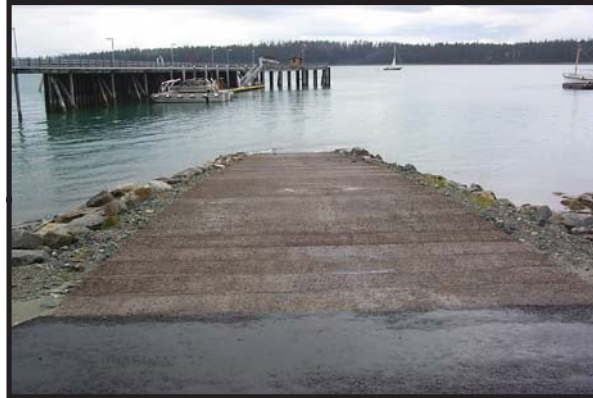
Route 0903

Route	Public / NonPublic	Date Visited	Area (sq ft)	Lane Miles *	Surface Type	Condition / PCR
0903	Public	8/21/2002	1804	0.03	CO	EXCELLENT / 97

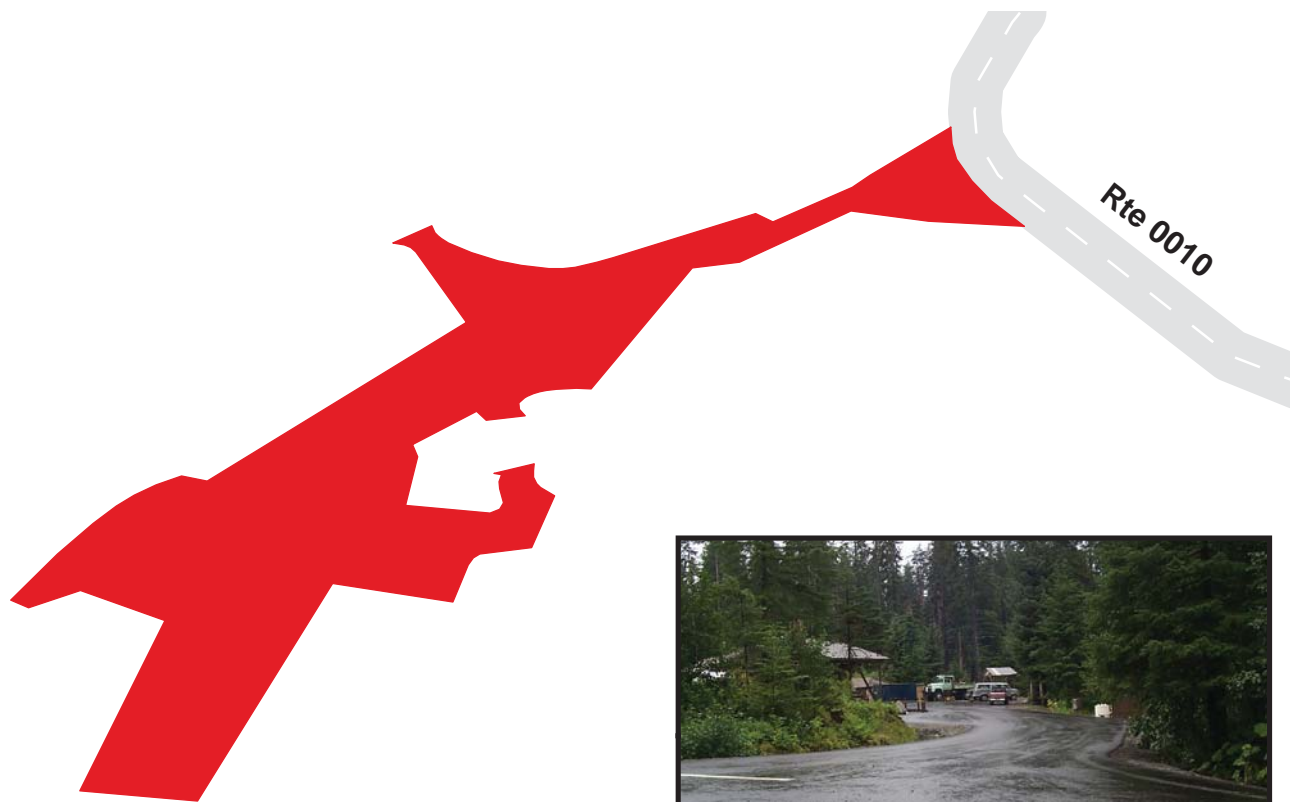
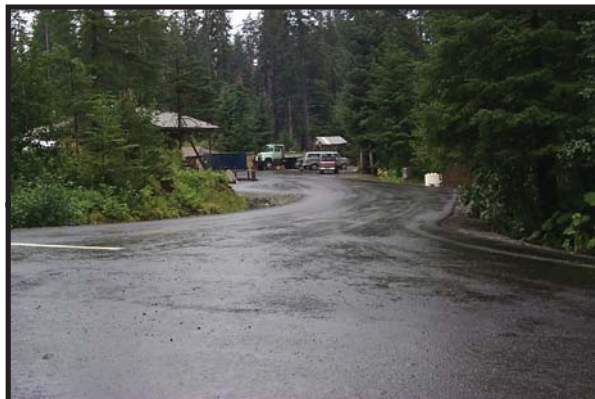
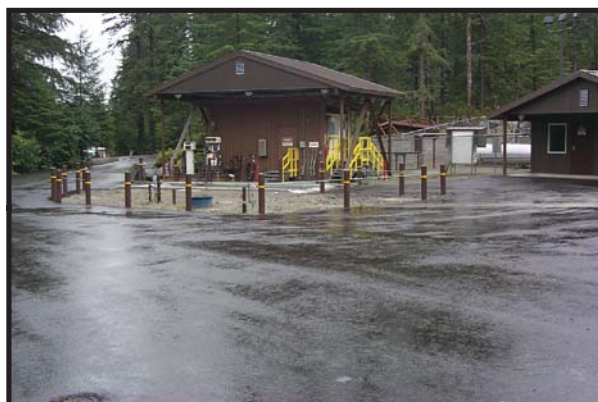
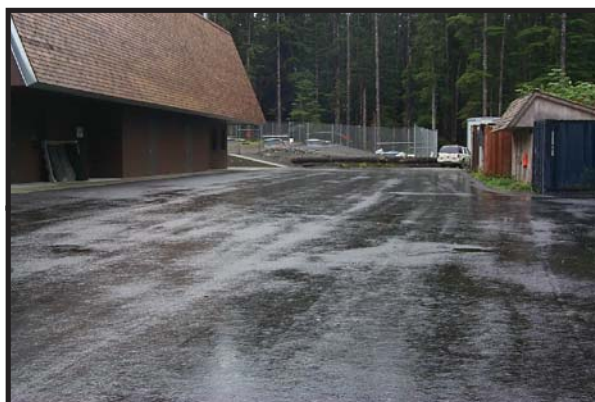
Route 0904

Route	Public / NonPublic	Date Visited	Area (sq ft)	Lane Miles *	Surface Type	Condition / PCR
0904	NonPublic	8/21/2002	21714	0.37	AS	EXCELLENT / 97

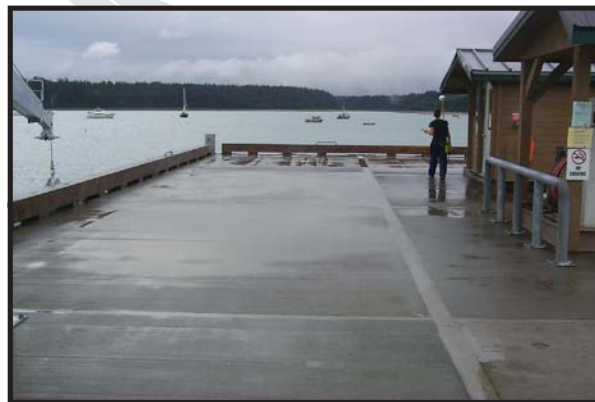
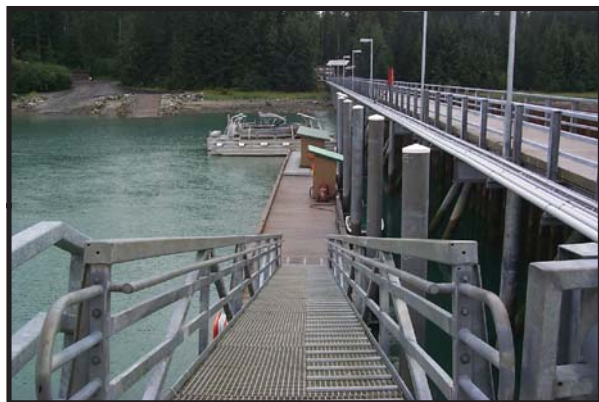
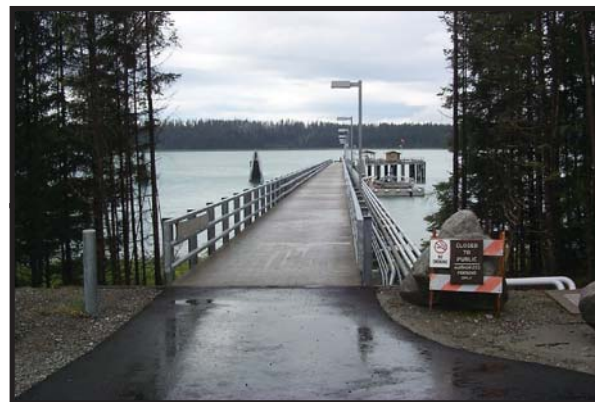
Route 0905

Route	Public / NonPublic	Date Visited	Area (sq ft)	Lane Miles *	Surface Type	Condition / PCR
0905	NonPublic	8/21/2002	10769	0.19	CO	EXCELLENT / 97

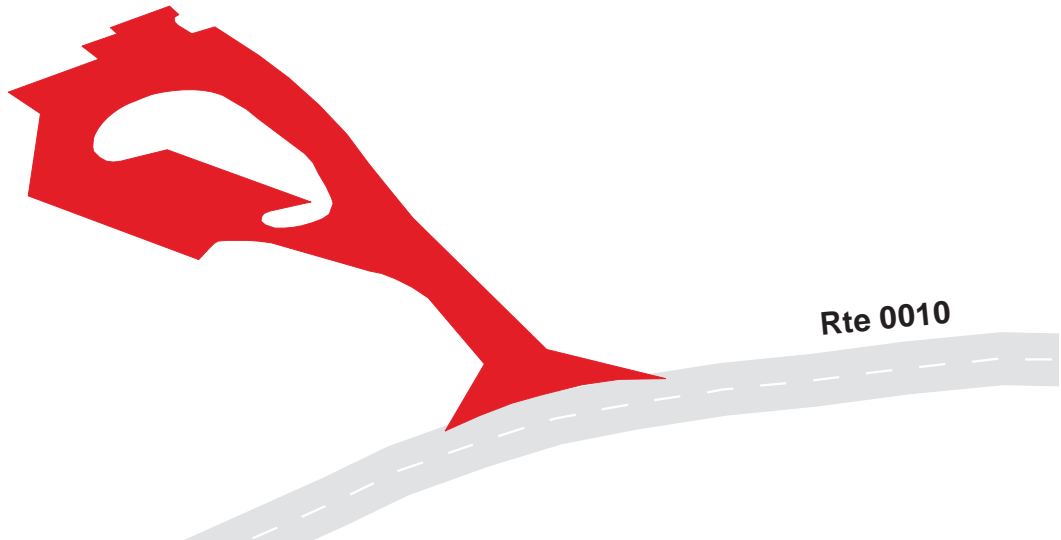
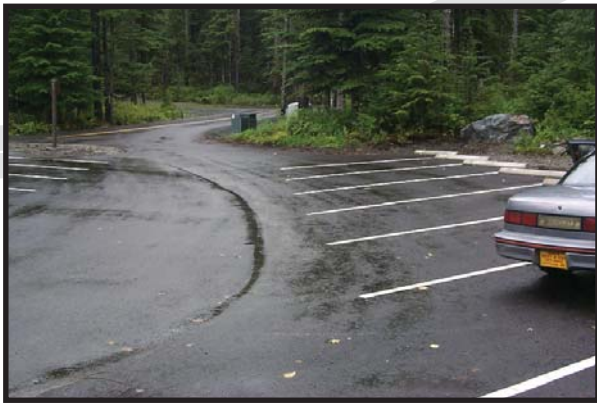
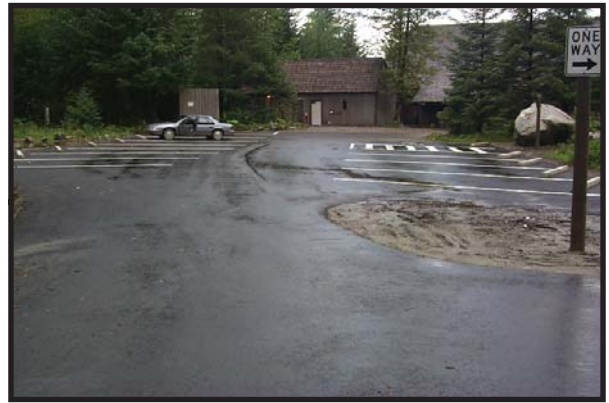
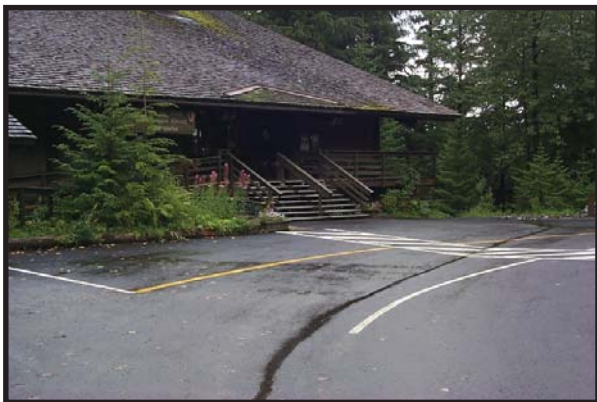
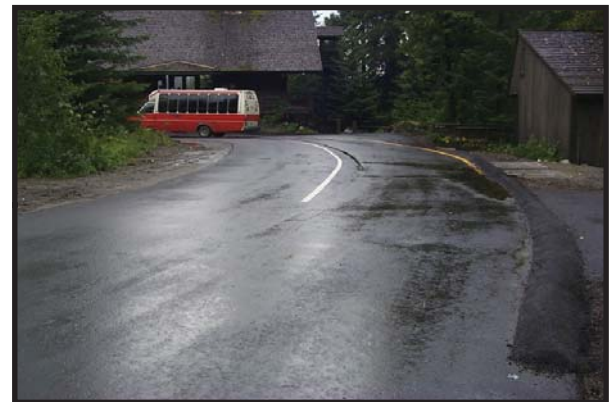
Route 0907

Route	Public / NonPublic	Date Visited	Area (sq ft)	Lane Miles *	Surface Type	Condition / PCR
0907	Public	8/21/2002	19226	0.33	AS	EXCELLENT / 97

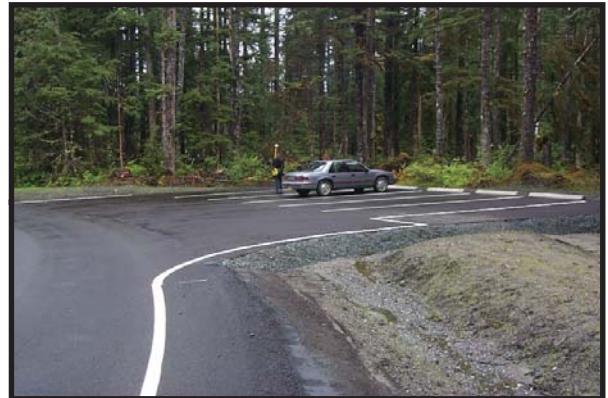
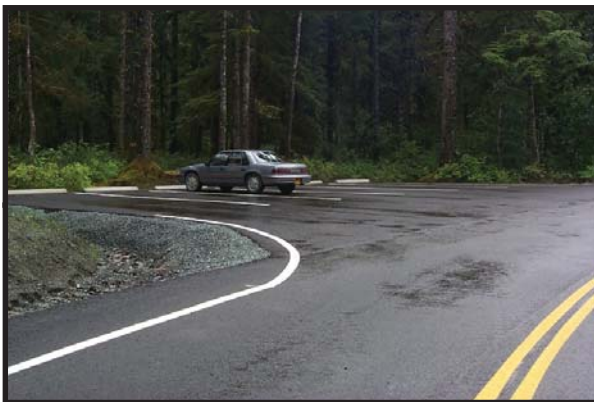
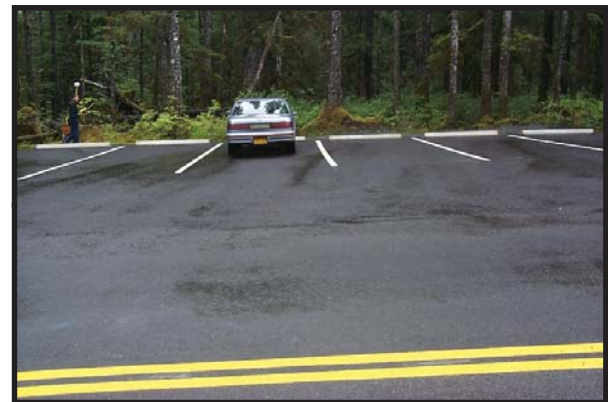
Route 0913

Route	Public / NonPublic	Date Visited	Area (sq ft)	Lane Miles *	Surface Type	Condition / PCR
0913	Public	8/22/2002	3086	0.05	AS	EXCELLENT / 97

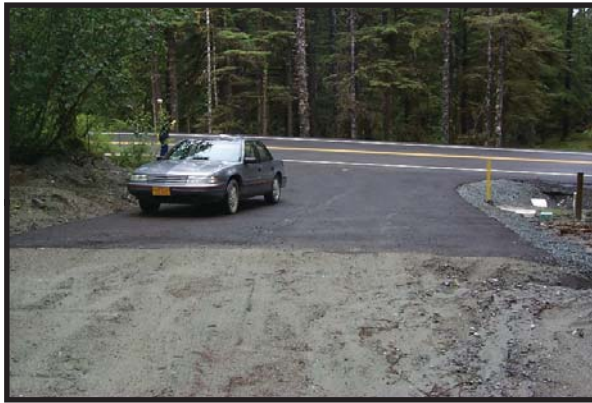
Route 0914

Route	Public / NonPublic	Date Visited	Area (sq ft)	Lane Miles *	Surface Type	Condition / PCR
0914	NonPublic	8/22/2002	1432	0.02	AS	EXCELLENT / 97
