# The Road Inventory of Golden Spike National Historic Site GOSP - 1450

## Road Inventory Program

Prepared By:  
Federal Highway Administration  
Eastern Federal Lands Highway Division  
Cycle 3

# Golden Spike National Historic Site in Utah

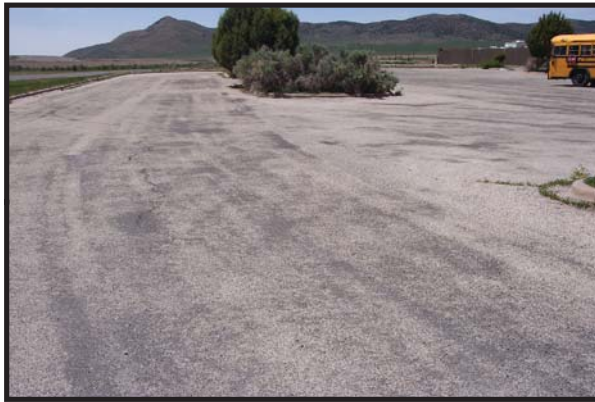
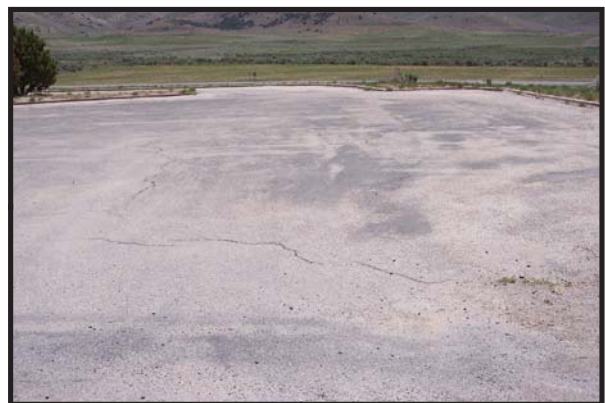
## Route 0900

Visitor Parking  
From Golden Spike Drive

Route	Public / NonPublic	Date Visited	Area (sq ft)	Lane Miles *	Surface Type	Condition / PCR
0900	Public	5/17/2004	57876	1.00	OC	FAIR / 73

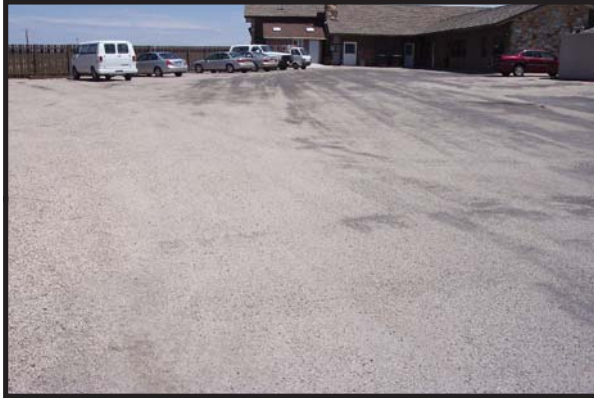
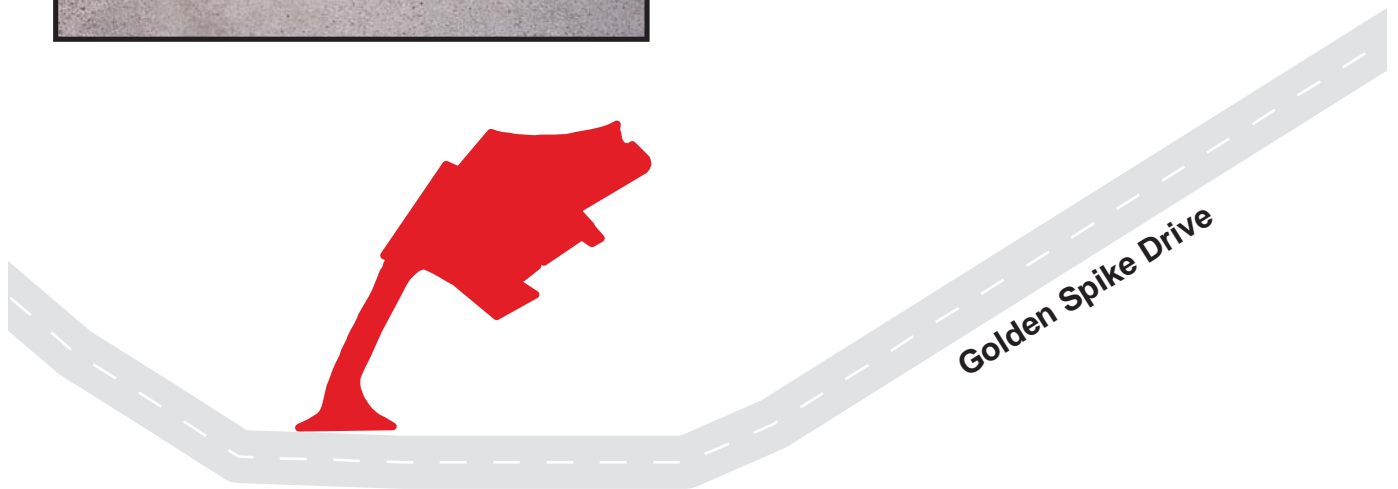
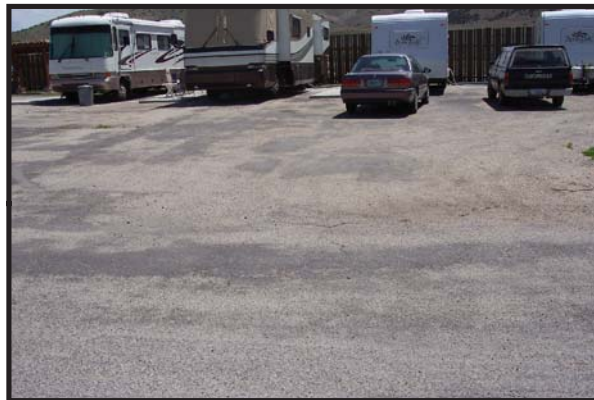
## Route 0901

Administrative Parking  
From Golden Spike Drive

Route	Public / NonPublic	Date Visited	Area (sq ft)	Lane Miles *	Surface Type	Condition / PCR
0901	NonPublic	5/17/2004	21078	0.36	OC	FAIR / 73
