**The Road Inventory
of
Grand Canyon National Park
GRCA – 8210
Volume 1**

Prepared By:
Federal Highway Administration
Eastern Federal Lands Highway Division
Cycle 3

Grand Canyon National Park in Arizona

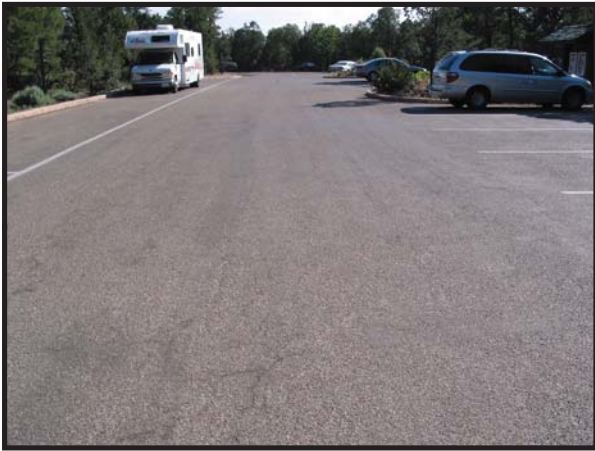
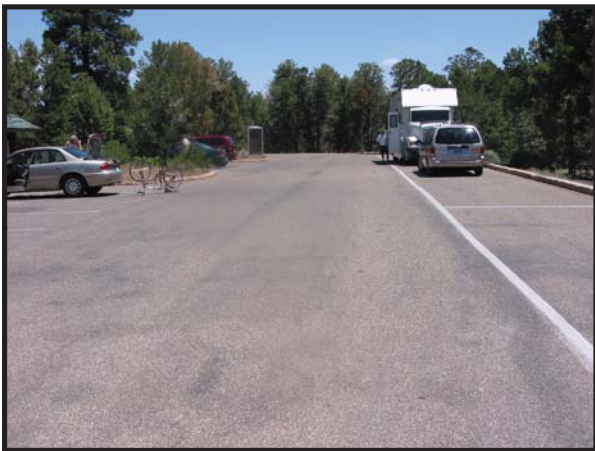
Route 0901

Route	Public / NonPublic	Date Visited	Area (sq ft)	Lane Miles *	Surface Type	Condition / PCR
0901	Public	6/3/2003	6320	0.11	OC	GOOD / 90

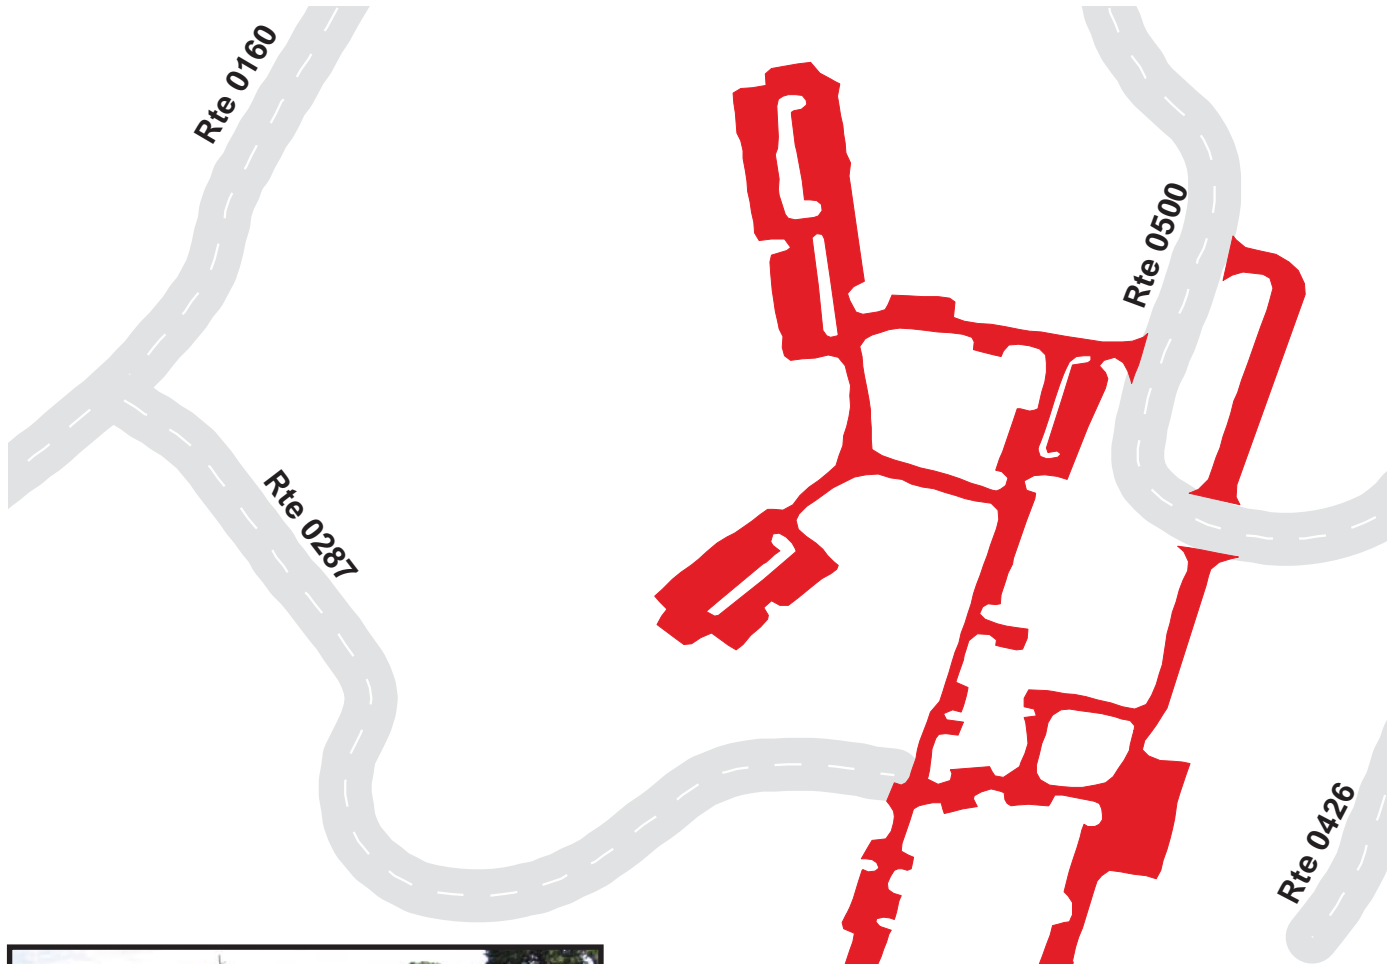
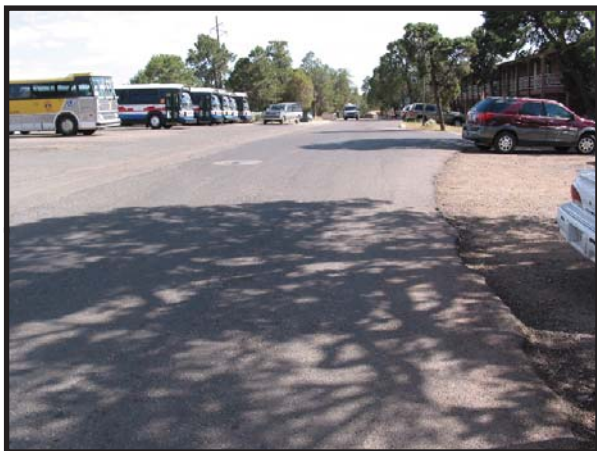
Route 0909

Route	Public / NonPublic	Date Visited	Area (sq ft)	Lane Miles *	Surface Type	Condition / PCR
0909	Public	6/3/2003	57174	0.98	AS	POOR / 45

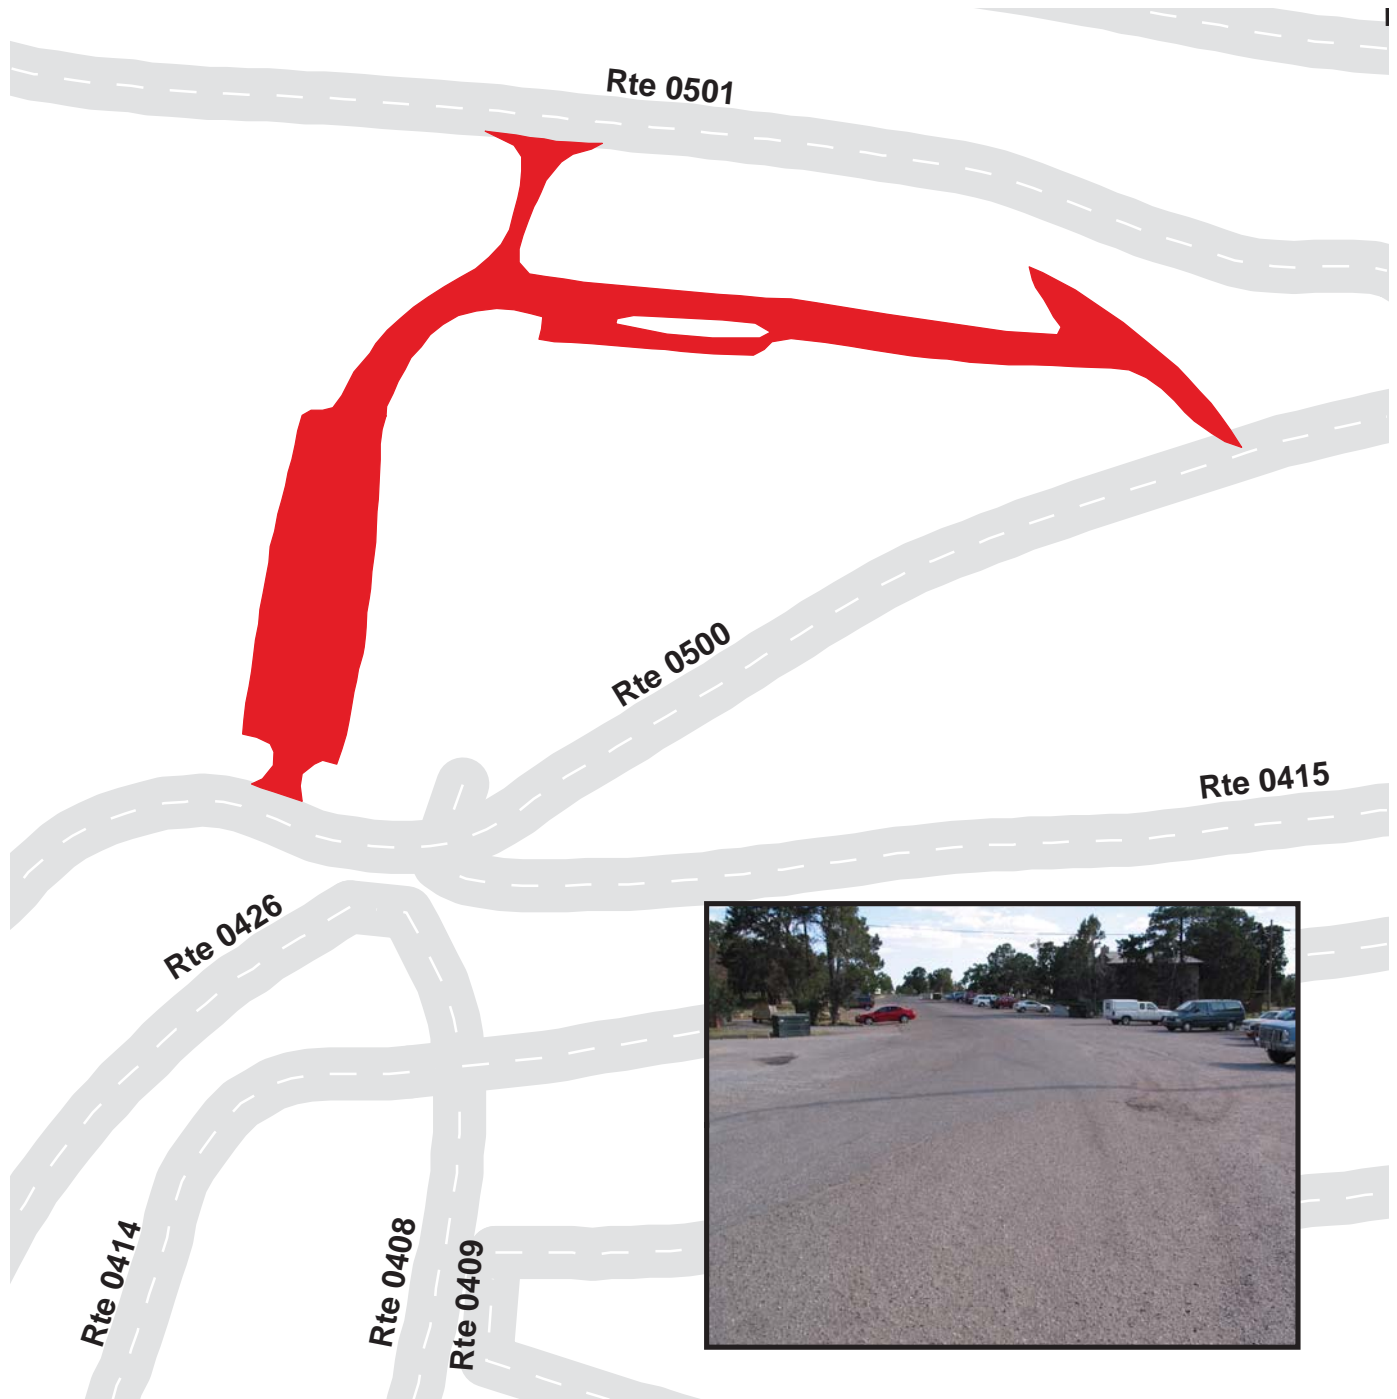
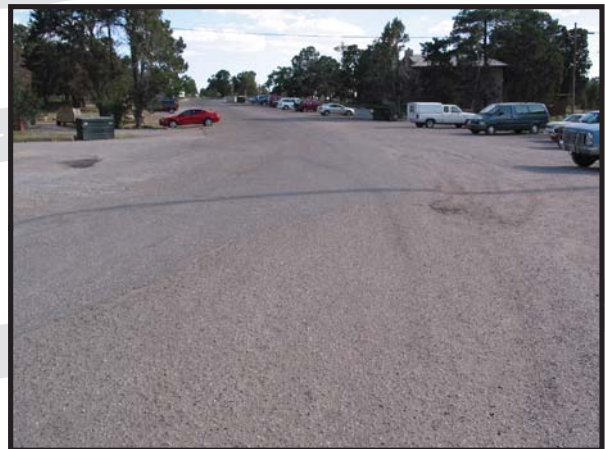
Route 0910

Route	Public / NonPublic	Date Visited	Area (sq ft)	Lane Miles *	Surface Type	Condition / PCR
0910	NonPublic	6/3/2003	5888	0.10	AS	FAIR / 73

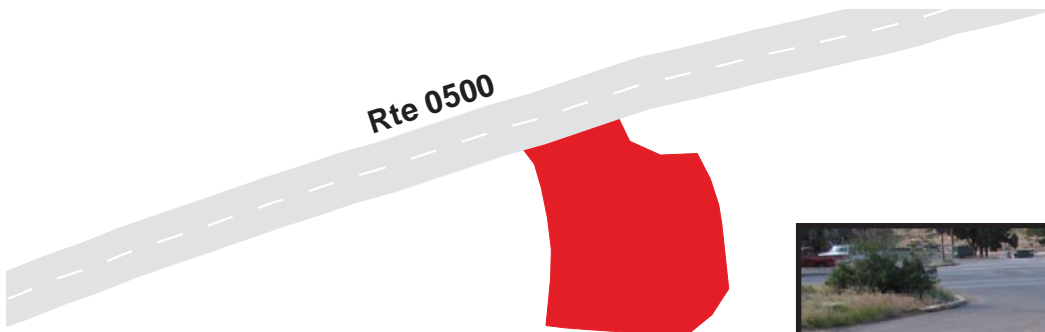
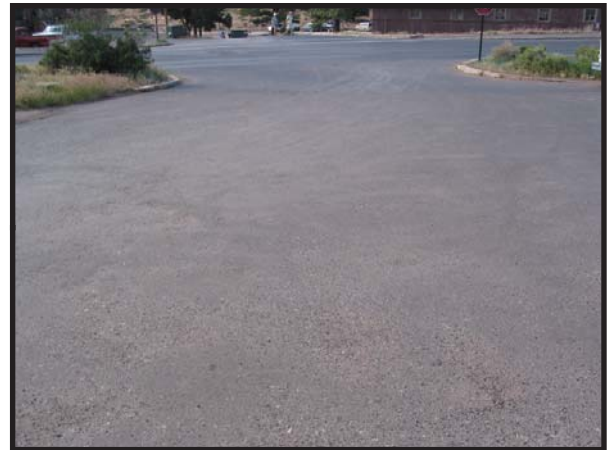
Route 0911

Route	Public / NonPublic	Date Visited	Area (sq ft)	Lane Miles *	Surface Type	Condition / PCR
0911	Public	6/4/2003	5774	0.10	AS	GOOD / 90

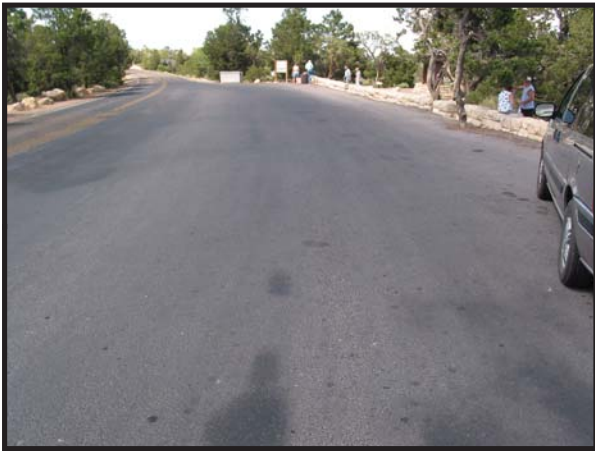
Route 0912

Route	Public / NonPublic	Date Visited	Area (sq ft)	Lane Miles *	Surface Type	Condition / PCR
0912	Public	6/4/2003	9584	0.17	AS	POOR / 45

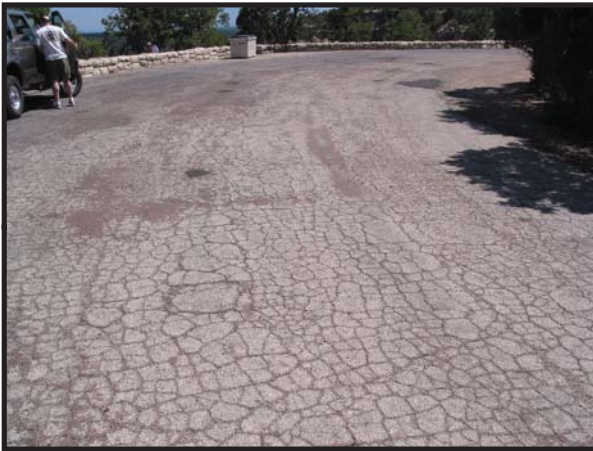
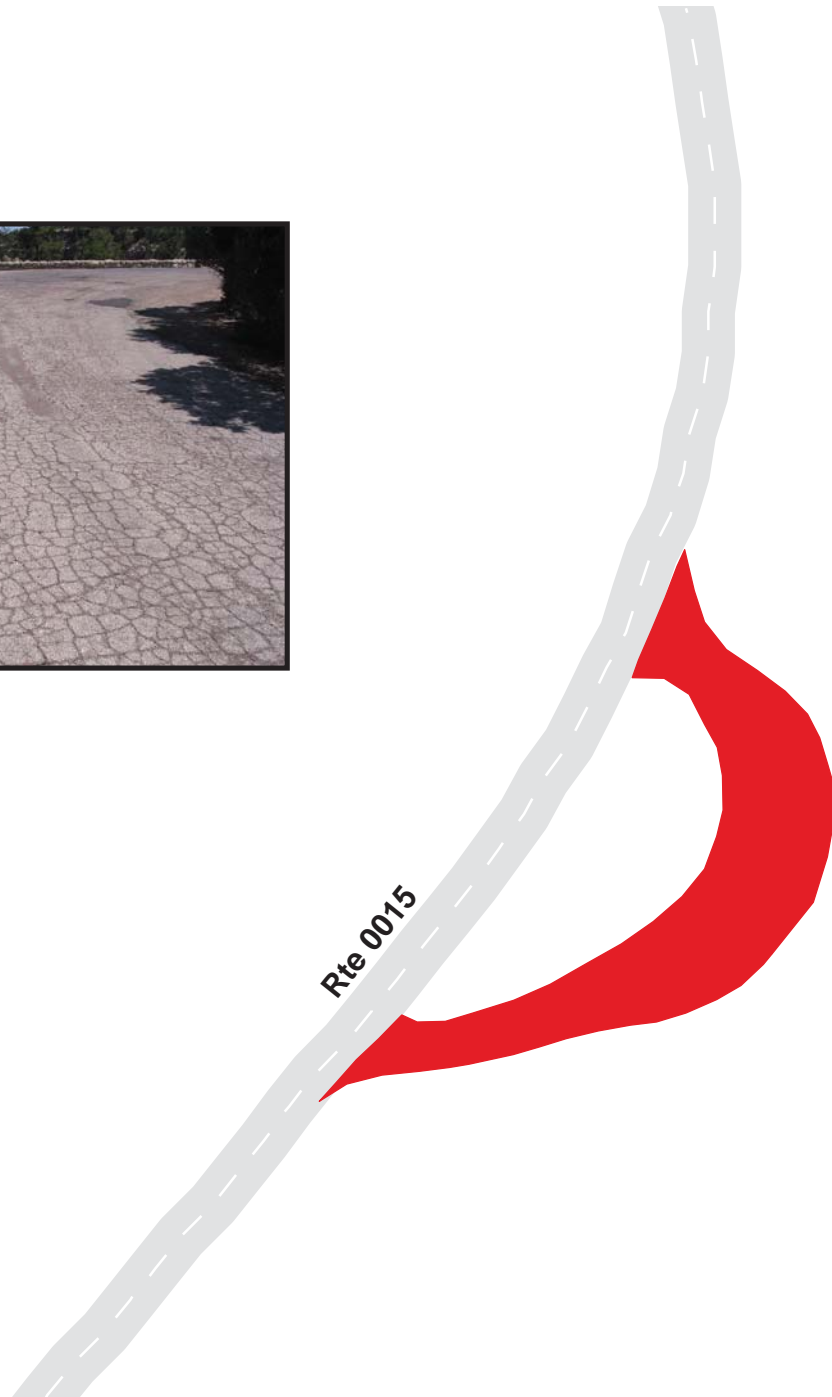
Route 0913

Route	Public / NonPublic	Date Visited	Area (sq ft)	Lane Miles *	Surface Type	Condition / PCR
0913	Public	6/4/2003	16279	0.28	AS	POOR / 45

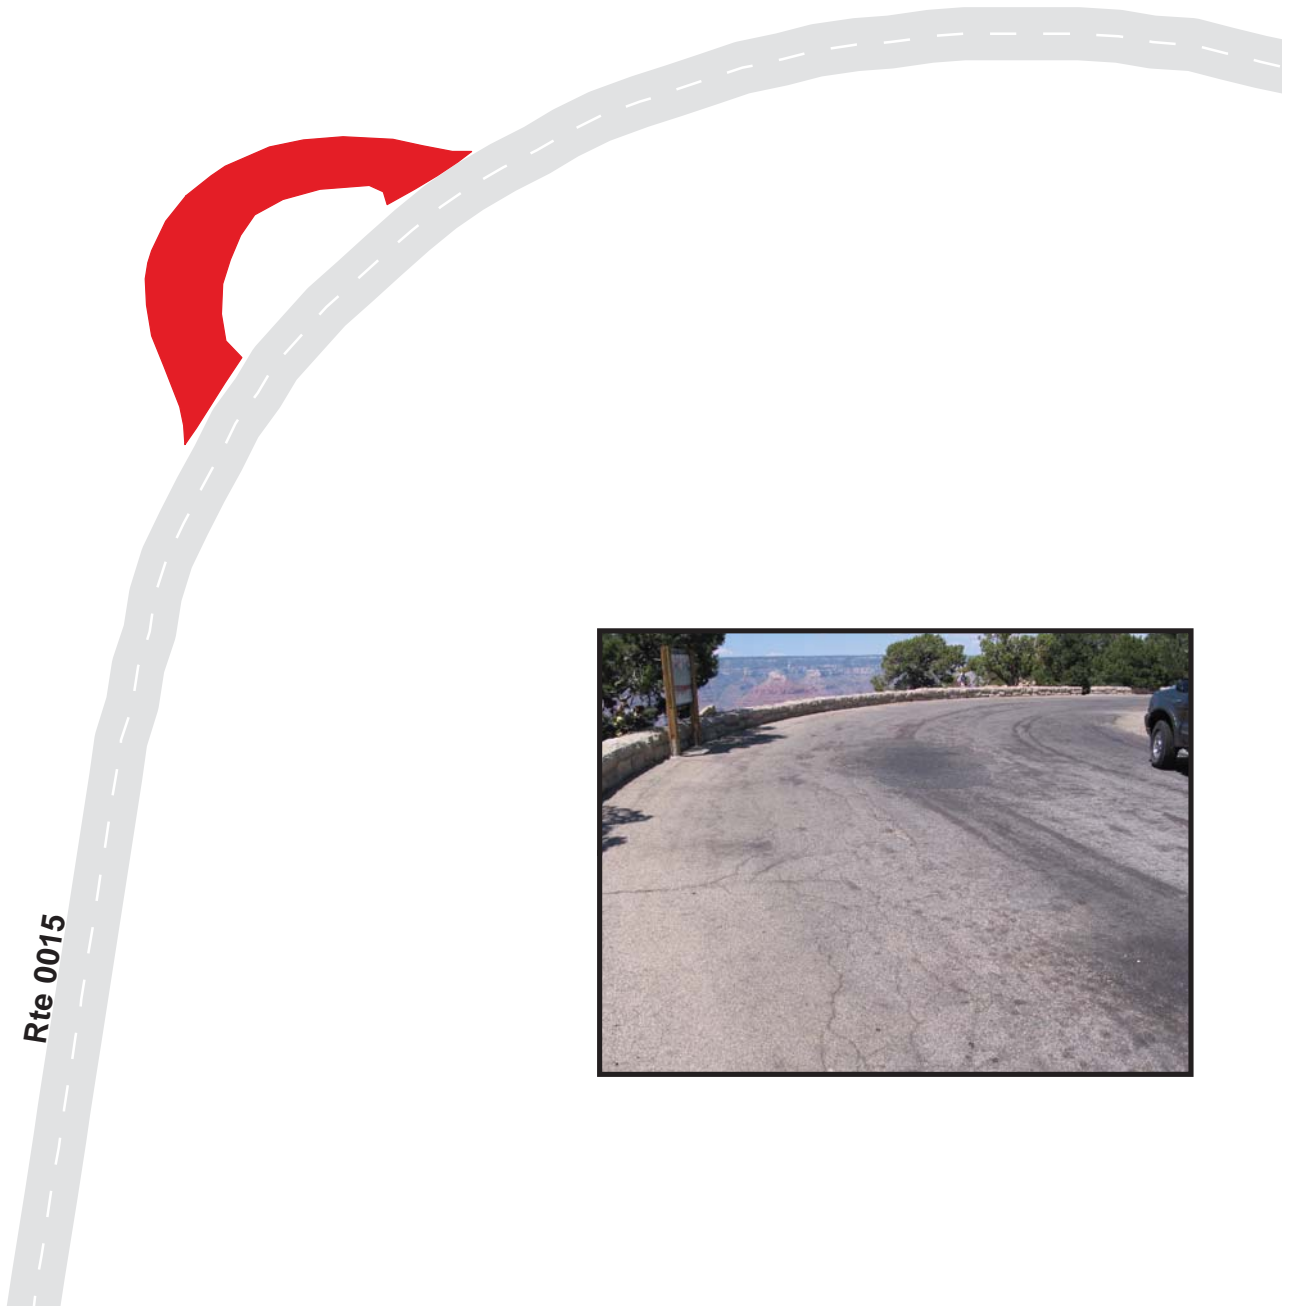
Route 0917

Route	Public / NonPublic	Date Visited	Area (sq ft)	Lane Miles *	Surface Type	Condition / PCR
0917	Public	6/4/2003	4356	0.07	AS	POOR / 45

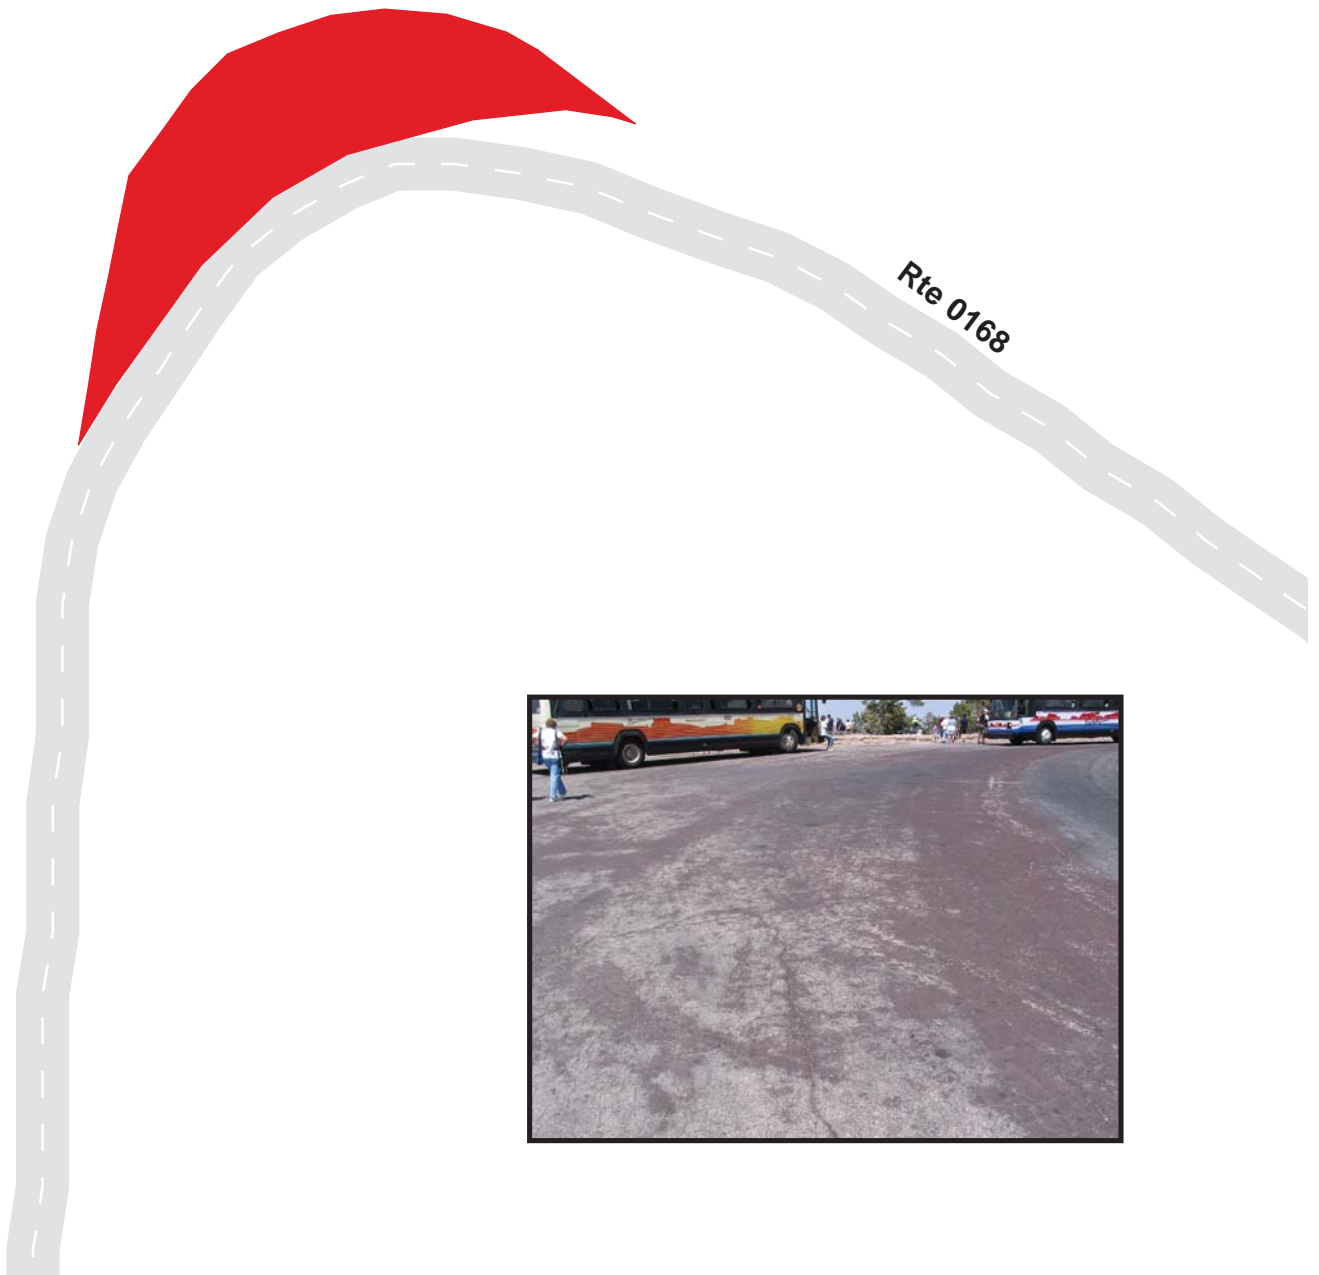
Route 0918

Route	Public / NonPublic	Date Visited	Area (sq ft)	Lane Miles *	Surface Type	Condition / PCR
0918	Public	6/4/2003	2900	0.05	AS	POOR / 45

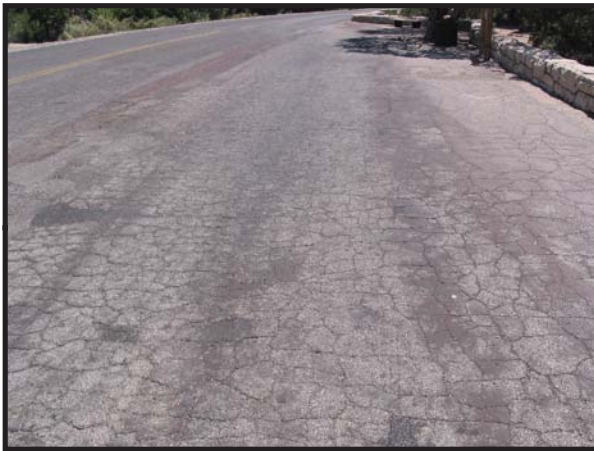
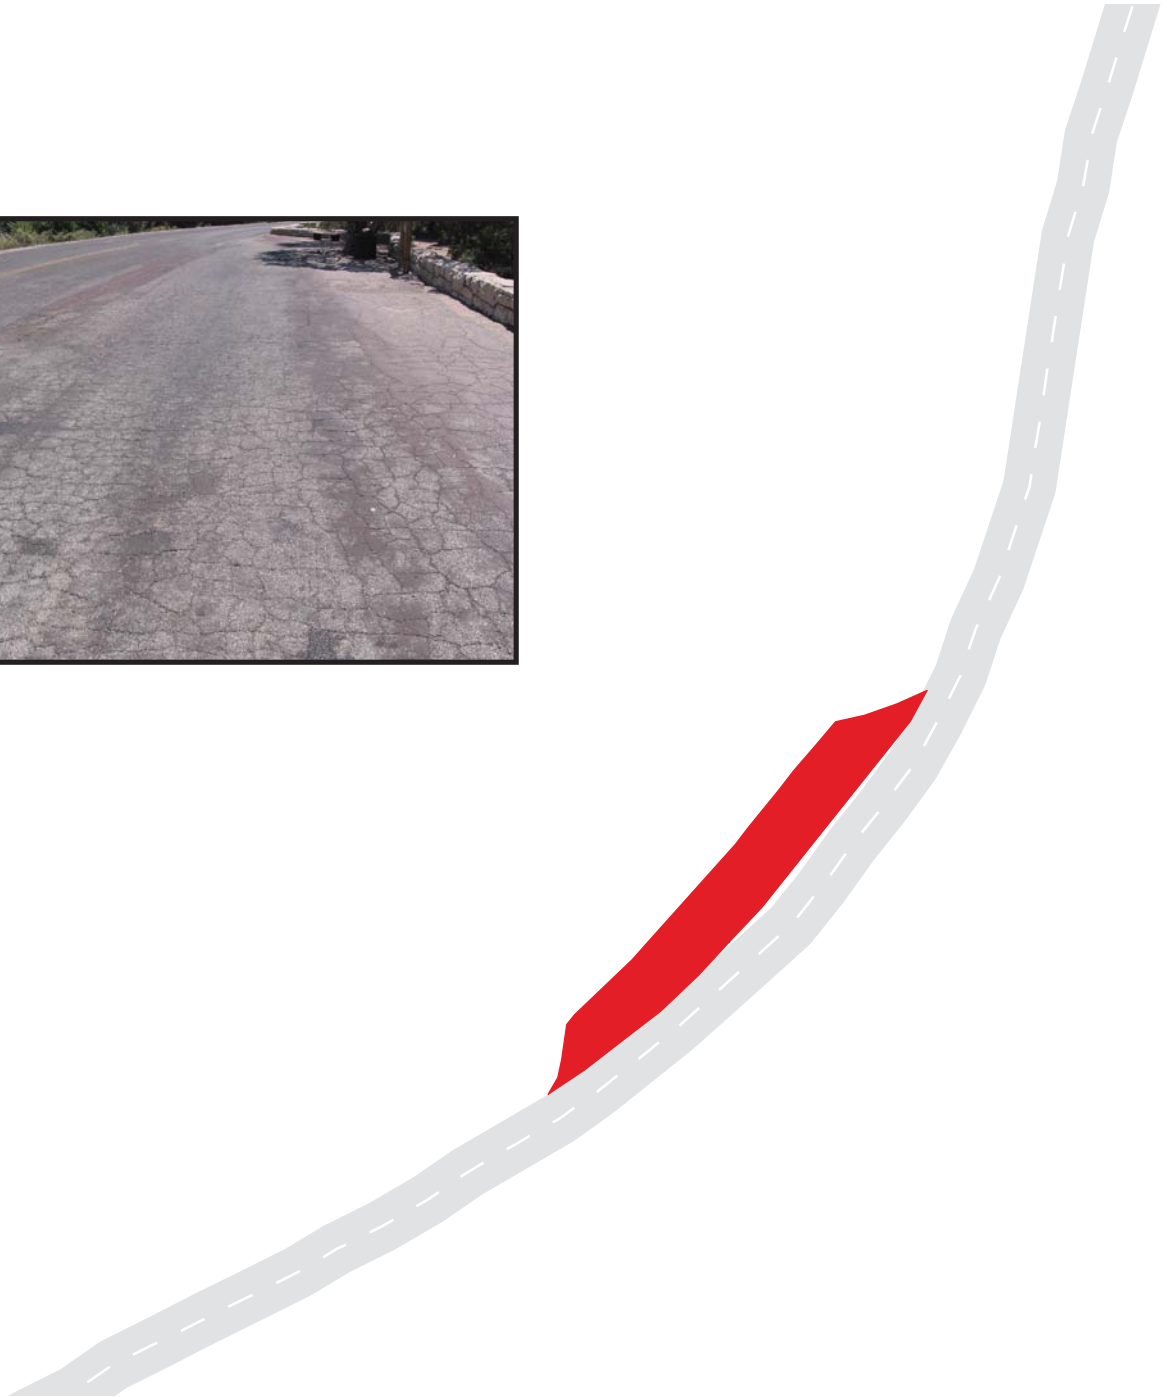
Route 0919

Route	Public / NonPublic	Date Visited	Area (sq ft)	Lane Miles *	Surface Type	Condition / PCR
0919	Public	6/4/2003	4226	0.07	AS	POOR / 45

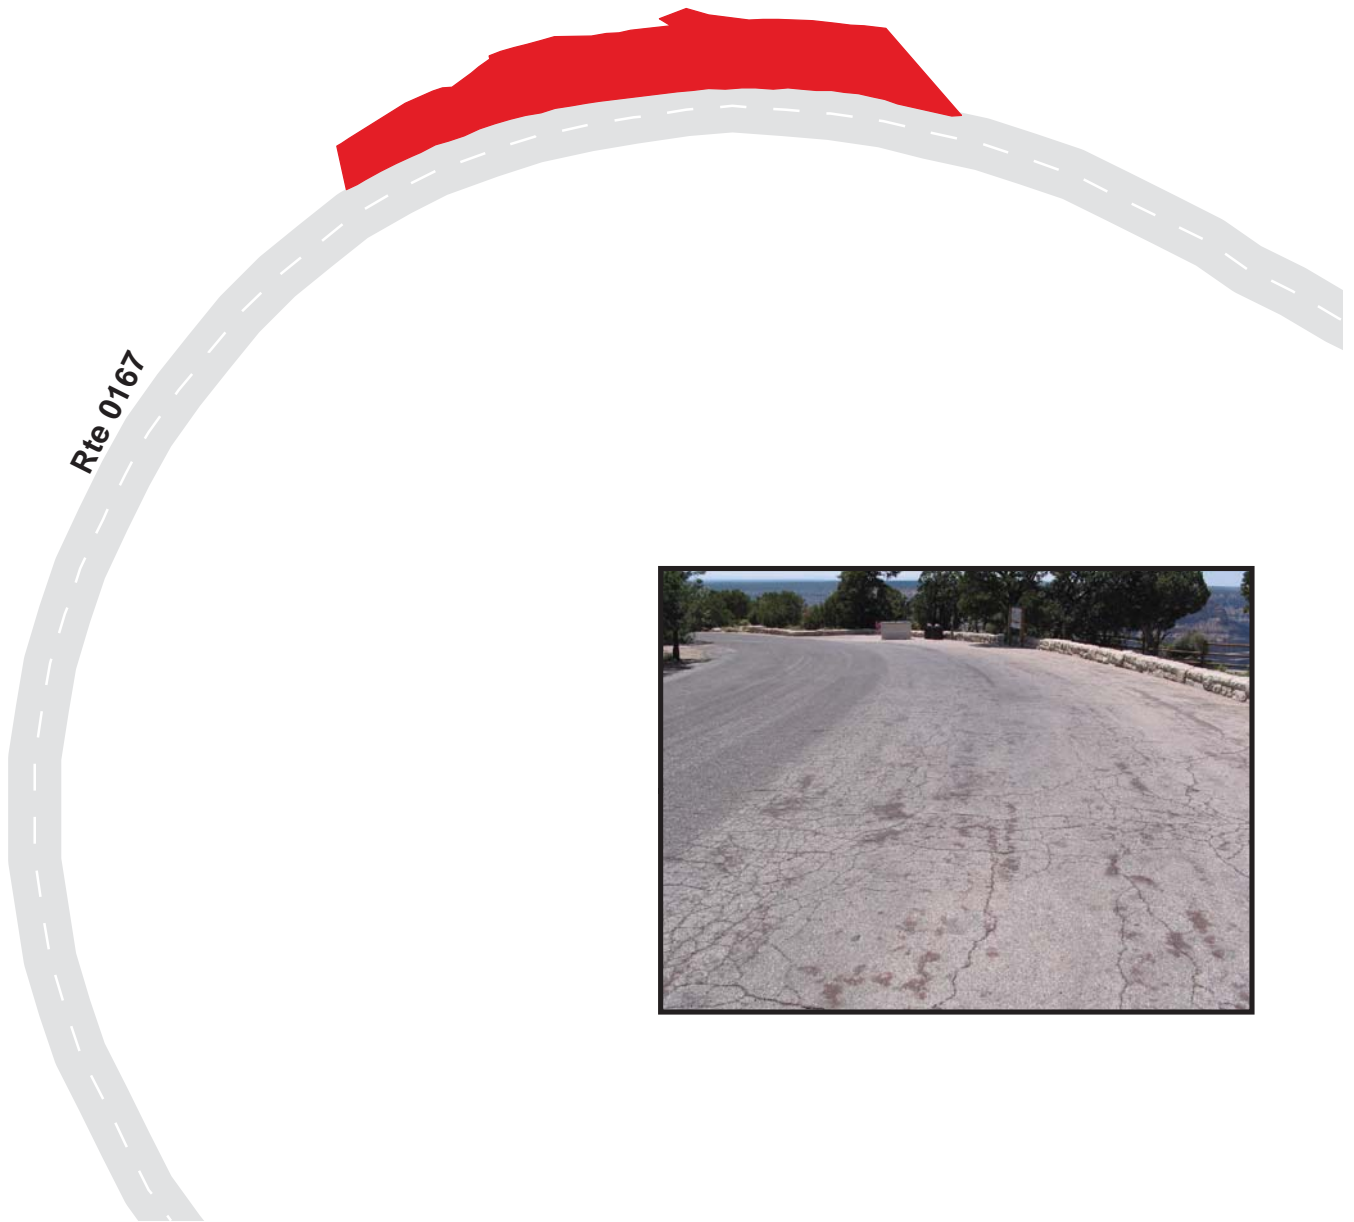
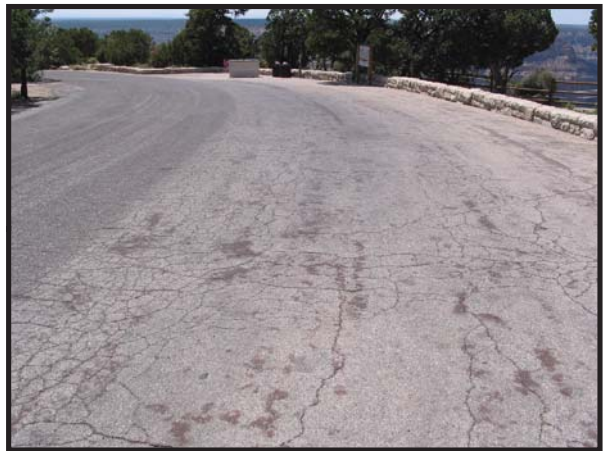
Route 0920

Route	Public / NonPublic	Date Visited	Area (sq ft)	Lane Miles *	Surface Type	Condition / PCR
0920	Public	6/4/2003	23570	0.41	AS	POOR / 45

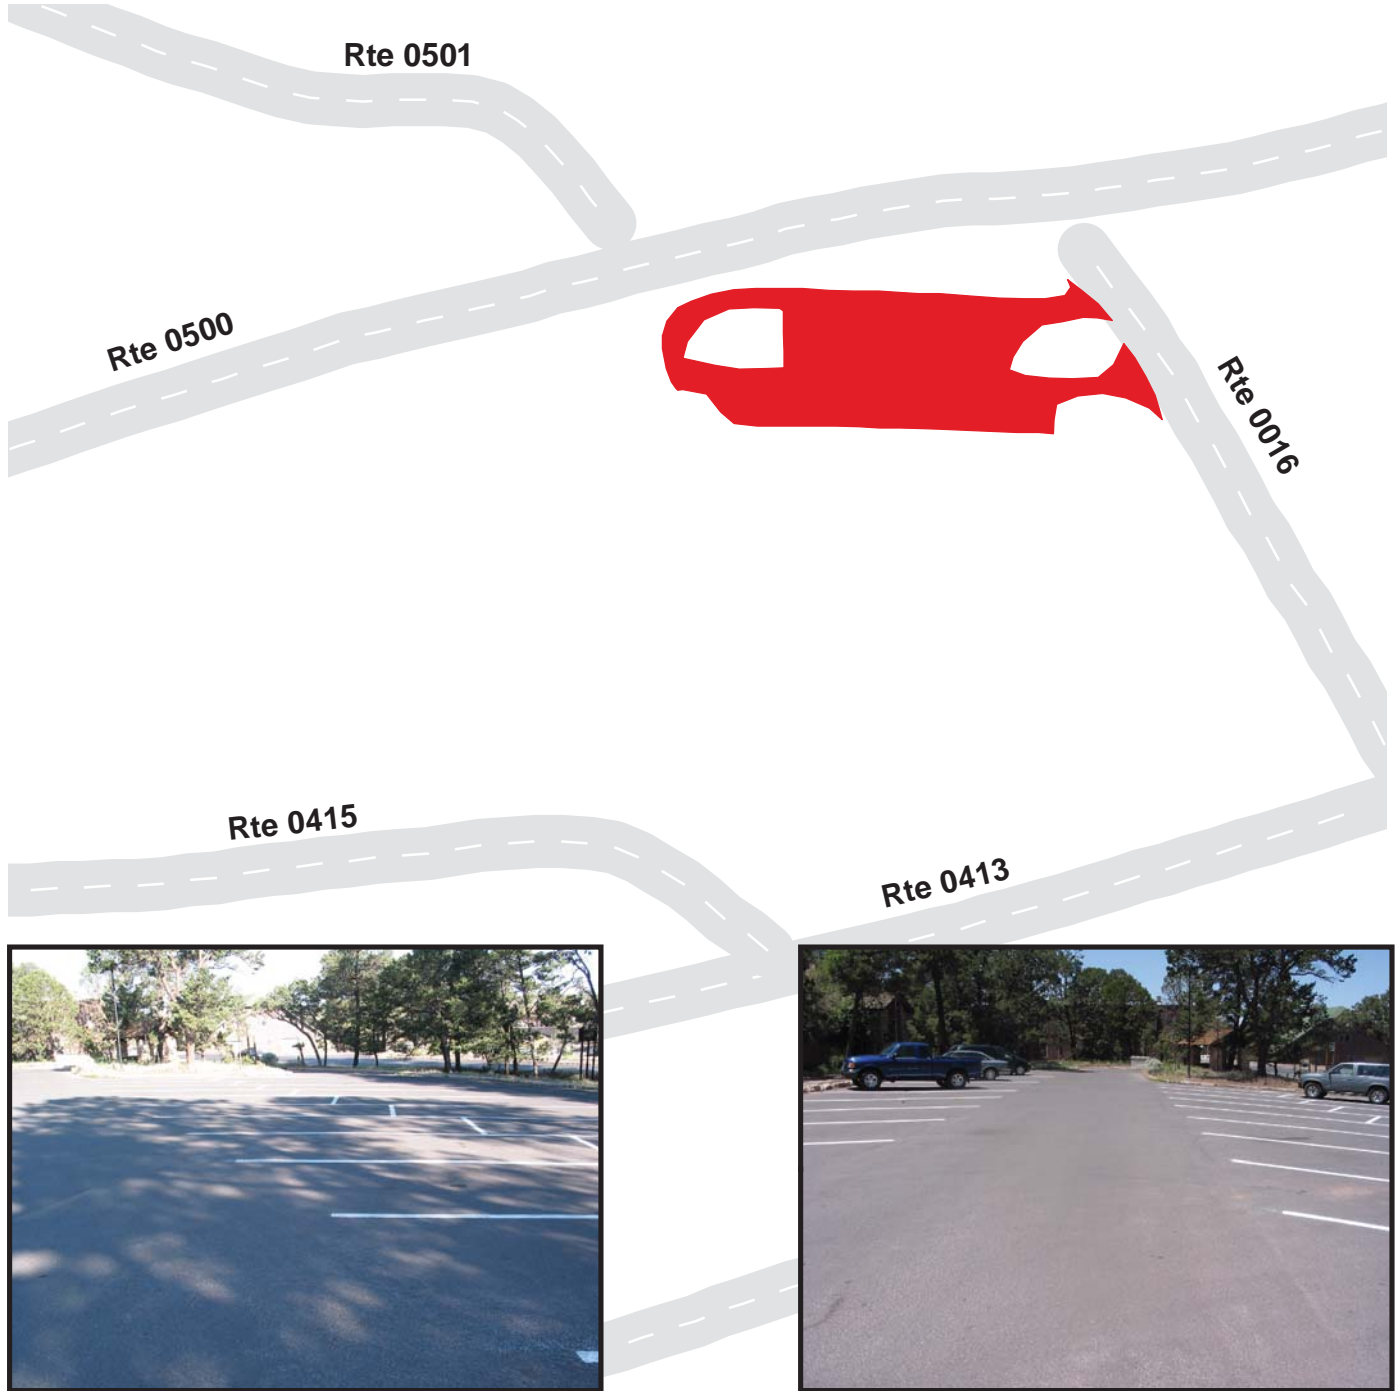
Route 0924B

Route	Public / NonPublic	Date Visited	Area (sq ft)	Lane Miles *	Surface Type	Condition / PCR
0924B	NonPublic	6/3/2003	7210	0.12	AS	GOOD / 90

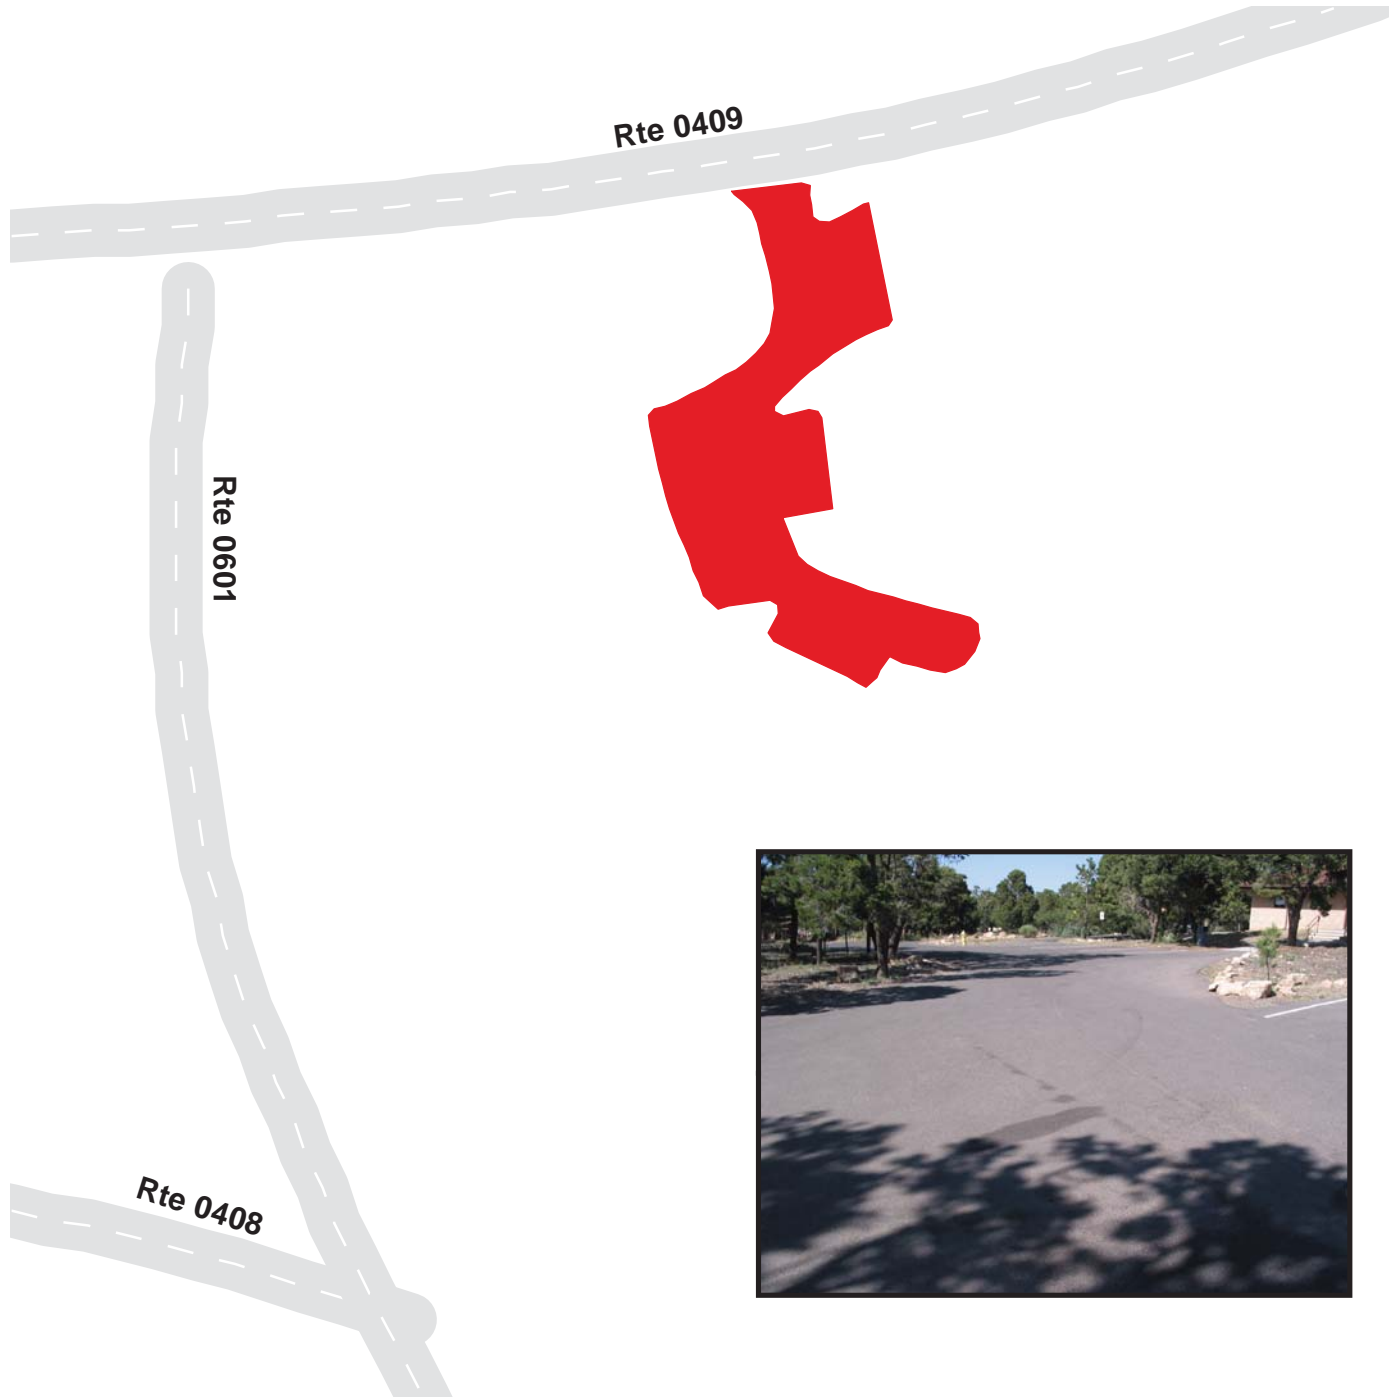
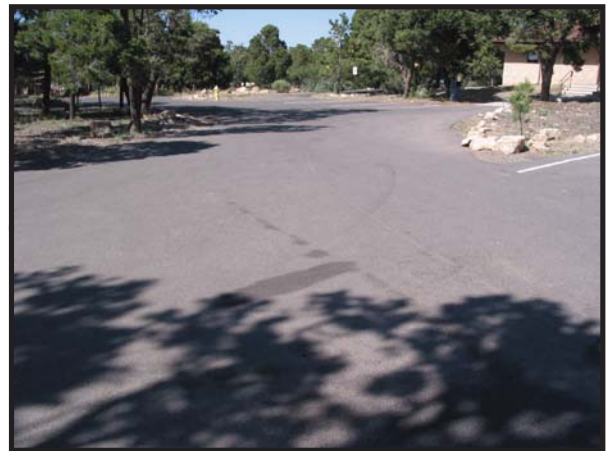
Route 0927

Route	Public / NonPublic	Date Visited	Area (sq ft)	Lane Miles *	Surface Type	Condition / PCR
0927	NonPublic	6/5/2003	4516	0.08	AS	POOR / 45

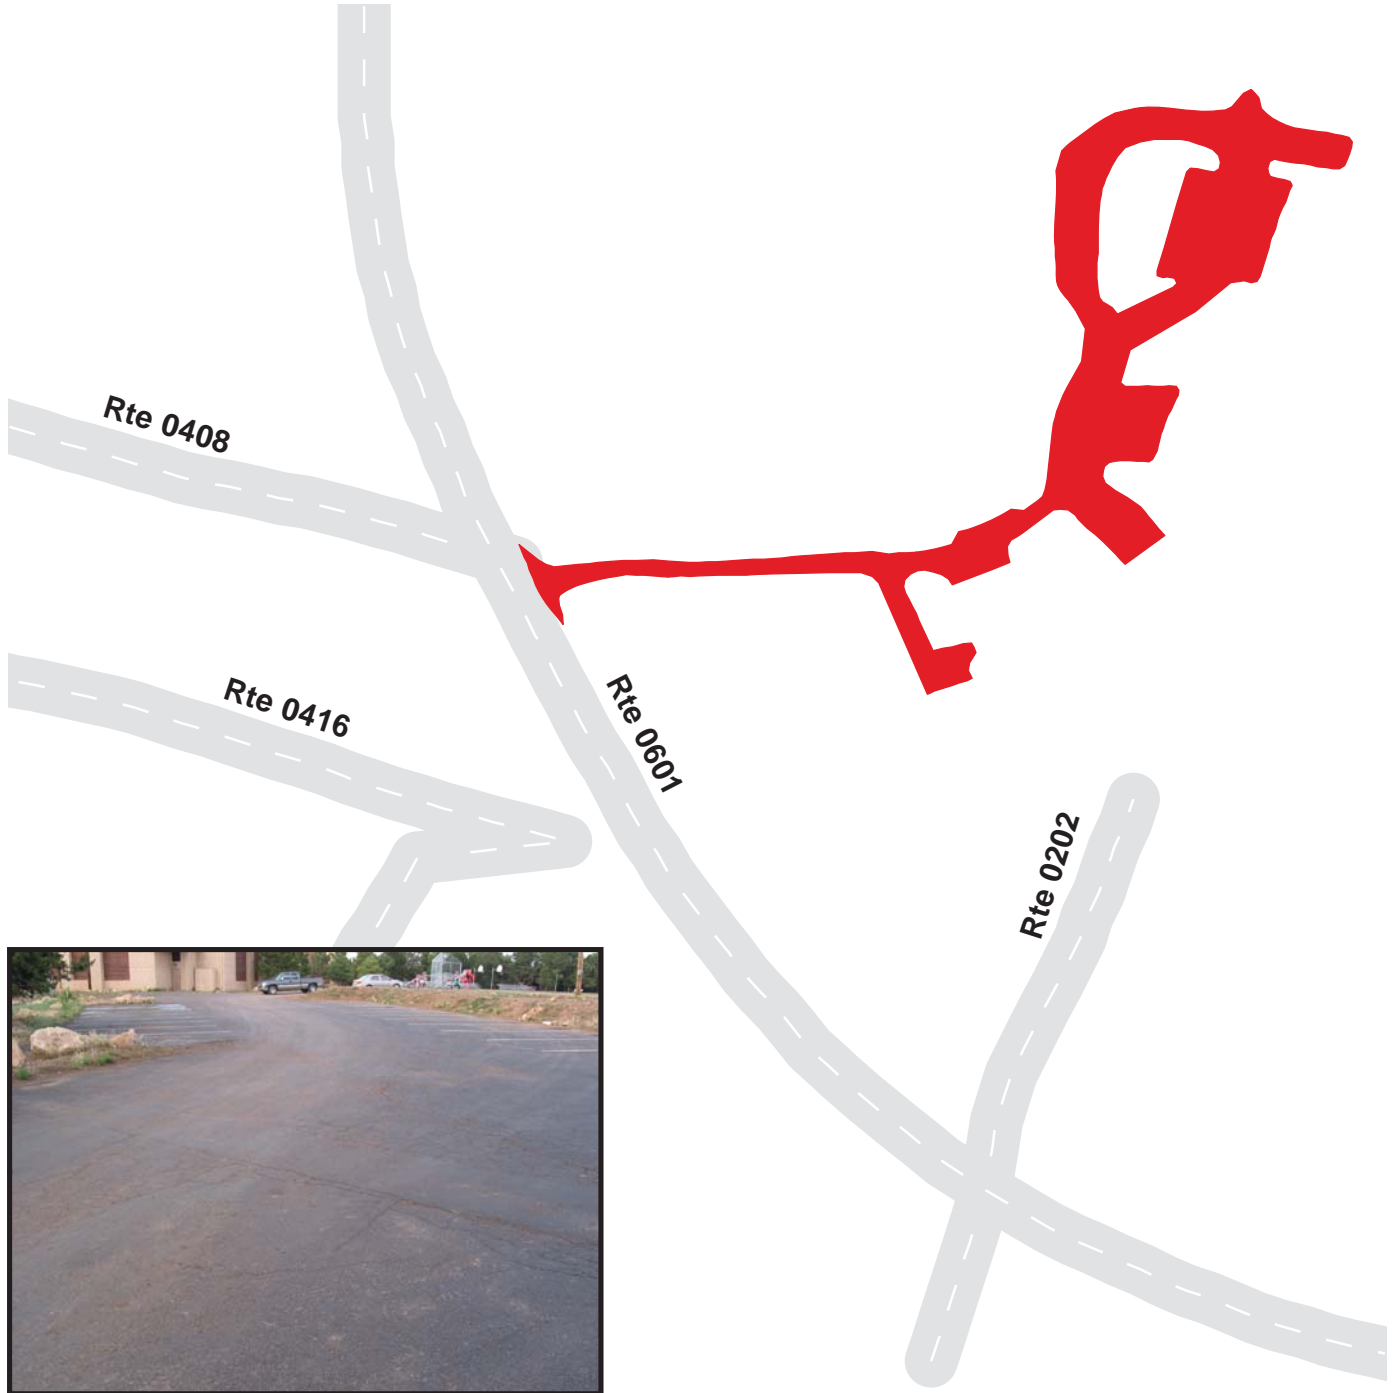
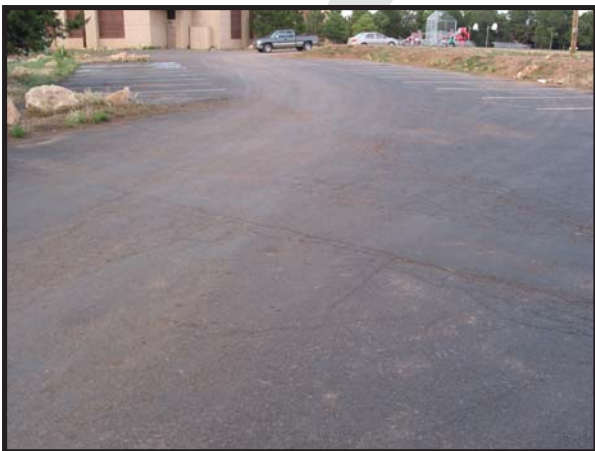
Route 0929

Route	Public / NonPublic	Date Visited	Area (sq ft)	Lane Miles *	Surface Type	Condition / PCR
0929	NonPublic	6/3/2003	36184	0.62	AS	POOR / 45

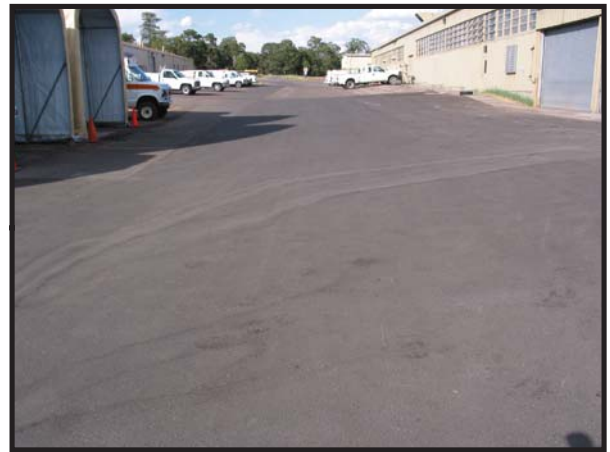
Route 0931

Route	Public / NonPublic	Date Visited	Area (sq ft)	Lane Miles *	Surface Type	Condition / PCR
0931	NonPublic	6/5/2003	43724	0.75	AS	POOR / 45

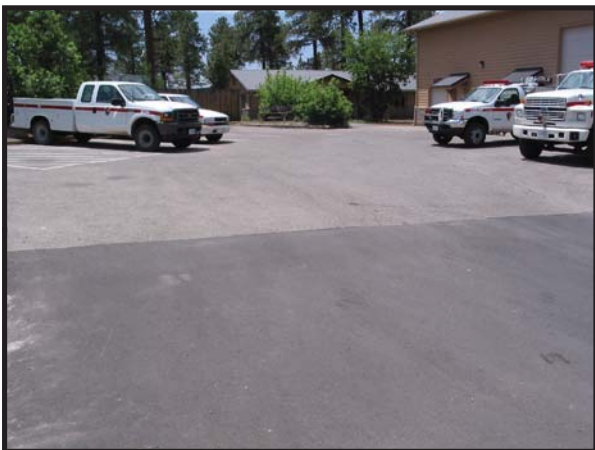
Route 0933

Route	Public / NonPublic	Date Visited	Area (sq ft)	Lane Miles *	Surface Type	Condition / PCR
0933	Public	6/5/2003	11336	0.20	AS	FAIR / 73

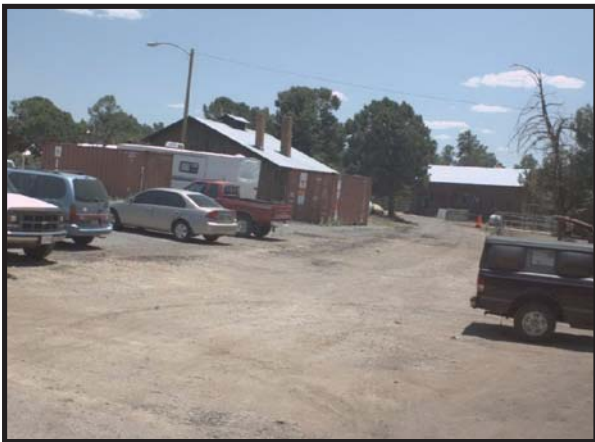
Route 0934B

Route	Public / NonPublic	Date Visited	Area (sq ft)	Lane Miles *	Surface Type	Condition / PCR
0934B	NonPublic	6/5/2003	6350	0.11	AS	POOR / 45

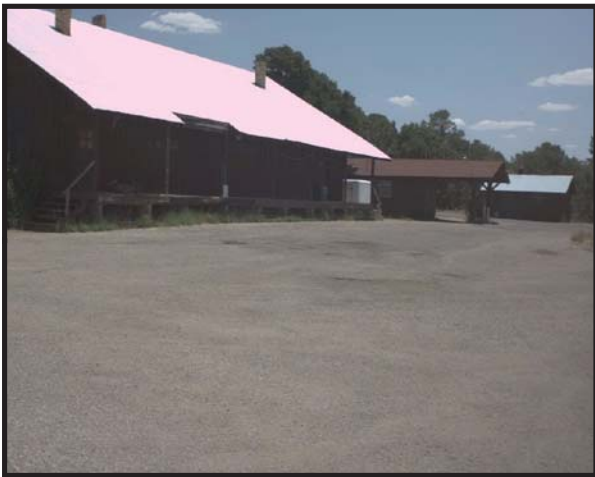
Route 0935

Route	Public / NonPublic	Date Visited	Area (sq ft)	Lane Miles *	Surface Type	Condition / PCR
0935	NonPublic	6/3/2003	8040	0.14	AS	POOR / 45

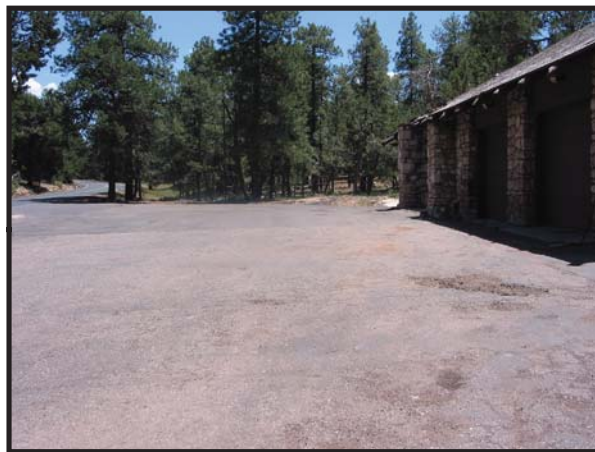
Route 0937

Route	Public / NonPublic	Date Visited	Area (sq ft)	Lane Miles *	Surface Type	Condition / PCR
0937	Public	6/5/2003	31391	0.54	AS	FAIR / 73

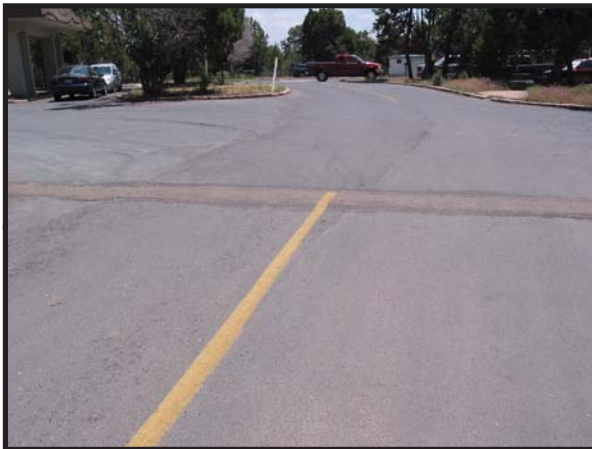
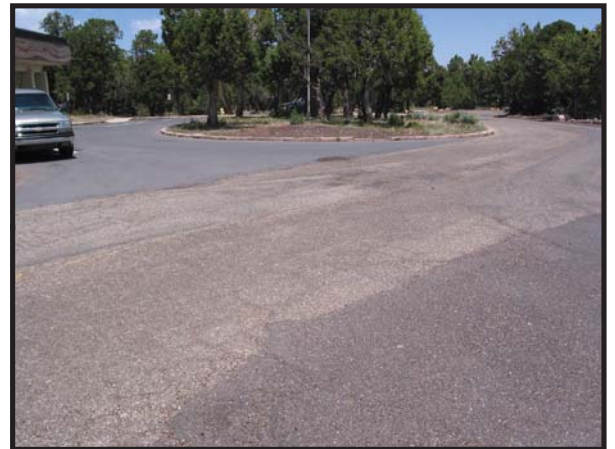
Route 0938

Route	Public / NonPublic	Date Visited	Area (sq ft)	Lane Miles *	Surface Type	Condition / PCR
0938	NonPublic	6/4/2003	9670	0.17	AS	POOR / 45

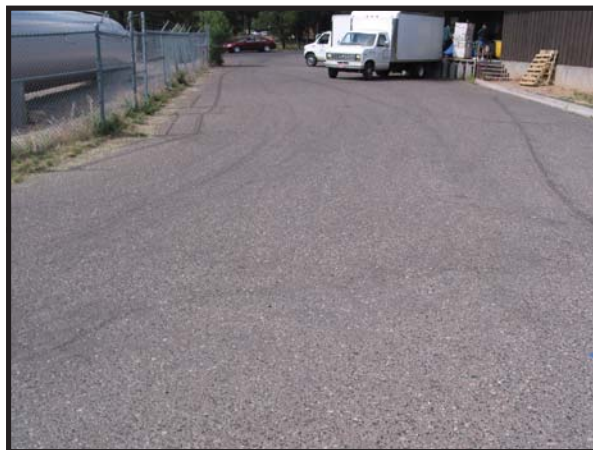
Route 0939

Route	Public / NonPublic	Date Visited	Area (sq ft)	Lane Miles *	Surface Type	Condition / PCR
0939	NonPublic	6/4/2003	37016	0.64	AS	FAIR / 73
