**The Road Inventory
of
Grand Canyon National Park
GRCA – 8210
Volume 1**

Prepared By:
Federal Highway Administration
Eastern Federal Lands Highway Division
Cycle 3

Grand Canyon National Park in Arizona

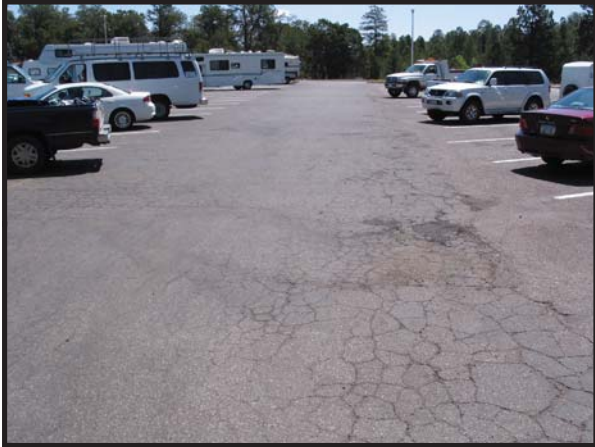
Route 0941

Route	Public / NonPublic	Date Visited	Area (sq ft)	Lane Miles *	Surface Type	Condition / PCR
0941	Public	6/5/2003	28149	0.48	AS	POOR / 45

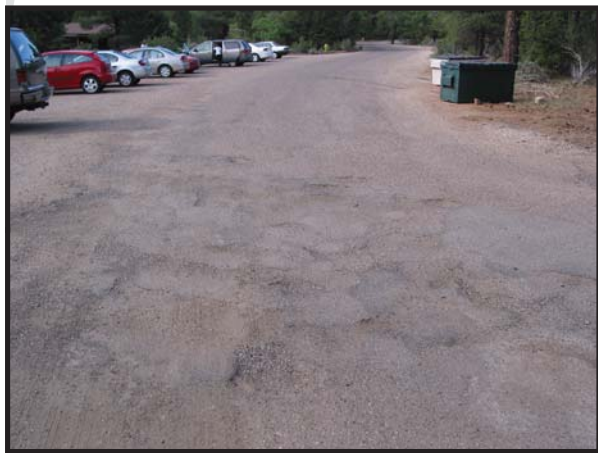
Route 0944

Route	Public / NonPublic	Date Visited	Area (sq ft)	Lane Miles *	Surface Type	Condition / PCR
0944	Public	6/4/2003	53634	0.92	AS	POOR / 45

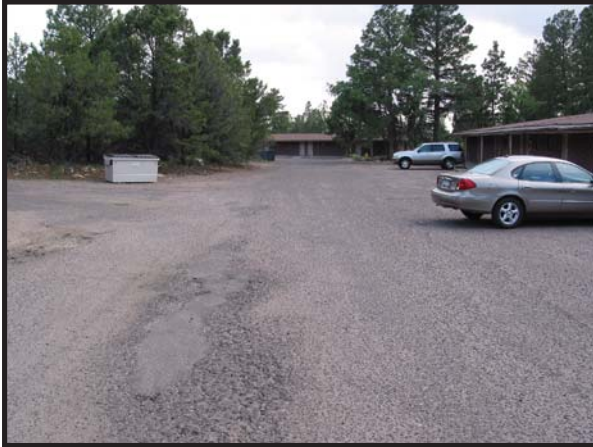
Route 0945

Route	Public / NonPublic	Date Visited	Area (sq ft)	Lane Miles *	Surface Type	Condition / PCR
0945	Public	6/4/2003	5363	0.09	AS	FAIR / 73

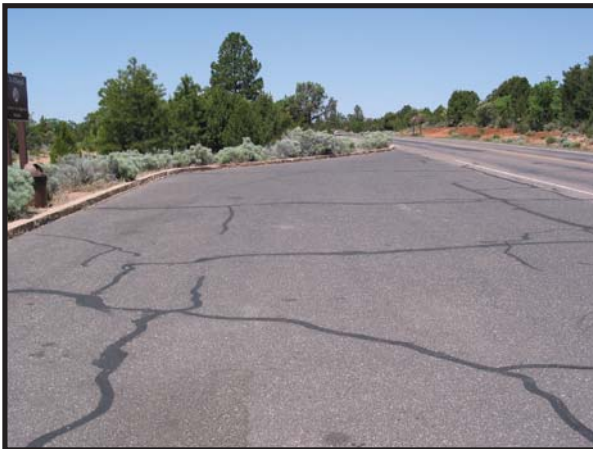
Route 0946

Route	Public / NonPublic	Date Visited	Area (sq ft)	Lane Miles *	Surface Type	Condition / PCR
0946	Public	6/4/2003	8211	0.14	AS	FAIR / 73

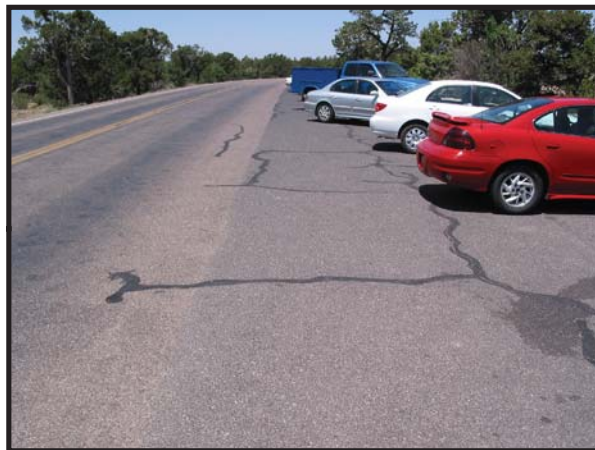
Route 0947

Route	Public / NonPublic	Date Visited	Area (sq ft)	Lane Miles *	Surface Type	Condition / PCR
0947	Public	6/4/2003	6355	0.11	AS	FAIR / 73

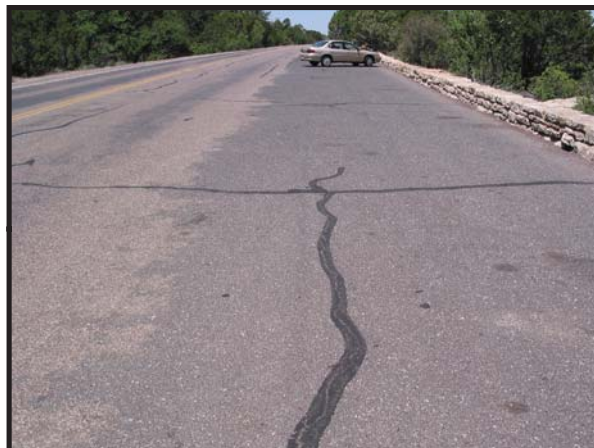
Route 0948

Route	Public / NonPublic	Date Visited	Area (sq ft)	Lane Miles *	Surface Type	Condition / PCR
0948	Public	6/4/2003	6169	0.11	AS	POOR / 45

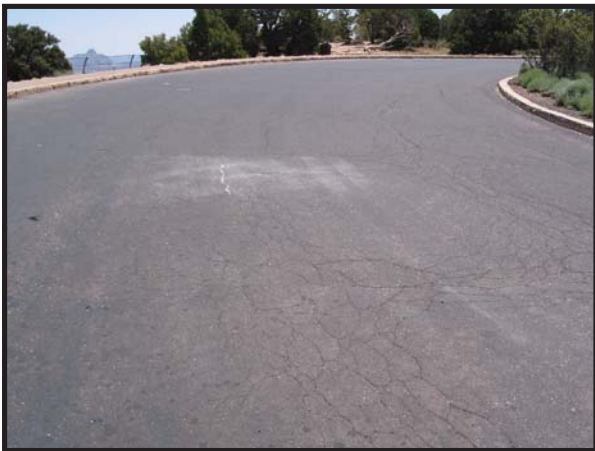
Route 0949

Route	Public / NonPublic	Date Visited	Area (sq ft)	Lane Miles *	Surface Type	Condition / PCR
0949	Public	6/4/2003	21339	0.37	AS	FAIR / 73

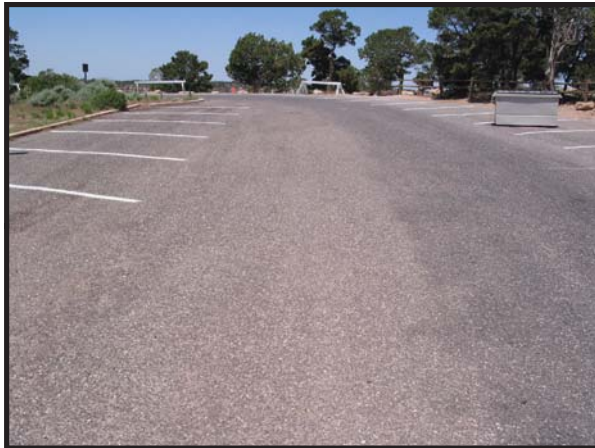
Route 0950

Route	Public / NonPublic	Date Visited	Area (sq ft)	Lane Miles *	Surface Type	Condition / PCR
0950	Public	6/4/2003	22776	0.39	AS	GOOD / 90

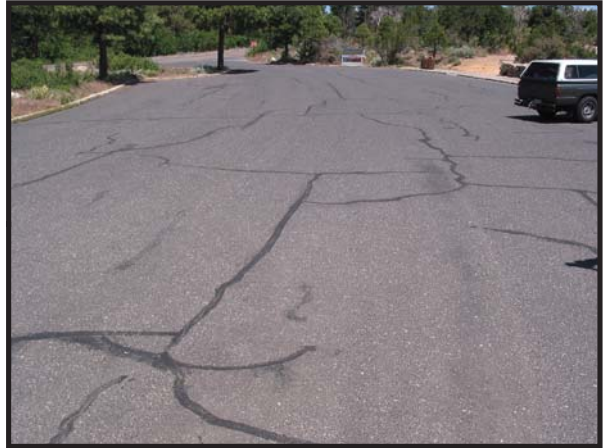
Route 0951

Route	Public / NonPublic	Date Visited	Area (sq ft)	Lane Miles *	Surface Type	Condition / PCR
0951	Public	6/4/2003	5859	0.10	AS	GOOD / 90

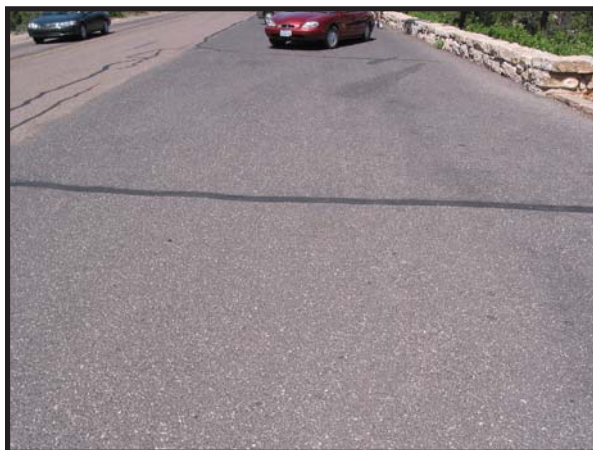
Route 0952

Route	Public / NonPublic	Date Visited	Area (sq ft)	Lane Miles *	Surface Type	Condition / PCR
0952	Public	6/4/2003	5996	0.10	AS	GOOD / 90

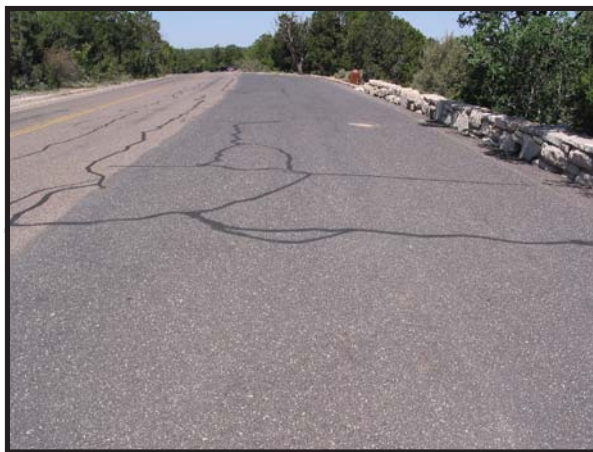
Route 0953

Route	Public / NonPublic	Date Visited	Area (sq ft)	Lane Miles *	Surface Type	Condition / PCR
0953	Public	6/4/2003	10745	0.19	AS	GOOD / 90

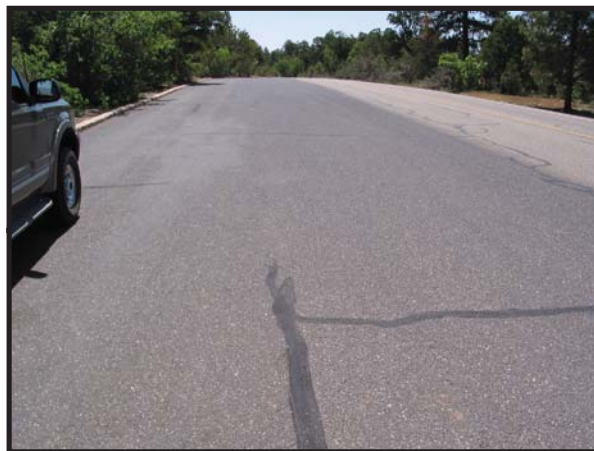
Grand Canyon National Park
Route 0954
 Buggeln Picnic Area
 Adjacent To Route 0011 at MP 12.00

Route	Public / NonPublic	Date Visited	Area (sq ft)	Lane Miles *	Surface Type	Condition / PCR
0954	Public	6/4/2003	11489	0.20	AS	FAIR / 73

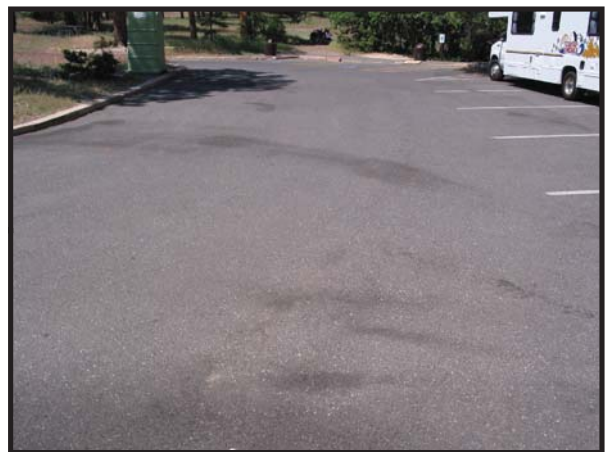
Route 0955

Route	Public / NonPublic	Date Visited	Area (sq ft)	Lane Miles *	Surface Type	Condition / PCR
0955	Public	6/4/2003	14409	0.25	AS	FAIR / 73

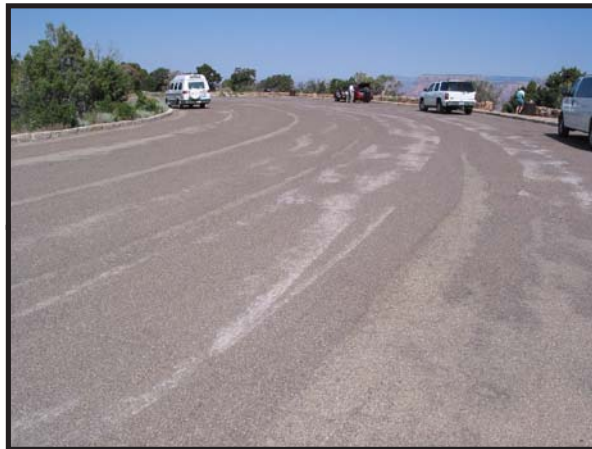
Grand Canyon National Park
Route 0957
Desert View Parking
Adjacent To Route 0011 at MP 21.68

Route	Public / NonPublic	Date Visited	Area (sq ft)	Lane Miles *	Surface Type	Condition / PCR
0957	Public	6/4/2003	69881	1.20	AS	FAIR / 73

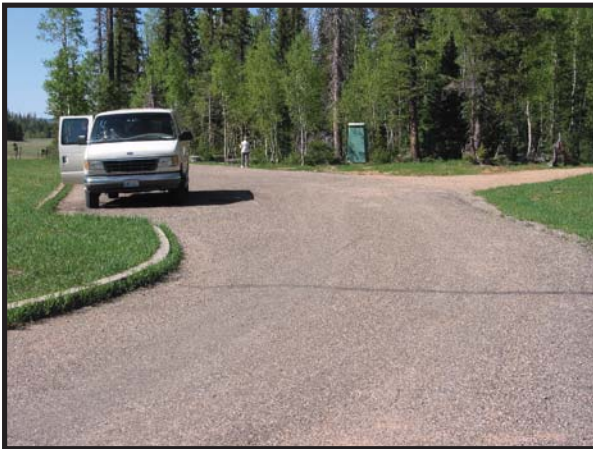
Route 0961

Route	Public / NonPublic	Date Visited	Area (sq ft)	Lane Miles *	Surface Type	Condition / PCR
0961	Public	6/4/2003	10496	0.18	OC	GOOD / 90

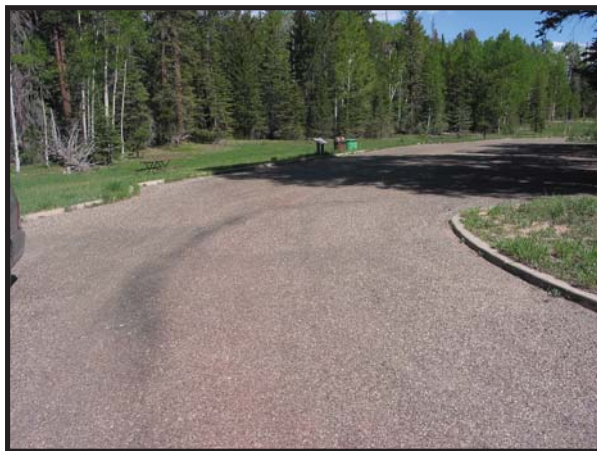
Route 0963

Route	Public / NonPublic	Date Visited	Area (sq ft)	Lane Miles *	Surface Type	Condition / PCR
0963	Public	6/4/2003	25737	0.44	AS	FAIR / 73

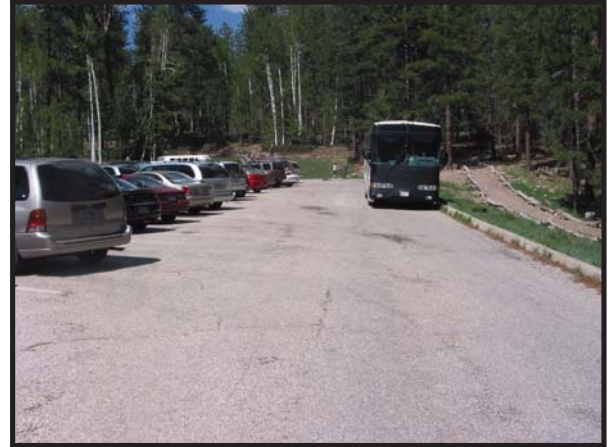
Route 0965

Route	Public / NonPublic	Date Visited	Area (sq ft)	Lane Miles *	Surface Type	Condition / PCR
0965	Public	6/4/2003	130951	2.25	AS	FAIR / 73

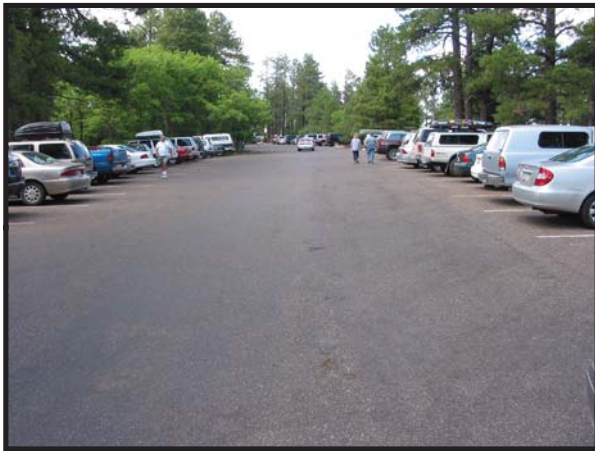
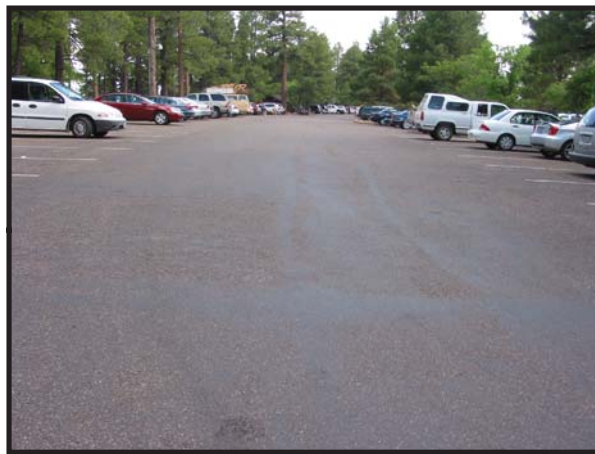
Route 0966

Route	Public / NonPublic	Date Visited	Area (sq ft)	Lane Miles *	Surface Type	Condition / PCR
0966	Public	6/4/2003	4612	0.08	OC	FAIR / 73

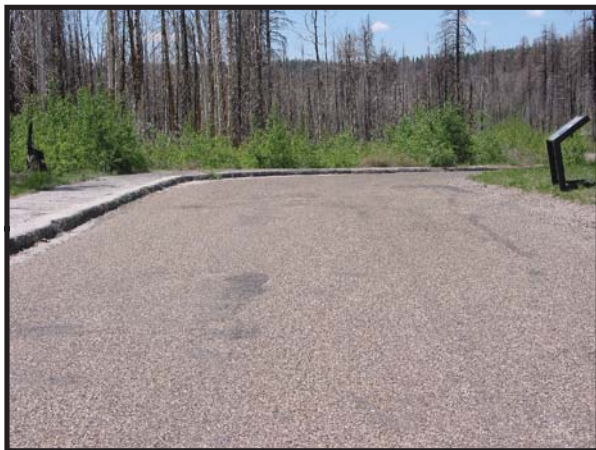
Route 0967

Route	Public / NonPublic	Date Visited	Area (sq ft)	Lane Miles *	Surface Type	Condition / PCR
0967	Public	6/4/2003	50488	0.87	OC	FAIR / 73

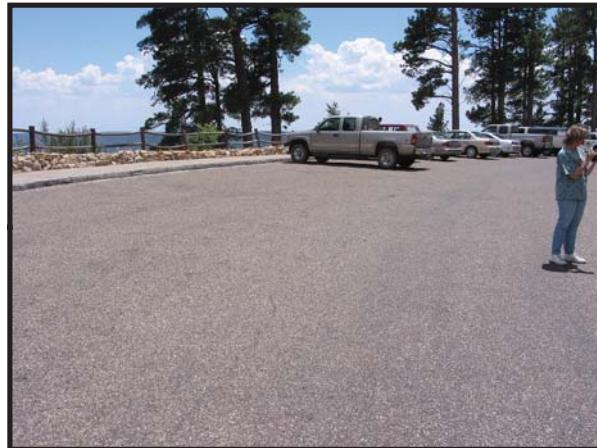
Route 0968

Route	Public / NonPublic	Date Visited	Area (sq ft)	Lane Miles *	Surface Type	Condition / PCR
0968	Public	6/4/2003	12590	0.22	AS	POOR / 45

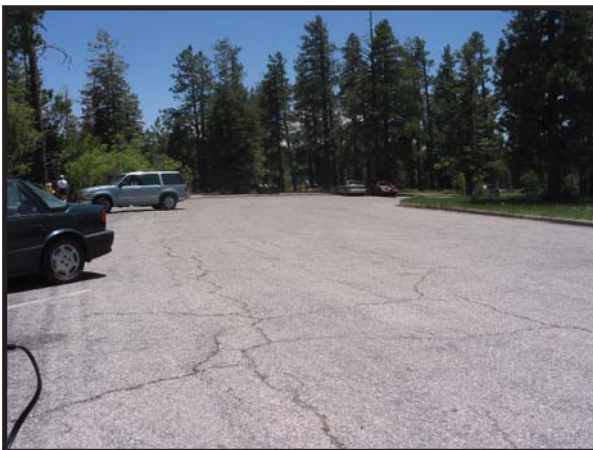
Route 0969

Route	Public / NonPublic	Date Visited	Area (sq ft)	Lane Miles *	Surface Type	Condition / PCR
0969	Public	6/4/2003	5514	0.09	AS	FAIR / 73

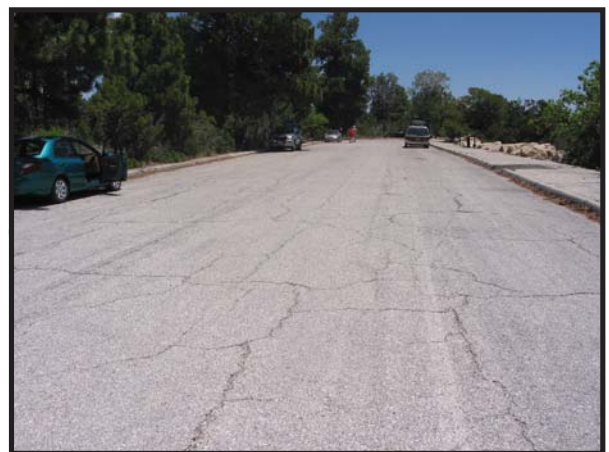
Route 0971

Route	Public / NonPublic	Date Visited	Area (sq ft)	Lane Miles *	Surface Type	Condition / PCR
0971	Public	6/5/2003	10269	0.18	AS	GOOD / 90

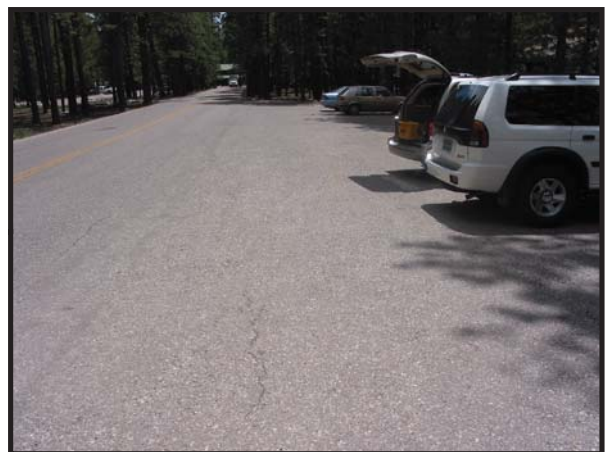
Route 0973

Route	Public / NonPublic	Date Visited	Area (sq ft)	Lane Miles *	Surface Type	Condition / PCR
0973	Public	6/5/2003	2323	0.04	AS	FAIR / 73

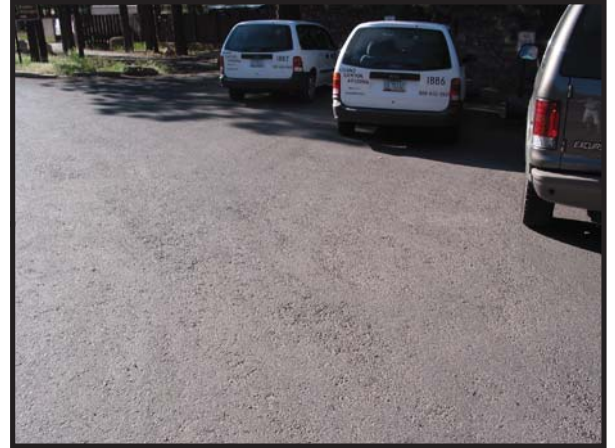
Route 0980A

Route	Public / NonPublic	Date Visited	Area (sq ft)	Lane Miles *	Surface Type	Condition / PCR
0980A	Public	6/4/2003	5121	0.09	AS	FAIR / 73

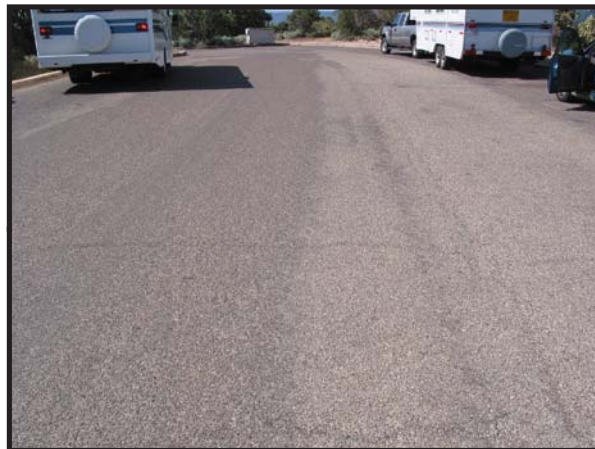
Route 0982

Route	Public / NonPublic	Date Visited	Area (sq ft)	Lane Miles *	Surface Type	Condition / PCR
0982	Public	6/4/2003	2554	0.04	AS	GOOD / 90

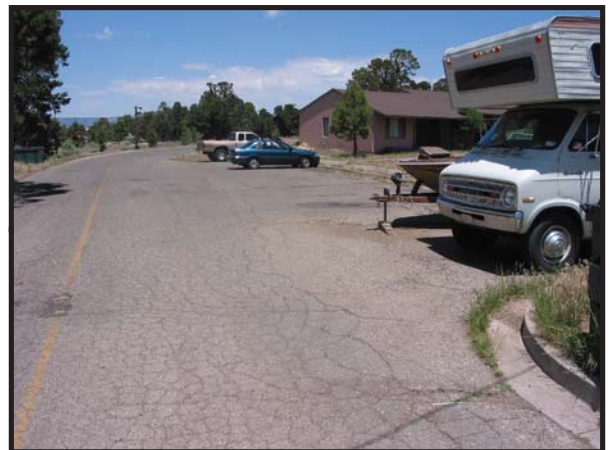
Route 0984

Route	Public / NonPublic	Date Visited	Area (sq ft)	Lane Miles *	Surface Type	Condition / PCR
0984	Public	6/5/2003	57970	1.00	AS	GOOD / 90

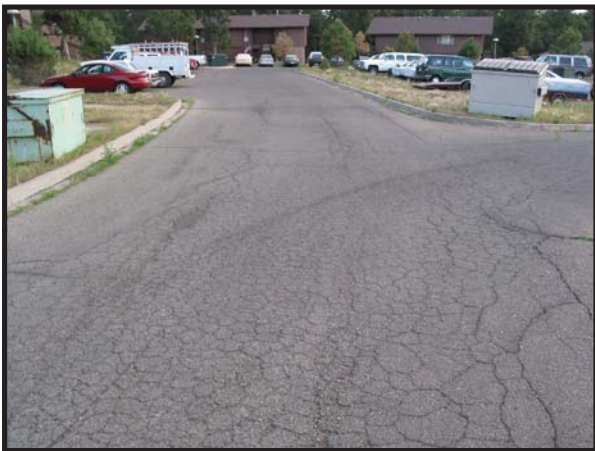
Route 0988

Route	Public / NonPublic	Date Visited	Area (sq ft)	Lane Miles *	Surface Type	Condition / PCR
0988	NonPublic	6/3/2003	6437	0.11	AS	POOR / 45

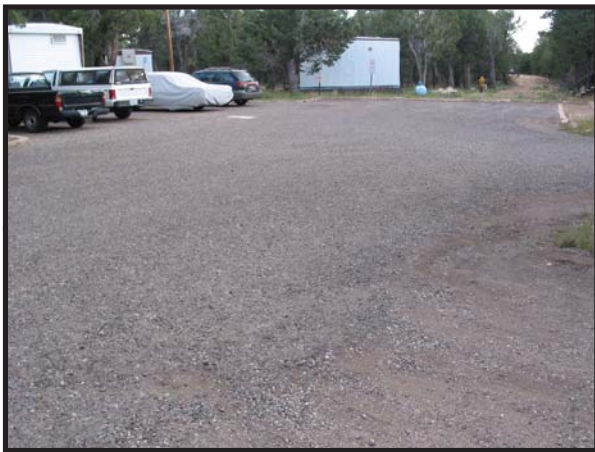
Route 0990A

Route	Public / NonPublic	Date Visited	Area (sq ft)	Lane Miles *	Surface Type	Condition / PCR
0990A	Public	6/4/2003	4908	0.08	AS	FAIR / 73

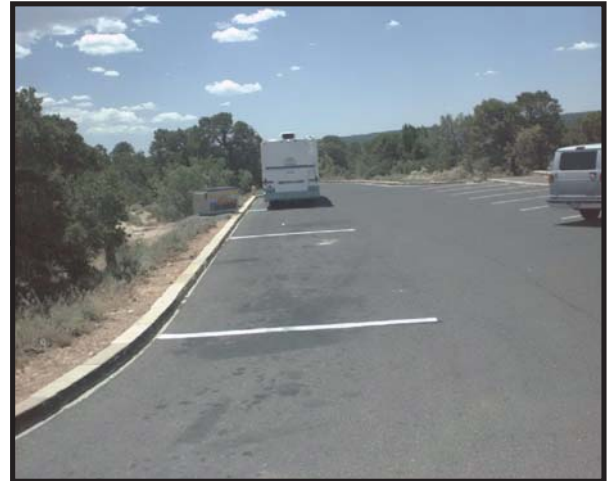
Route 0993

Route	Public / NonPublic	Date Visited	Area (sq ft)	Lane Miles *	Surface Type	Condition / PCR
0993	NonPublic	6/4/2003	9135	0.16	AS	EXCELLENT / 97

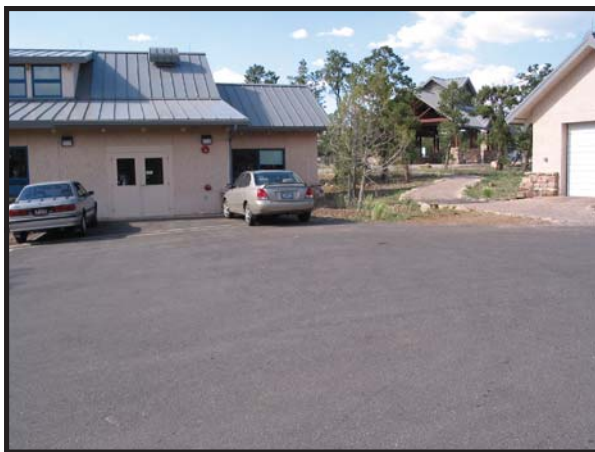
Route 0994

Route	Public / NonPublic	Date Visited	Area (sq ft)	Lane Miles *	Surface Type	Condition / PCR
0994	NonPublic	6/6/2003	18775	0.32	AS	POOR / 45

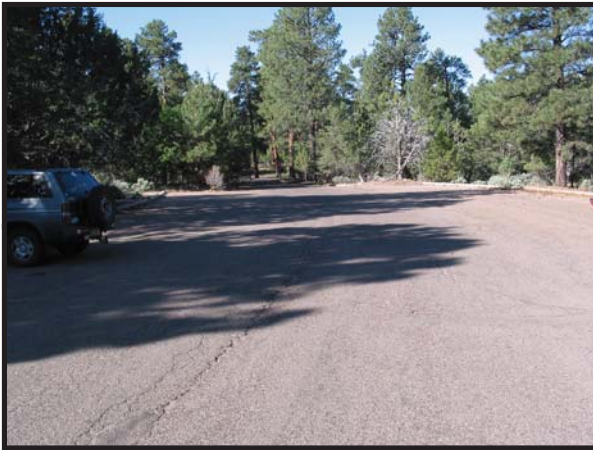
Route 0995

Route	Public / NonPublic	Date Visited	Area (sq ft)	Lane Miles *	Surface Type	Condition / PCR
0995	Public	6/4/2003	22706	0.39	AS	FAIR / 73

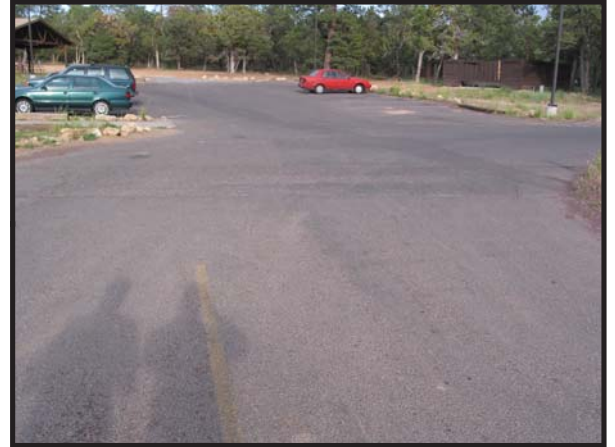
Route 0996

Route	Public / NonPublic	Date Visited	Area (sq ft)	Lane Miles *	Surface Type	Condition / PCR
0996	Public	6/5/2003	4555	0.08	AS	EXCELLENT / 97

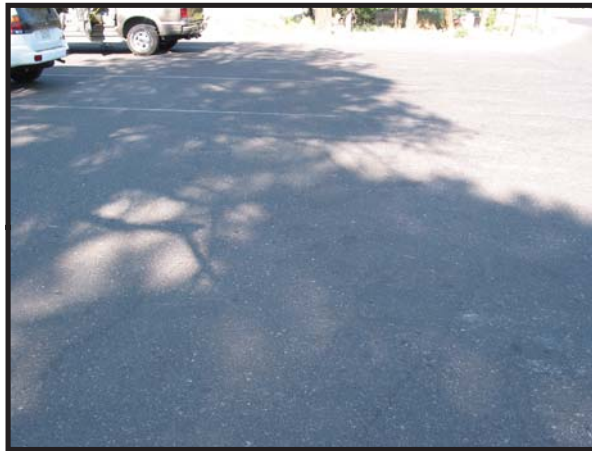
Route 0997

Route	Public / NonPublic	Date Visited	Area (sq ft)	Lane Miles *	Surface Type	Condition / PCR
0997	Public	6/5/2003	19452	0.33	AS	FAIR / 73

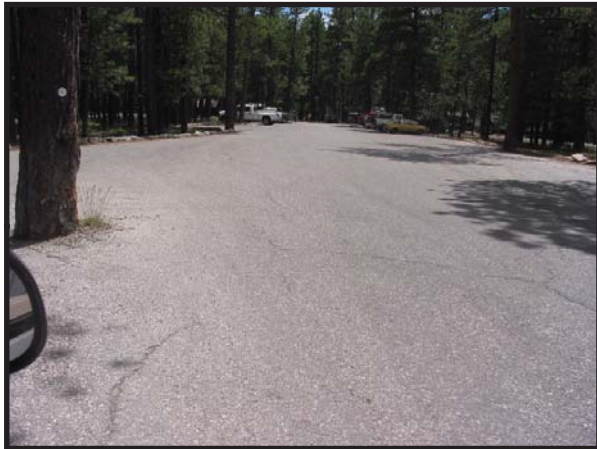
Route 0998

Route	Public / NonPublic	Date Visited	Area (sq ft)	Lane Miles *	Surface Type	Condition / PCR
0998	Public	6/5/2003	6945	0.12	AS	EXCELLENT / 97

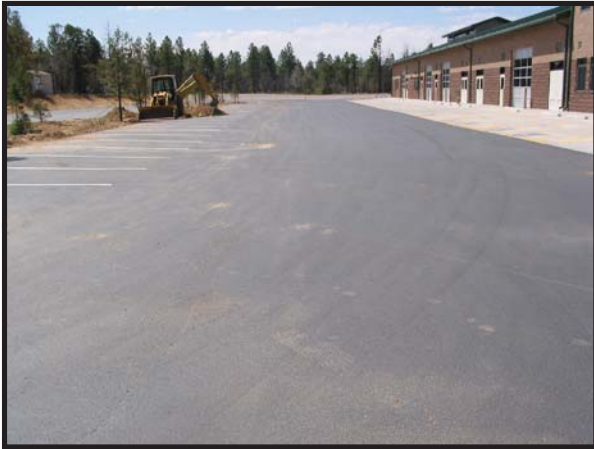
Route 1000

Route	Public / NonPublic	Date Visited	Area (sq ft)	Lane Miles *	Surface Type	Condition / PCR
1000	NonPublic	6/5/2003	3835	0.07	AS	GOOD / 90

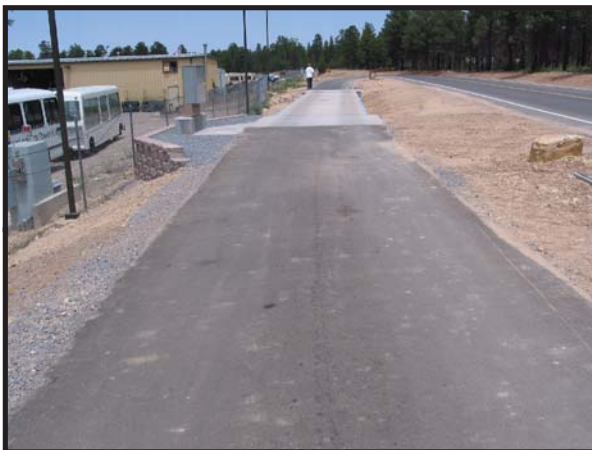
Route 1001A

Route	Public / NonPublic	Date Visited	Area (sq ft)	Lane Miles *	Surface Type	Condition / PCR
1001A	NonPublic	6/5/2003	1254	0.02	AS	FAIR / 73

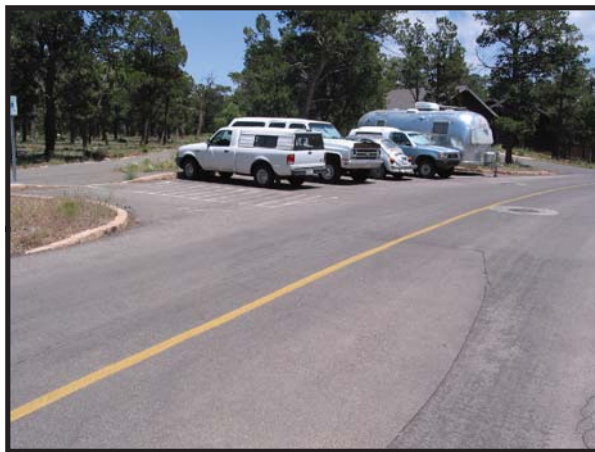
Route 1001B

Route	Public / NonPublic	Date Visited	Area (sq ft)	Lane Miles *	Surface Type	Condition / PCR
1001B	NonPublic	6/5/2003	1291	0.02	AS	GOOD / 90

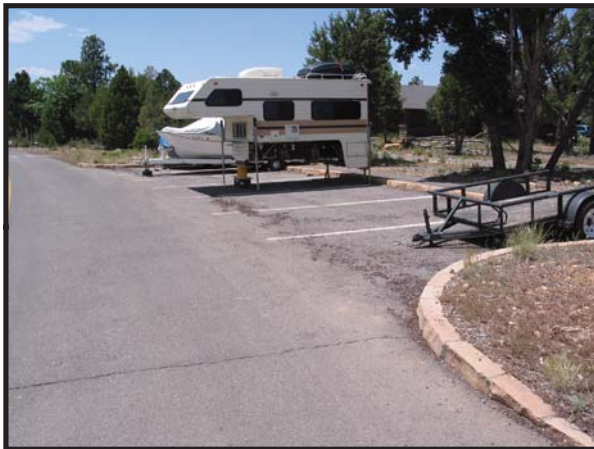
Route 1002

Route	Public / NonPublic	Date Visited	Area (sq ft)	Lane Miles *	Surface Type	Condition / PCR
1002	NonPublic	6/5/2003	1622	0.03	AS	GOOD / 90

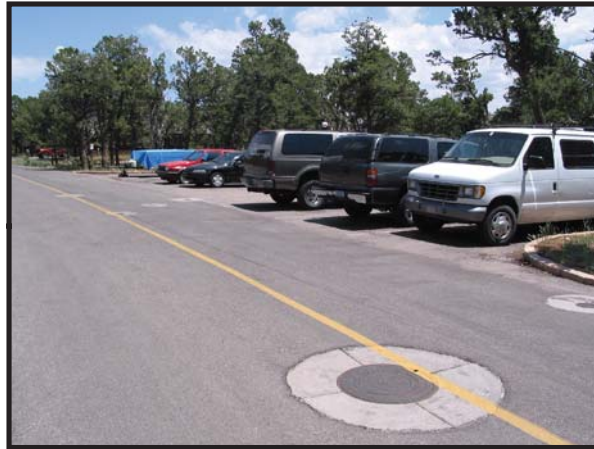
Route 1003A

Route	Public / NonPublic	Date Visited	Area (sq ft)	Lane Miles *	Surface Type	Condition / PCR
1003A	NonPublic	6/5/2003	3974	0.07	AS	POOR / 45

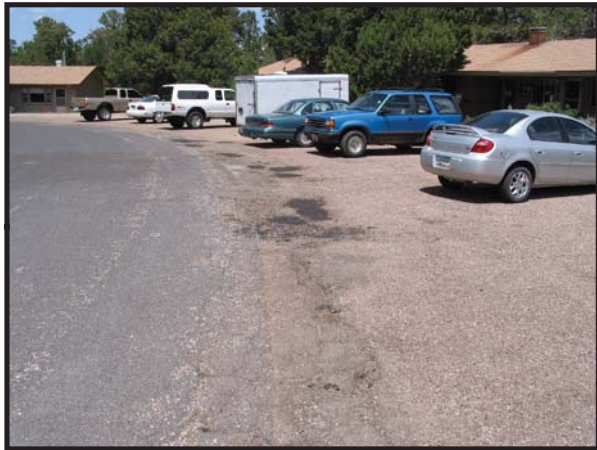
Route 1003B

Route	Public / NonPublic	Date Visited	Area (sq ft)	Lane Miles *	Surface Type	Condition / PCR
1003B	NonPublic	6/5/2003	2458	0.04	AS	POOR / 45

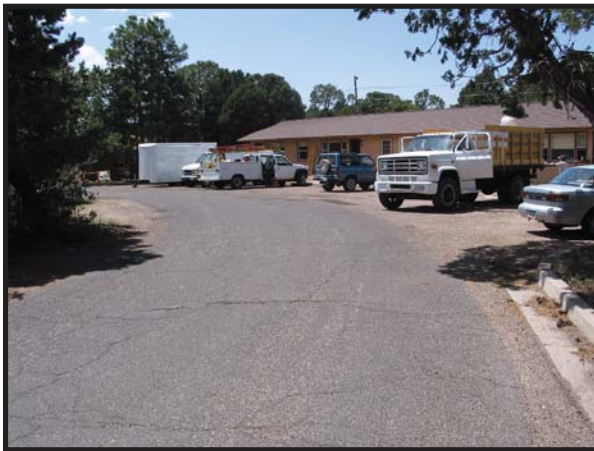
Route 1004

Route	Public / NonPublic	Date Visited	Area (sq ft)	Lane Miles *	Surface Type	Condition / PCR
1004	NonPublic	6/5/2003	4594	0.08	AS	GOOD / 90

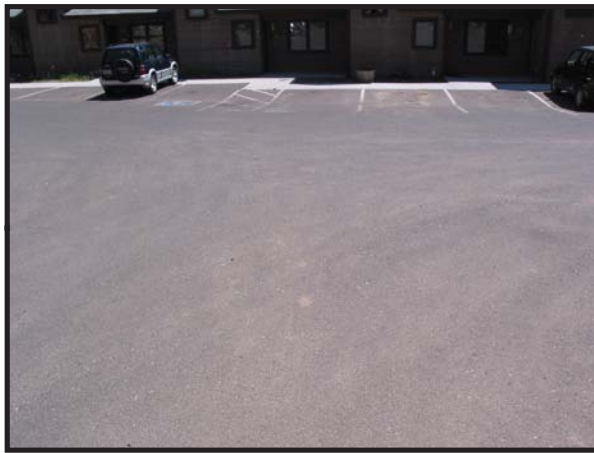
Route 1005

Route	Public / NonPublic	Date Visited	Area (sq ft)	Lane Miles *	Surface Type	Condition / PCR
1005	NonPublic	6/5/2003	8996	0.15	AS	POOR / 45

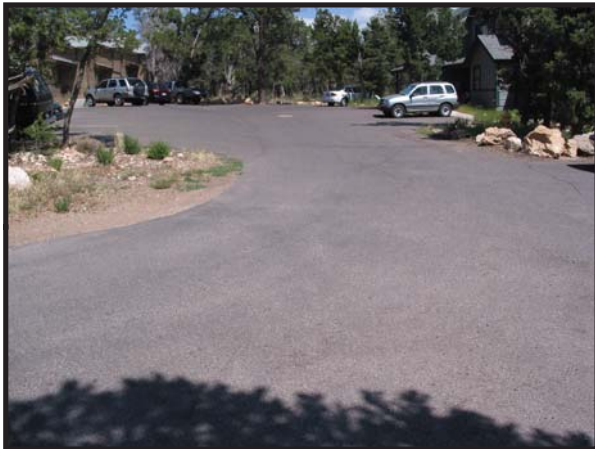
Route 1006

Route	Public / NonPublic	Date Visited	Area (sq ft)	Lane Miles *	Surface Type	Condition / PCR
1006	NonPublic	6/5/2003	8727	0.15	AS	FAIR / 73

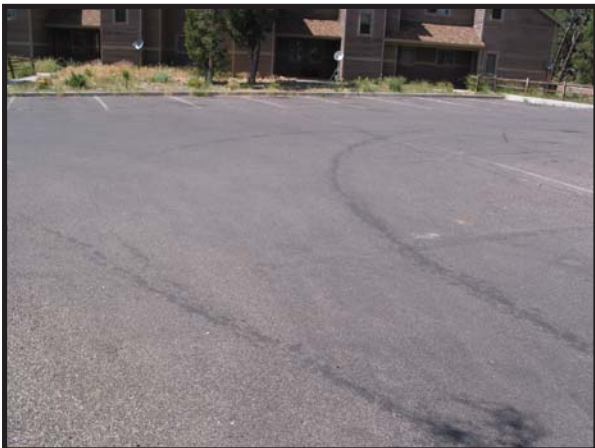
Route 1007A

Route	Public / NonPublic	Date Visited	Area (sq ft)	Lane Miles *	Surface Type	Condition / PCR
1007A	NonPublic	6/5/2003	1651	0.03	AS	FAIR / 73

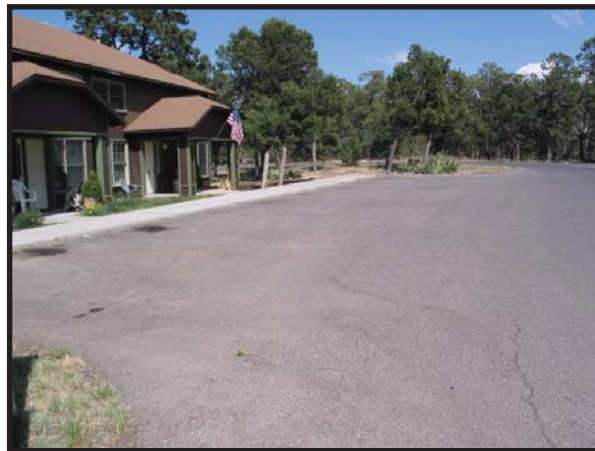
Route 1007C

Route	Public / NonPublic	Date Visited	Area (sq ft)	Lane Miles *	Surface Type	Condition / PCR
1007C	NonPublic	6/5/2003	1830	0.03	AS	FAIR / 73

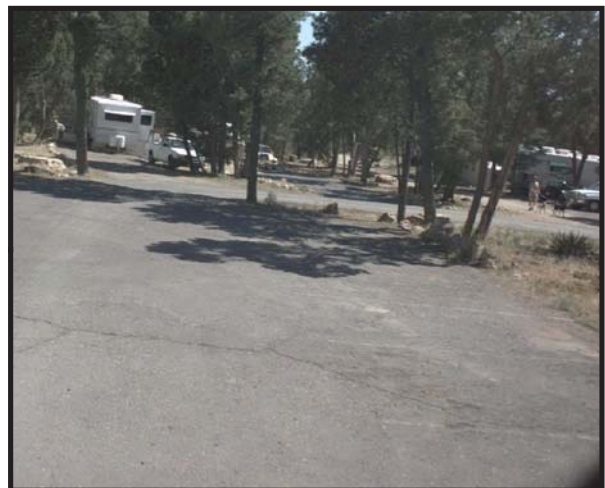
Route 1008B

Route	Public / NonPublic	Date Visited	Area (sq ft)	Lane Miles *	Surface Type	Condition / PCR
1008B	NonPublic	6/5/2003	585	0.01	AS	POOR / 45

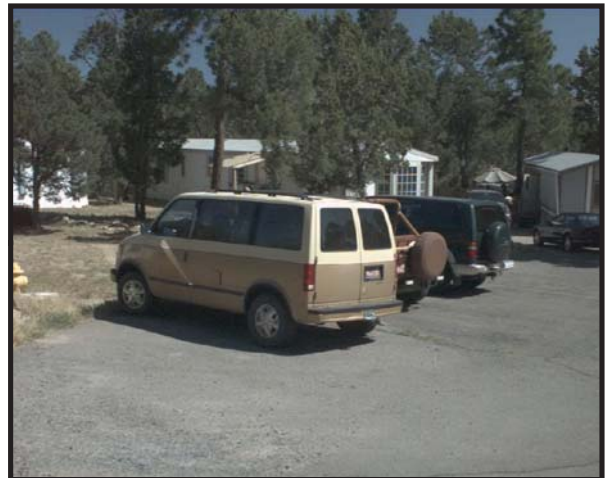
Route 1009

Route	Public / NonPublic	Date Visited	Area (sq ft)	Lane Miles *	Surface Type	Condition / PCR
1009	NonPublic	6/5/2003	7179	0.12	AS	POOR / 45

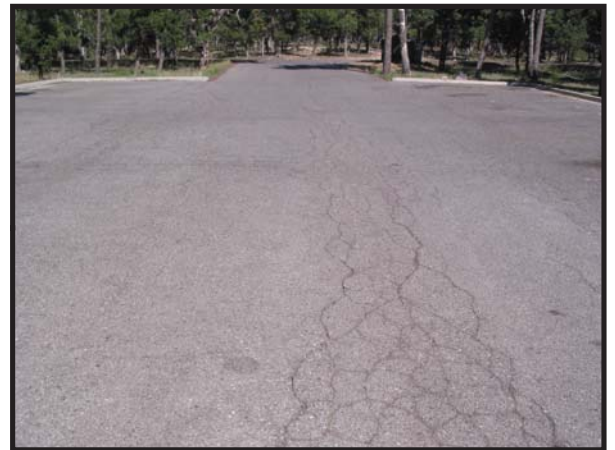
Route 1010A

Route	Public / NonPublic	Date Visited	Area (sq ft)	Lane Miles *	Surface Type	Condition / PCR
1010A	NonPublic	6/5/2003	2897	0.05	AS	POOR / 45

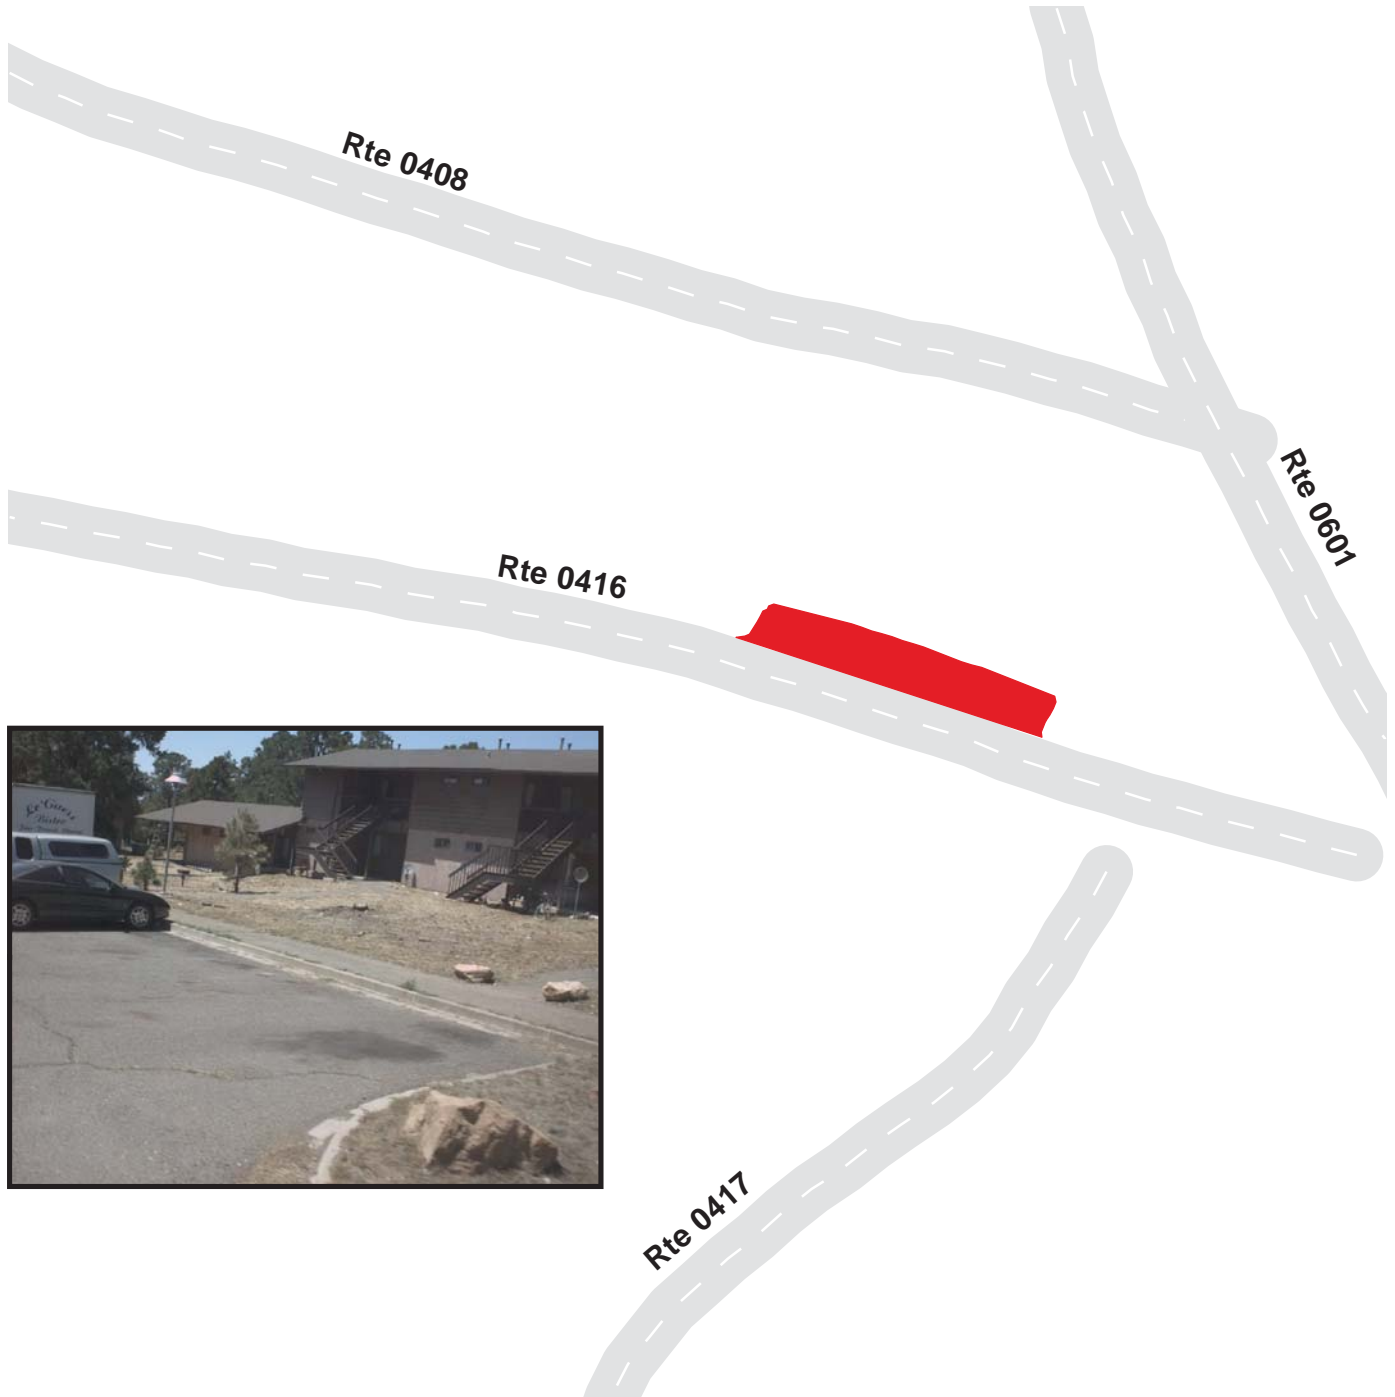
Grand Canyon National Park
Route 1010B
 Muave Court Parking B
 Adjacent To Route 0416 at MP 0.04 on Left

Route	Public / NonPublic	Date Visited	Area (sq ft)	Lane Miles *	Surface Type	Condition / PCR
1010B	NonPublic	6/5/2003	2311	0.04	AS	POOR / 45

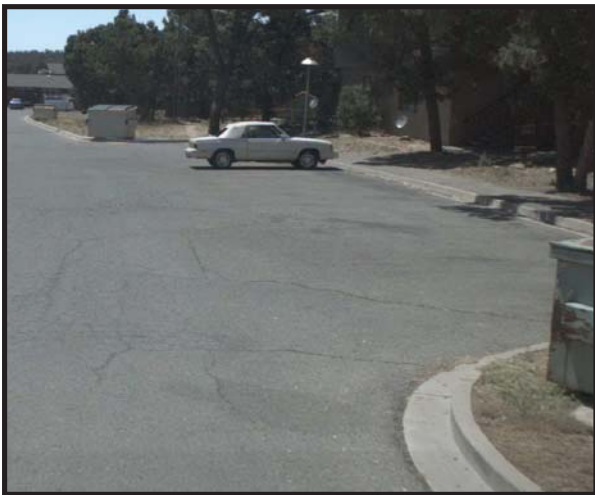
Route 1010D

Route	Public / NonPublic	Date Visited	Area (sq ft)	Lane Miles *	Surface Type	Condition / PCR
1010D	NonPublic	6/5/2003	2598	0.04	AS	POOR / 45

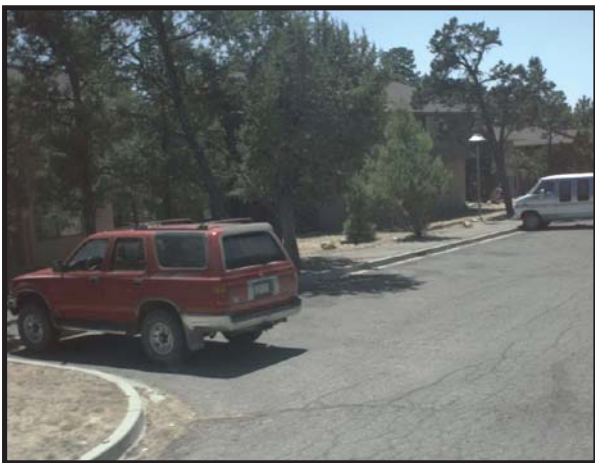
Route 1010E

Route	Public / NonPublic	Date Visited	Area (sq ft)	Lane Miles *	Surface Type	Condition / PCR
1010E	NonPublic	6/5/2003	2163	0.04	AS	POOR / 45

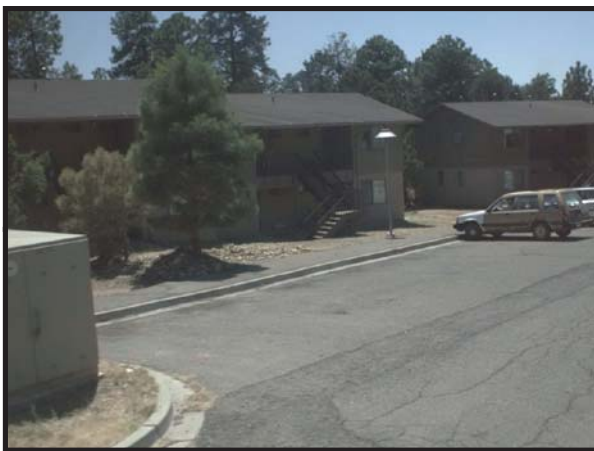
Route 1010F

Route	Public / NonPublic	Date Visited	Area (sq ft)	Lane Miles *	Surface Type	Condition / PCR
1010F	NonPublic	6/5/2003	3227	0.06	AS	POOR / 45

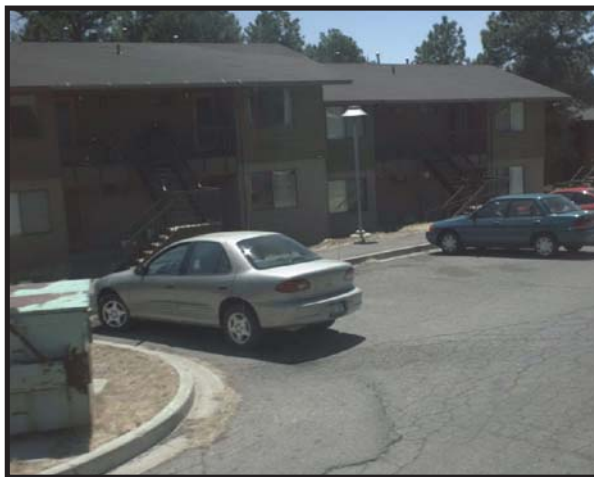
Route 1010G

Route	Public / NonPublic	Date Visited	Area (sq ft)	Lane Miles *	Surface Type	Condition / PCR
1010G	NonPublic	6/5/2003	2872	0.05	AS	POOR / 45

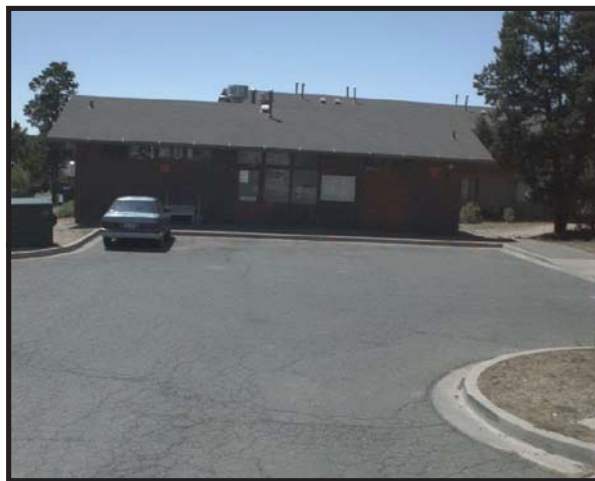
Route 1011A

Route	Public / NonPublic	Date Visited	Area (sq ft)	Lane Miles *	Surface Type	Condition / PCR
1011A	NonPublic	6/5/2003	1161	0.02	CO	FAIR / 73

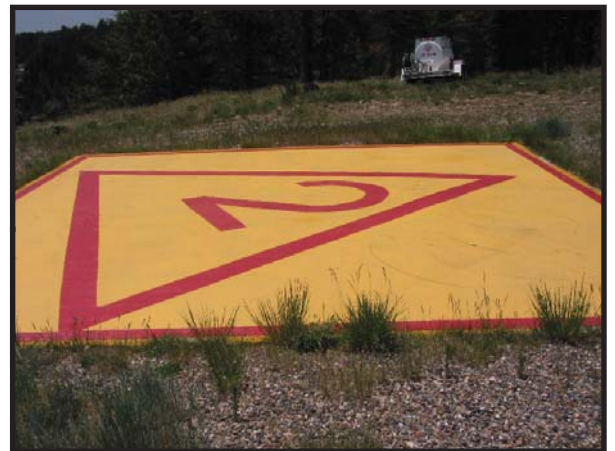
Route 1012

Route	Public / NonPublic	Date Visited	Area (sq ft)	Lane Miles *	Surface Type	Condition / PCR
1012	NonPublic	6/5/2003	5774	0.10	AS	FAIR / 73

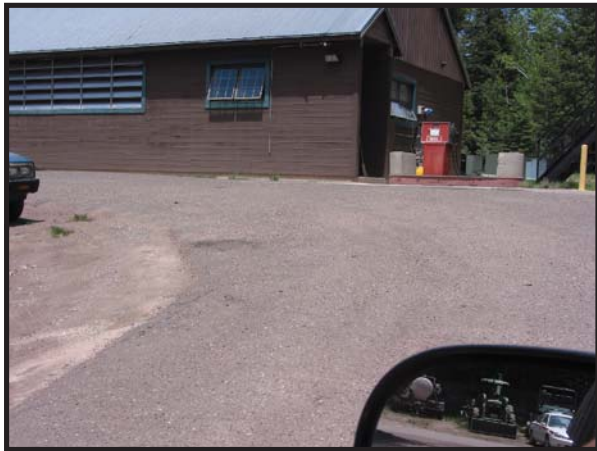
Route 1013

Route	Public / NonPublic	Date Visited	Area (sq ft)	Lane Miles *	Surface Type	Condition / PCR
1013	NonPublic	6/5/2003	1220	0.02	AS	GOOD / 90

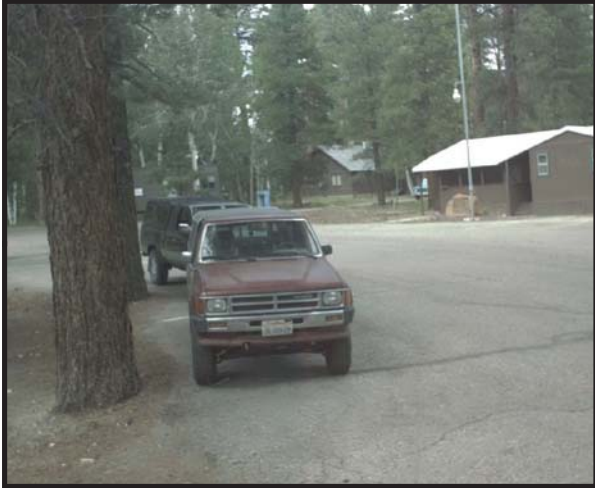
Route 1014A

Route	Public / NonPublic	Date Visited	Area (sq ft)	Lane Miles *	Surface Type	Condition / PCR
1014A	NonPublic	6/5/2003	7204	0.12	AS	FAIR / 73

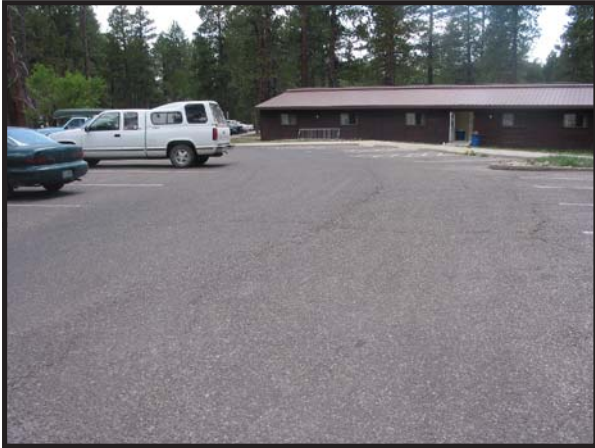
Route 1014B

Route	Public / NonPublic	Date Visited	Area (sq ft)	Lane Miles *	Surface Type	Condition / PCR
1014B	NonPublic	6/5/2003	1417	0.02	AS	FAIR / 73

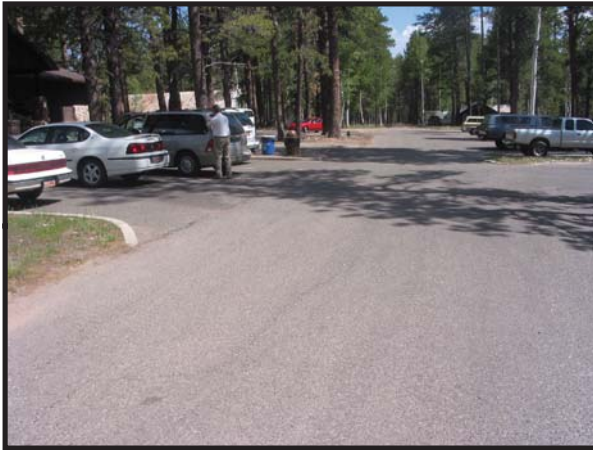
Route 1014C

Route	Public / NonPublic	Date Visited	Area (sq ft)	Lane Miles *	Surface Type	Condition / PCR
1014C	NonPublic	6/5/2003	2051	0.04	AS	GOOD / 90

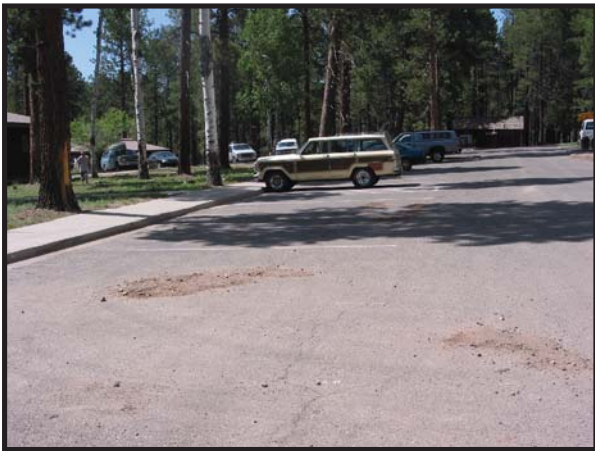
Route 1014D

Route	Public / NonPublic	Date Visited	Area (sq ft)	Lane Miles *	Surface Type	Condition / PCR
1014D	NonPublic	6/5/2003	4462	0.08	AS	FAIR / 73

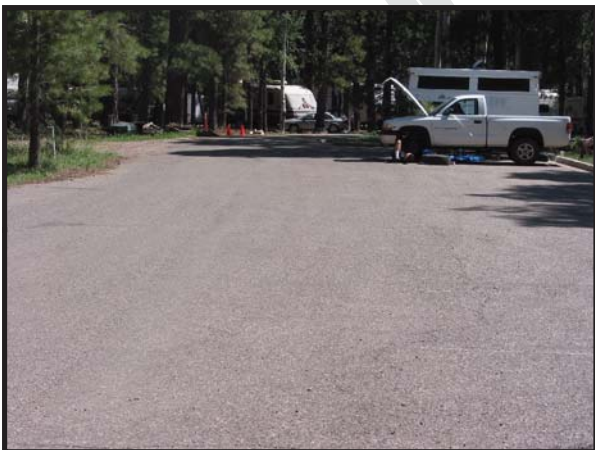
Route 1014E

Route	Public / NonPublic	Date Visited	Area (sq ft)	Lane Miles *	Surface Type	Condition / PCR
1014E	NonPublic	6/4/2003	3680	0.06	AS	GOOD / 90

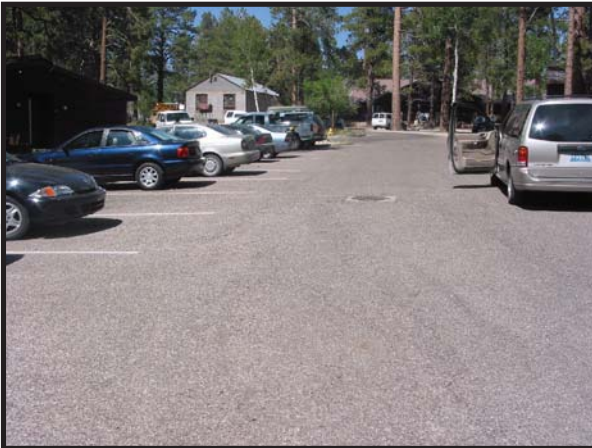
Route 1014F

Route	Public / NonPublic	Date Visited	Area (sq ft)	Lane Miles *	Surface Type	Condition / PCR
1014F	NonPublic	6/4/2003	2659	0.05	AS	GOOD / 90

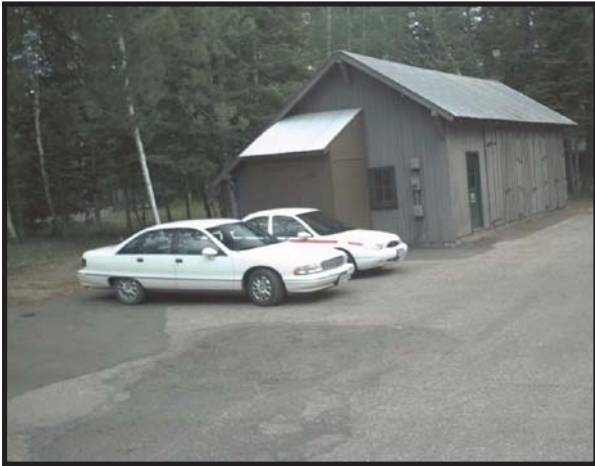
Route	Public / NonPublic	Date Visited	Area (sq ft)	Lane Miles *	Surface Type	Condition / PCR
1017	NonPublic	6/5/2003	1867	0.03	AS	FAIR / 73
