The Road Inventory of Greenbelt Park GREE - 3240

Road Inventory Program

Prepared By:
Federal Highway Administration
Eastern Federal Lands Highway Division
Cycle 3

Greenbelt Park in Maryland

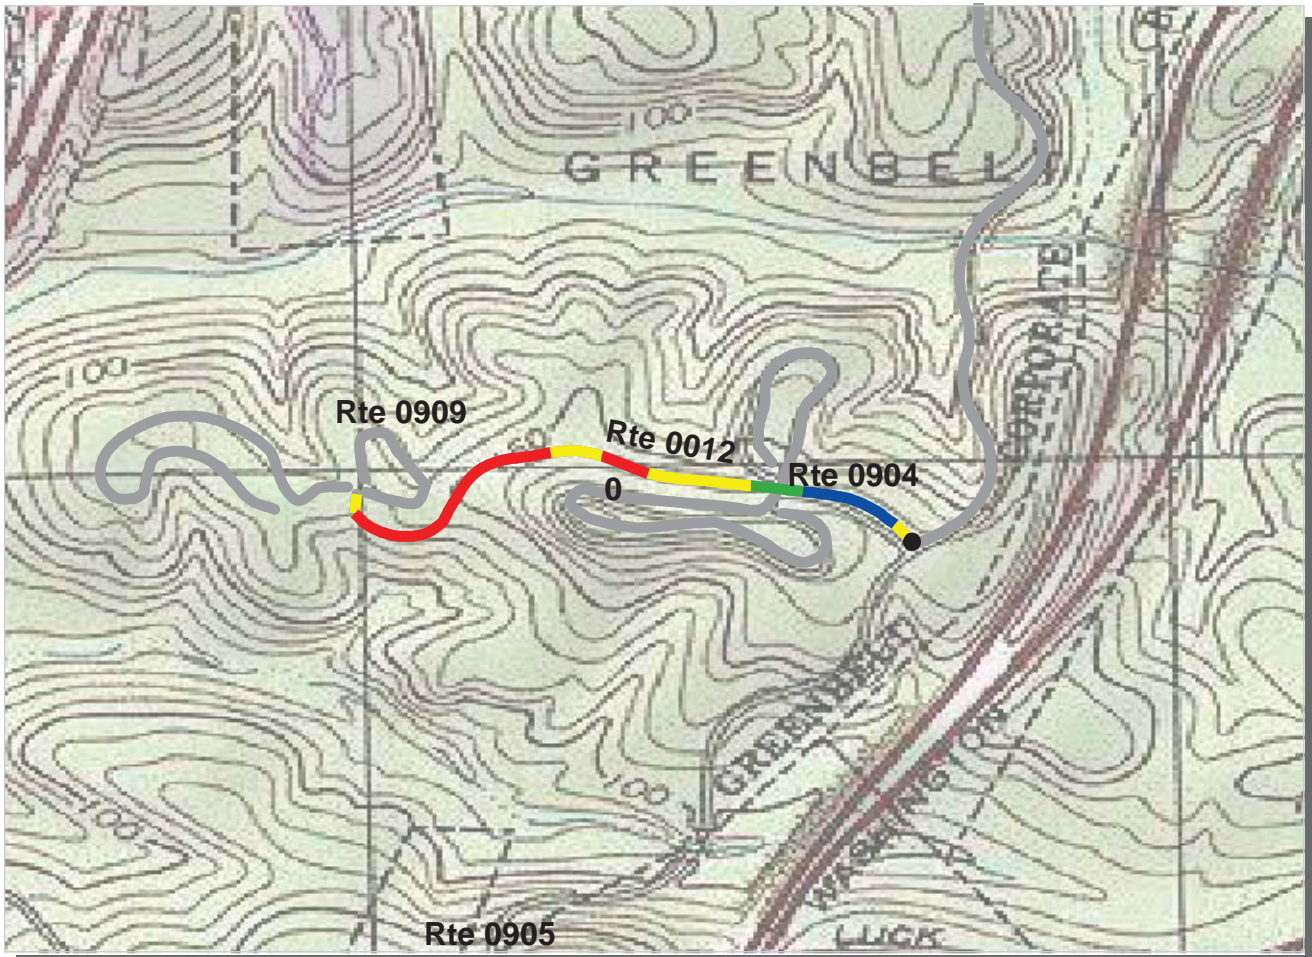
ROUTE: 0012 Campground Access **TOTAL LENGTH: 0.53 Miles**

Section Number	0				
Section Length (mi)	0.53				
AADT	**				
SADT	**				
ADT Date	**				
Cross Section Information					
Number of Lanes	2				
Paved Width (ft)	19				
Lane Width (ft)	10				
Shoulder Width (ft)	4				
Roadway Condition Information					
PCR (Pavement Condition Rating)	57				
RCI (Roughness Condition Index)	62				
SCR (Surface Condition Rating)	51				
Alligator Cracking Index	64				
Rutting Index	85				
Patching Index	99				
Transverse Cracking Index	98				
Longitudinal Cracking Index	98				
Shoulder Condition Rating	GOOD				
Drainage Condition Rating	GOOD

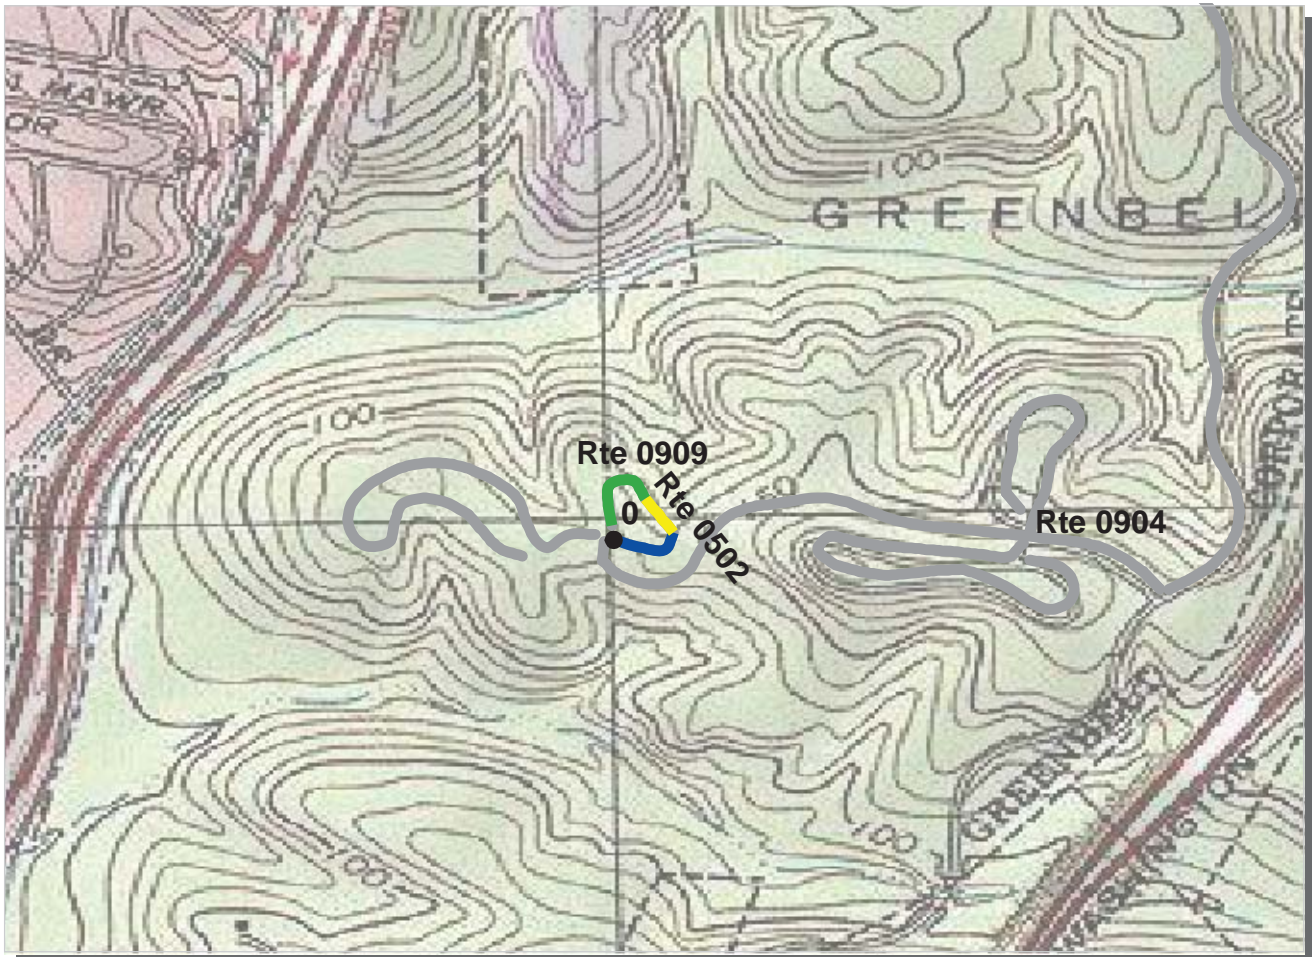
ROUTE: 0502 Greenbelt Campground Loop C **TOTAL LENGTH: 0.20 Miles**

Section Number	0				
Section Length (mi)	0.20				
AADT	**				
SADT	**				
ADT Date	**				
Cross Section Information					
Number of Lanes	1				
Paved Width (ft)	15				
Lane Width (ft)	15				
Shoulder Width (ft)	0				
Roadway Condition Information					
PCR (Pavement Condition Rating)	91				
RCI (Roughness Condition Index)	NC				
SCR (Surface Condition Rating)	91				
Alligator Cracking Index	99				
Rutting Index	91				
Patching Index	100				
Transverse Cracking Index	100				
Longitudinal Cracking Index	99				
Shoulder Condition Rating	N/A				
Drainage Condition Rating	GOOD

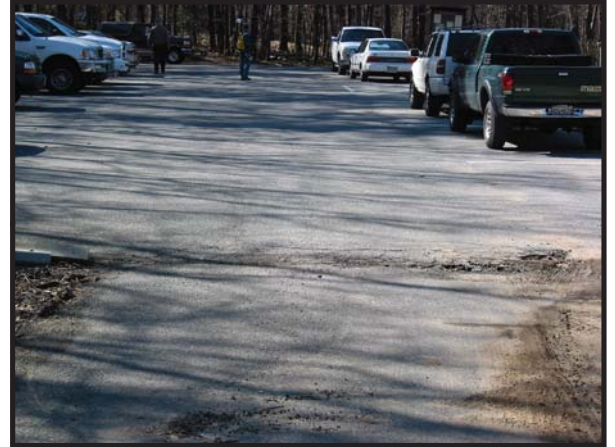
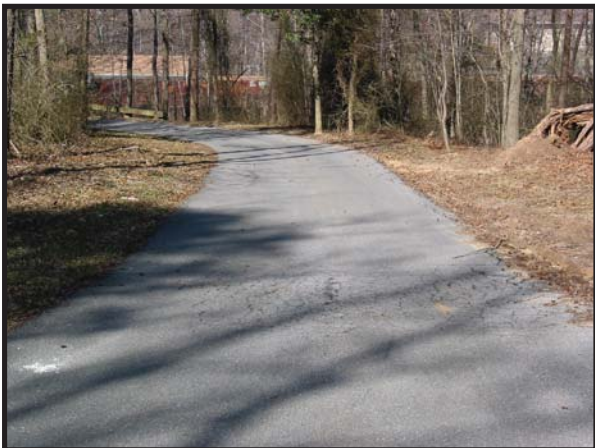
Greenbelt Park Route 0907A

Sweet Gum Picnic Parking A
Adjacent to Route 0200 at MP 0.06, on left

Route	Public / NonPublic	Date Visited	Area (sq ft)	Lane Miles *	Surface Type	Condition / PCR
0907A	Public	3/12/2004	5000	0.09	AS	GOOD / 90
