# The Road Inventory of Grant-Kohrs Ranch National Historic Site GRKO - 1586

## Road Inventory Program

Prepared By:  
Federal Highway Administration  
Eastern Federal Lands Highway Division  
Cycle 3

# Grant-Kohrs Ranch National Historic Site in Montana

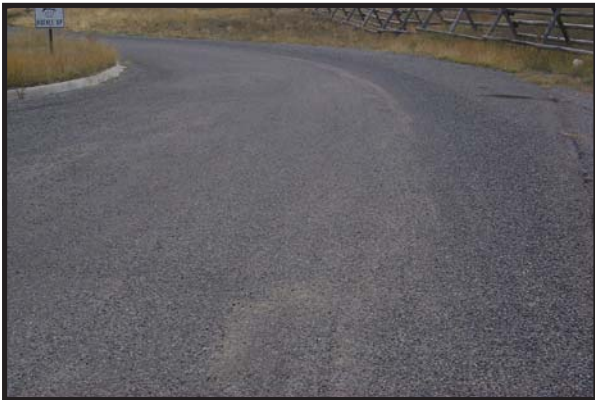
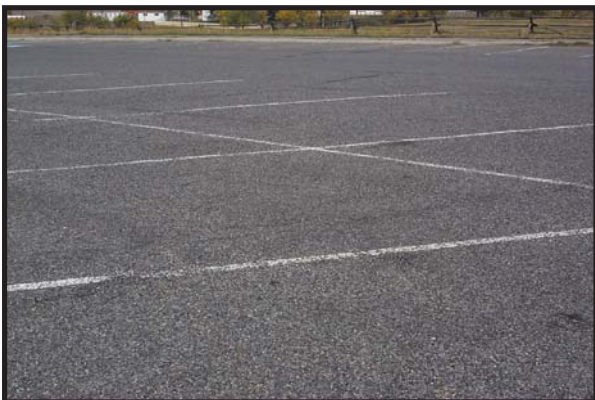
## Route 0900

### VISITOR CENTER PARKING

From US Highway 10

Route	Public / NonPublic	Date Visited	Area (sq ft)	Lane Miles *	Surface Type	Condition / PCR
0900	Public	10/8/2002	38048	0.66	NC	GOOD / 90

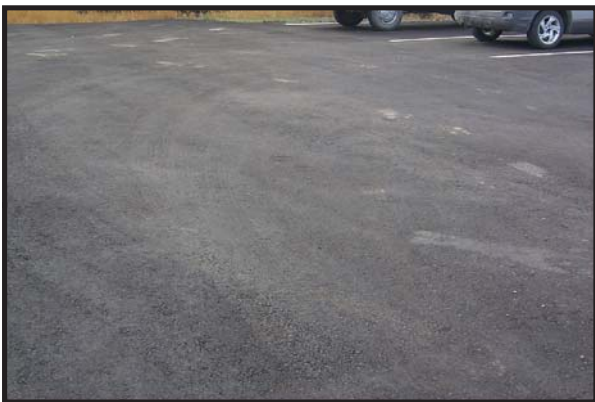
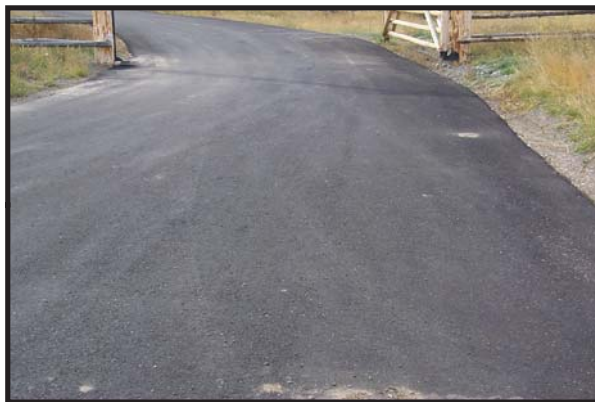
## Route 0901

MUSEUM PARKING

From Route 0900

Route	Public / NonPublic	Date Visited	Area (sq ft)	Lane Miles *	Surface Type	Condition / PCR
0901	Public	10/8/2002	5913	0.10	AS	EXCELLENT / 97
