# The Road Inventory of Grand Portage National Monument GRPO - 6150

Prepared By:  
Federal Highway Administration  
Eastern Federal Lands Highway Division  
Cycle 3

# Grand Portage National Monument in Minnesota

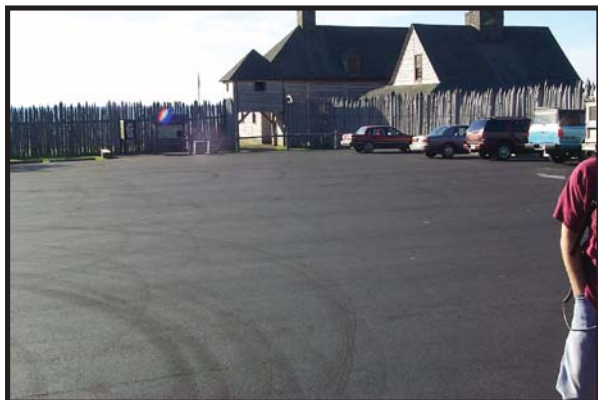
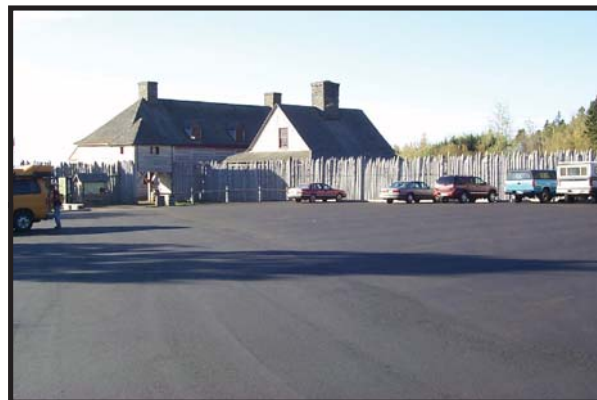
## Route 0900

VISITOR CENTER PARKING AREA  
FROM COUNTY ROUTE 17

Route	Public / NonPublic	Date Visited	Area (sq ft)	Lane Miles *	Surface Type	Condition / PCR
0900	Public	9/26/2001	18949	0.33	AS	EXCELLENT / 97
