The Road Inventory of Guilford Courthouse National Military Park GUCO - 5170

Road Inventory Program

Prepared By:
Federal Highway Administration
Eastern Federal Lands Highway Division
Cycle 3

Guilford Courthouse National Military Park in North Carolina

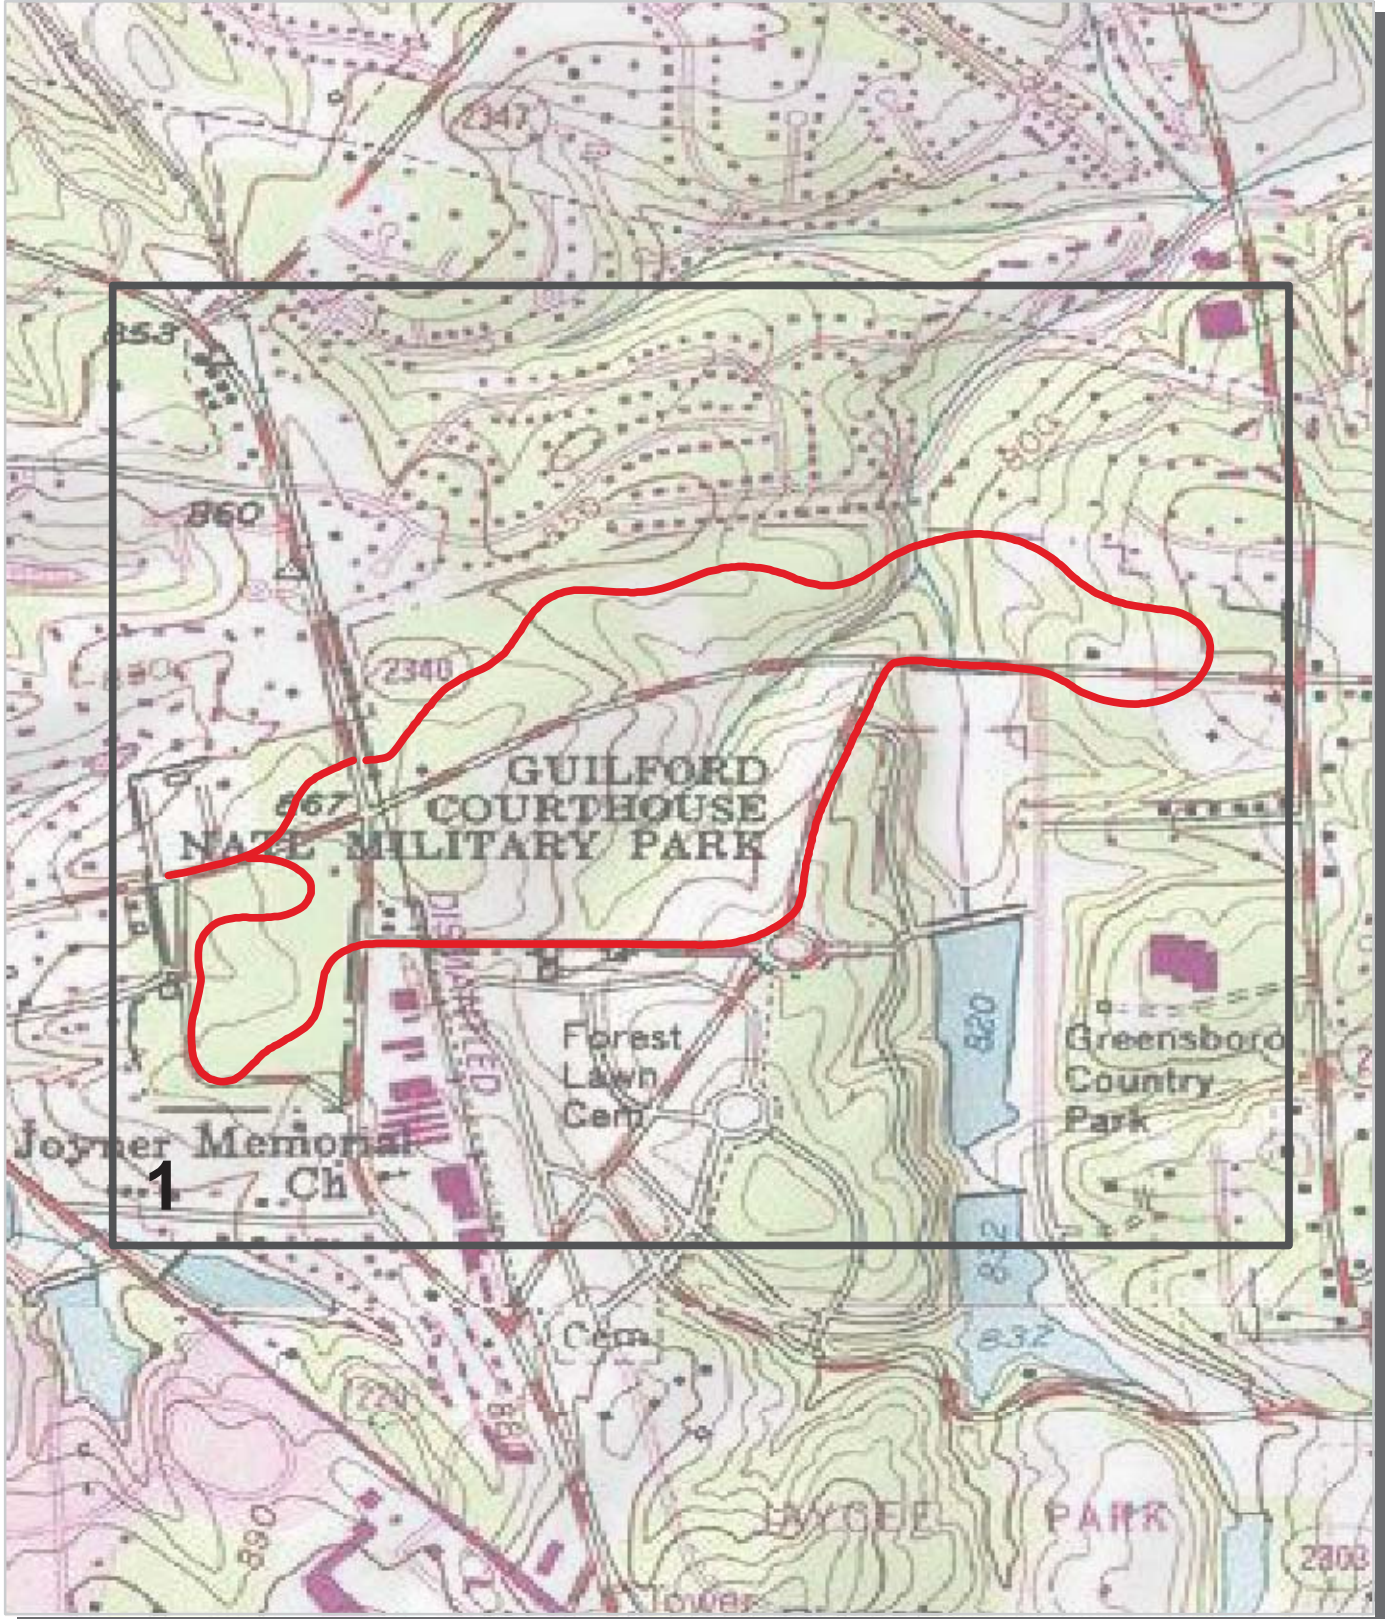
Guilford Courthouse National Military Park Route Location Key Map

Park Owned Routes

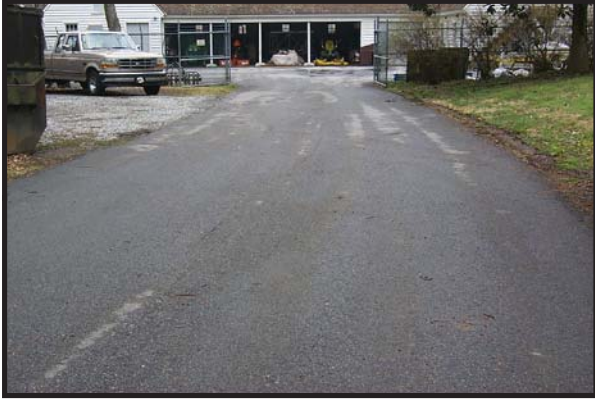
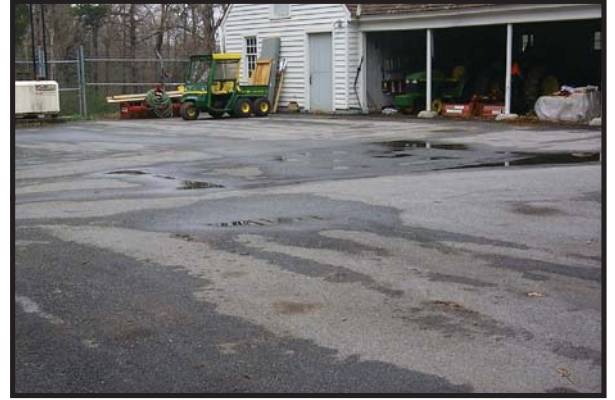
Route 0901

Route	Public / NonPublic	Date Visited	Area (sq ft)	Lane Miles *	Surface Type	Condition / PCR
0901	NonPublic	3/13/2002	16704	0.29	AS	GOOD / 90

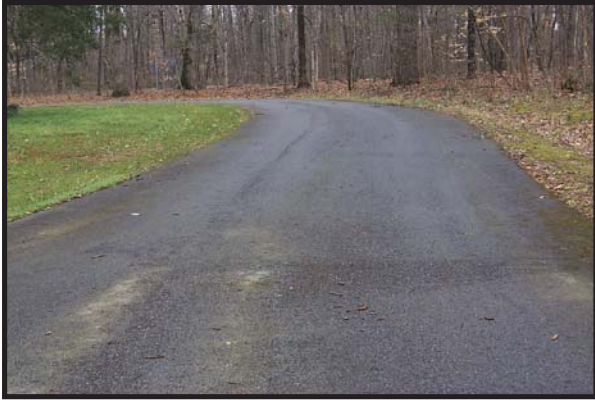
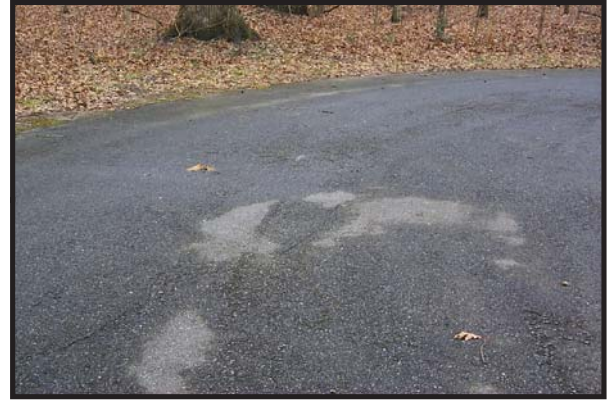
Route 0902

Route	Public / NonPublic	Date Visited	Area (sq ft)	Lane Miles *	Surface Type	Condition / PCR
0902	NonPublic	3/13/2002	8620	0.15	AS	GOOD / 90

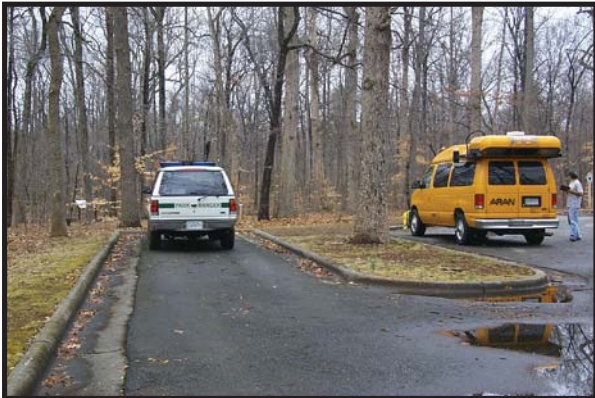
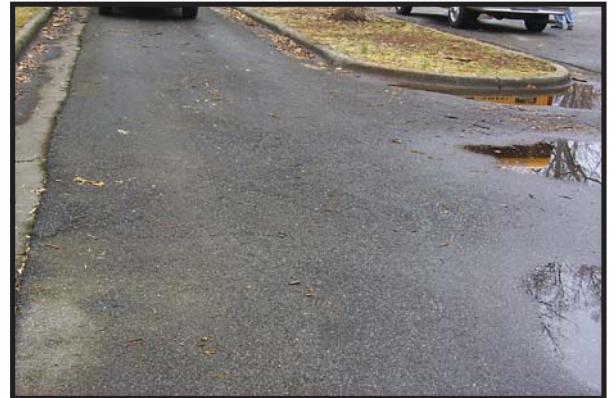
Route 0904

Route	Public / NonPublic	Date Visited	Area (sq ft)	Lane Miles *	Surface Type	Condition / PCR
0904	Public	3/13/2002	2586	0.04	AS	FAIR / 73

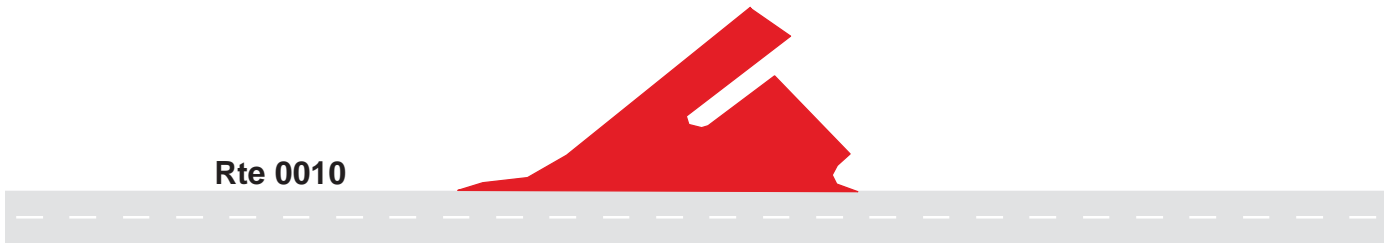
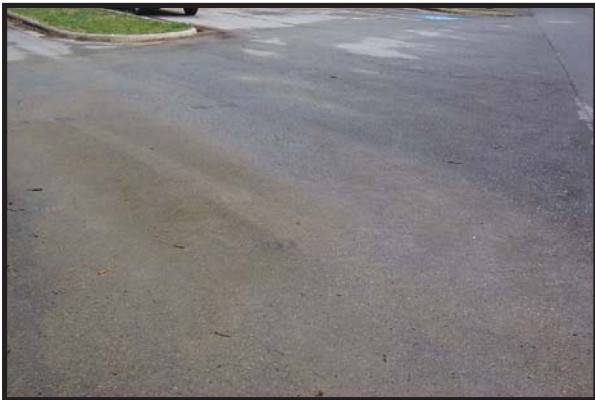
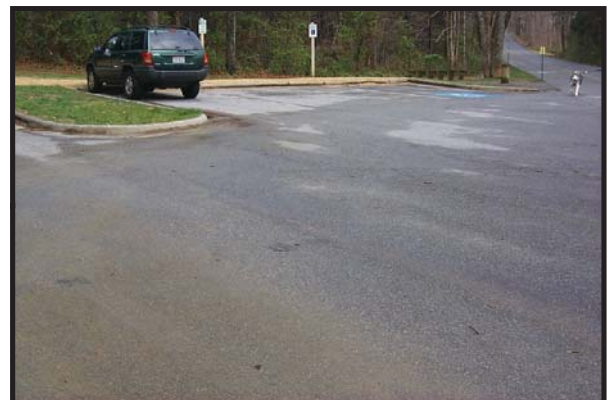
Route 0905

Route	Public / NonPublic	Date Visited	Area (sq ft)	Lane Miles *	Surface Type	Condition / PCR
0905	Public	3/13/2002	3444	0.06	AS	GOOD / 90

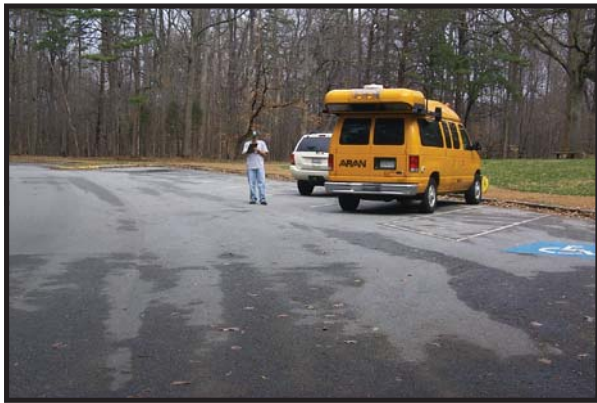
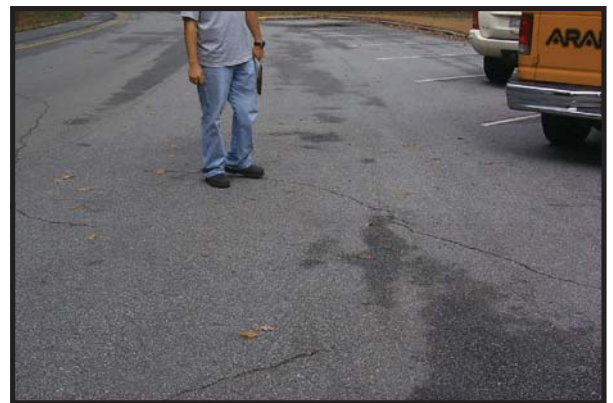
Route 0906

Route	Public / NonPublic	Date Visited	Area (sq ft)	Lane Miles *	Surface Type	Condition / PCR
0906	Public	3/13/2002	4748	0.08	AS	GOOD / 90

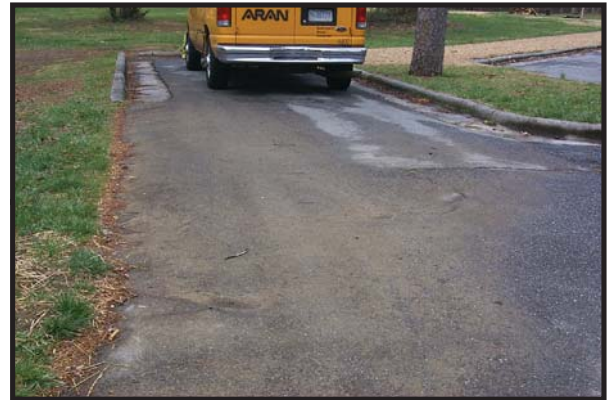
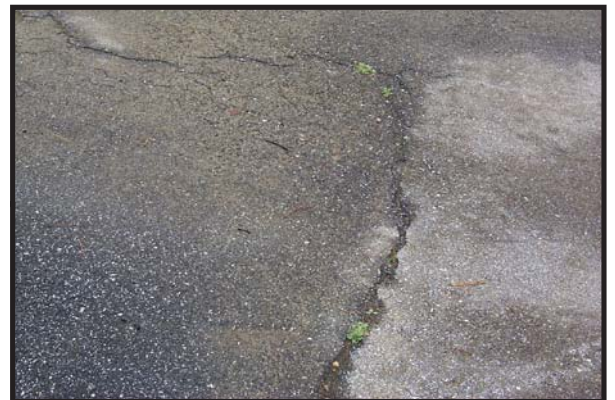
Route 0907

Route	Public / NonPublic	Date Visited	Area (sq ft)	Lane Miles *	Surface Type	Condition / PCR
0907	Public	3/13/2002	3006	0.05	AS	GOOD / 90

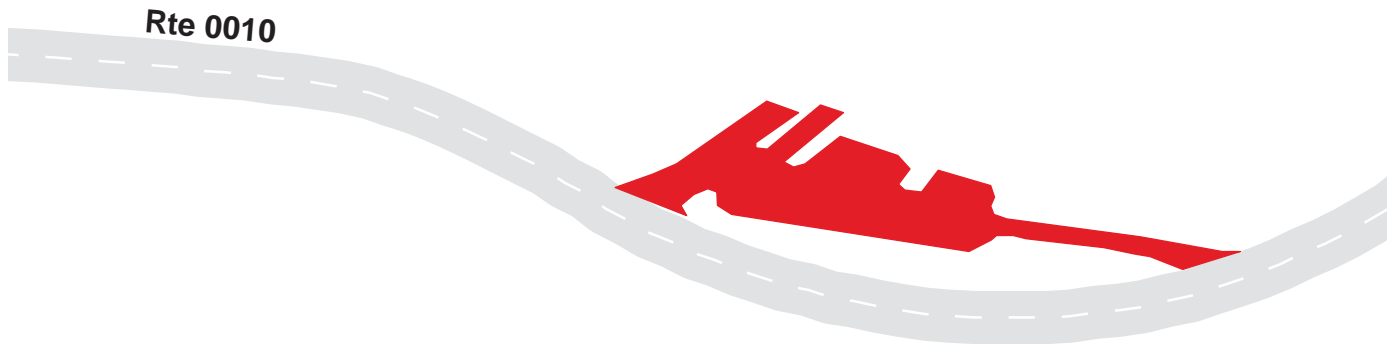
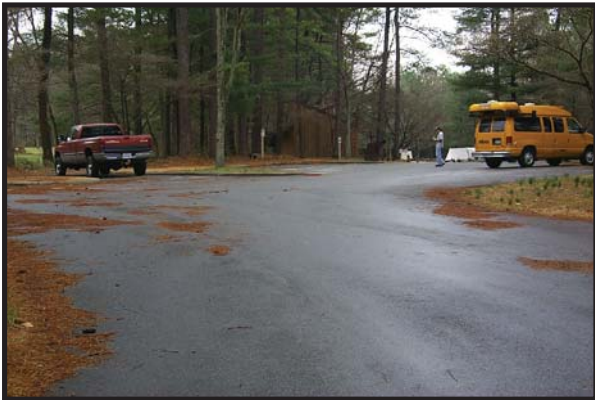
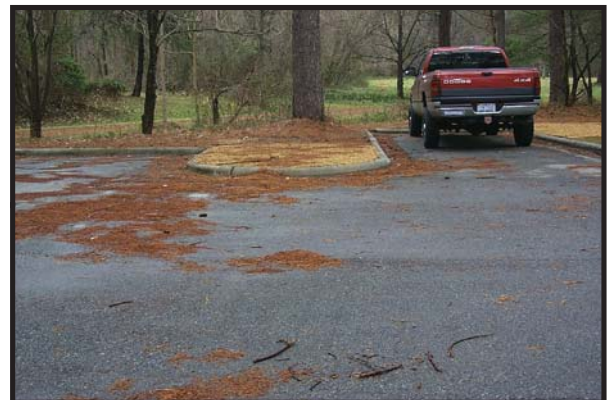
Route 0908

Route	Public / NonPublic	Date Visited	Area (sq ft)	Lane Miles *	Surface Type	Condition / PCR
0908	Public	3/13/2002	14124	0.24	AS	GOOD / 90

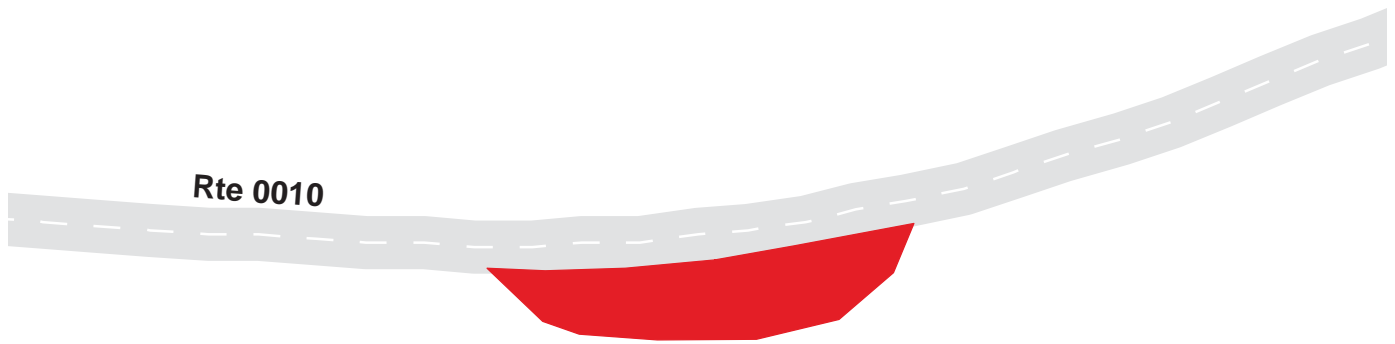
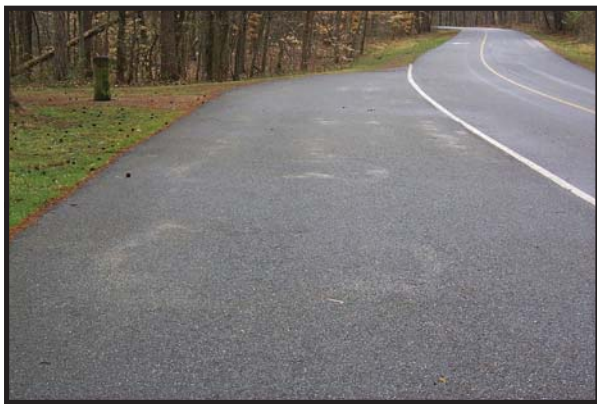
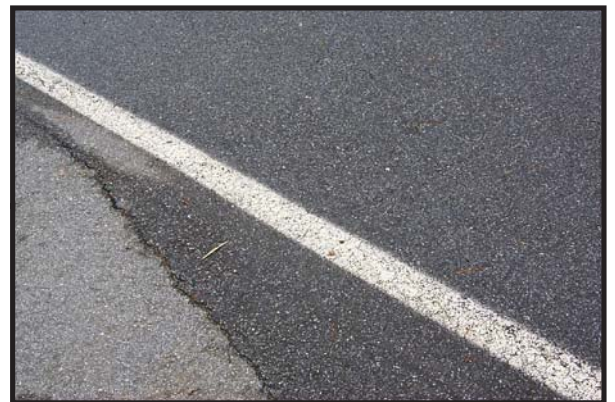
Route 0909

Route	Public / NonPublic	Date Visited	Area (sq ft)	Lane Miles *	Surface Type	Condition / PCR
0909	Public	3/13/2002	2510	0.04	AS	GOOD / 90

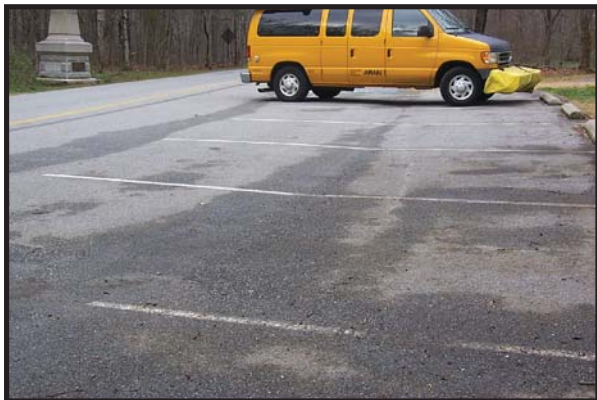
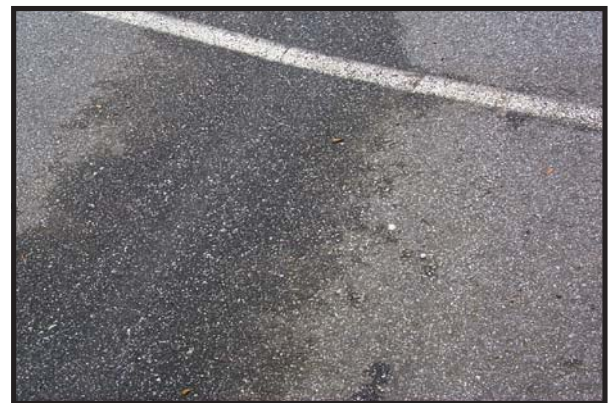
Route 0910

Route	Public / NonPublic	Date Visited	Area (sq ft)	Lane Miles *	Surface Type	Condition / PCR
0910	Public	3/13/2002	1714	0.03	AS	GOOD / 90
