The Road Inventory of Gulf Islands National Seashore GUIS – 5320

Prepared By:
Federal Highway Administration
Eastern Federal Lands Highway Division
Cycle 3

Gulf Islands National Seashore in Florida

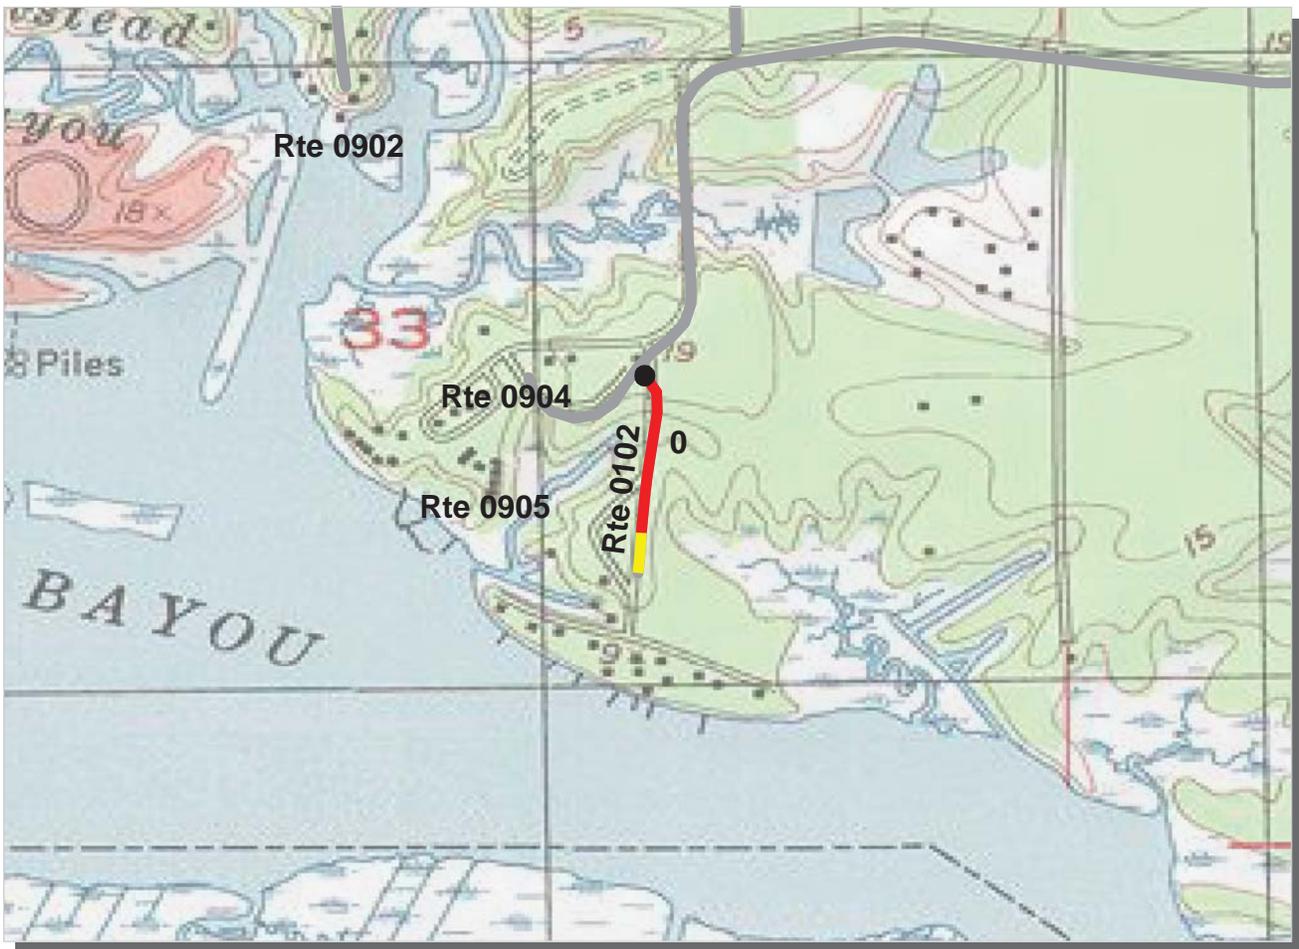
ROUTE: 0100 Langdon Beach Access

Section Number	0			
Section Length (mi)	0.33			
AADT	**			
SADT	**			
ADT Date	**			
Cross Section Information				
Number of Lanes	2			
Paved Width (ft)	21			
Lane Width (ft)	10			
Shoulder Width (ft)	0			
Roadway Condition Information				
PCR (Pavement Condition Rating)	61			
RCI (Roughness Condition Index)	90			
SCR (Surface Condition Rating)	50			
Alligator Cracking Index	100			
Rutting Index	56			
Patching Index	100			
Transverse Cracking Index	97			
Longitudinal Cracking Index	96			
Shoulder Condition Rating	N/A			
Drainage Condition Rating	N/C

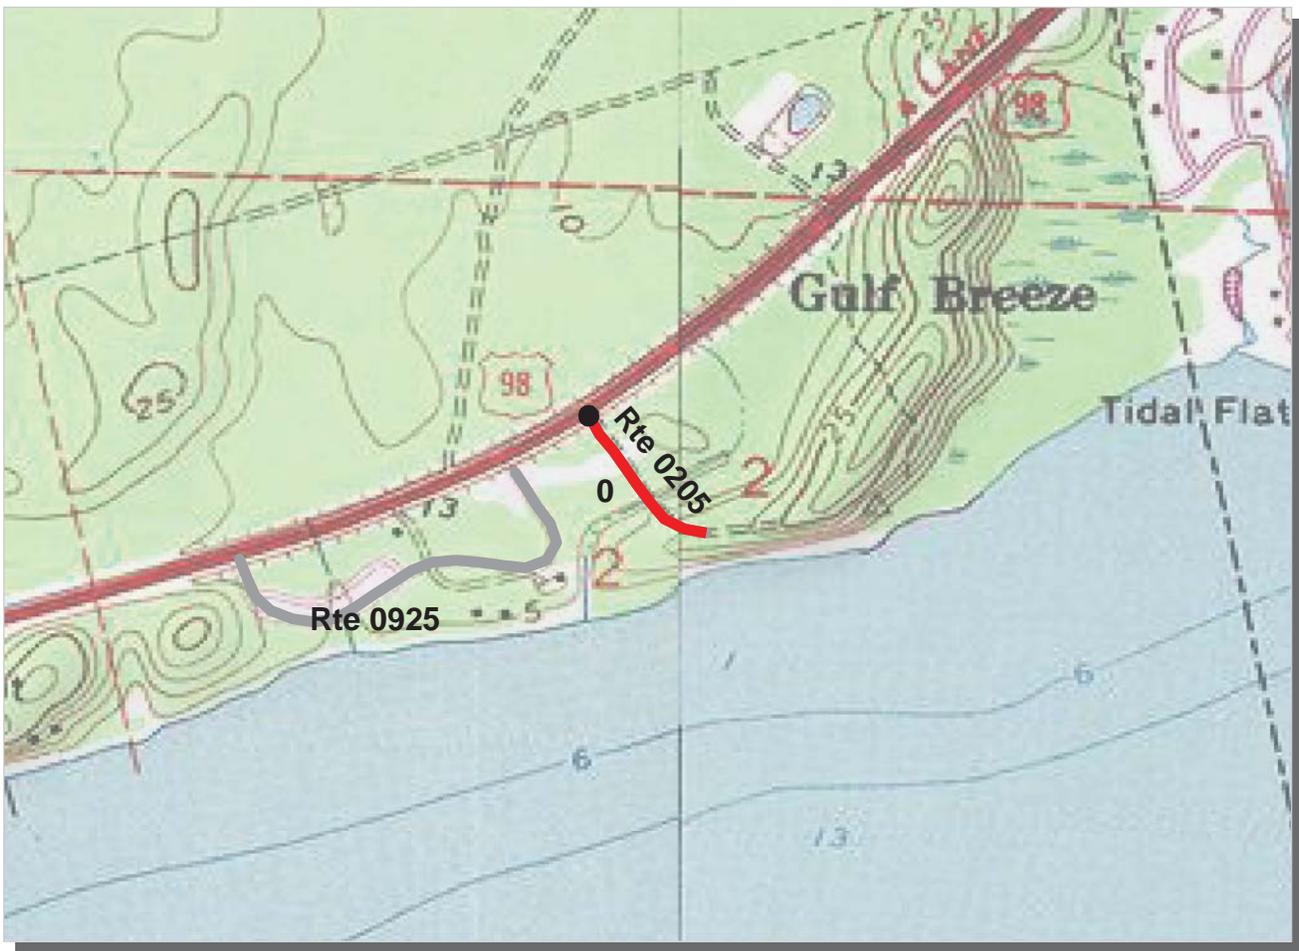
ROUTE: 0200 Nature Trail Access

Section Number	0				
Section Length (mi)	0.15				
AADT	**				
SADT	**				
ADT Date	**				
Cross Section Information					
Number of Lanes	2				
Paved Width (ft)	21				
Lane Width (ft)	10				
Shoulder Width (ft)	0				
Roadway Condition Information					
PCR (Pavement Condition Rating)	66				
RCI (Roughness Condition Index)	97				
SCR (Surface Condition Rating)	62				
Alligator Cracking Index	100				
Rutting Index	62				
Patching Index	100				
Transverse Cracking Index	100				
Longitudinal Cracking Index	100				
Shoulder Condition Rating	N/A				
Drainage Condition Rating	N/C

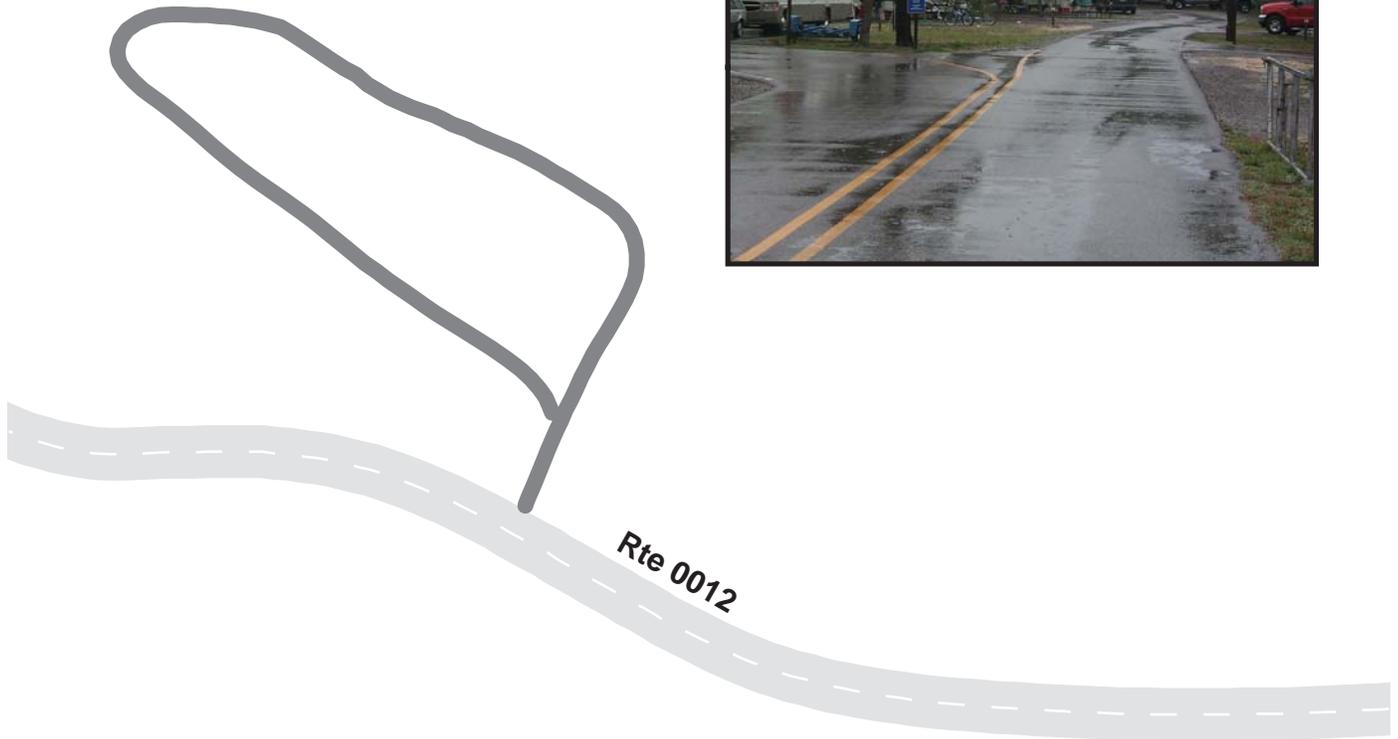
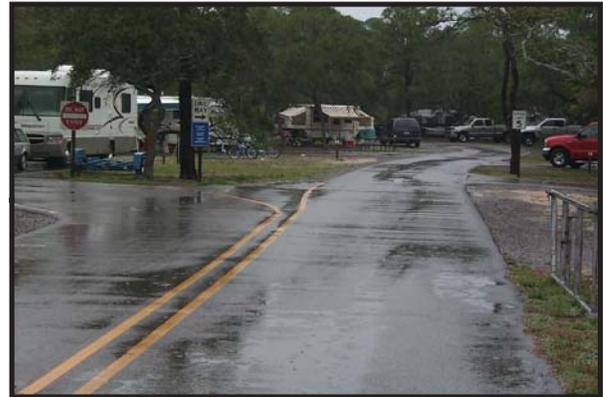
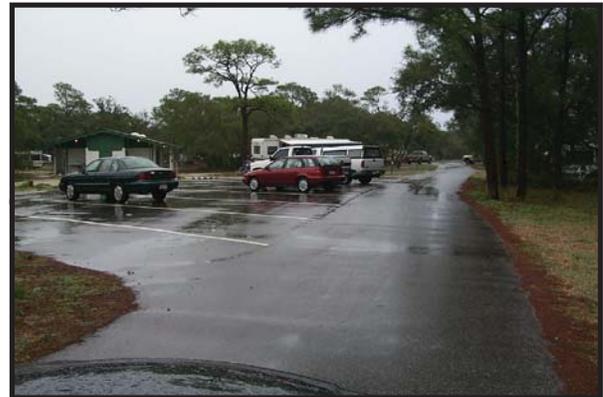
Route 0202

Route	Length (mi)	Width (ft)	Area (sq ft)	Lane Miles *	Condition / PCR	Surface Type
0202	0.34	14.00	24985	0.43	GOOD / 90	AS

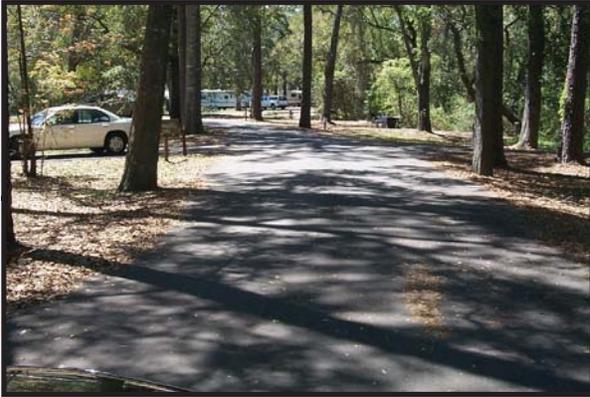
Route 0206A

Route	Length (mi)	Width (ft)	Area (sq ft)	Lane Miles *	Condition / PCR	Surface Type
0206A	0.31	14.00	22767	0.39	EXCELLENT / 97	AS

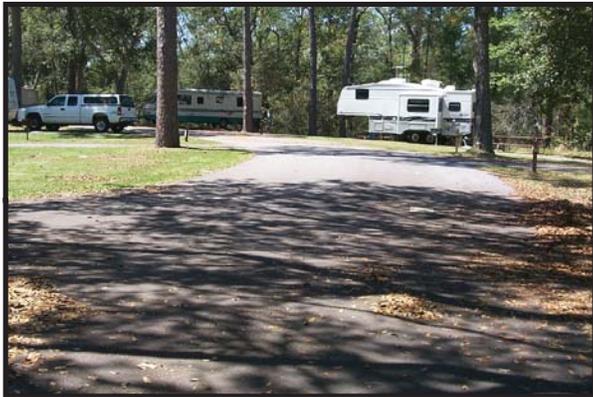
Route 0206B

Route	Length (mi)	Width (ft)	Area (sq ft)	Lane Miles *	Condition / PCR	Surface Type
0206B	0.13	14.00	9314	0.16	EXCELLENT / 97	AS

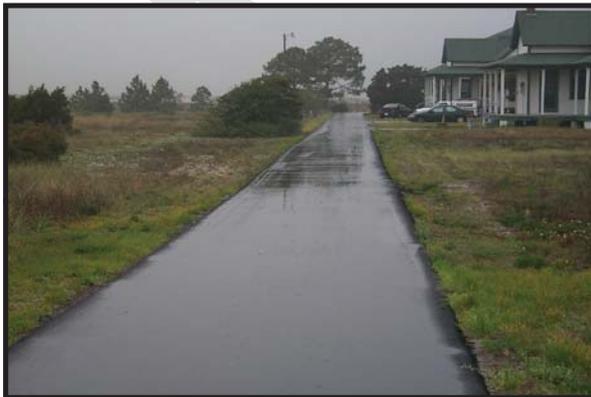
Gulf Islands National Seashore
Route 0402
 Fort Pickens Service Road
 FROM ROUTE 0012 AT MP 7.0, RIGHT

Route	Length (mi)	Width (ft)	Area (sq ft)	Lane Miles *	Condition / PCR	Surface Type
0402	0.14	12.00	9060	0.16	EXCELLENT / 97	AS

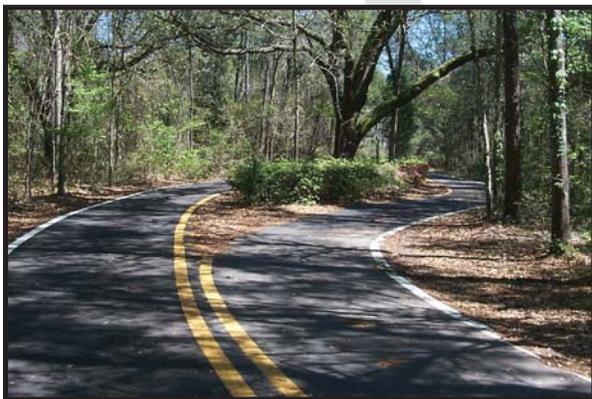
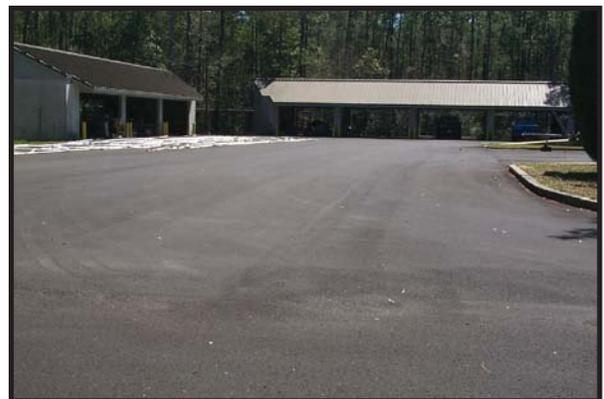
Route 0903

Route	Public / NonPublic	Date Visited	Area (sq ft)	Lane Miles *	Surface Type	Condition / PCR
0903	NonPublic	3/27/2002	51522	0.89	AS	EXCELLENT / 97

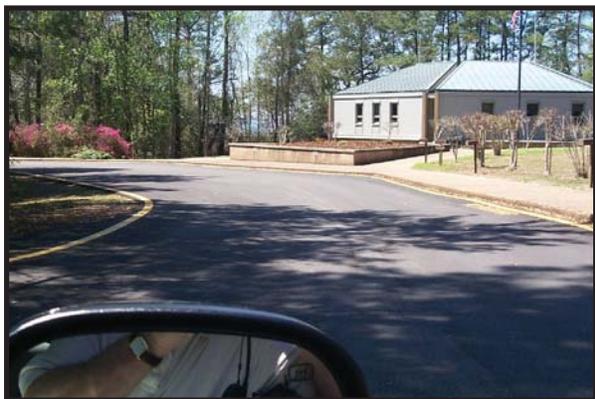
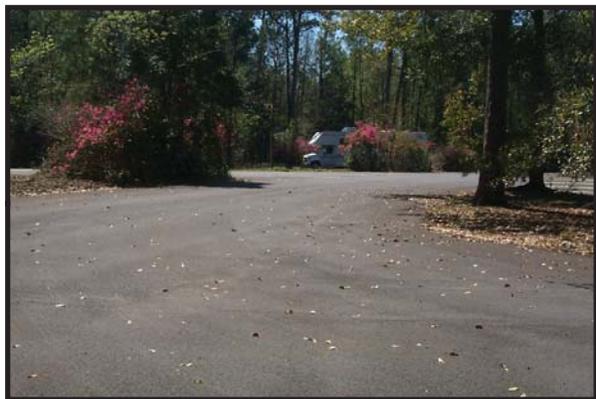
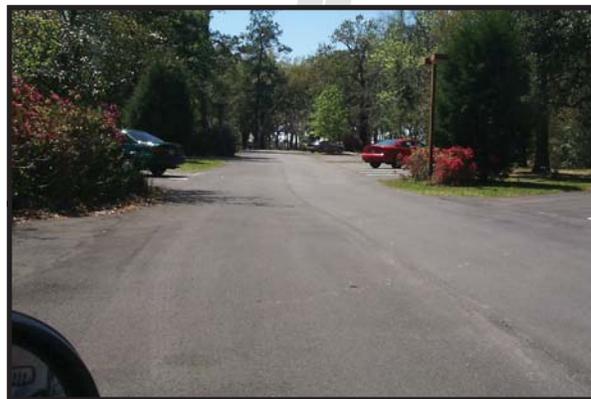
Route 0904

Route	Public / NonPublic	Date Visited	Area (sq ft)	Lane Miles *	Surface Type	Condition / PCR
0904	Public	3/27/2002	88497	1.52	AS	GOOD / 90

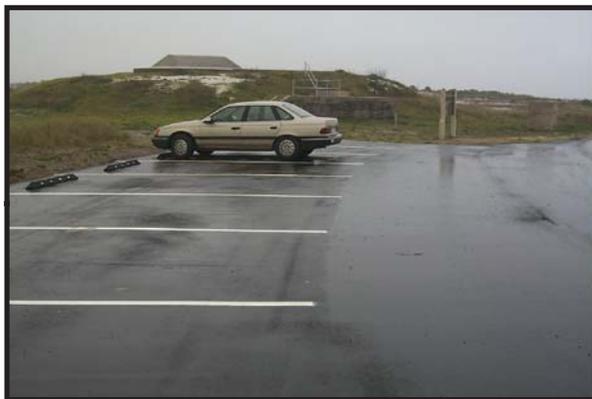
Gulf Islands National Seashore
Route 0912
 Graves Parking
 ADJACENT TO ROUTE 0012 AT MP 6.4

Route	Public / NonPublic	Date Visited	Area (sq ft)	Lane Miles *	Surface Type	Condition / PCR
0912	Public	3/27/2002	5210	0.09	AS	EXCELLENT / 97

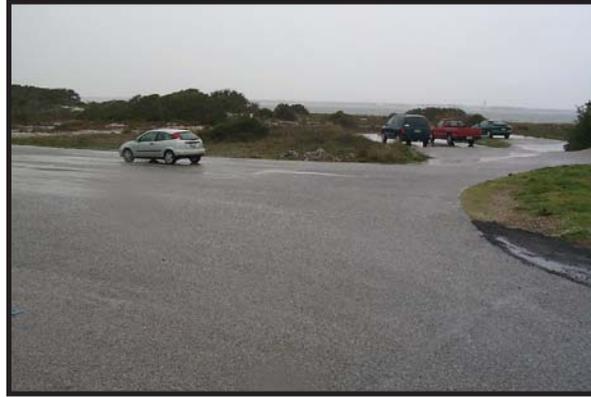
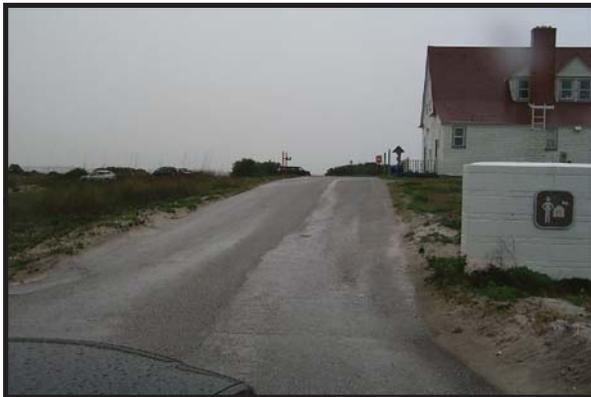
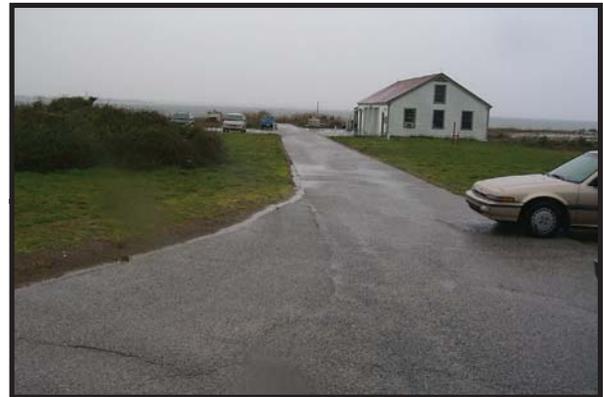
Route 0920

Route	Public / NonPublic	Date Visited	Area (sq ft)	Lane Miles *	Surface Type	Condition / PCR
0920	Public	3/27/2002	12714	0.22	AS	GOOD / 90

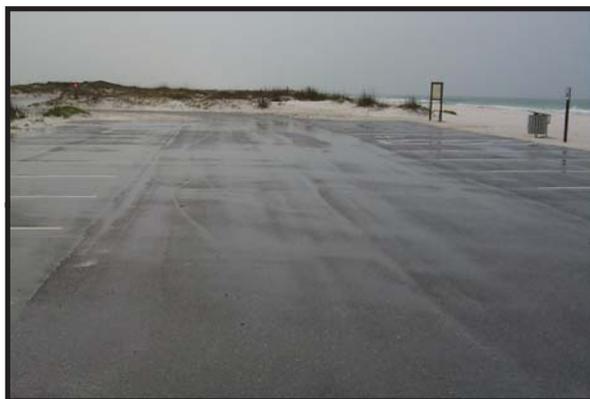
Route 0921

Route	Public / NonPublic	Date Visited	Area (sq ft)	Lane Miles *	Surface Type	Condition / PCR
0921	Public	3/27/2002	12629	0.22	AS	GOOD / 90

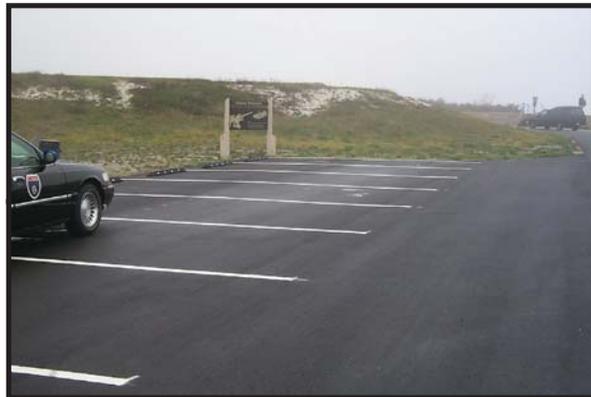
Route 0922

Route	Public / NonPublic	Date Visited	Area (sq ft)	Lane Miles *	Surface Type	Condition / PCR
0922	Public	3/27/2002	13821	0.24	AS	GOOD / 90

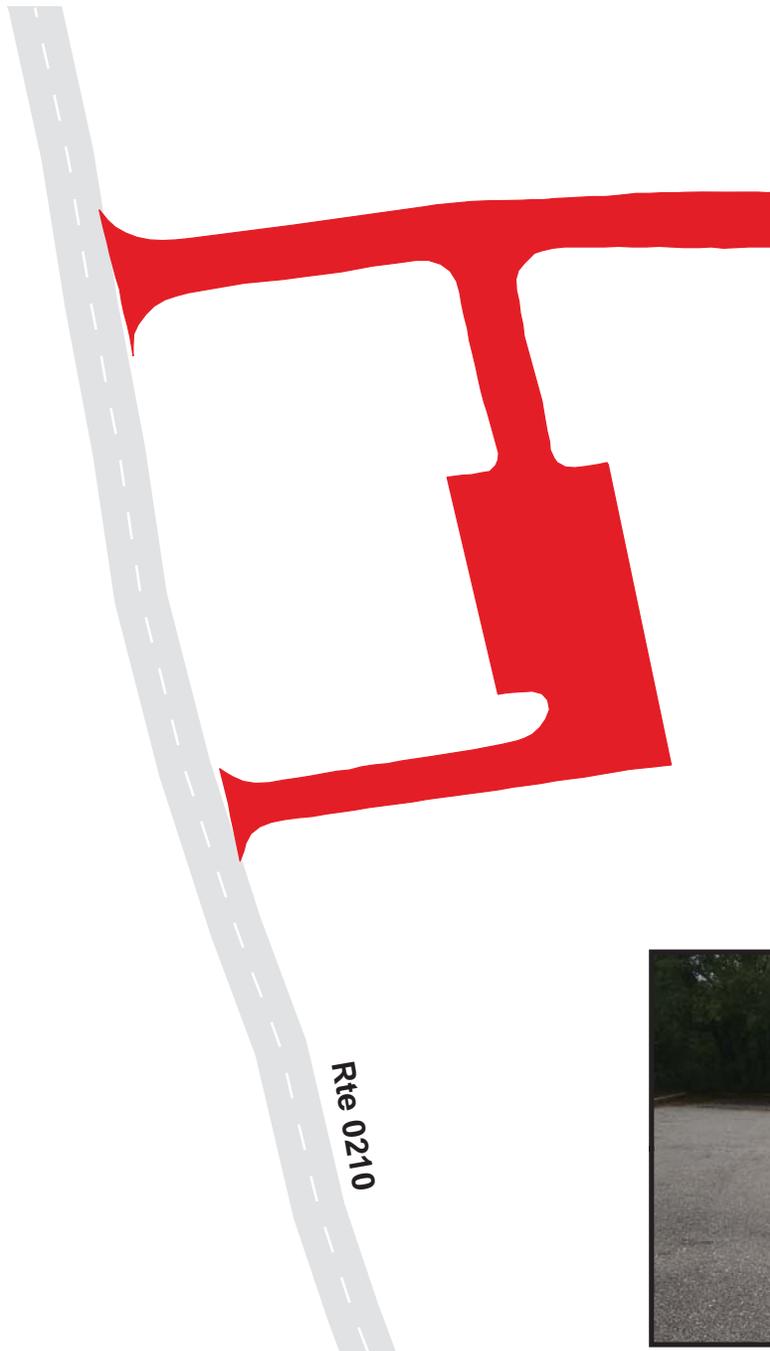
Gulf Islands National Seashore Route 0924

Naval Live Oaks Maintenance Complex
ADJACENT TO ROUTE 0923

Route	Public / NonPublic	Date Visited	Area (sq ft)	Lane Miles *	Surface Type	Condition / PCR
0924	Public	3/27/2002	48644	0.84	AS	GOOD / 90

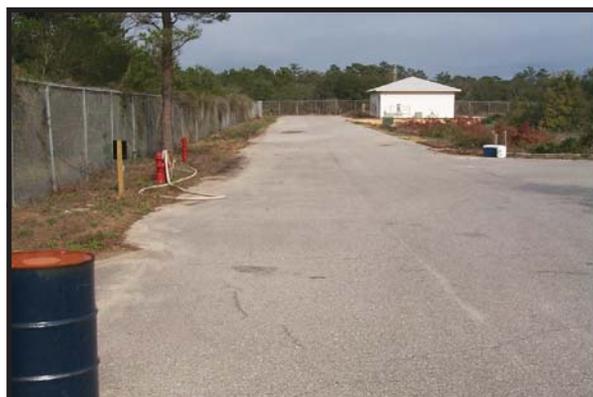
Route 0925

Route	Public / NonPublic	Date Visited	Area (sq ft)	Lane Miles *	Surface Type	Condition / PCR
0925	Public	3/27/2002	57011	0.98	AS	GOOD / 90

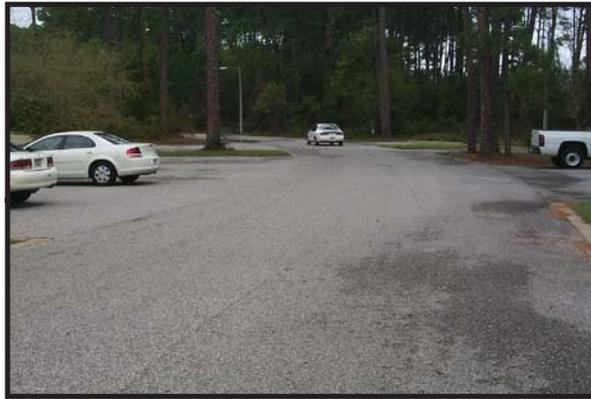
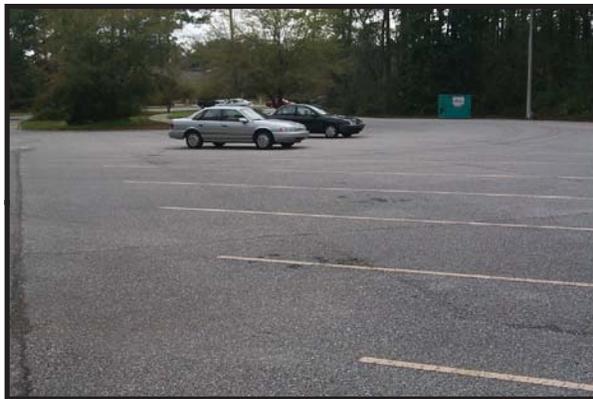
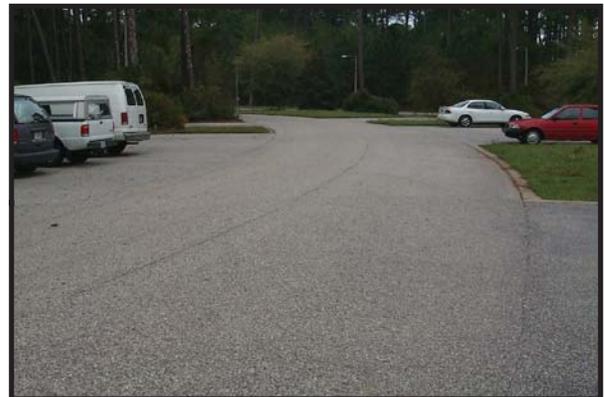
Route 0926

Route	Public / NonPublic	Date Visited	Area (sq ft)	Lane Miles *	Surface Type	Condition / PCR
0926	Public	3/27/2002	19835	0.34	AS	EXCELLENT / 97

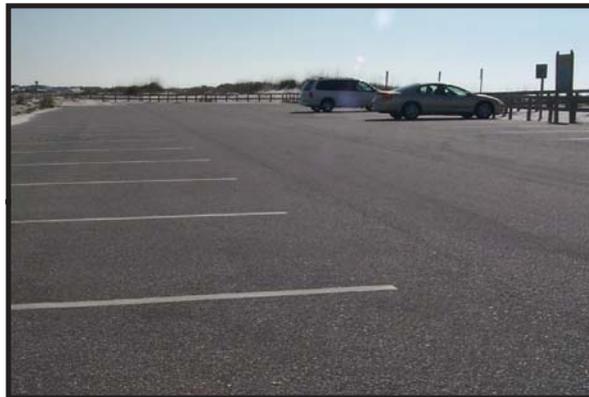
Route 0927

Route	Public / NonPublic	Date Visited	Area (sq ft)	Lane Miles *	Surface Type	Condition / PCR
0927	Public	3/27/2002	19813	0.34	AS	GOOD / 90

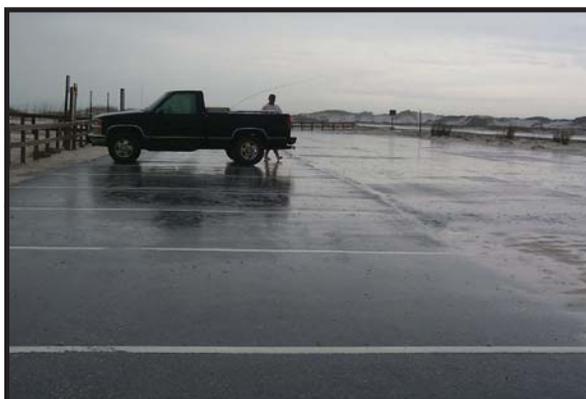
Route 0928

Route	Public / NonPublic	Date Visited	Area (sq ft)	Lane Miles *	Surface Type	Condition / PCR
0928	Public	3/27/2002	93120	1.60	AS	GOOD / 90

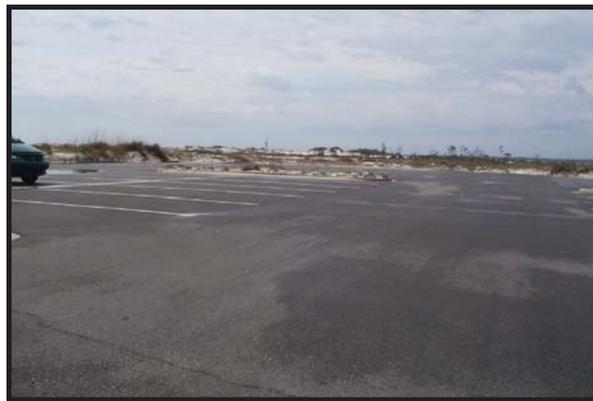
Gulf Islands National Seashore
Route 0929
 Public Parking #8
 ADJACENT TO ROUTE 0011 AT MP 3.9

Route	Public / NonPublic	Date Visited	Area (sq ft)	Lane Miles *	Surface Type	Condition / PCR
0929	Public	3/27/2002	20598	0.35	AS	GOOD / 90

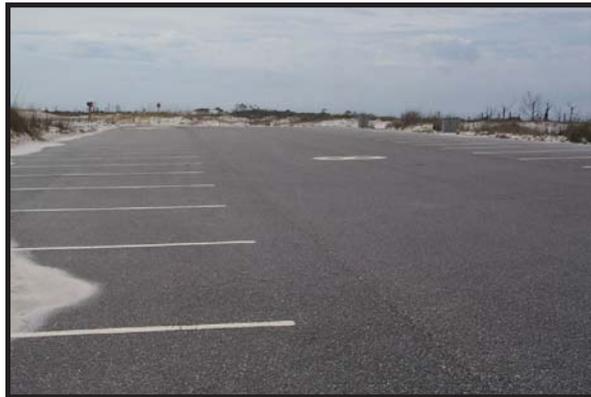
Gulf Islands National Seashore
Route 0930
 Opal Beach Access (East)
 ADJACENT TO ROUTE 0011 AT MP 4.2

Route	Public / NonPublic	Date Visited	Area (sq ft)	Lane Miles *	Surface Type	Condition / PCR
0930	Public	3/27/2002	134956	2.32	AS	GOOD / 90

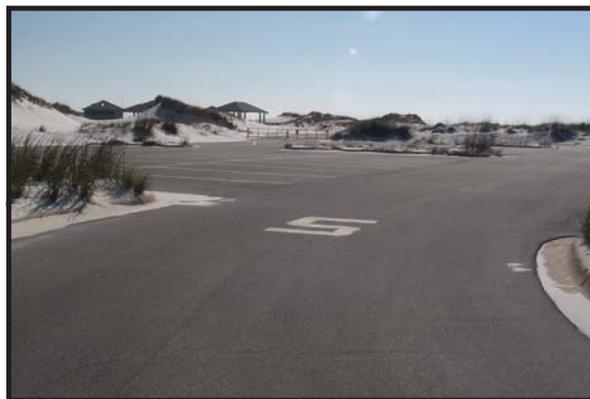
Route 0931

Route	Public / NonPublic	Date Visited	Area (sq ft)	Lane Miles *	Surface Type	Condition / PCR
0931	Public	3/27/2002	19988	0.34	AS	GOOD / 90

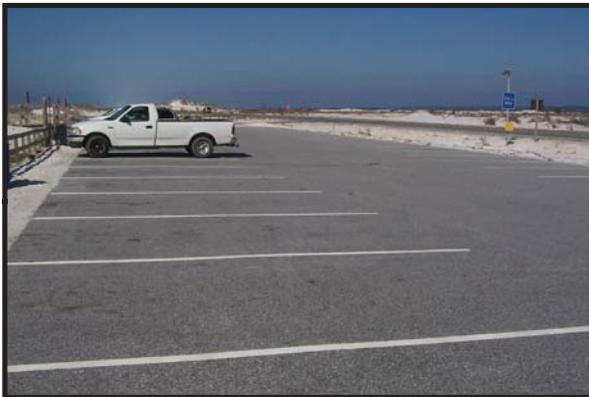
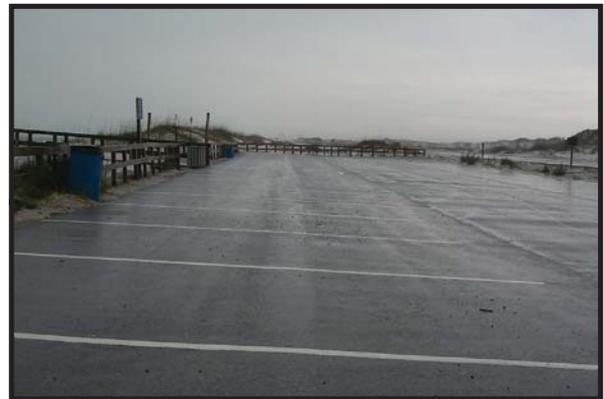
Route 0932

Route	Public / NonPublic	Date Visited	Area (sq ft)	Lane Miles *	Surface Type	Condition / PCR
0932	Public	3/27/2002	95776	1.65	AS	GOOD / 90

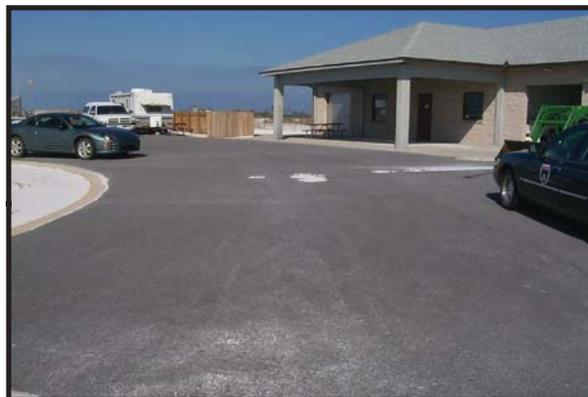
Route 0935

Route	Public / NonPublic	Date Visited	Area (sq ft)	Lane Miles *	Surface Type	Condition / PCR
0935	Public	3/27/2002	8866	0.15	AS	GOOD / 90
