The Road Inventory of Guadalupe Mountains National Park GUMO - 7180

Road Inventory Program

Prepared By:
Federal Highway Administration
Eastern Federal Lands Highway Division
Cycle 3

Guadalupe Mountains National Park in Texas

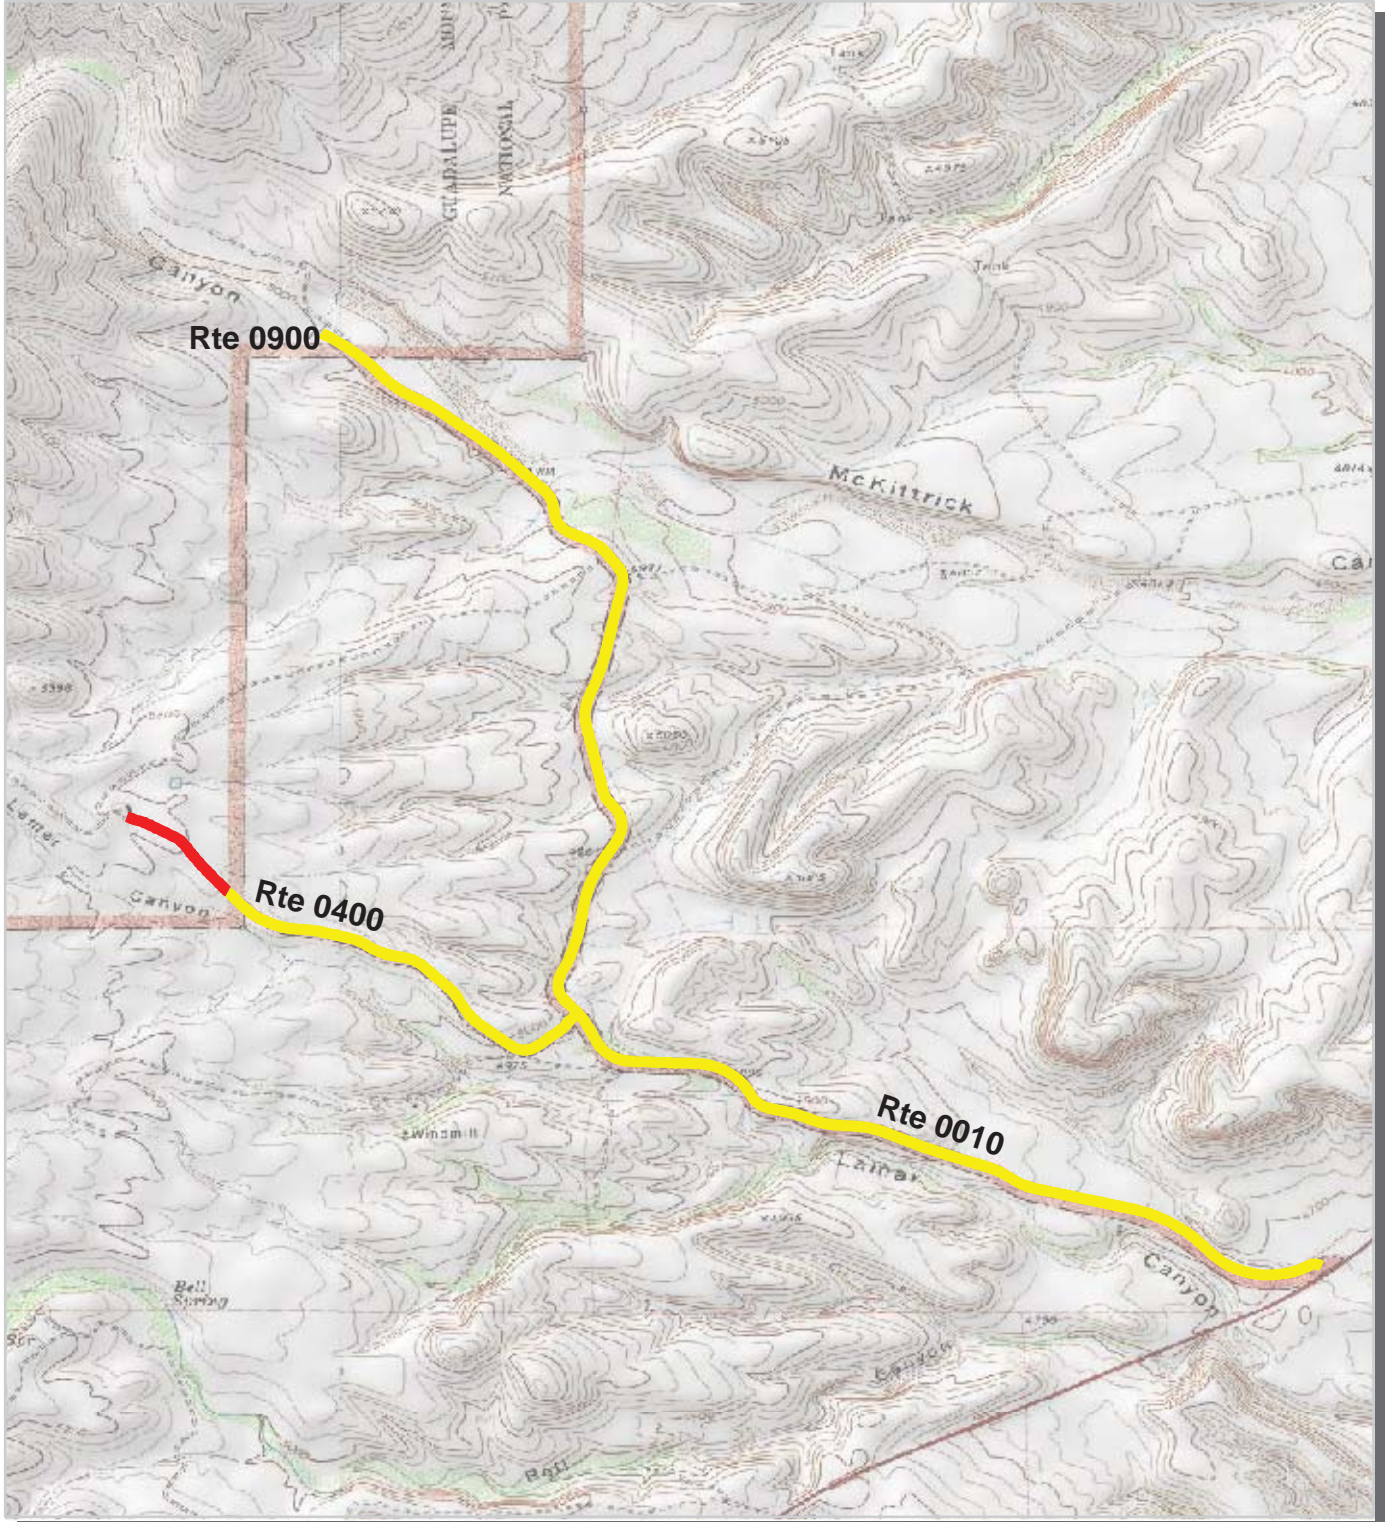
Route Condition Area Map 2

PCR - Mile by Mile

PCR	Poor		Fair		Good		Excellent	
		(<=60)		(61 - 84)		(85 - 94)		(95 - 100)

* If the PCR rating is not available for a section, the SCR rating will be displayed. See appendix for definitions and formulas.

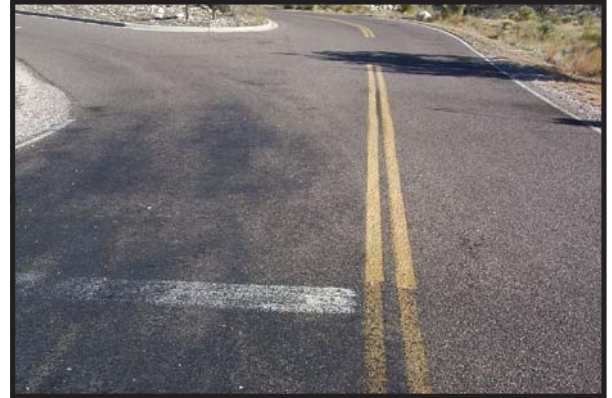
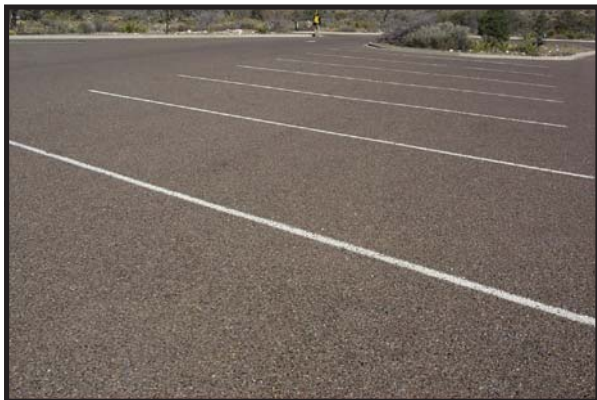
Route 0903

Route	Public / NonPublic	Date Visited	Area (sq ft)	Lane Miles *	Surface Type	Condition / PCR
0903	Public	3/3/2003	68028	1.17	OC	GOOD / 90

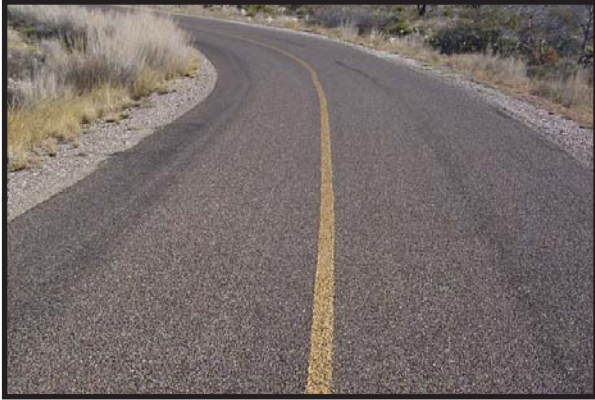
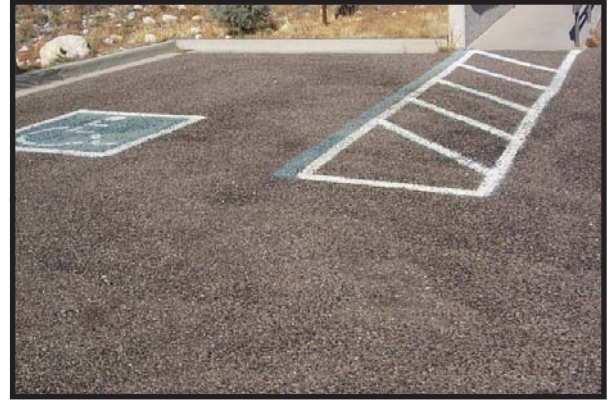
Route 0904

Route	Public / NonPublic	Date Visited	Area (sq ft)	Lane Miles *	Surface Type	Condition / PCR
0904	NonPublic	3/4/2003	13584	0.23	OC	GOOD / 90

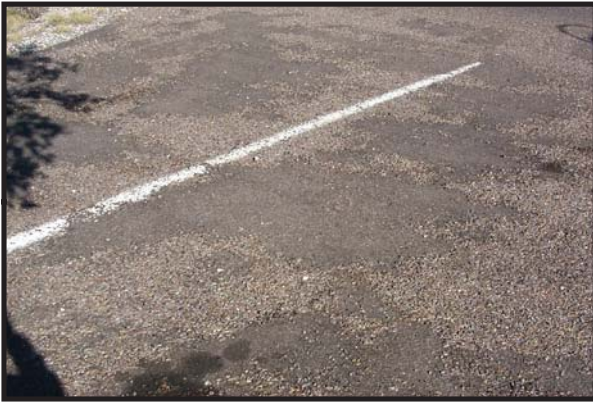
Route 0906

Route	Public / NonPublic	Date Visited	Area (sq ft)	Lane Miles *	Surface Type	Condition / PCR
0906	Public	3/3/2003	906	0.02	OC	FAIR / 73

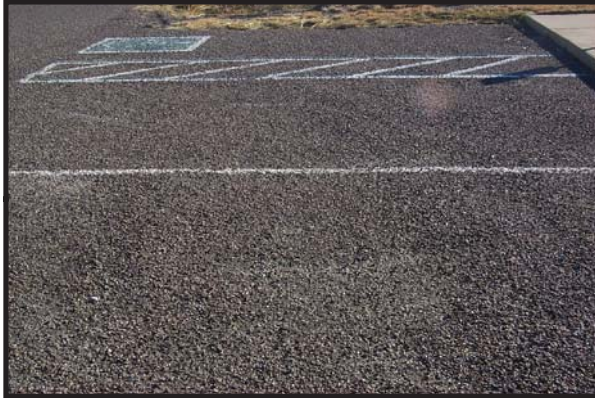
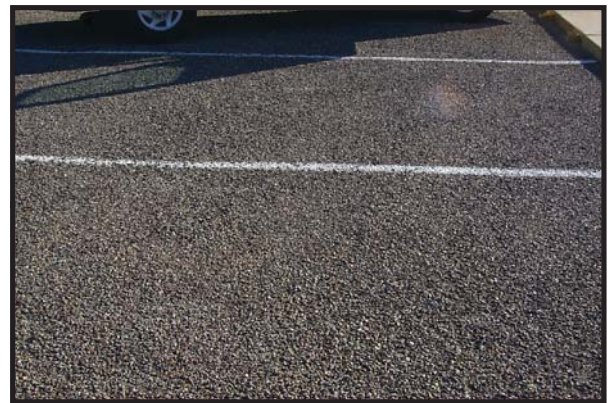
Route 0913

Route	Public / NonPublic	Date Visited	Area (sq ft)	Lane Miles *	Surface Type	Condition / PCR
0913	NonPublic	3/3/2003	1377	0.02	OC	GOOD / 90

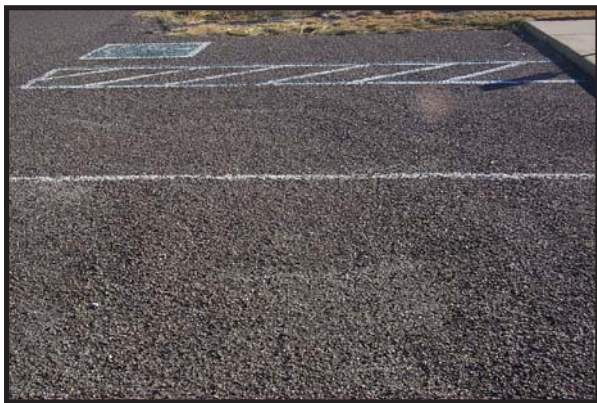
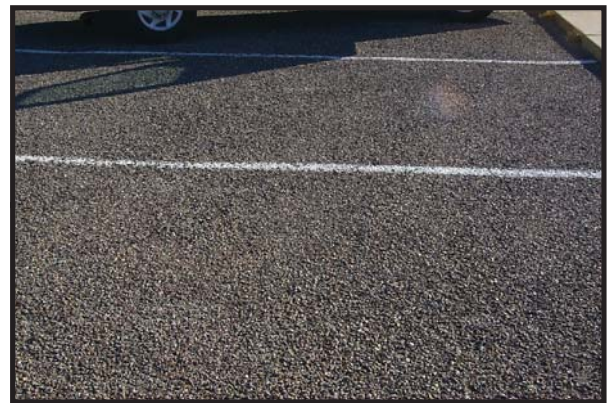
Route 0914A

Route	Public / NonPublic	Date Visited	Area (sq ft)	Lane Miles *	Surface Type	Condition / PCR
0914A	NonPublic	3/3/2003	40709	0.70	OC	GOOD / 90
