**The Road Inventory
of
George Washington Carver National Monument
GWCA - 6360**

Road Inventory Program

Prepared By:
Federal Highway Administration
Eastern Federal Lands Highway Division
Cycle 3

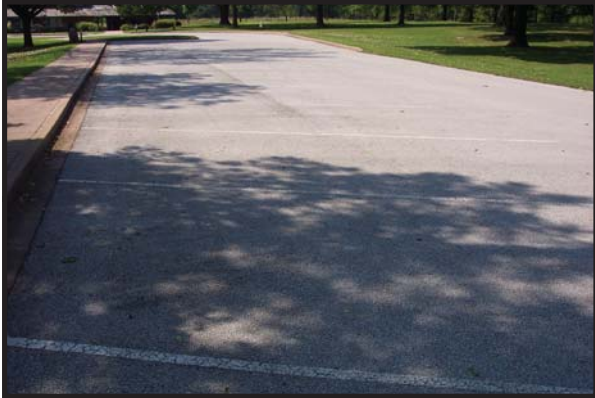
Route	Public / NonPublic	Date Visited	Area (sq ft)	Lane Miles *	Surface Type	Condition / PCR
0900A	Public	9/10/2003	4658	0.08	AS	GOOD / 90

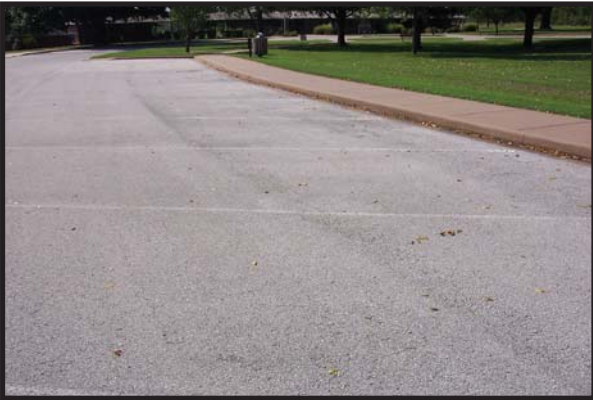
Route 0900B

Route	Public / NonPublic	Date Visited	Area (sq ft)	Lane Miles *	Surface Type	Condition / PCR
0900B	Public	9/10/2003	5781	0.10	AS	GOOD / 90

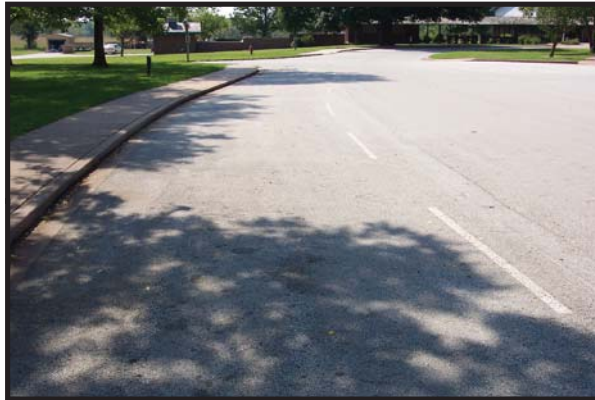
Route 0900C

Route	Public / NonPublic	Date Visited	Area (sq ft)	Lane Miles *	Surface Type	Condition / PCR
0900C	Public	9/10/2003	2672	0.05	AS	GOOD / 90

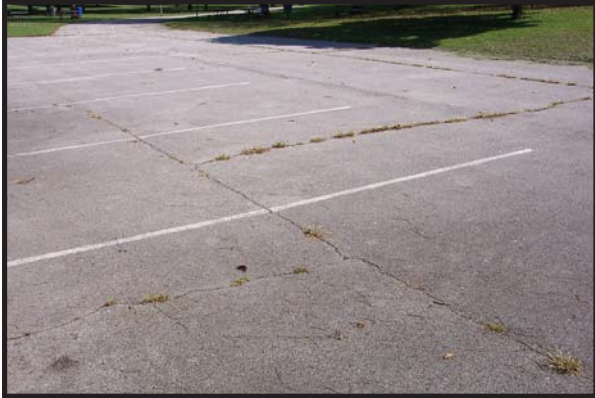
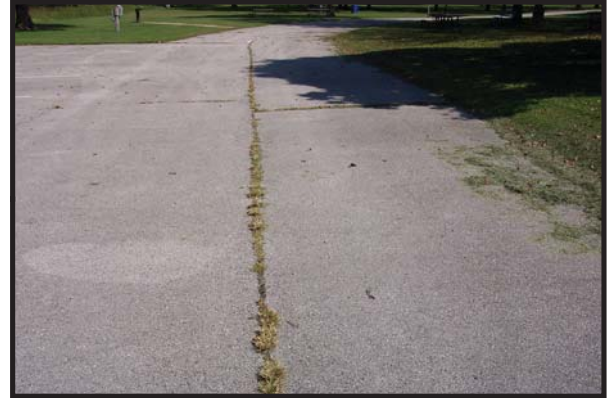
Route 0901

Route	Public / NonPublic	Date Visited	Area (sq ft)	Lane Miles *	Surface Type	Condition / PCR
0901	Public	9/10/2003	4397	0.08	AS	FAIR / 73

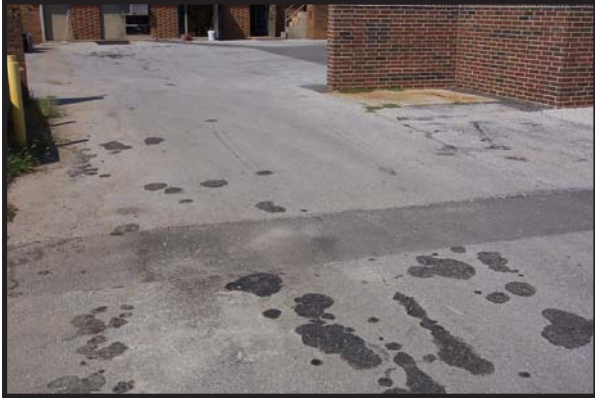
Route 0902

Route	Public / NonPublic	Date Visited	Area (sq ft)	Lane Miles *	Surface Type	Condition / PCR
0902	NonPublic	9/10/2003	7232	0.12	AS	FAIR / 73

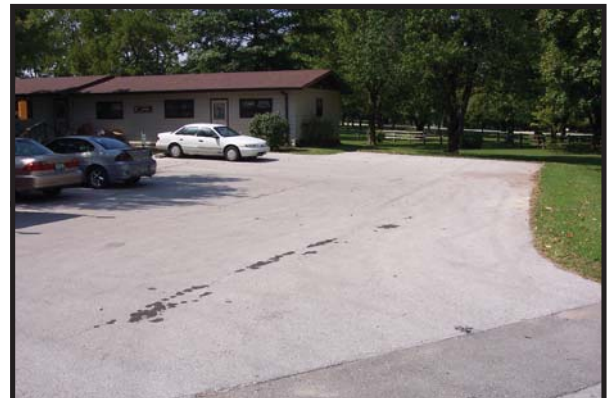
Route 0903A

Route	Public / NonPublic	Date Visited	Area (sq ft)	Lane Miles *	Surface Type	Condition / PCR
0903A	NonPublic	9/10/2003	4037	0.07	AS	FAIR / 73

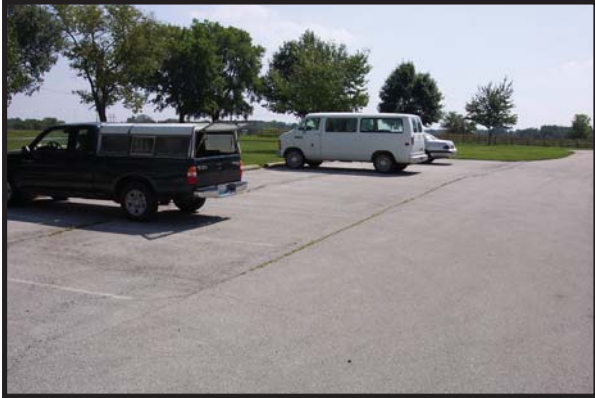
Route	Public / NonPublic	Date Visited	Area (sq ft)	Lane Miles *	Surface Type	Condition / PCR
0903B	Public	9/10/2003	2243	0.04	AS	FAIR / 73

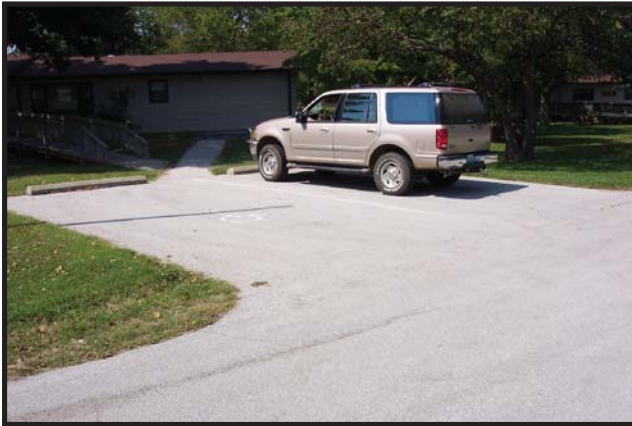
Route 0903C

Route	Public / NonPublic	Date Visited	Area (sq ft)	Lane Miles *	Surface Type	Condition / PCR
0903C	Public	9/10/2003	783	0.01	AS	FAIR / 73

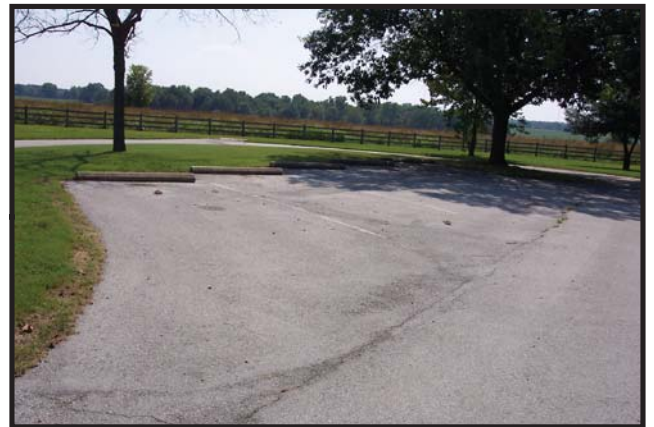
Route 0903D

Route	Public / NonPublic	Date Visited	Area (sq ft)	Lane Miles *	Surface Type	Condition / PCR
0903D	Public	9/10/2003	1500	0.03	AS	FAIR / 73
