**The Road Inventory
of
Hampton National Historic Site
HAMP - 4350**

Road Inventory Program

Prepared By:
Federal Highway Administration
Eastern Federal Lands Highway Division
Cycle 3

Hampton National Historic Site in Maryland

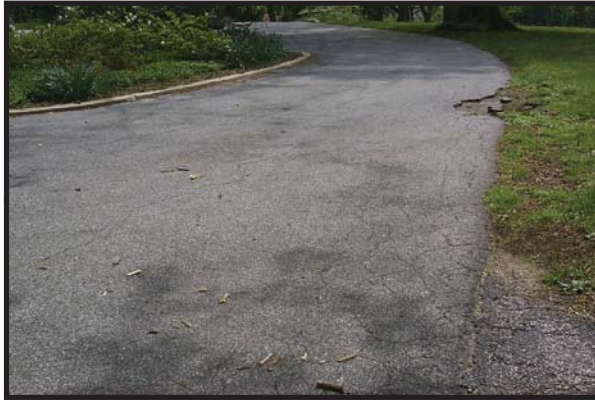
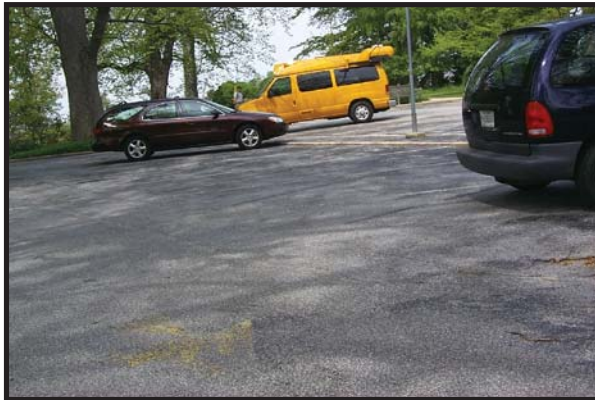
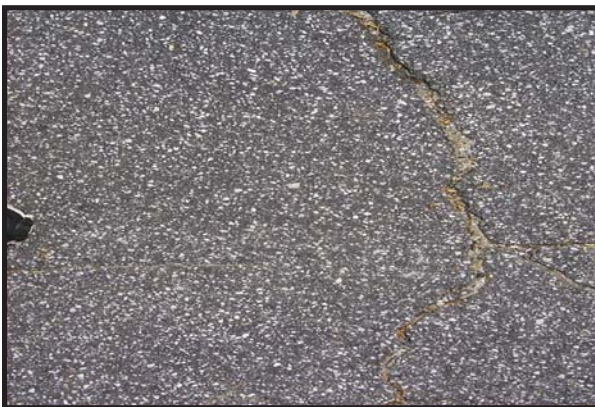
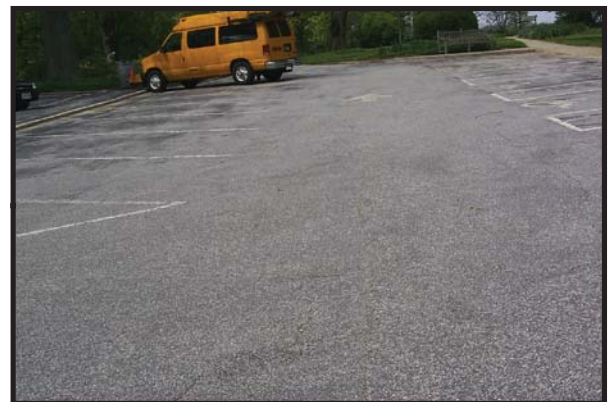
Route	Public / NonPublic	Date Visited	Area (sq ft)	Lane Miles *	Surface Type	Condition / PCR
0900	Public	4/27/2002	19317	0.33	AS	FAIR / 73

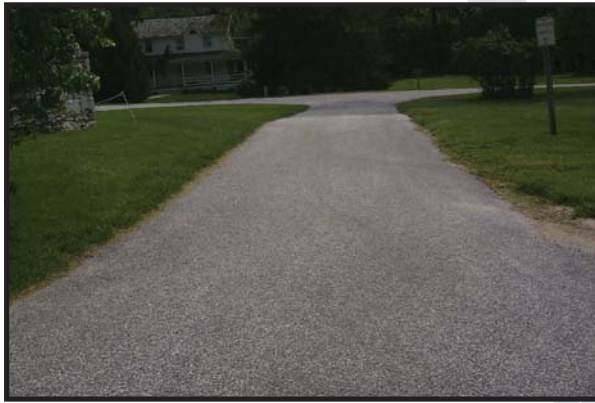
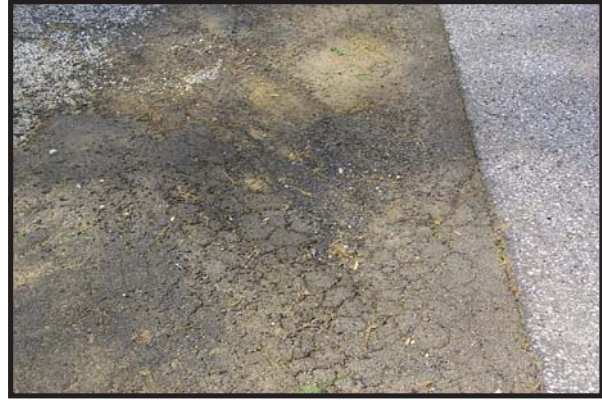
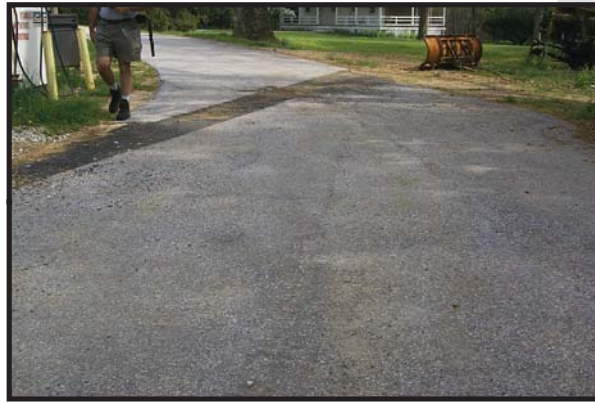
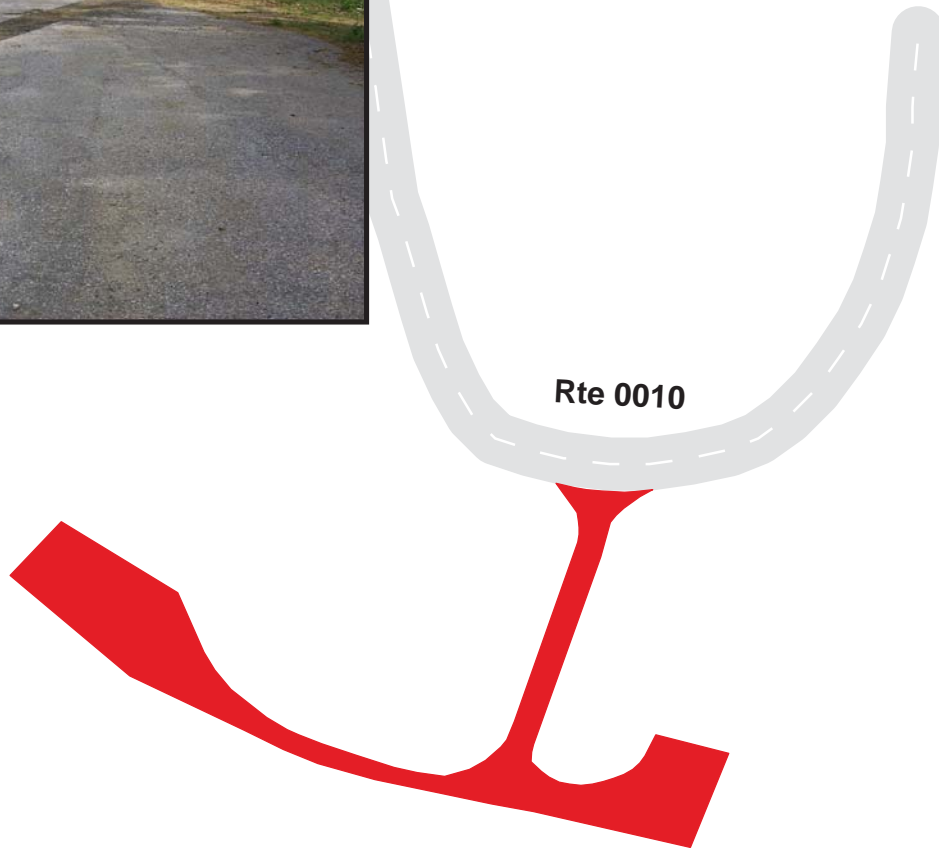
Route 0902

Route	Public / NonPublic	Date Visited	Area (sq ft)	Lane Miles *	Surface Type	Condition / PCR
0902	NonPublic	4/27/2002	8533	0.15	AS	FAIR / 73

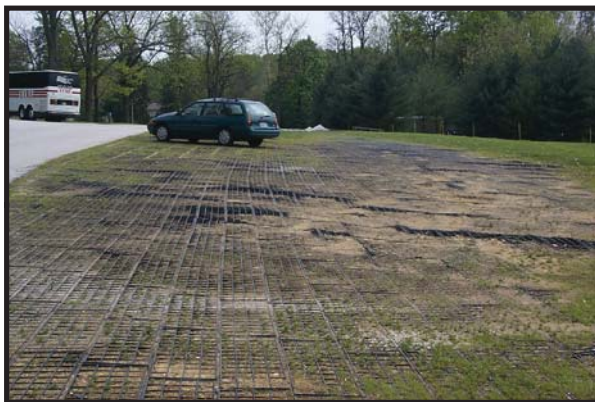
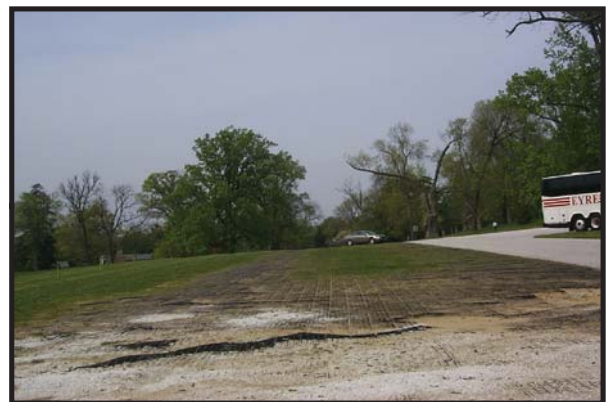
Route 0903

Route	Public / NonPublic	Date Visited	Area (sq ft)	Lane Miles *	Surface Type	Condition / PCR
0903	Public	4/27/2002	20103	0.35	OT	POOR / 45

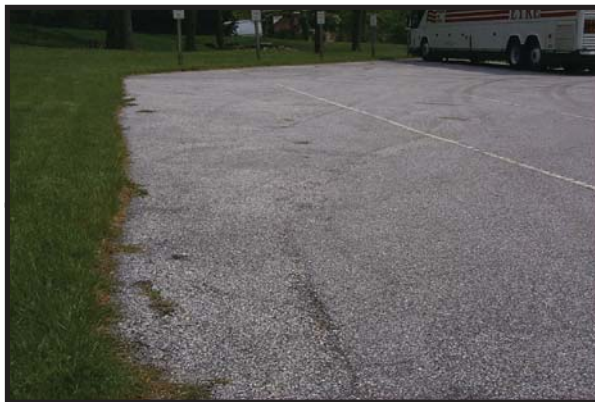
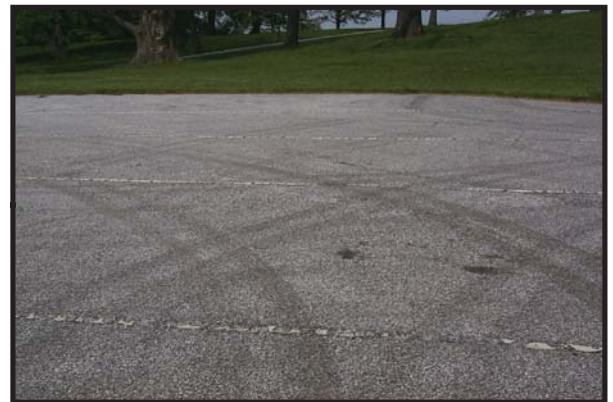
Route 0907

Route	Public / NonPublic	Date Visited	Area (sq ft)	Lane Miles *	Surface Type	Condition / PCR
0907	Public	4/27/2002	3518	0.06	AS	GOOD / 90
