**The Road Inventory
of
Herbert Hoover National Historic Site
HEHO – 6470**

Road Inventory Program

Prepared By:
Federal Highway Administration
Eastern Federal Lands Highway Division
Cycle 3

Herbert Hoover National Historic Site in Iowa

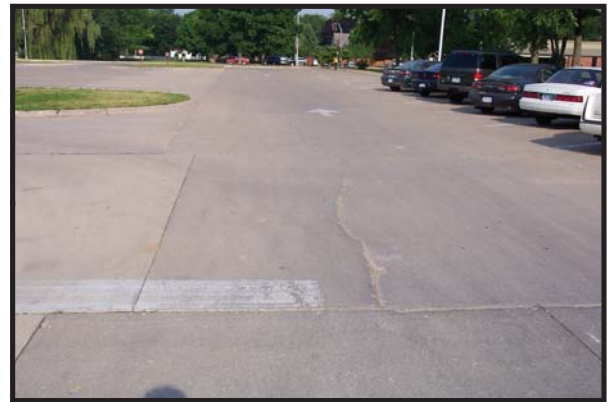
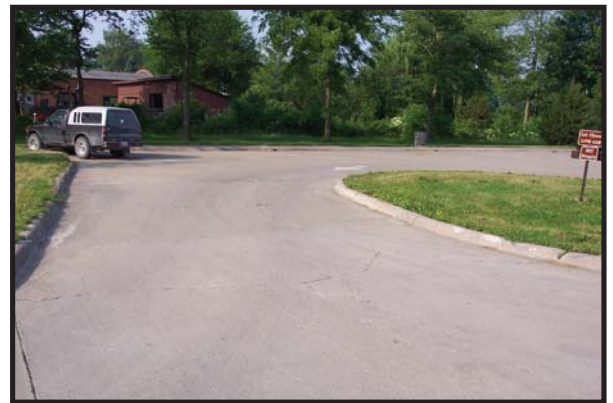
Route 0901

Route	Public / NonPublic	Date Visited	Area (sq ft)	Lane Miles *	Surface Type	Condition / PCR
0901	Public	6/25/2003	27572	0.47	CO	FAIR / 73

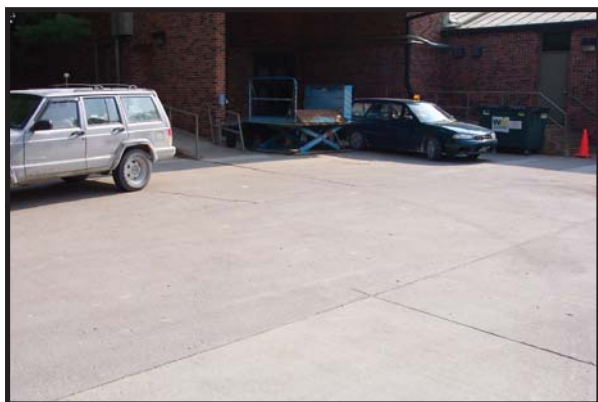
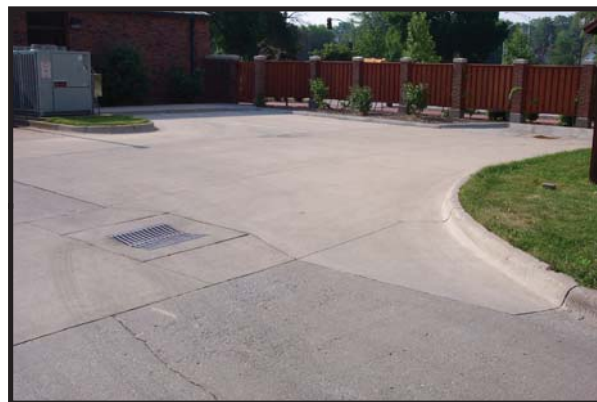
Route 0902

Route	Public / NonPublic	Date Visited	Area (sq ft)	Lane Miles *	Surface Type	Condition / PCR
0902	NonPublic	6/25/2003	4896	0.08	CO	FAIR / 73

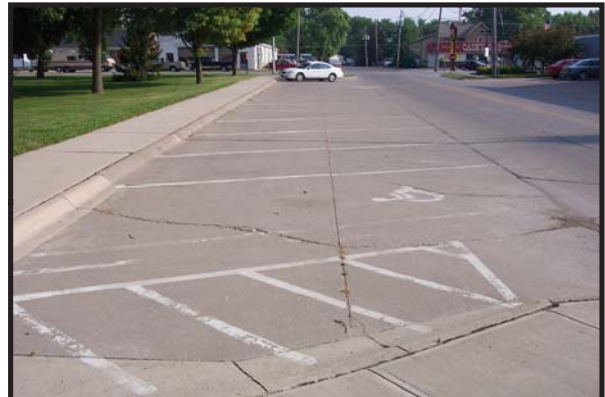
Route 0903

Route	Public / NonPublic	Date Visited	Area (sq ft)	Lane Miles *	Surface Type	Condition / PCR
0903	Public	6/25/2003	3625	0.06	CO	FAIR / 73

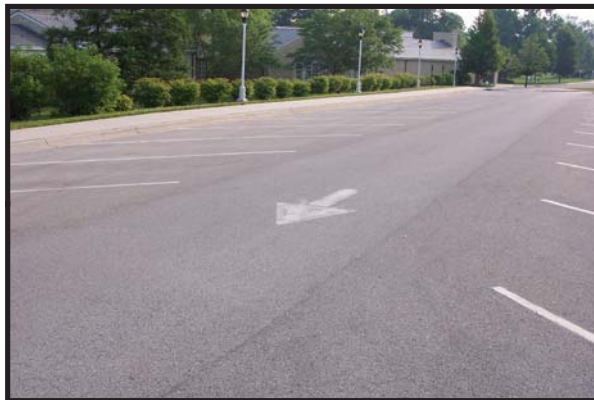
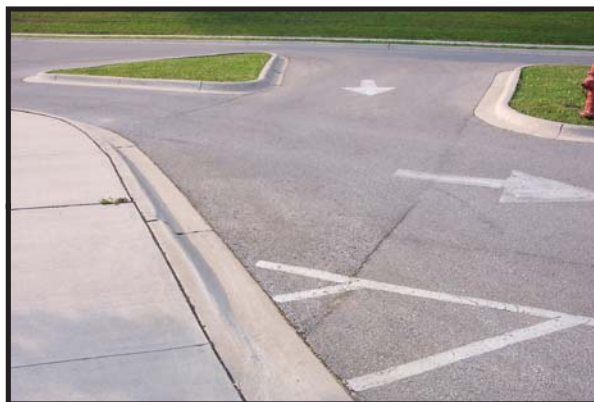
Route 0904

Route	Public / NonPublic	Date Visited	Area (sq ft)	Lane Miles *	Surface Type	Condition / PCR
0904	Public	6/25/2003	18498	0.32	AS	GOOD / 90

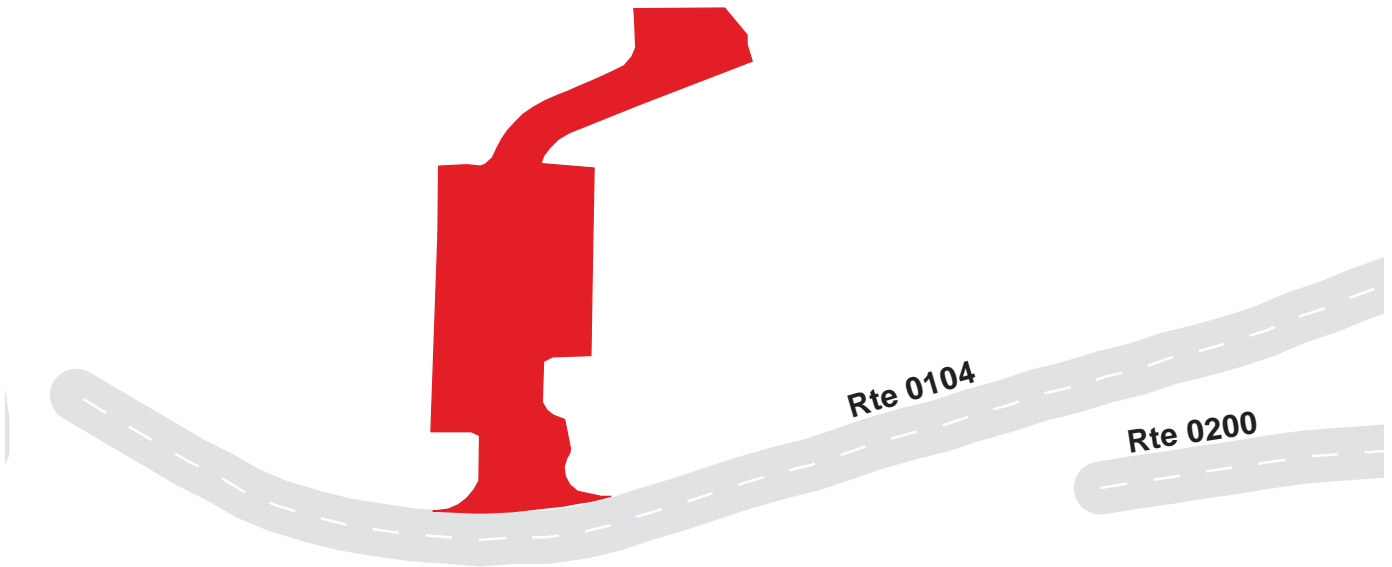
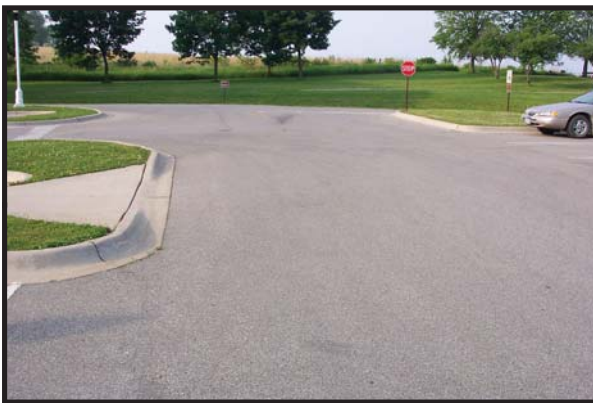
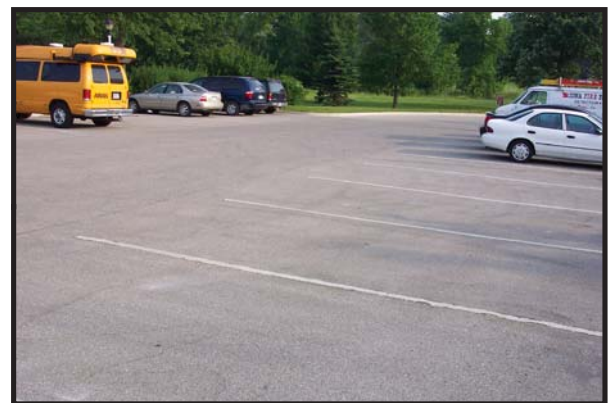
Route 0905

Route	Public / NonPublic	Date Visited	Area (sq ft)	Lane Miles *	Surface Type	Condition / PCR
0905	Public	6/25/2003	13181	0.23	AS	GOOD / 90

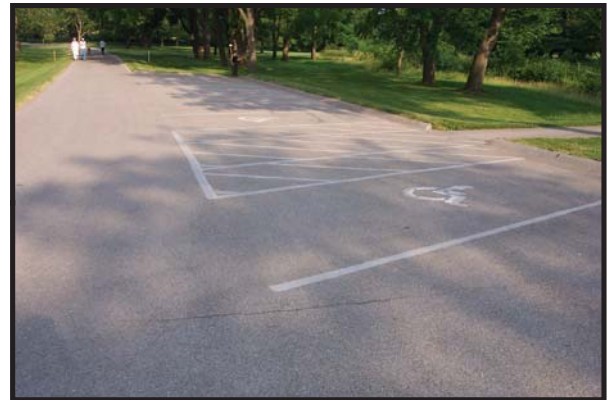
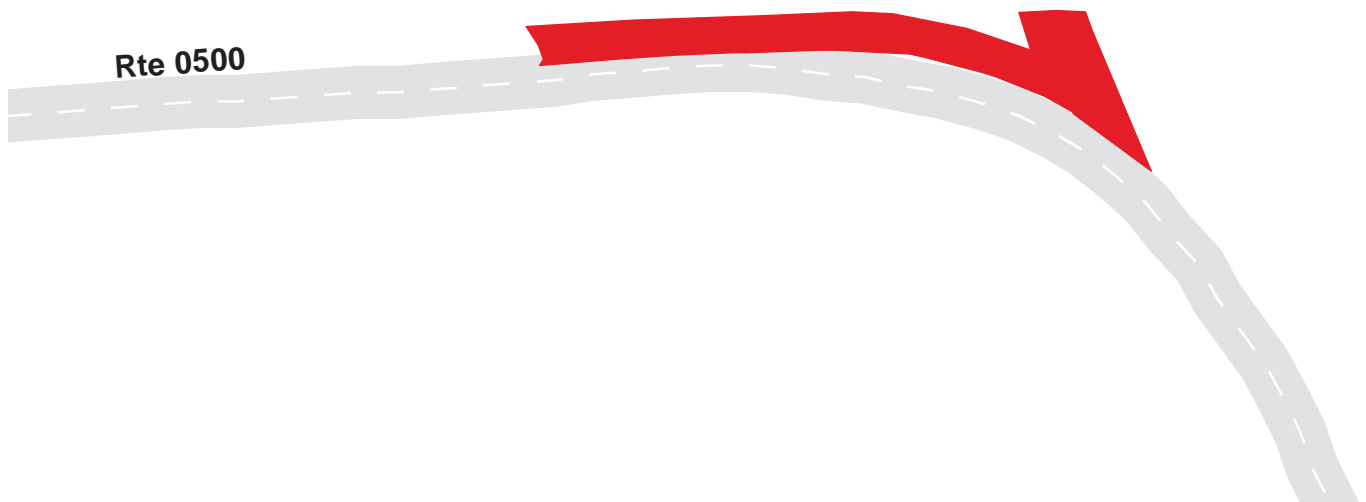
Route	Public / NonPublic	Date Visited	Area (sq ft)	Lane Miles *	Surface Type	Condition / PCR
0906	Public	6/25/2003	4483	0.08	AS	GOOD / 90

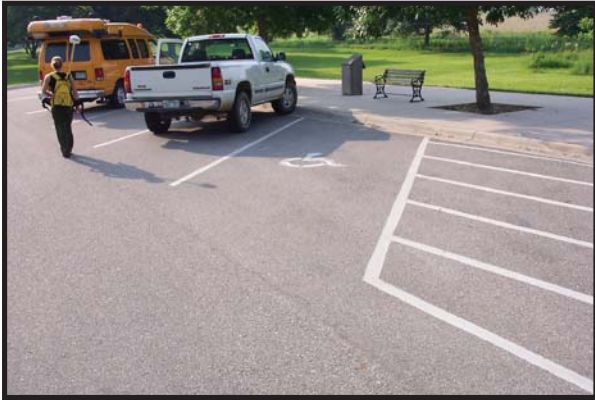
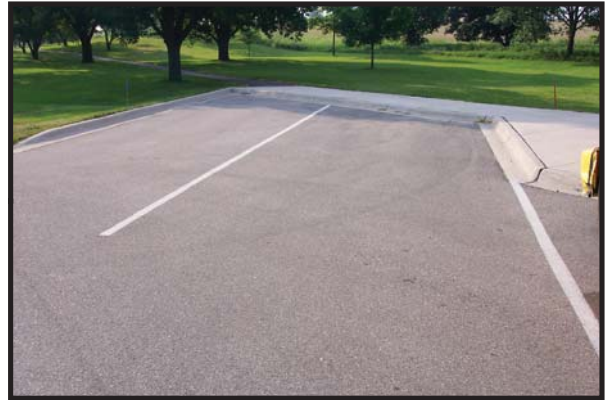
Route 0907

Route	Public / NonPublic	Date Visited	Area (sq ft)	Lane Miles *	Surface Type	Condition / PCR
0907	Public	6/25/2003	1989	0.03	AS	GOOD / 90

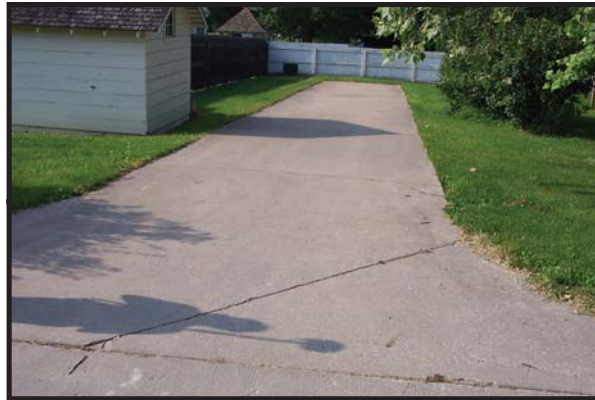
Route 0908

Route	Public / NonPublic	Date Visited	Area (sq ft)	Lane Miles *	Surface Type	Condition / PCR
0908	Public	6/25/2003	1040	0.02	CO	GOOD / 90

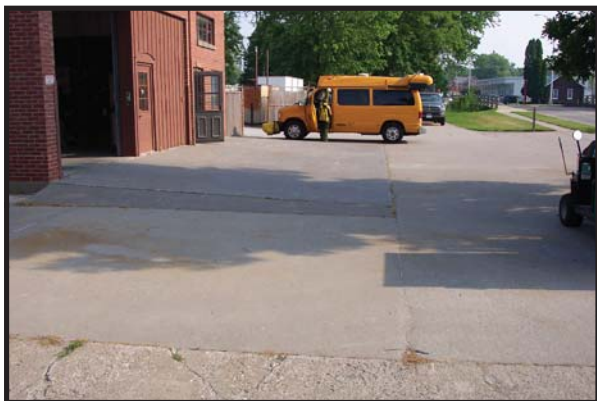
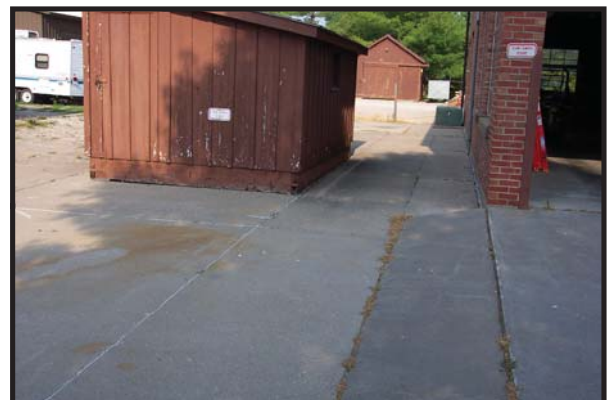
Route 0909

Route	Public / NonPublic	Date Visited	Area (sq ft)	Lane Miles *	Surface Type	Condition / PCR
0909	NonPublic	6/25/2003	5927	0.10	CO	GOOD / 90
