The Road Inventory of Horace M. Albright Training Center HOAL – 2670

Road Inventory Program

Prepared By:
Federal Highway Administration
Eastern Federal Lands Highway Division
Cycle 3

Horace M. Albright Training Center in Arizona

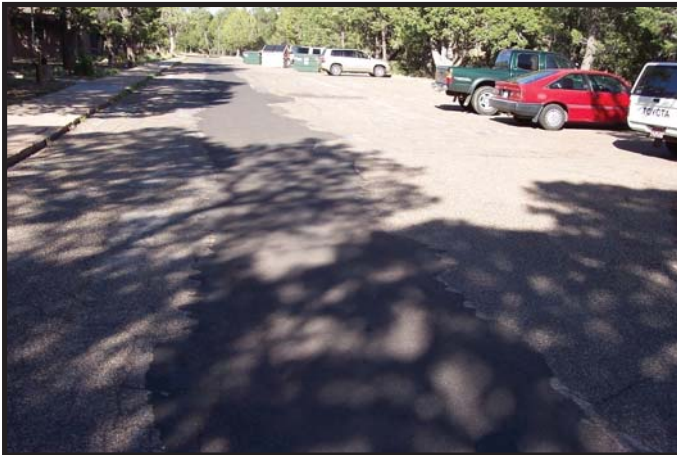
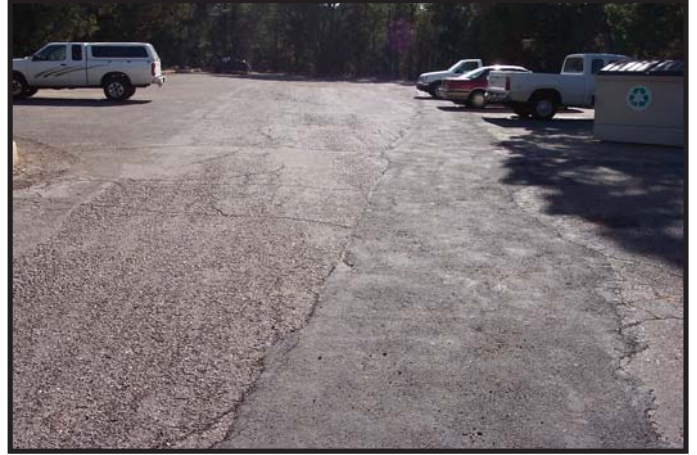
Route 0900

Training Center Parking
From Albright Avenue

| Route | Public / NonPublic | Date Visited | Area (sq ft) | Lane Miles * | Surface Type | Condition / PCR |
| 0900 | NonPublic | 5/20/2004 | 60525 | 1.04 | OC | POOR / 45 |
