The Road Inventory of Horseshoe Bend National Military Park HOBE - 5480

Road Inventory Program

Prepared By:
Federal Highway Administration
Eastern Federal Lands Highway Division
Cycle 3

Horseshoe Bend National Military Park in Alabama

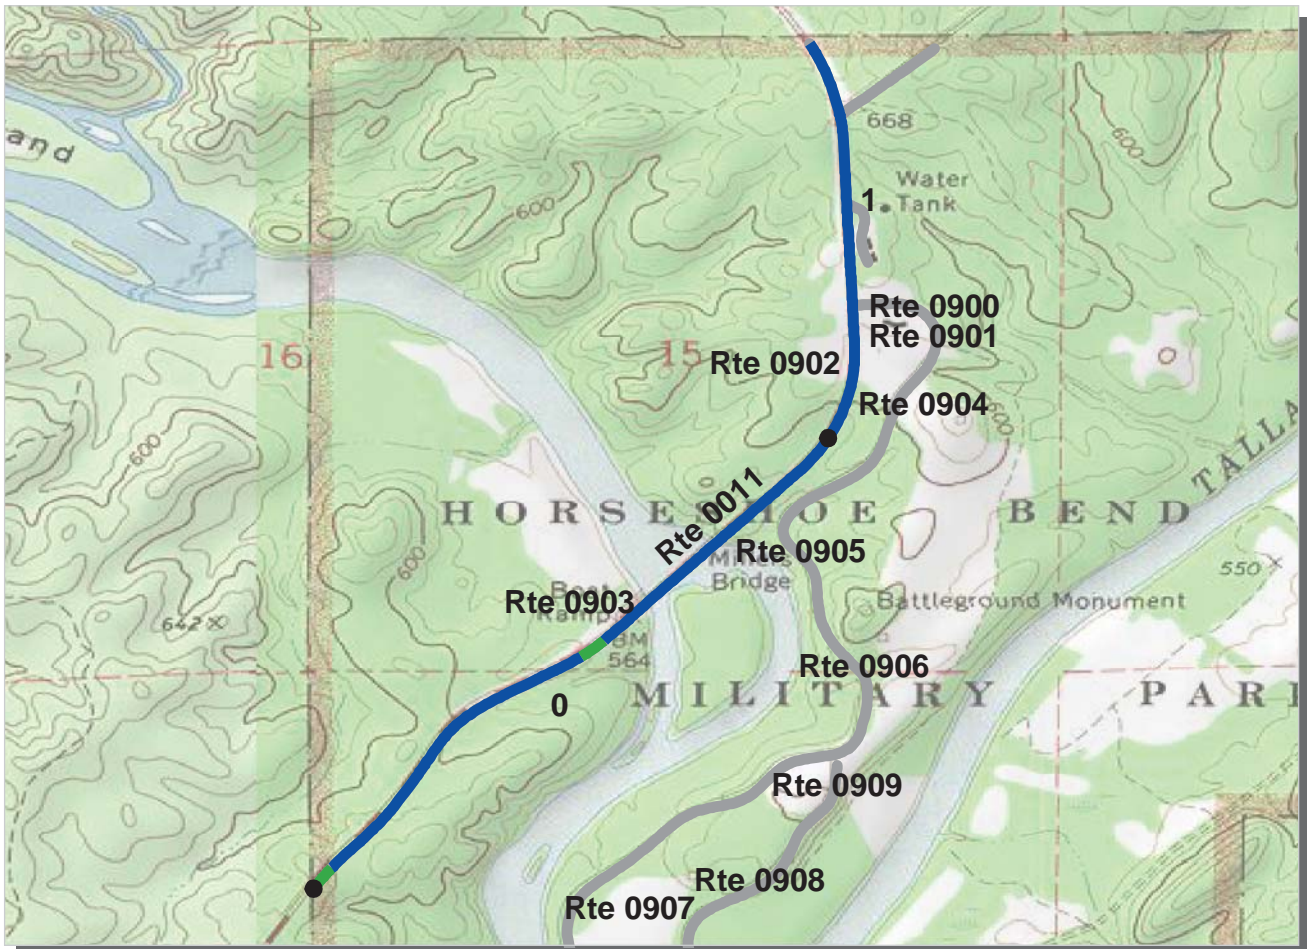
ROUTE: 0011 Highway 49 **TOTAL LENGTH: 1.65 Miles**

Section Number	0	1			
Section Length (mi)	1.00	0.65			
AADT	**				
SADT	**				
ADT Date	**				
Cross Section Information					
Number of Lanes	2	2			
Paved Width (ft)	21	21			
Lane Width (ft)	10	10			
Shoulder Width (ft)	2	2			
Roadway Condition Information					
PCR (Pavement Condition Rating)	99	98			
RCI (Roughness Condition Index)	100	100			
SCR (Surface Condition Rating)	98	98			
Alligator Cracking Index	100	100			
Rutting Index	98	98			
Patching Index	100	100			
Transverse Cracking Index	99	99			
Longitudinal Cracking Index	100	100			
Shoulder Condition Rating	GOOD	GOOD			
Drainage Condition Rating	GOOD	GOOD

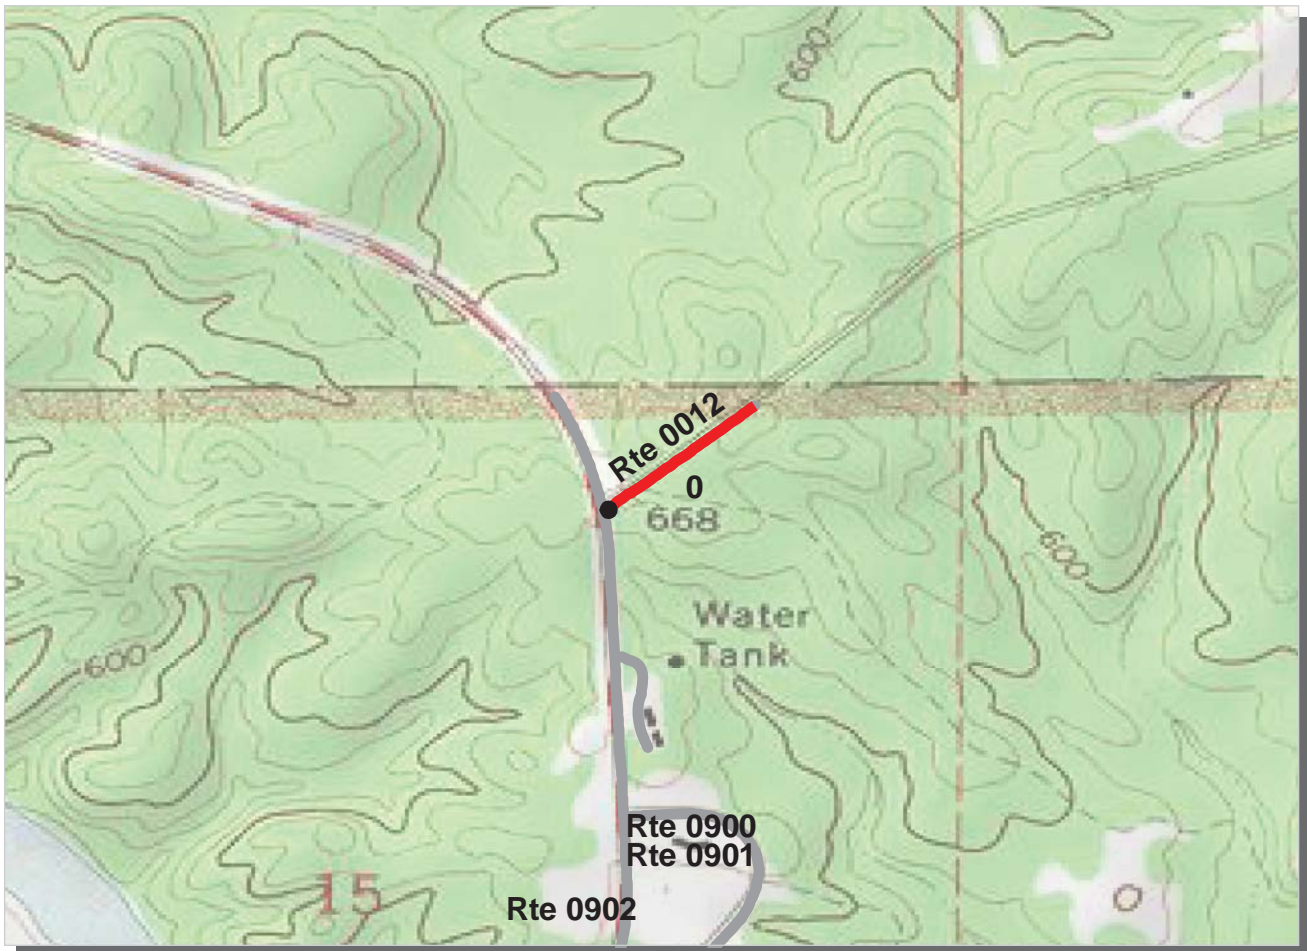
ROUTE: 0012 Highway 79 **TOTAL LENGTH: 0.18 Miles**

Section Number	0				
Section Length (mi)	0.18				
AADT	**				
SADT	**				
ADT Date	**				
Cross Section Information					
Number of Lanes	2				
Paved Width (ft)	16				
Lane Width (ft)	8				
Shoulder Width (ft)	0				
Roadway Condition Information					
PCR (Pavement Condition Rating)	36				
RCI (Roughness Condition Index)	42				
SCR (Surface Condition Rating)	31				
Alligator Cracking Index	97				
Rutting Index	35				
Patching Index	98				
Transverse Cracking Index	99				
Longitudinal Cracking Index	99				
Shoulder Condition Rating	N/A				
Drainage Condition Rating	GOOD

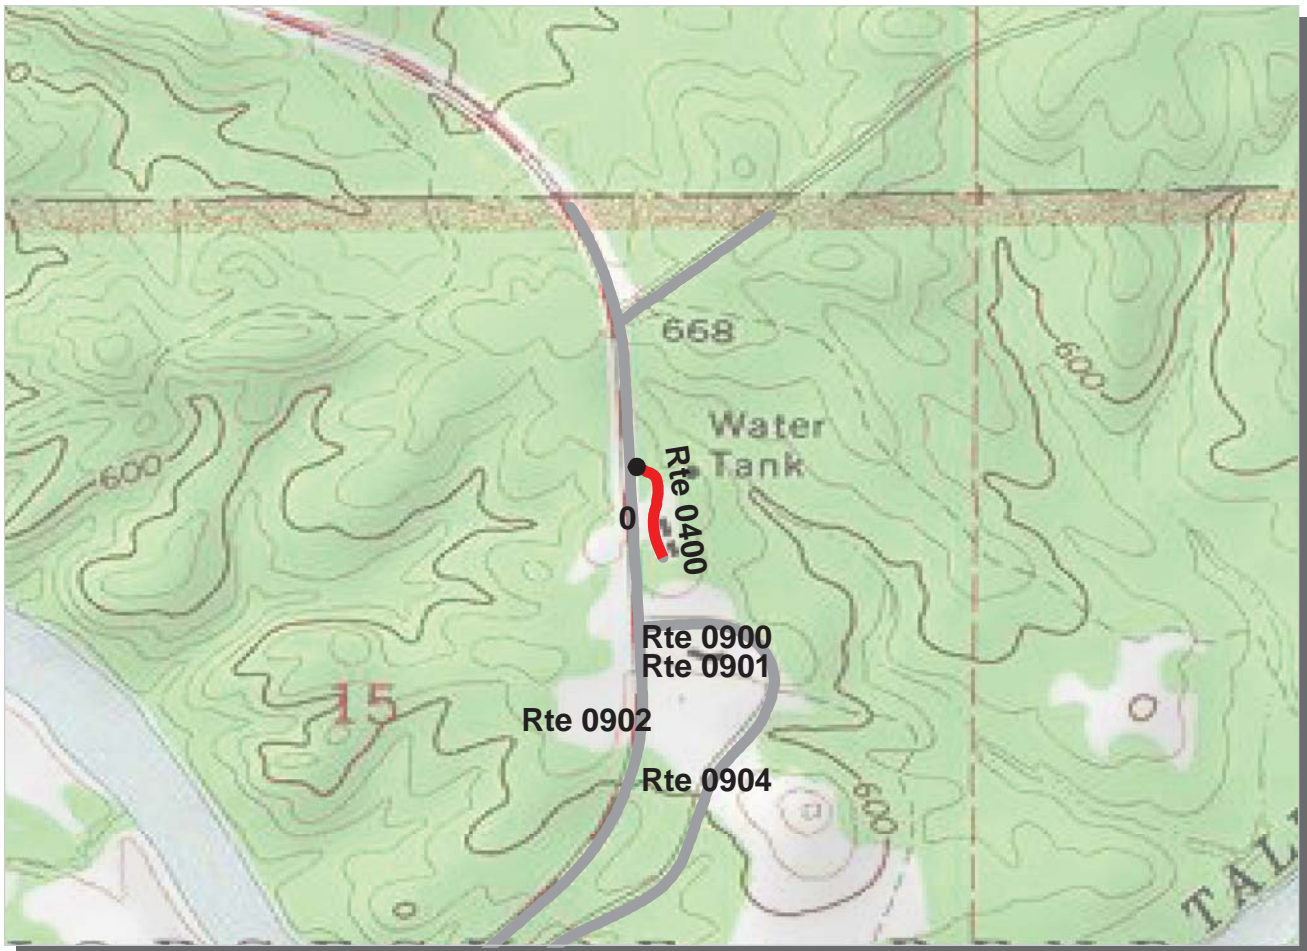
ROUTE: 0400 Horseshoe Bend Residence Road **TOTAL LENGTH: 0.12 Miles**

Section Number	0				
Section Length (mi)	0.12				
AADT	**				
SADT	**				
ADT Date	**				
Cross Section Information					
Number of Lanes	2				
Paved Width (ft)	14				
Lane Width (ft)	8				
Shoulder Width (ft)	0				
Roadway Condition Information					
PCR (Pavement Condition Rating)	37				
RCI (Roughness Condition Index)	33				
SCR (Surface Condition Rating)	41				
Alligator Cracking Index	100				
Rutting Index	46				
Patching Index	100				
Transverse Cracking Index	96				
Longitudinal Cracking Index	97				
Shoulder Condition Rating	N/A				
Drainage Condition Rating	GOOD

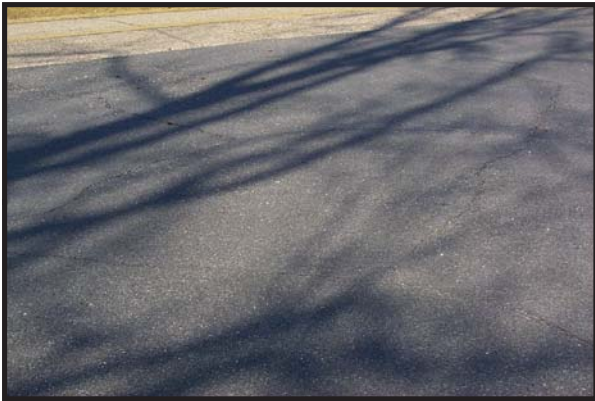
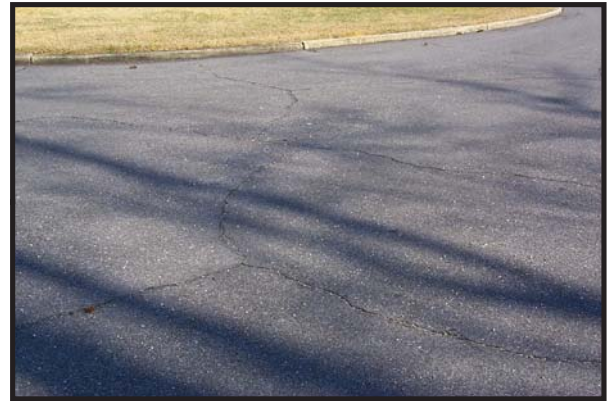
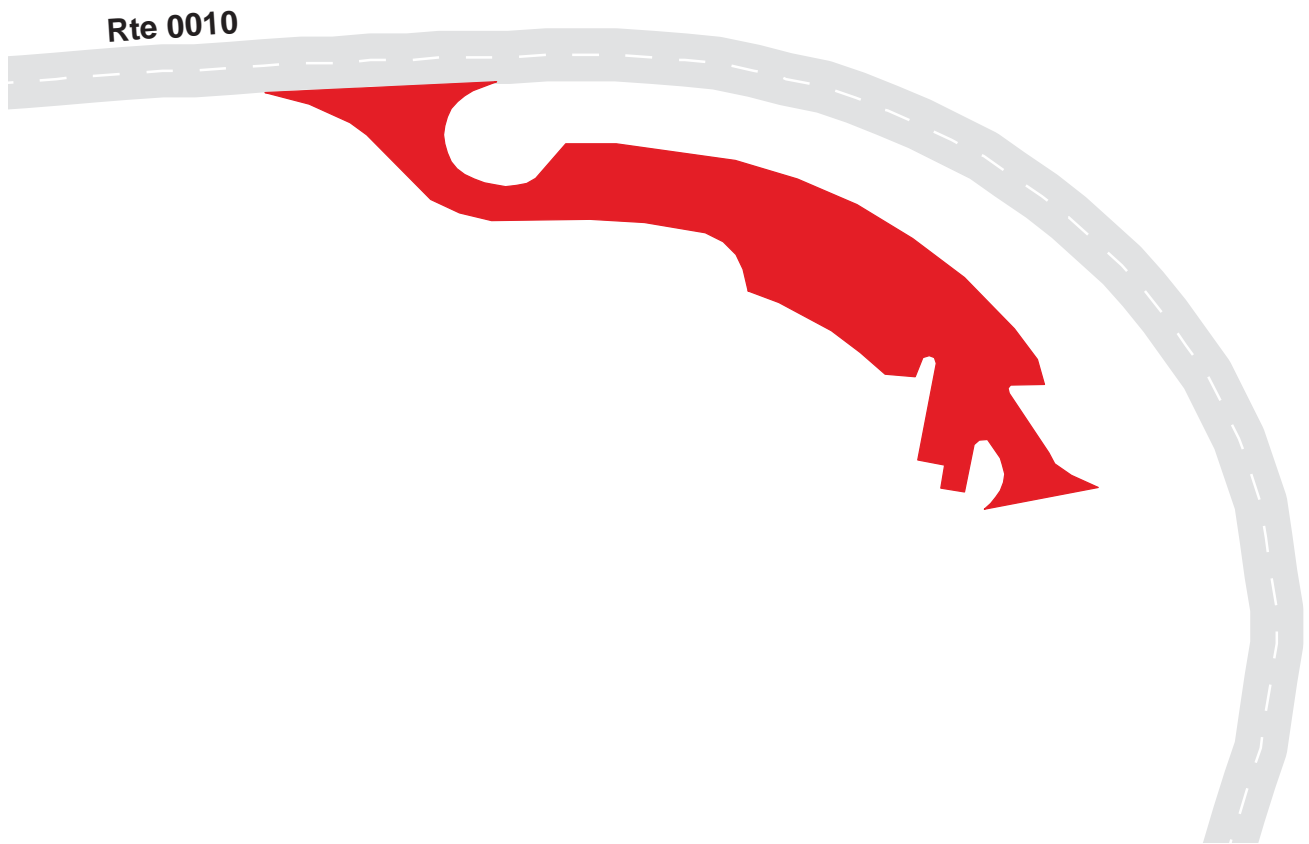
Route	Public / NonPublic	Date Visited	Area (sq ft)	Lane Miles *	Surface Type	Condition / PCR
0900	Public	3/6/2002	16939	0.29	AS	FAIR / 73

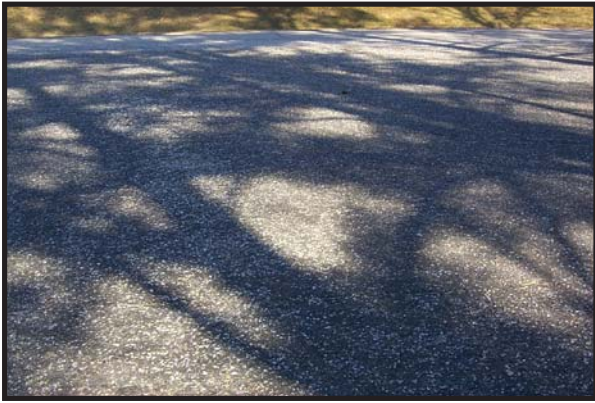
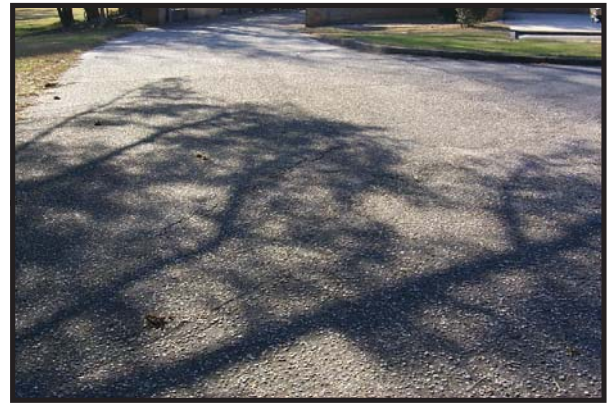
Route 0901

Route	Public / NonPublic	Date Visited	Area (sq ft)	Lane Miles *	Surface Type	Condition / PCR
0901	NonPublic	3/6/2002	7293	0.13	NC	FAIR / 73

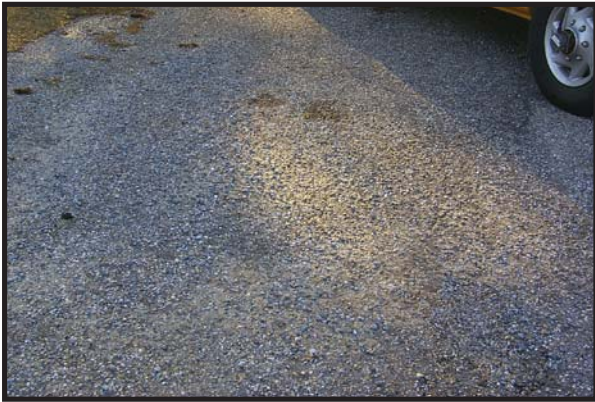
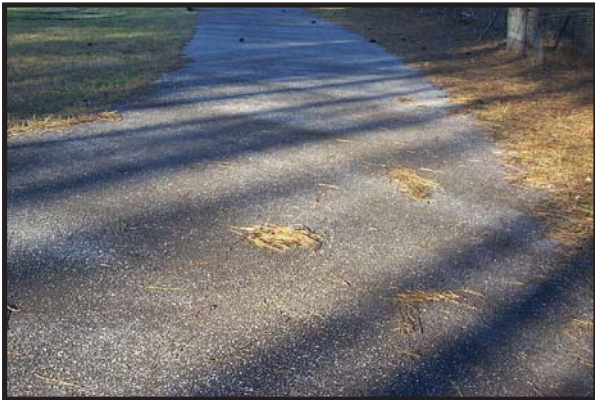
Route 0902

Route	Public / NonPublic	Date Visited	Area (sq ft)	Lane Miles *	Surface Type	Condition / PCR
0902	NonPublic	3/6/2002	9874	0.17	AS	POOR / 45

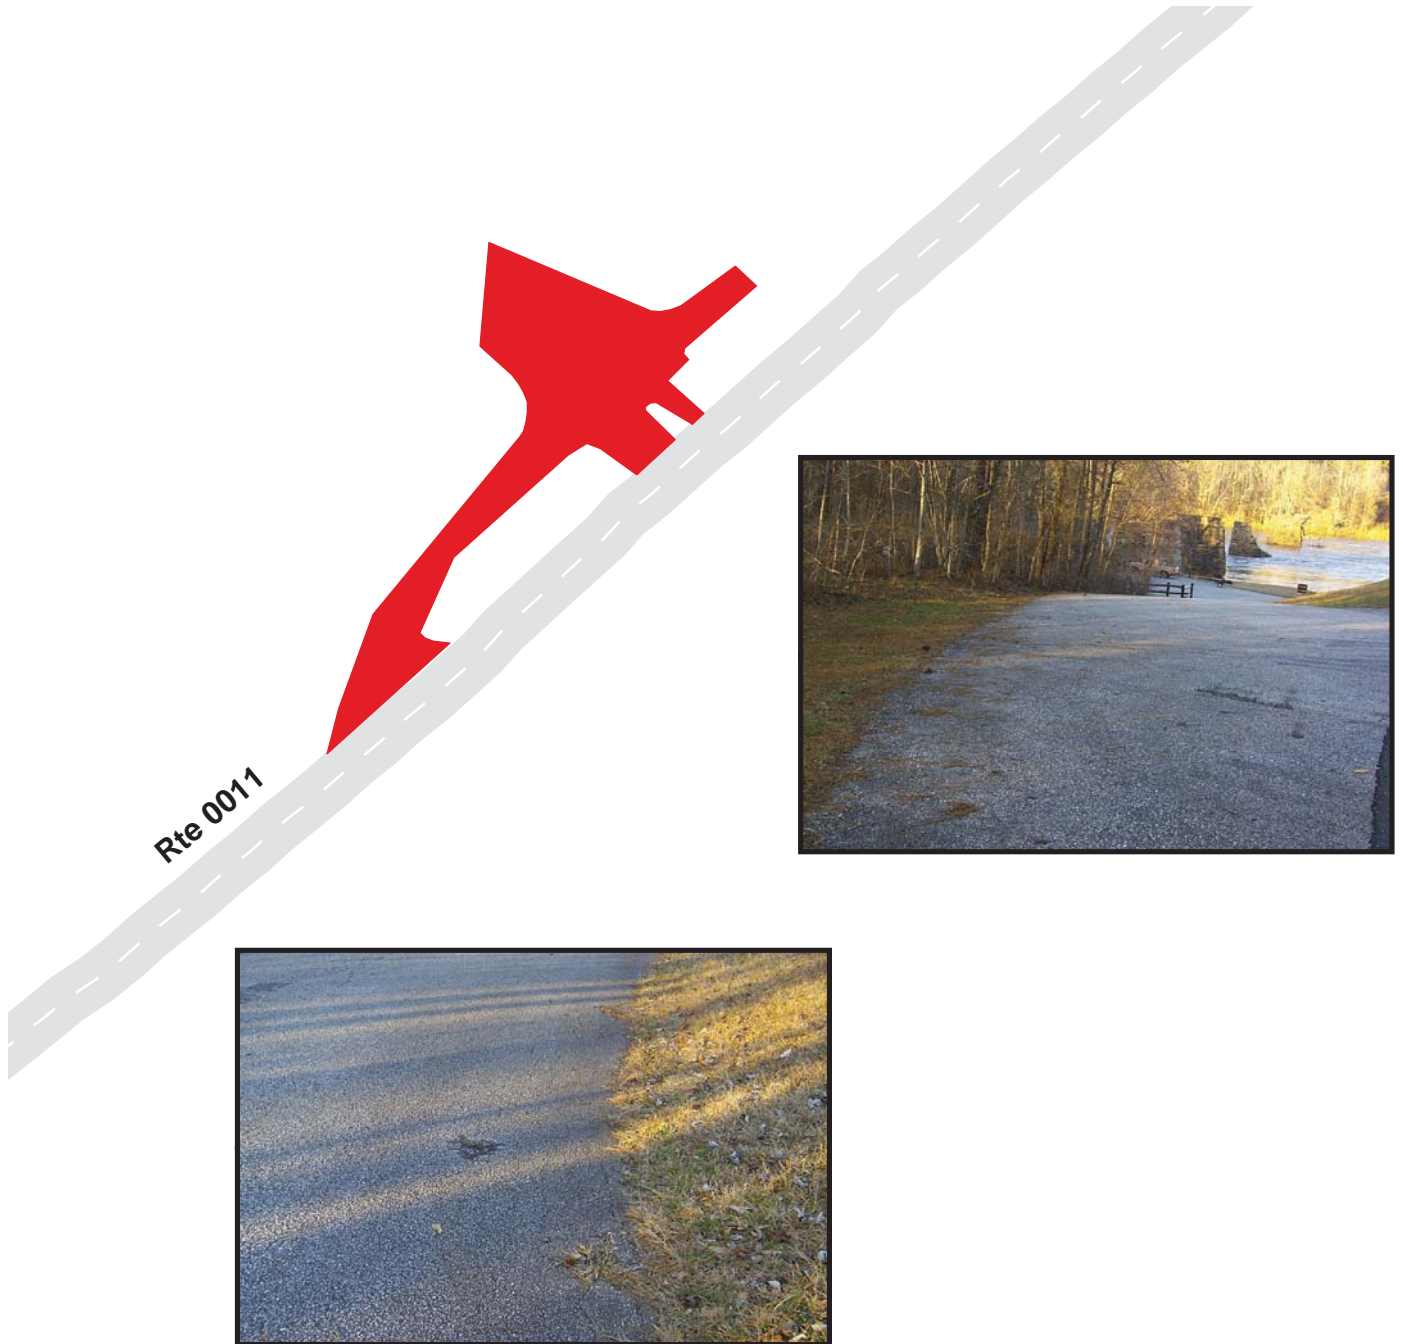
Route 0903

Route	Public / NonPublic	Date Visited	Area (sq ft)	Lane Miles *	Surface Type	Condition / PCR
0903	Public	3/6/2002	11647	0.20	AS	GOOD / 90

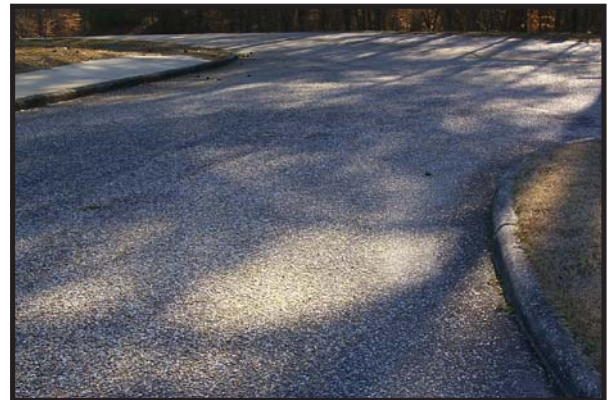
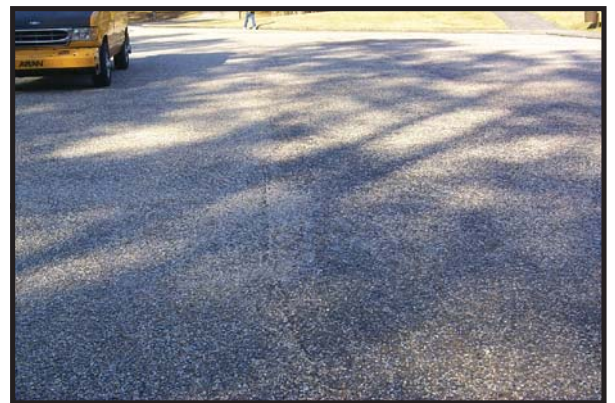
Route 0904

Route	Public / NonPublic	Date Visited	Area (sq ft)	Lane Miles *	Surface Type	Condition / PCR
0904	Public	3/6/2002	8589	0.15	NC	GOOD / 90

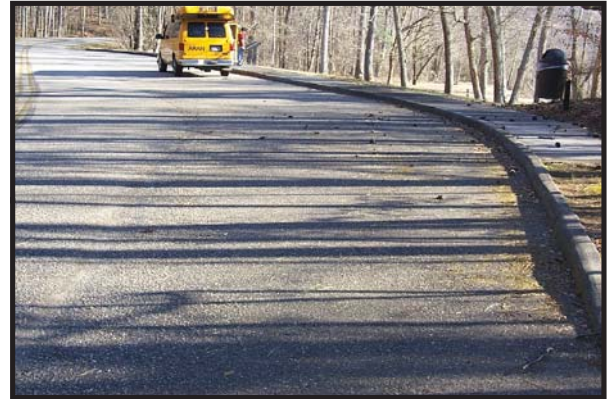
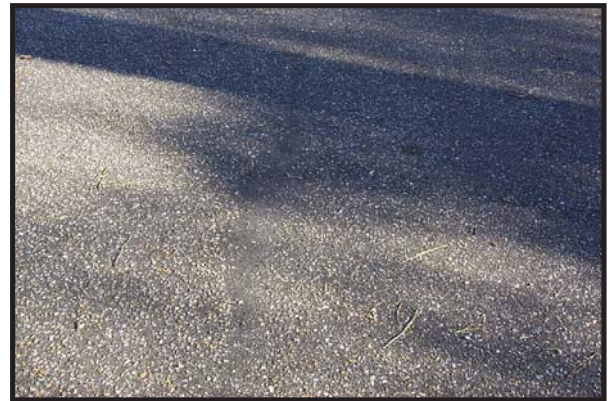
Route 0905

Route	Public / NonPublic	Date Visited	Area (sq ft)	Lane Miles *	Surface Type	Condition / PCR
0905	Public	3/6/2002	3487	0.06	NC	GOOD / 90

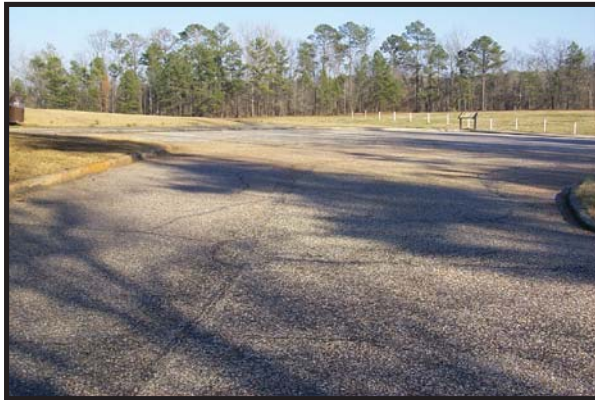
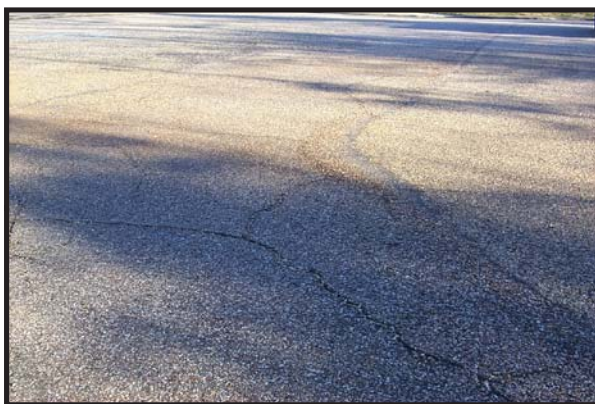
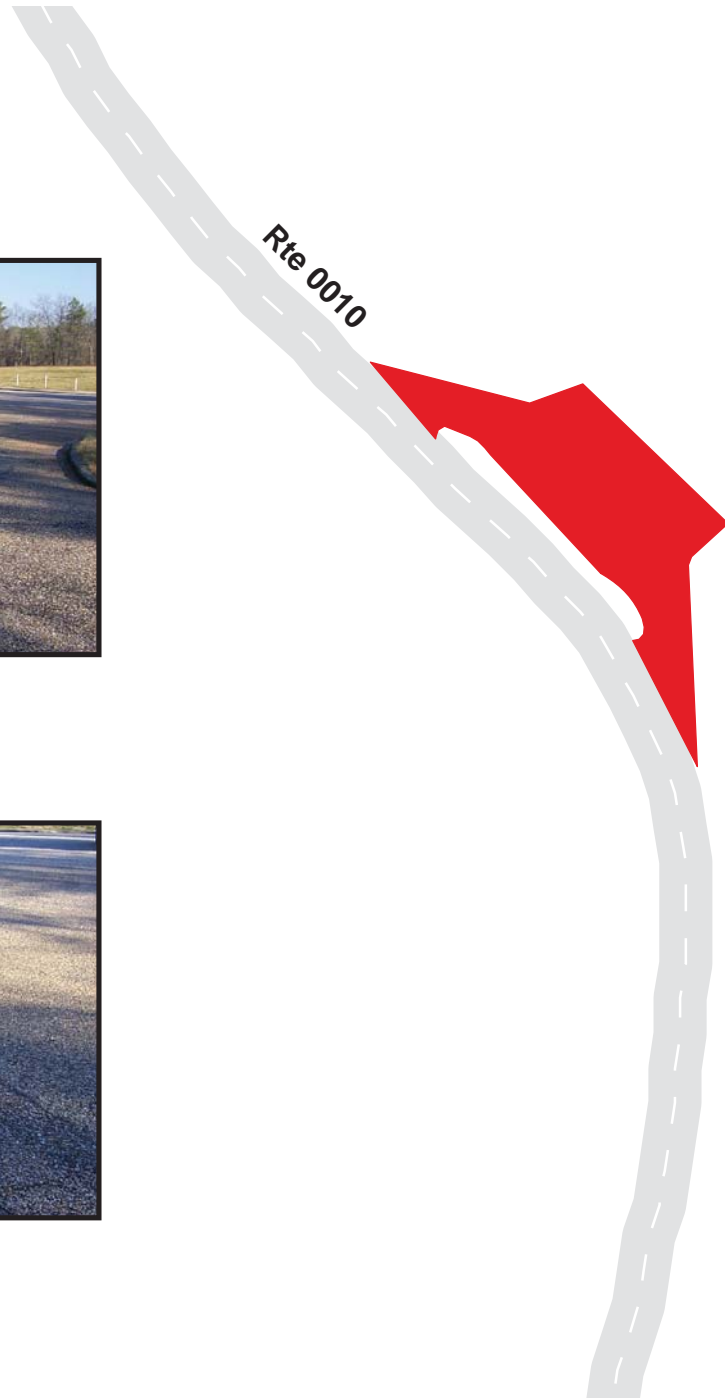
Route 0906

Route	Public / NonPublic	Date Visited	Area (sq ft)	Lane Miles *	Surface Type	Condition / PCR
0906	Public	3/6/2002	9044	0.16	NC	FAIR / 73

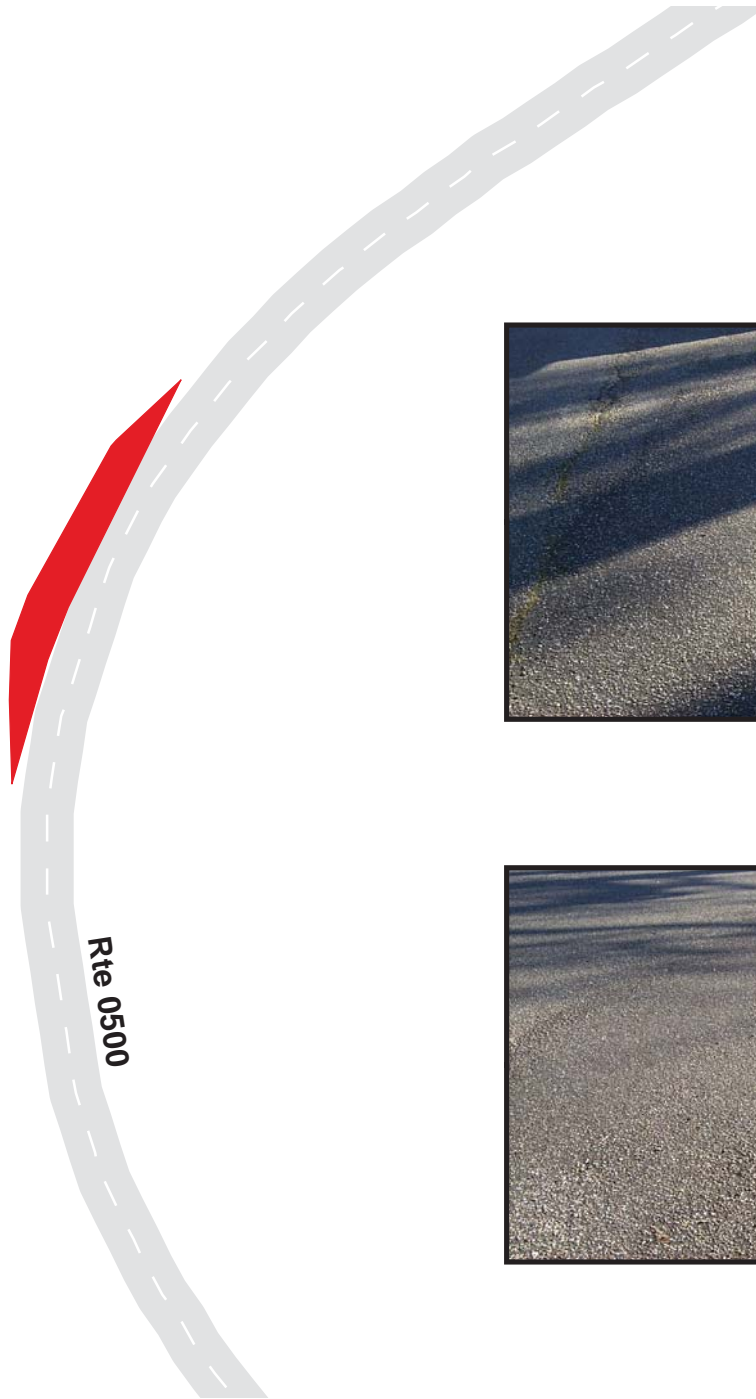
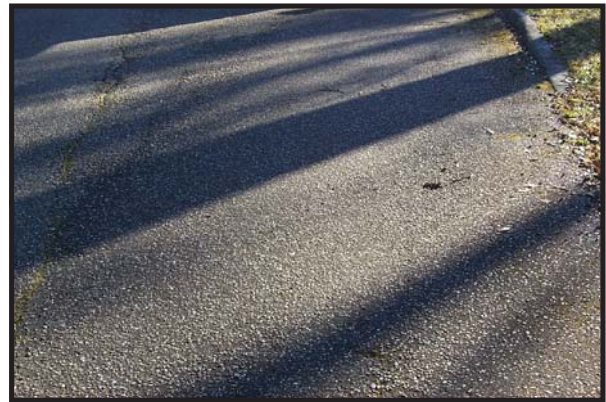
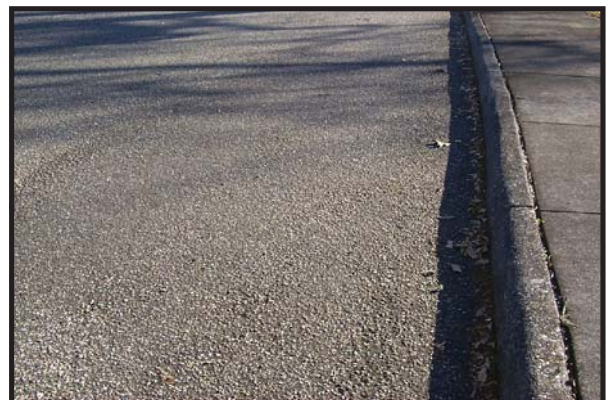
Route 0907

Route	Public / NonPublic	Date Visited	Area (sq ft)	Lane Miles *	Surface Type	Condition / PCR
0907	Public	3/6/2002	3584	0.06	NC	FAIR / 73

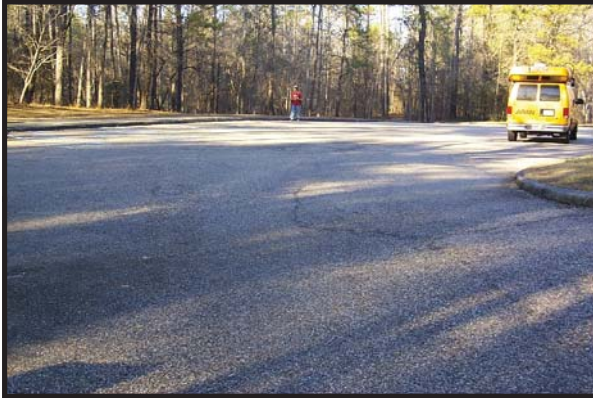
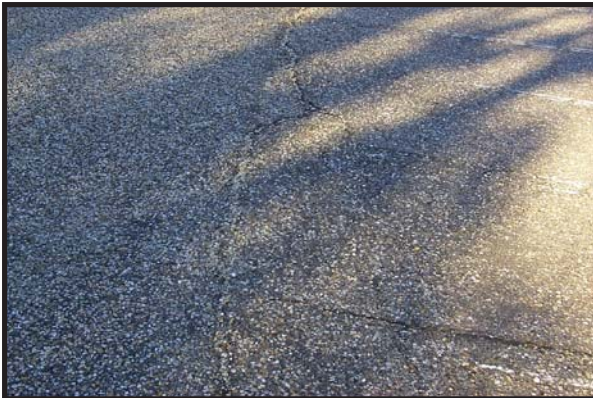
Route 0908

Route	Public / NonPublic	Date Visited	Area (sq ft)	Lane Miles *	Surface Type	Condition / PCR
0908	Public	3/6/2002	8779	0.15	NC	FAIR / 73

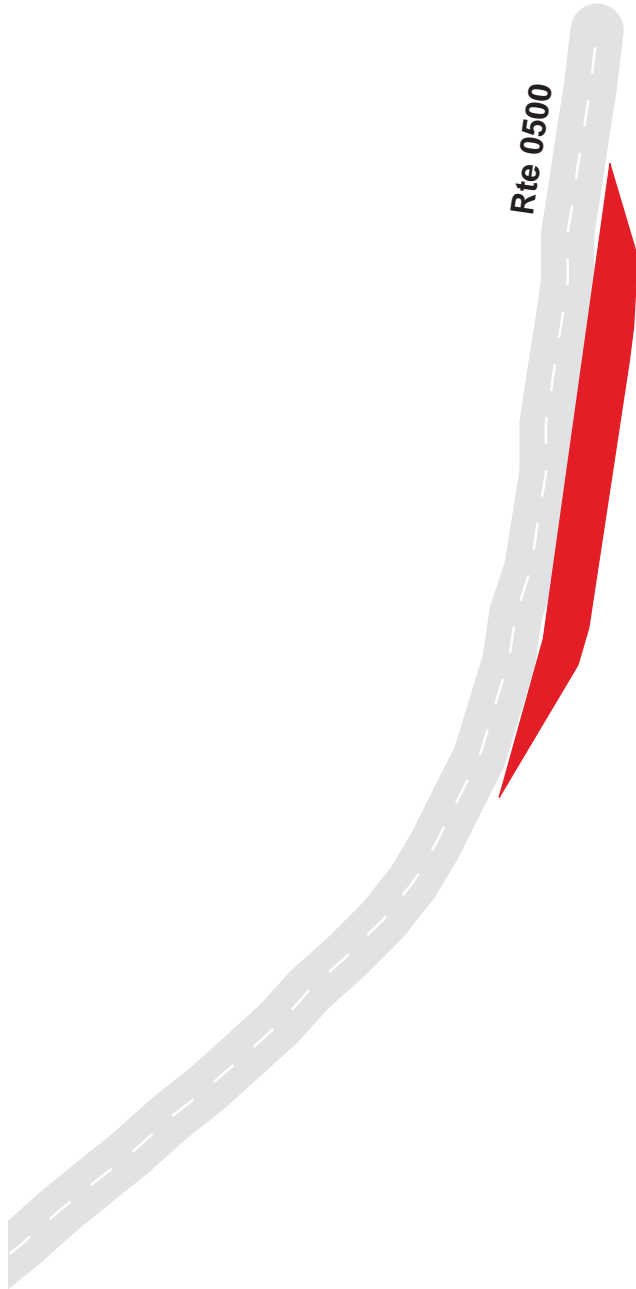
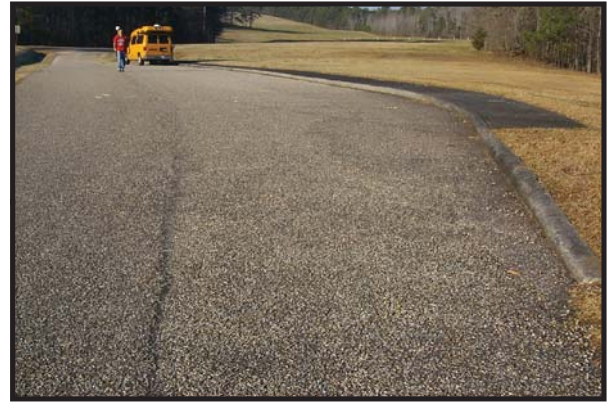
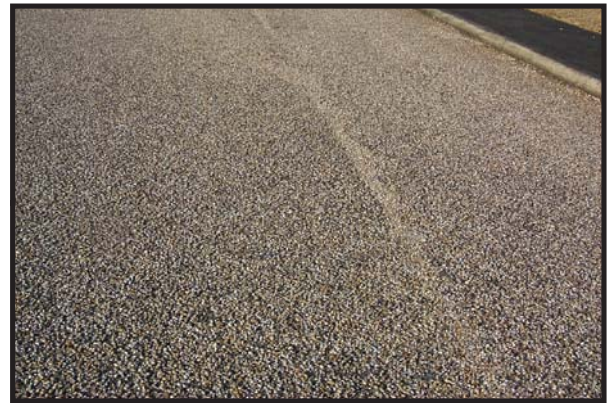
Route 0909

Route	Public / NonPublic	Date Visited	Area (sq ft)	Lane Miles *	Surface Type	Condition / PCR
0909	Public	3/6/2002	2726	0.05	NC	GOOD / 90
