**The Road Inventory  
of  
Hopewell Culture National Historical Park  
HOCU – 6514**

**Road Inventory Program**

Prepared By:  
Federal Highway Administration  
Eastern Federal Lands Highway Division  
Cycle 3

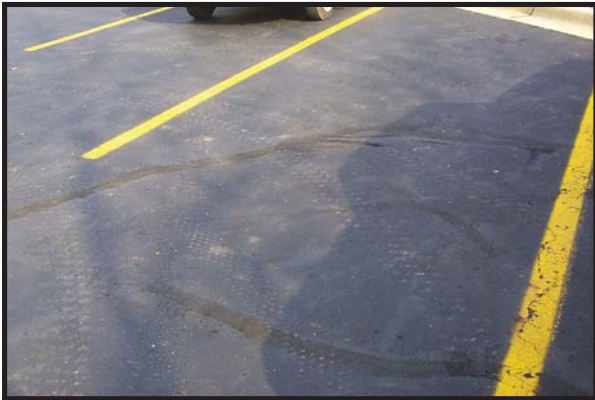
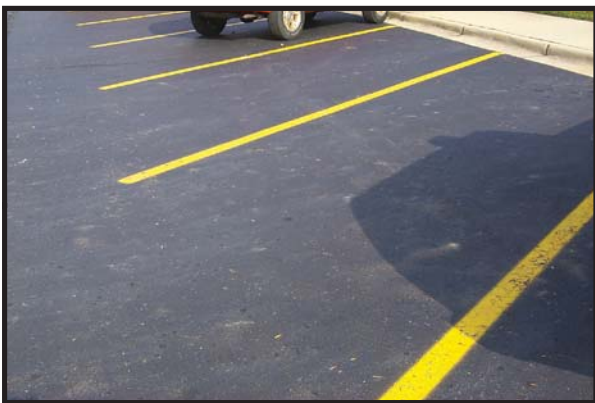
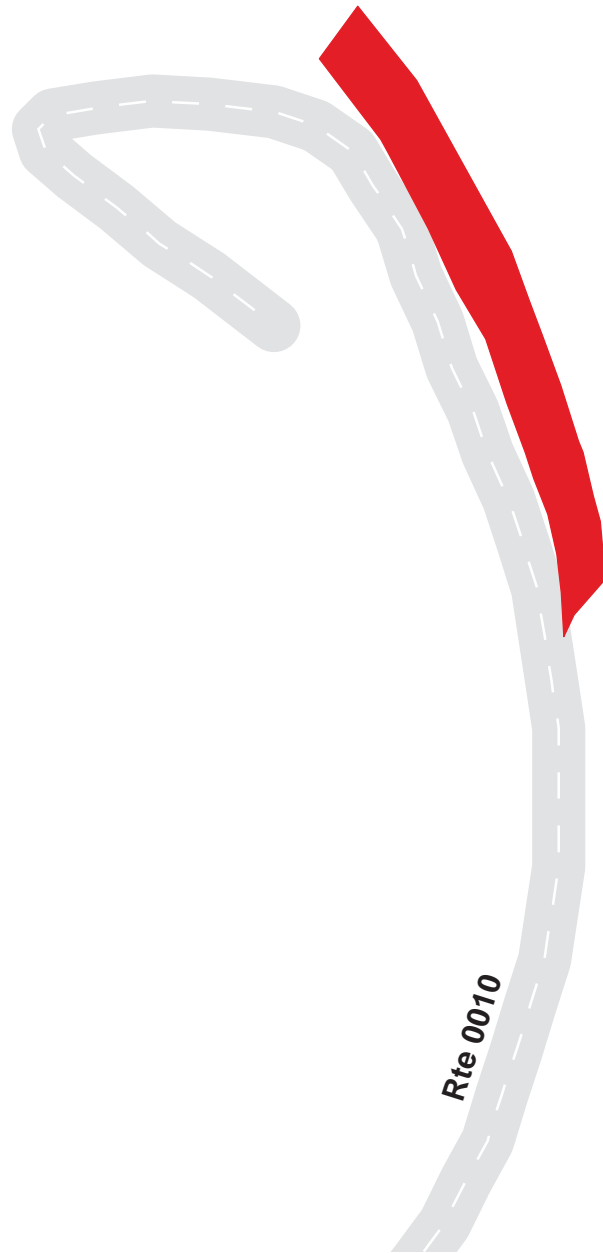
## Route 0900

Route	Public / NonPublic	Date Visited	Area (sq ft)	Lane Miles *	Surface Type	Condition / PCR
0900	Public	11/12/2002	4274	0.07	AS	GOOD / 90

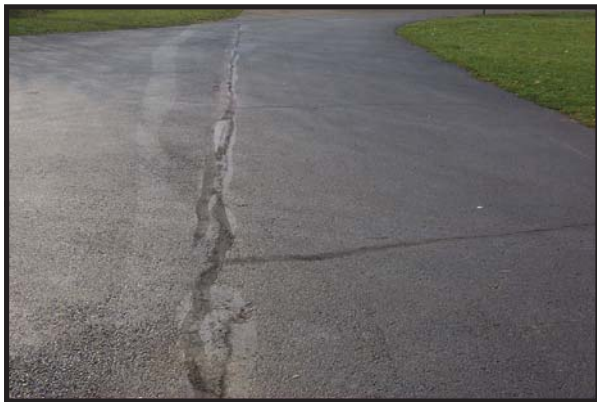
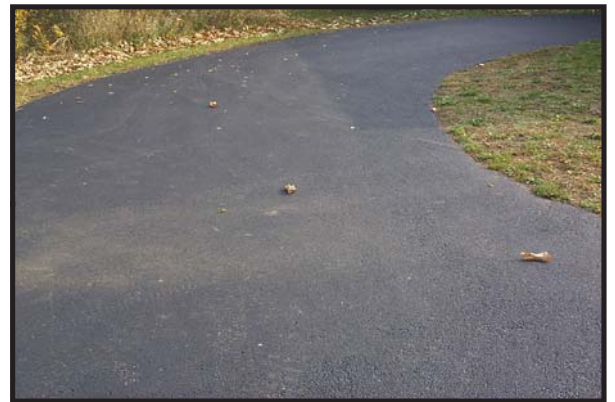
## Route 0901

Route	Public / NonPublic	Date Visited	Area (sq ft)	Lane Miles *	Surface Type	Condition / PCR
0901	NonPublic	11/12/2002	15725	0.27	AS	GOOD / 90

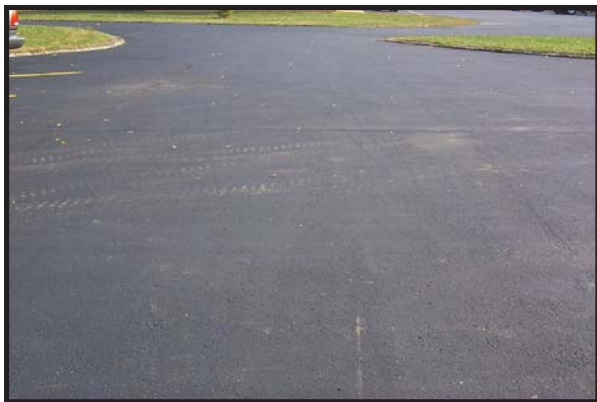
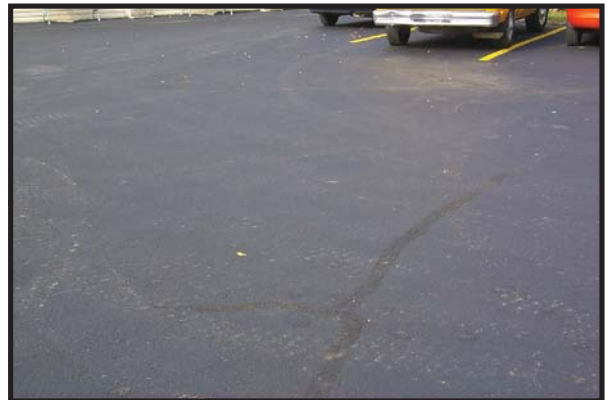
## Route 0902

Route	Public / NonPublic	Date Visited	Area (sq ft)	Lane Miles *	Surface Type	Condition / PCR
0902	NonPublic	11/12/2002	4795	0.08	AS	GOOD / 90

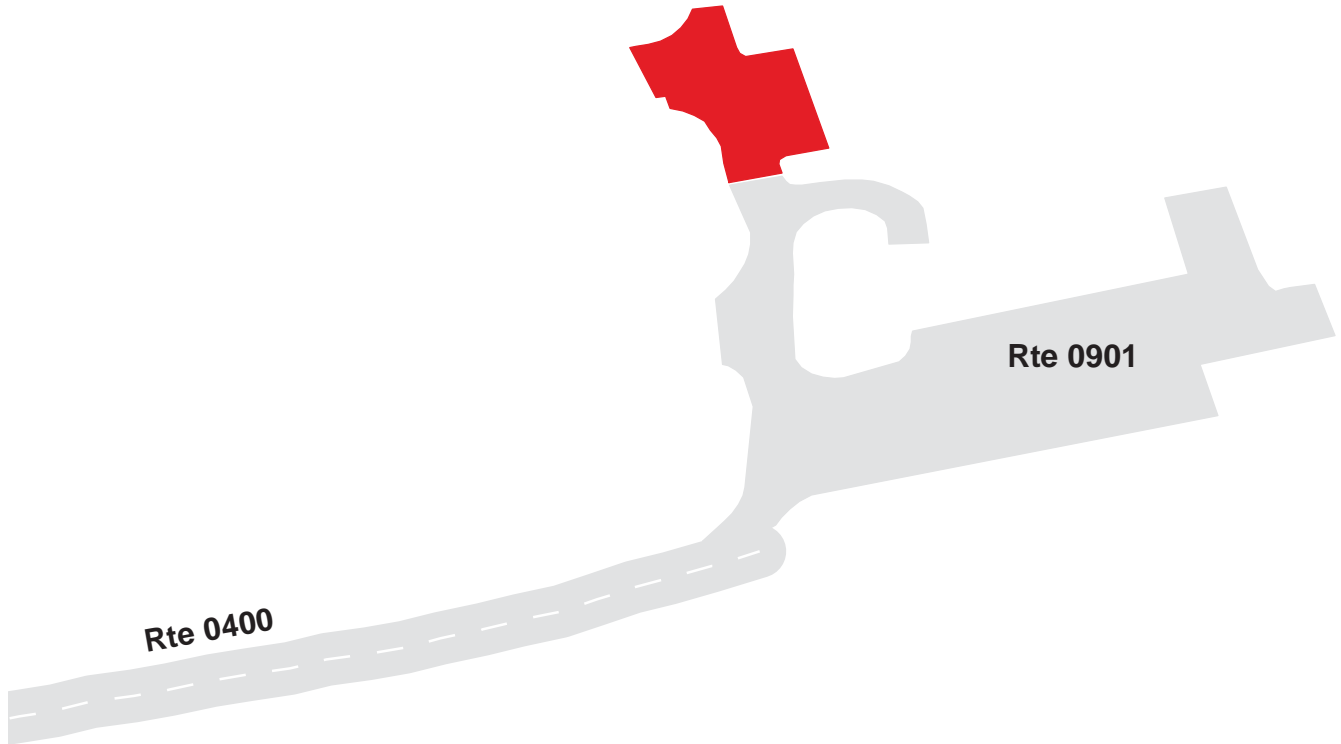
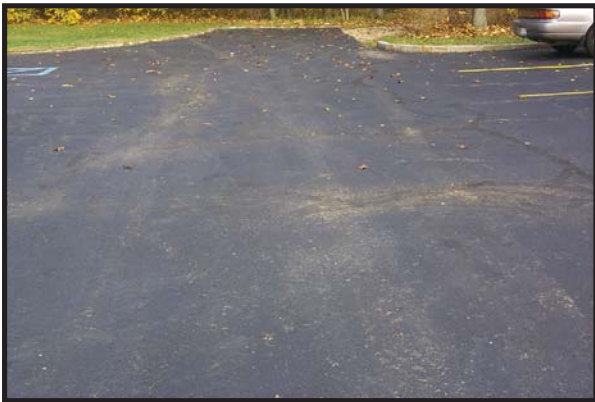
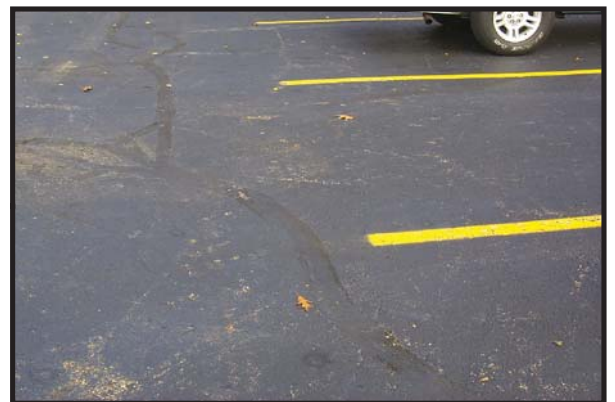
## Route 0903

Route	Public / NonPublic	Date Visited	Area (sq ft)	Lane Miles *	Surface Type	Condition / PCR
0903	NonPublic	11/12/2002	2946	0.05	AS	FAIR / 73

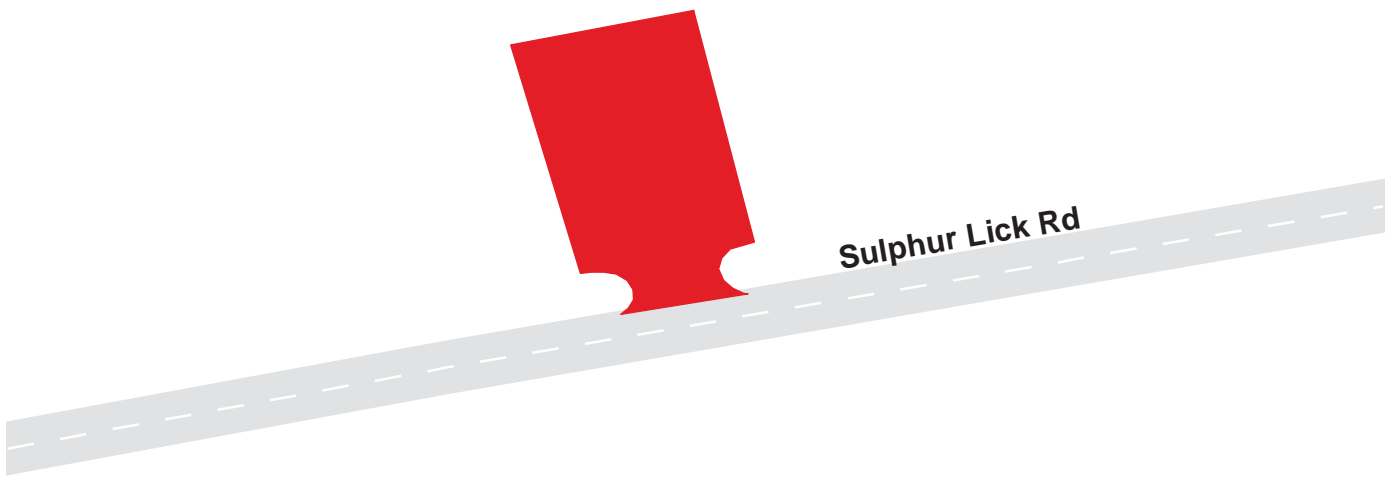
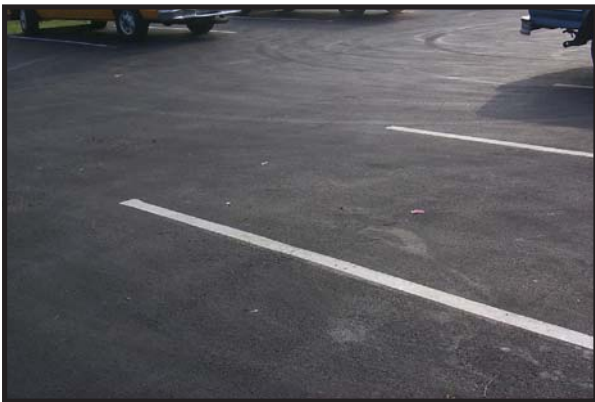
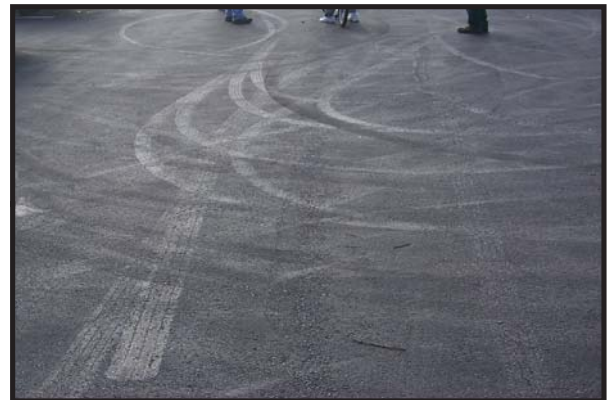
## Route 0905

Route	Public / NonPublic	Date Visited	Area (sq ft)	Lane Miles *	Surface Type	Condition / PCR
0905	Public	11/12/2002	6787	0.12	AS	GOOD / 90
