**The Road Inventory
of
Home of Franklin D. Roosevelt
National Historic Site
HOFR - 1795**

Road Inventory Program

Prepared By:
Federal Highway Administration
Eastern Federal Lands Highway Division
Cycle 3

Home of Franklin D Roosevelt National in New York

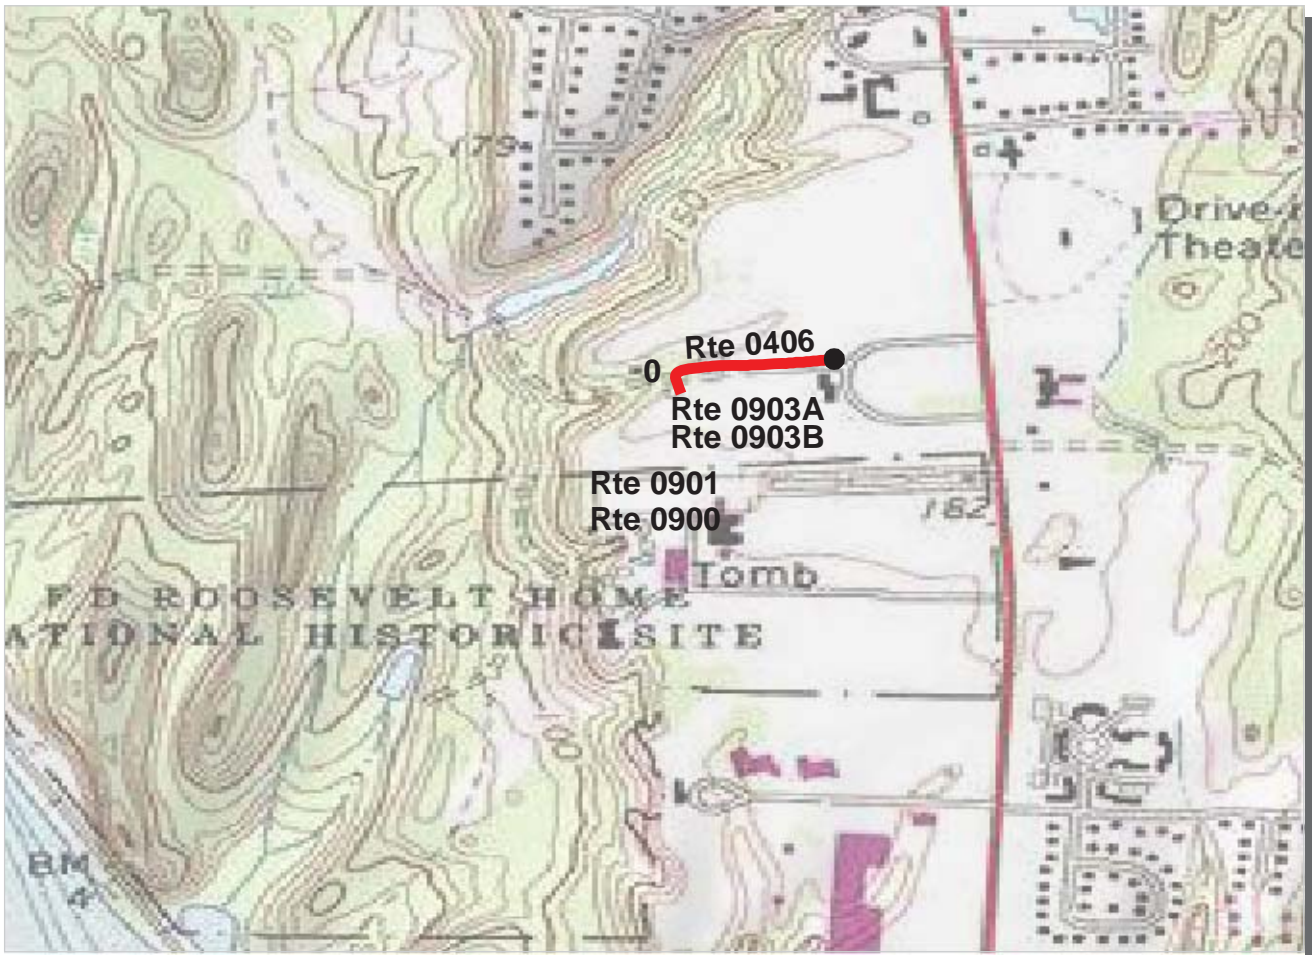
ROUTE: 0406 BELLEFIELD MANSION REAR SERVICE DRIVE TOTAL LENGTH: 0.15 Miles

Section Number	0				
Section Length (mi)	0.15				
AADT	**				
SADT	**				
ADT Date	**				
Cross Section Information					
Number of Lanes	1				
Paved Width (ft)	14				
Lane Width (ft)	14				
Shoulder Width (ft)	0				
Roadway Condition Information					
PCR (Pavement Condition Rating)	63				
RCI (Roughness Condition Index)	61				
SCR (Surface Condition Rating)	62				
Alligator Cracking Index	100				
Rutting Index	62				
Patching Index	99				
Transverse Cracking Index	100				
Longitudinal Cracking Index	100				
Shoulder Condition Rating	N/A				
Drainage Condition Rating	GOOD

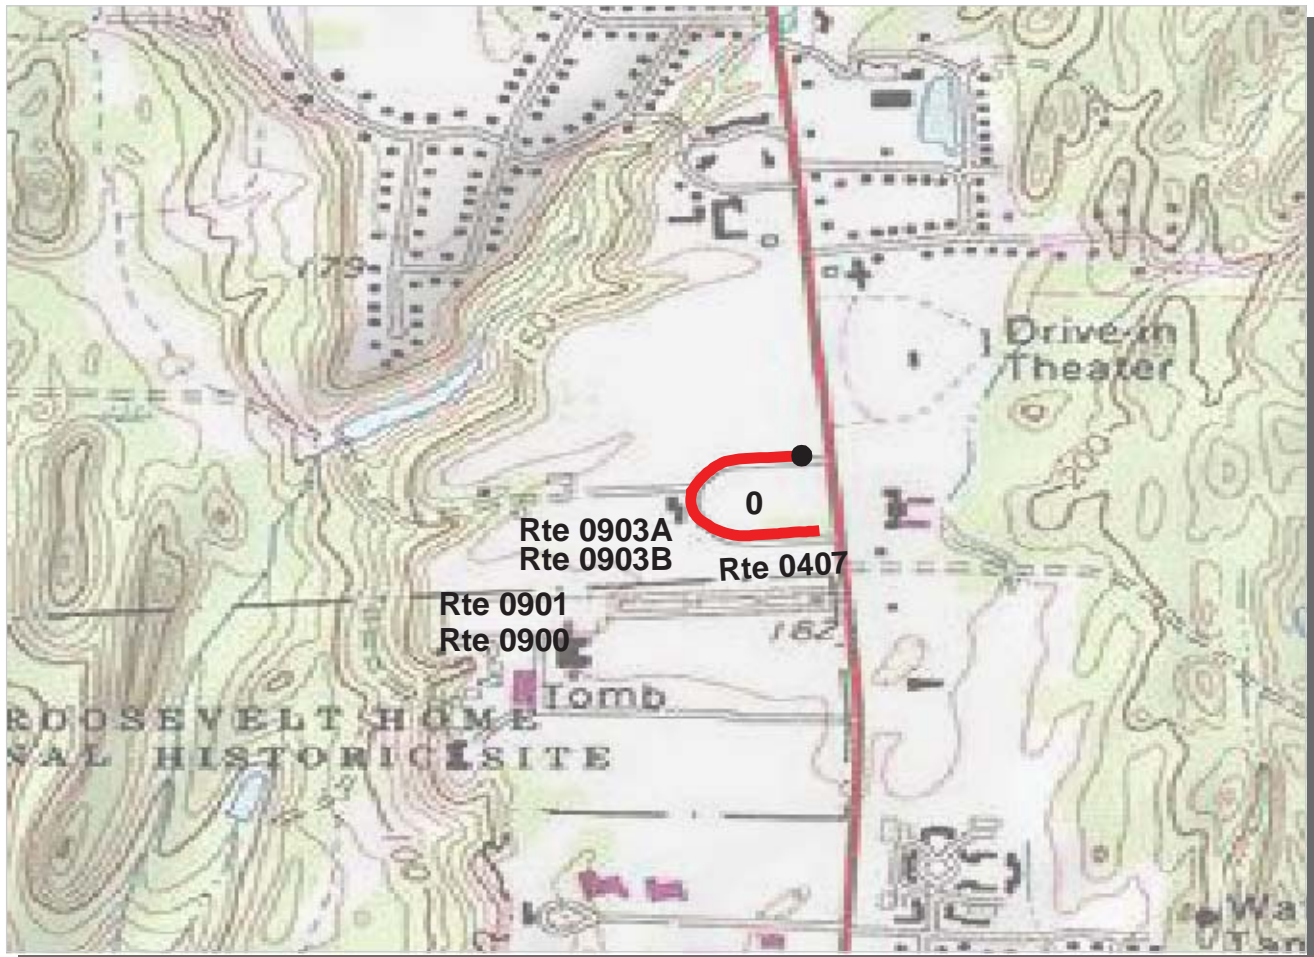
Section Number	0				
Section Length (mi)	0.24				
AADT	**				
SADT	**				
ADT Date	**				
Cross Section Information					
Number of Lanes	1				
Paved Width (ft)	9				
Lane Width (ft)	9				
Shoulder Width (ft)	0				
Roadway Condition Information					
PCR (Pavement Condition Rating)	42				
RCI (Roughness Condition Index)	38				
SCR (Surface Condition Rating)	41				
Alligator Cracking Index	100				
Rutting Index	41				
Patching Index	100				
Transverse Cracking Index	100				
Longitudinal Cracking Index	100				
Shoulder Condition Rating	N/A				
Drainage Condition Rating	GOOD

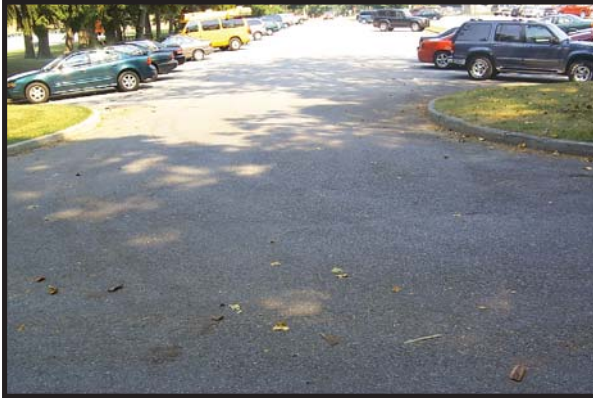
Route	Public / NonPublic	Date Visited	Area (sq ft)	Lane Miles *	Surface Type	Condition / PCR
0900	PUBLIC	8/12/2002	87731	1.51	AS	GOOD / 90

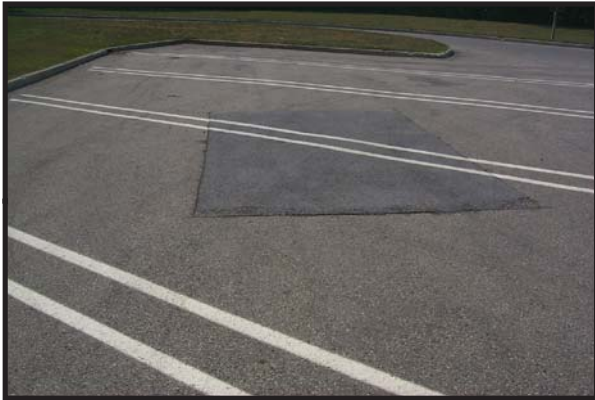
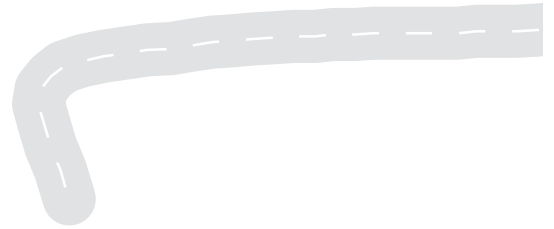
Route 0901

Route	Public / NonPublic	Date Visited	Area (sq ft)	Lane Miles *	Surface Type	Condition / PCR
0901	PUBLIC	8/12/2002	31534	0.54	AS	GOOD / 90

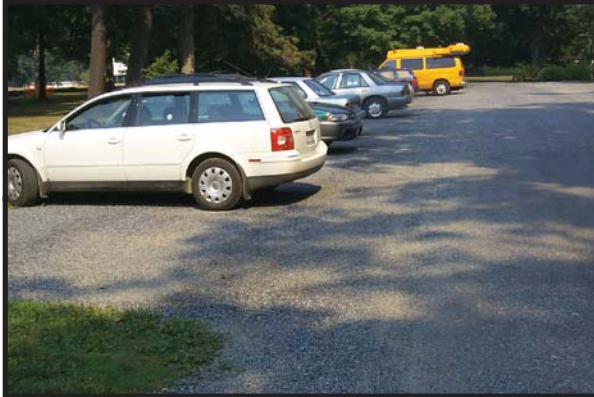
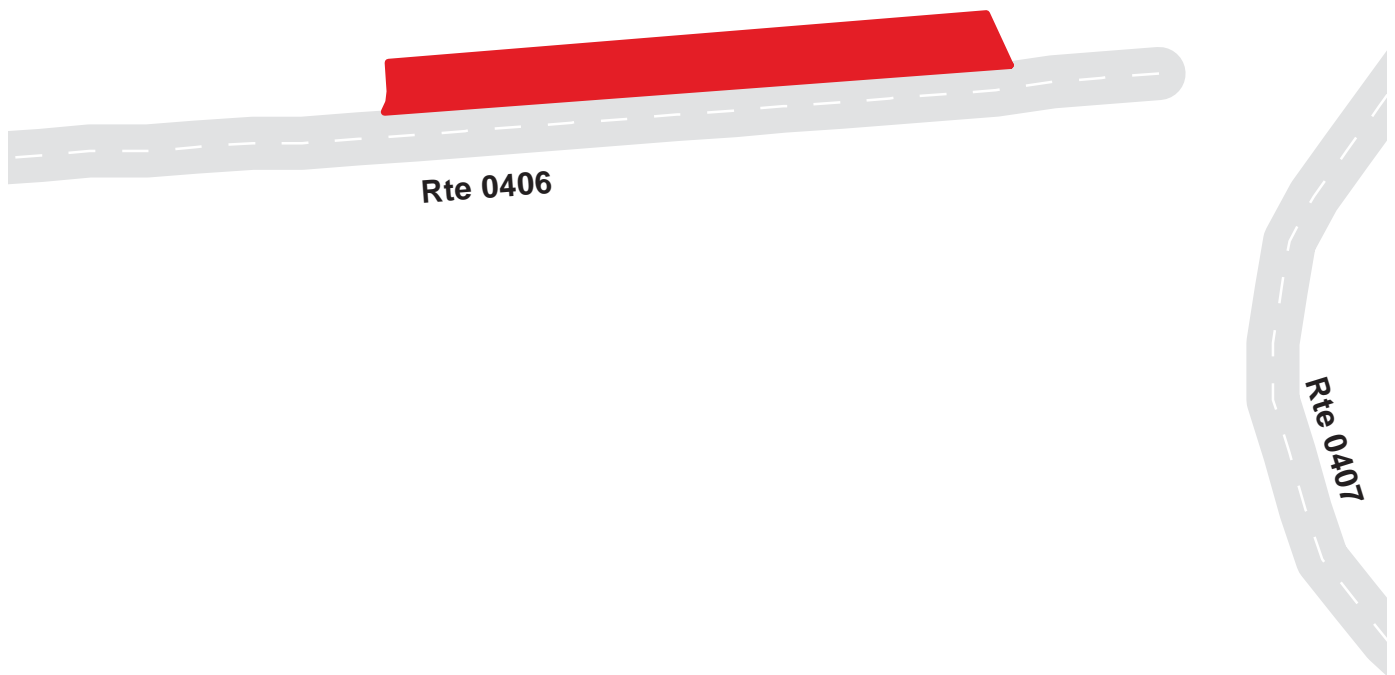
Route 0903A EMPLOYEE PARKING A FROM ROUTE 0406

Route	Public / NonPublic	Date Visited	Area (sq ft)	Lane Miles *	Surface Type	Condition / PCR
0903A	NONPUBLIC	8/12/2002	2667	0.05	NC	GOOD / 90

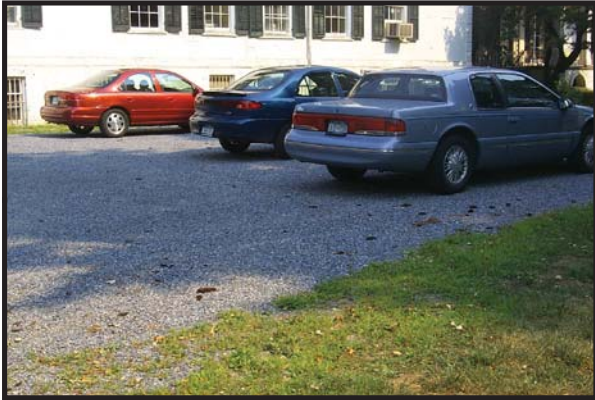
Route 0903B EMPLOYEE PARKING B FROM ROUTE 0406

Route	Public / NonPublic	Date Visited	Area (sq ft)	Lane Miles *	Surface Type	Condition / PCR
0903B	NONPUBLIC	8/12/2002	1066	0.02	NC	GOOD / 90
