# The Road Inventory of Hopewell Furnace National Historic Site HOFU - 4430

Prepared By:  
Federal Highway Administration  
Eastern Federal Lands Highway Division  
Cycle 3

# Hopewell Furnace National Historic Site in Pennsylvania

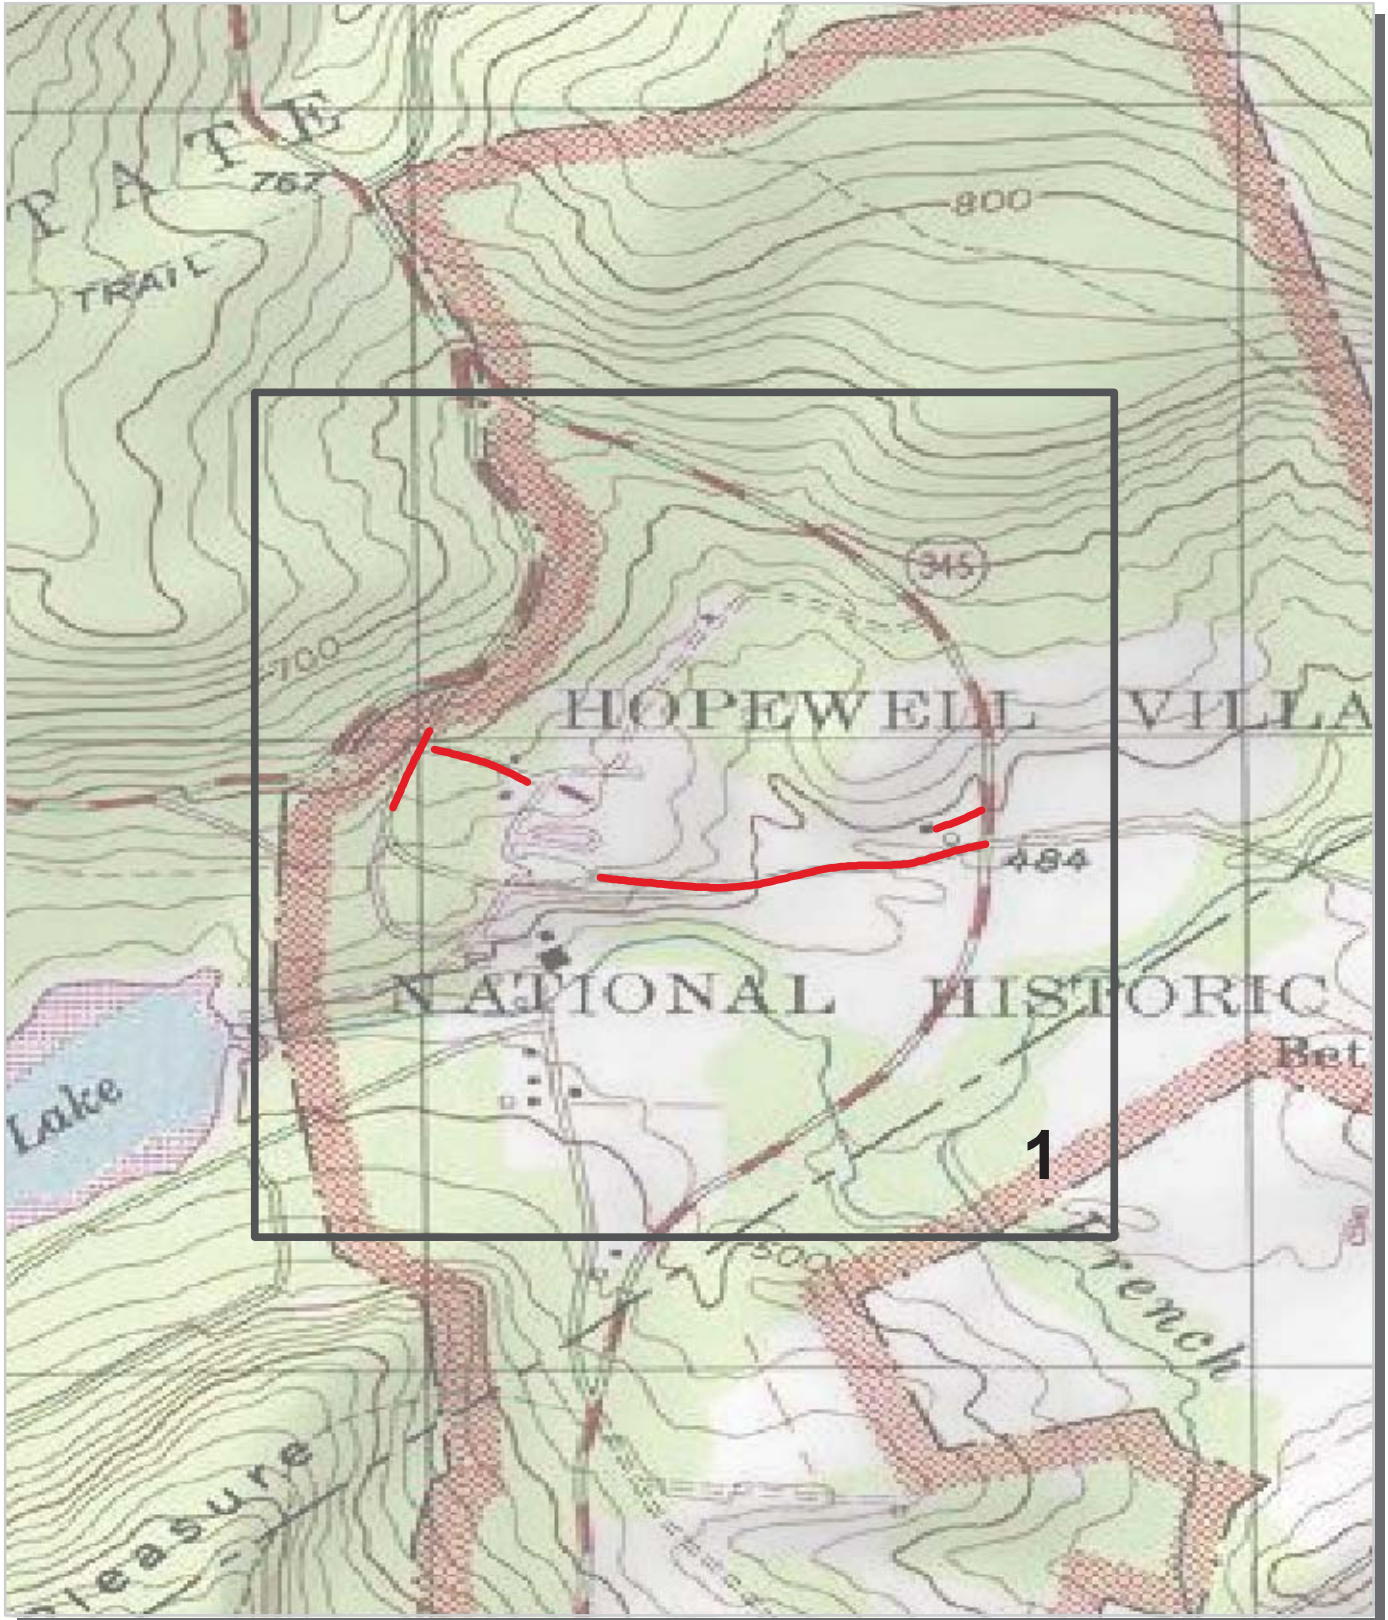
# Hopewell Furnace National Historic Site Route Location Key Map

Park Owned Routes

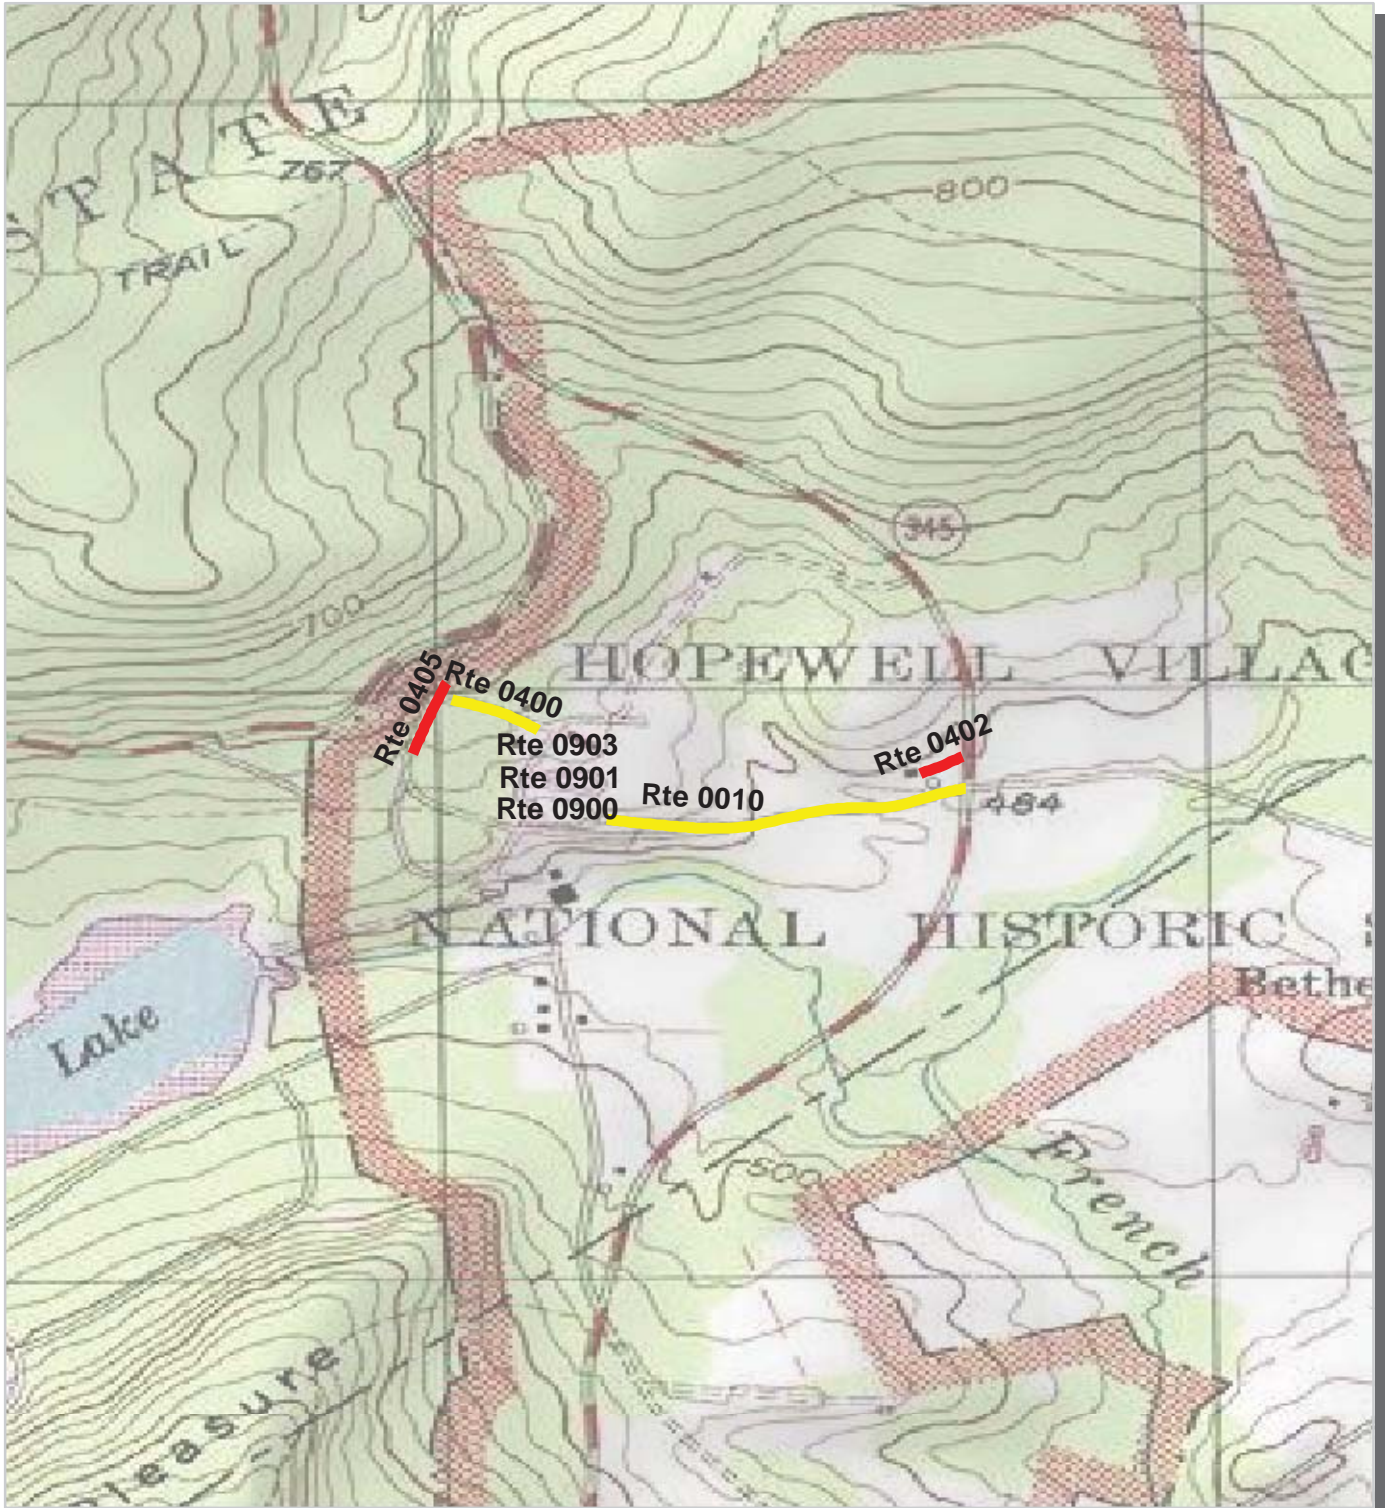
## Route Condition Key Map

### PCR - Mile by Mile

| PCR | Poor | | Fair | | Good | | Excellent | |
| | | ( $\leq 60$ ) | | (61 - 84) | | (85 - 94) | | (95 - 100) |

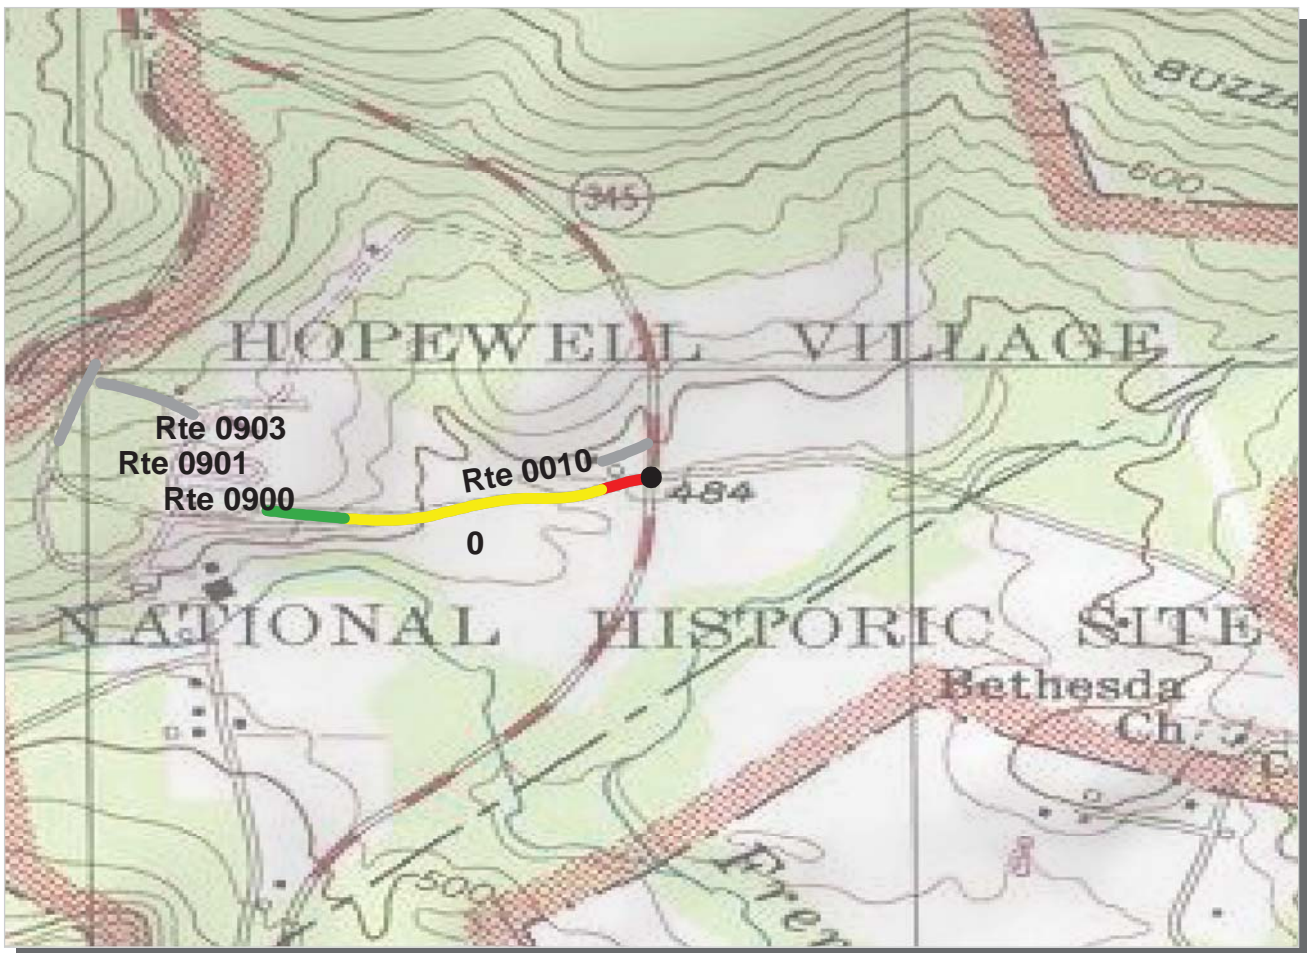
**ROUTE: 0010 Visitor Center Access Road**

| PCR (Pavement Condition Rating) | 74 | | | |
| SCR (Surface Condition Rating) | 72 | | | |
| Drainage Condition Rating | GOOD | | | |

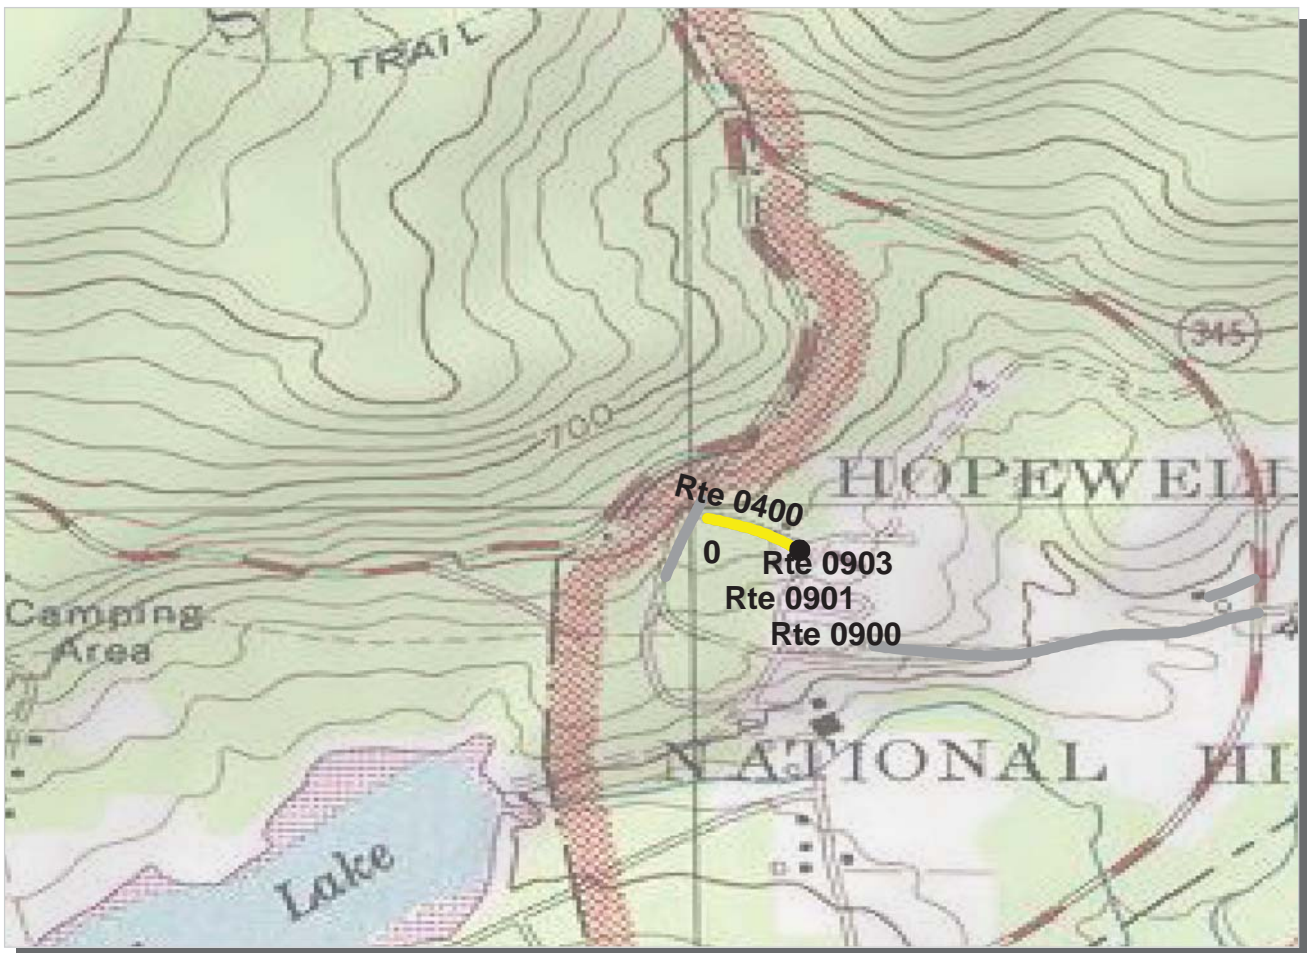
**ROUTE: 0400 Ranger Residence Access Road**

| PCR (Pavement Condition Rating) | 64 | | | | |
| SCR (Surface Condition Rating) | 64 | | | | |
| Drainage Condition Rating | POOR | | | | |

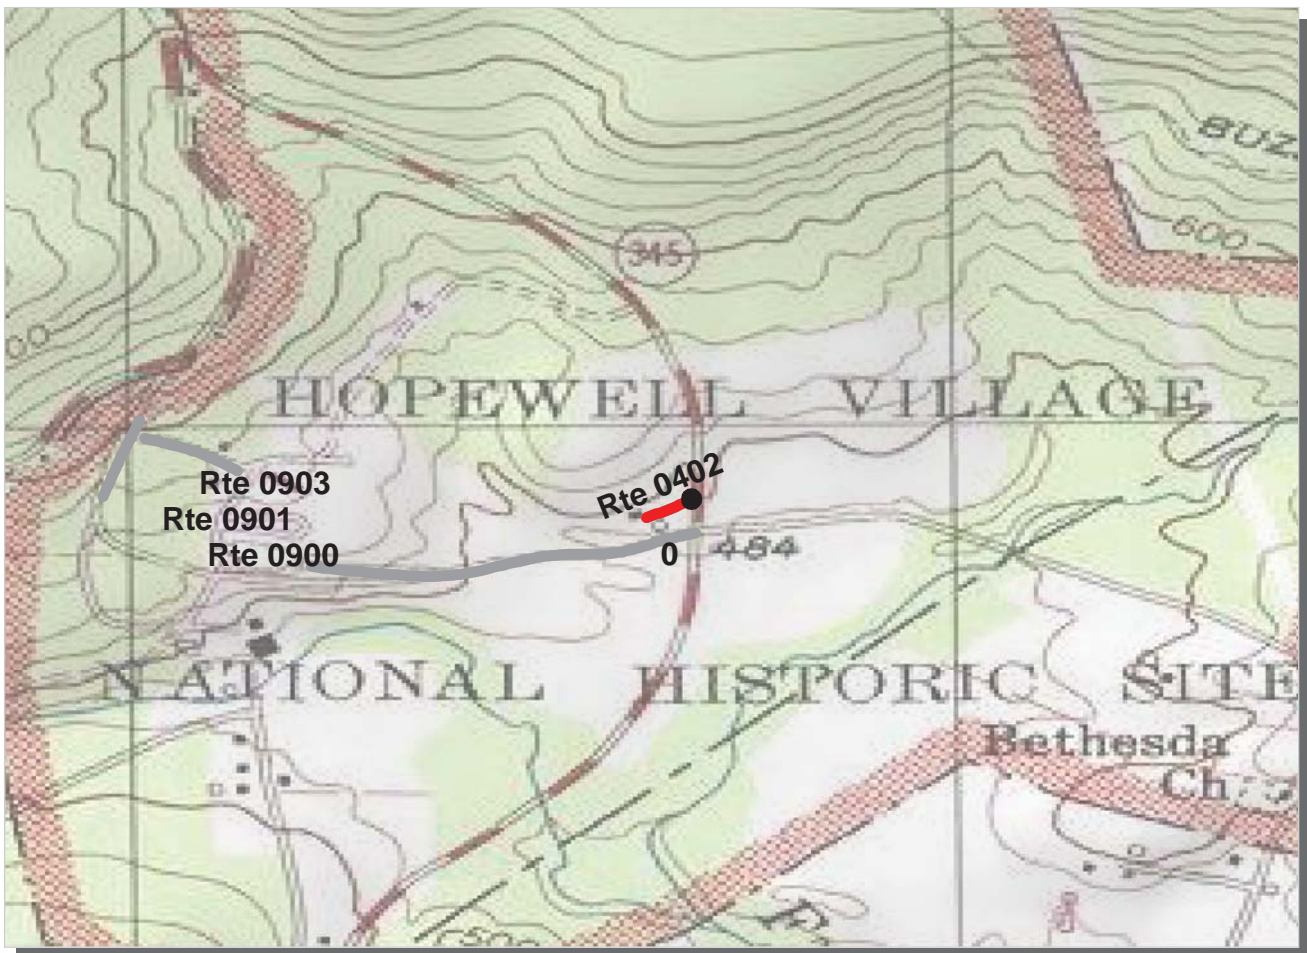
**ROUTE: 0402 Church House Access Road** **TOTAL LENGTH: 0.06 Miles**

| PCR (Pavement Condition Rating) | 23 | | | | |
| SCR (Surface Condition Rating) | 23 | | | | |
| Alligator Cracking Index | 84 | | | | |
| Drainage Condition Rating | GOOD | | | | |

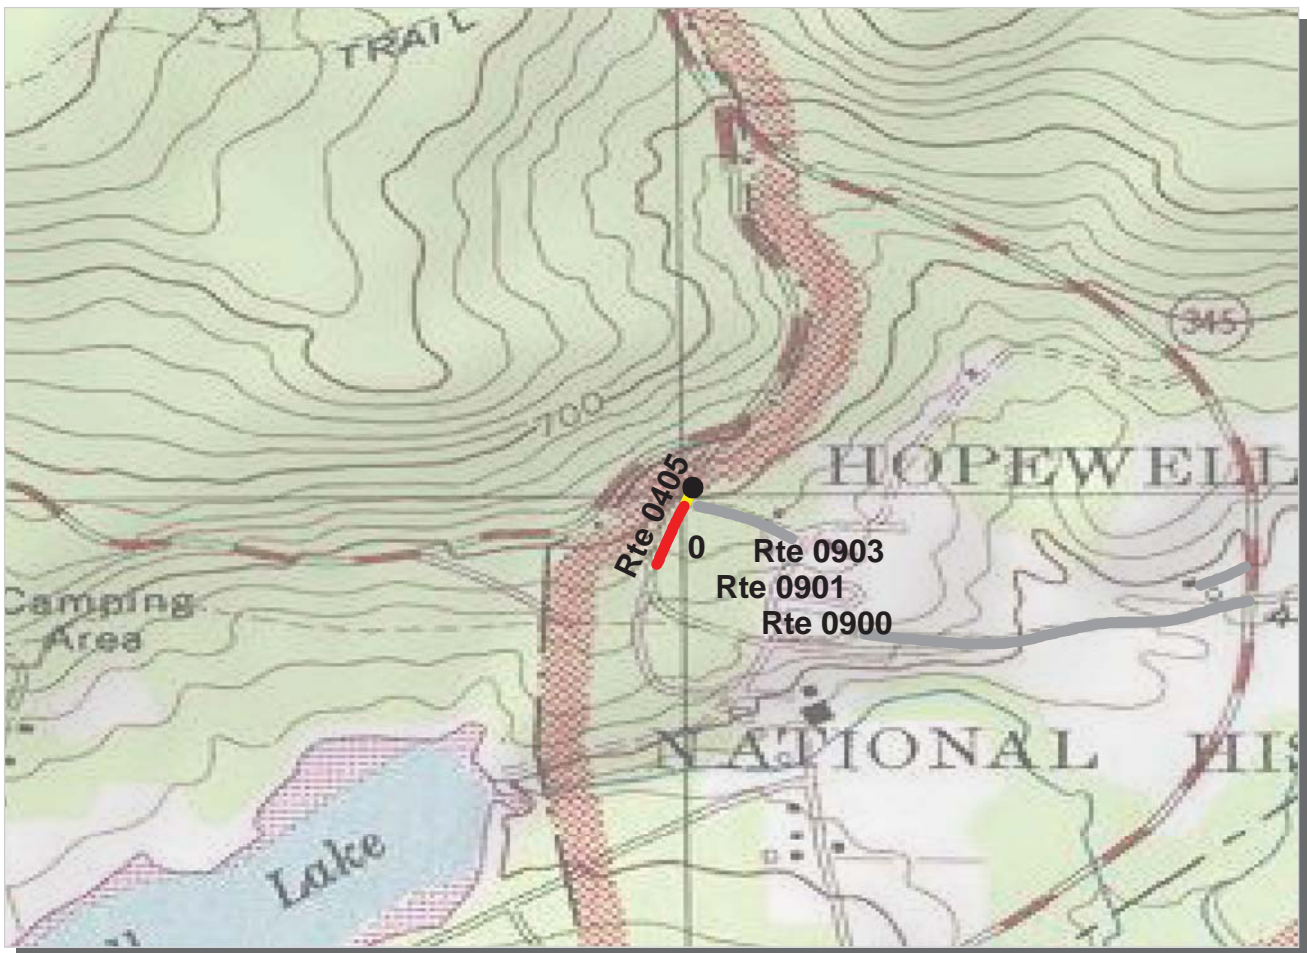
**ROUTE: 0405 Village Road** **TOTAL LENGTH: 0.09 Miles**

| PCR (Pavement Condition Rating) | 35 | | | | |
| SCR (Surface Condition Rating) | 35 | | | | |
| Drainage Condition Rating | POOR | | | | |

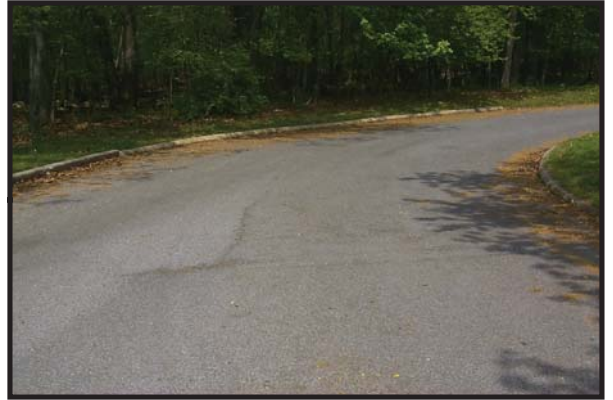
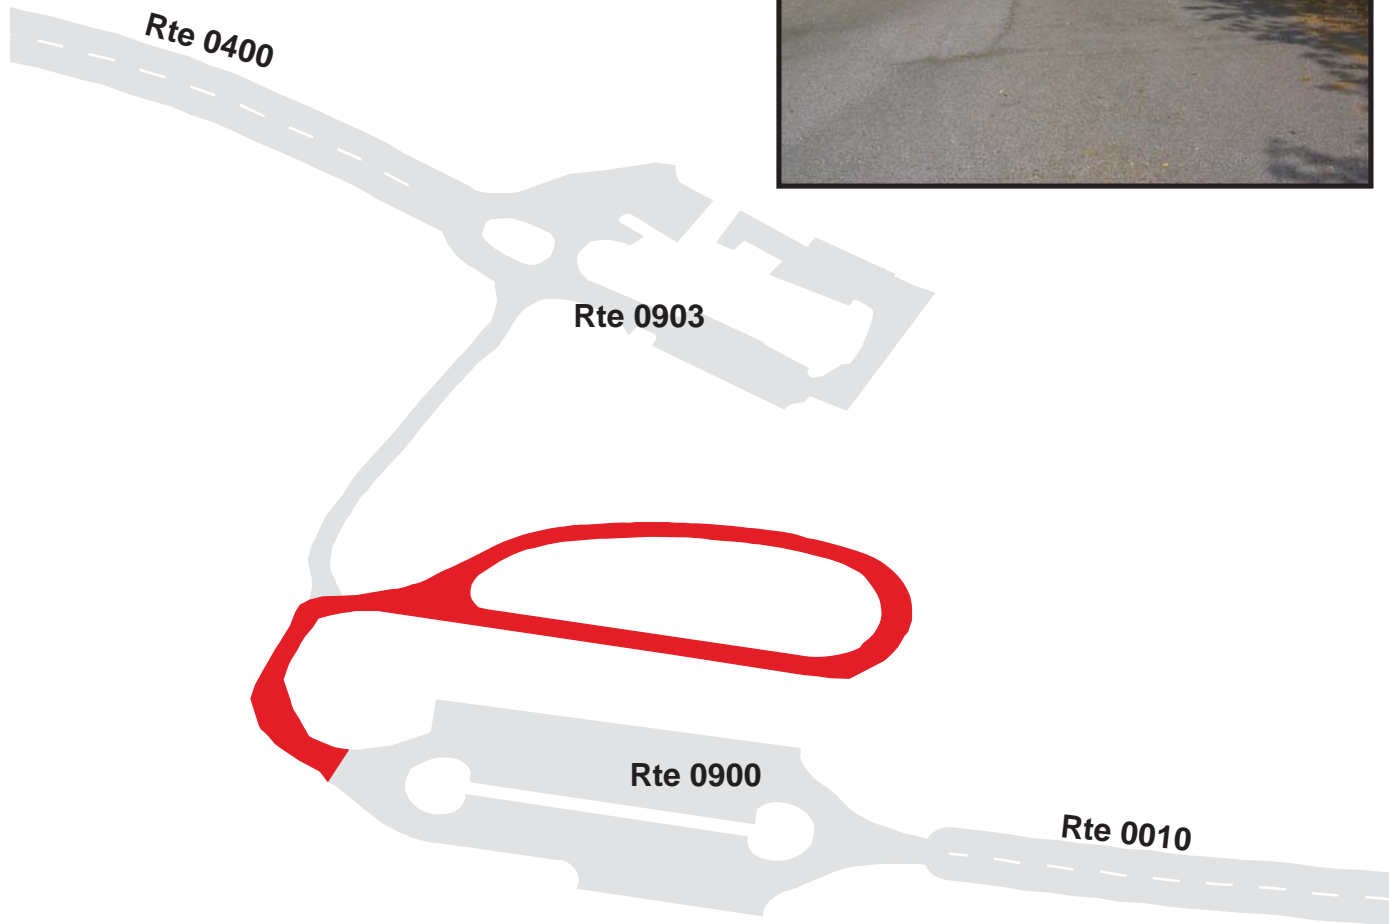
## Route 0901

| Route | Public / NonPublic | Date Visited | Area (sq ft) | Lane Miles * | Surface Type | Condition / PCR |
|---|---|---|---|---|---|---|
| 0901 | Public | 5/7/2002 | 11843 | 0.20 | AS | GOOD / 90 |

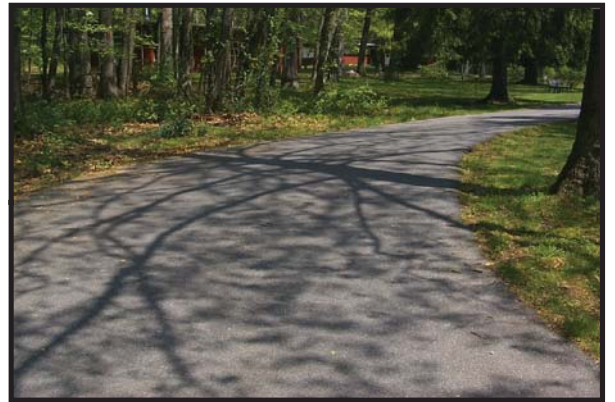
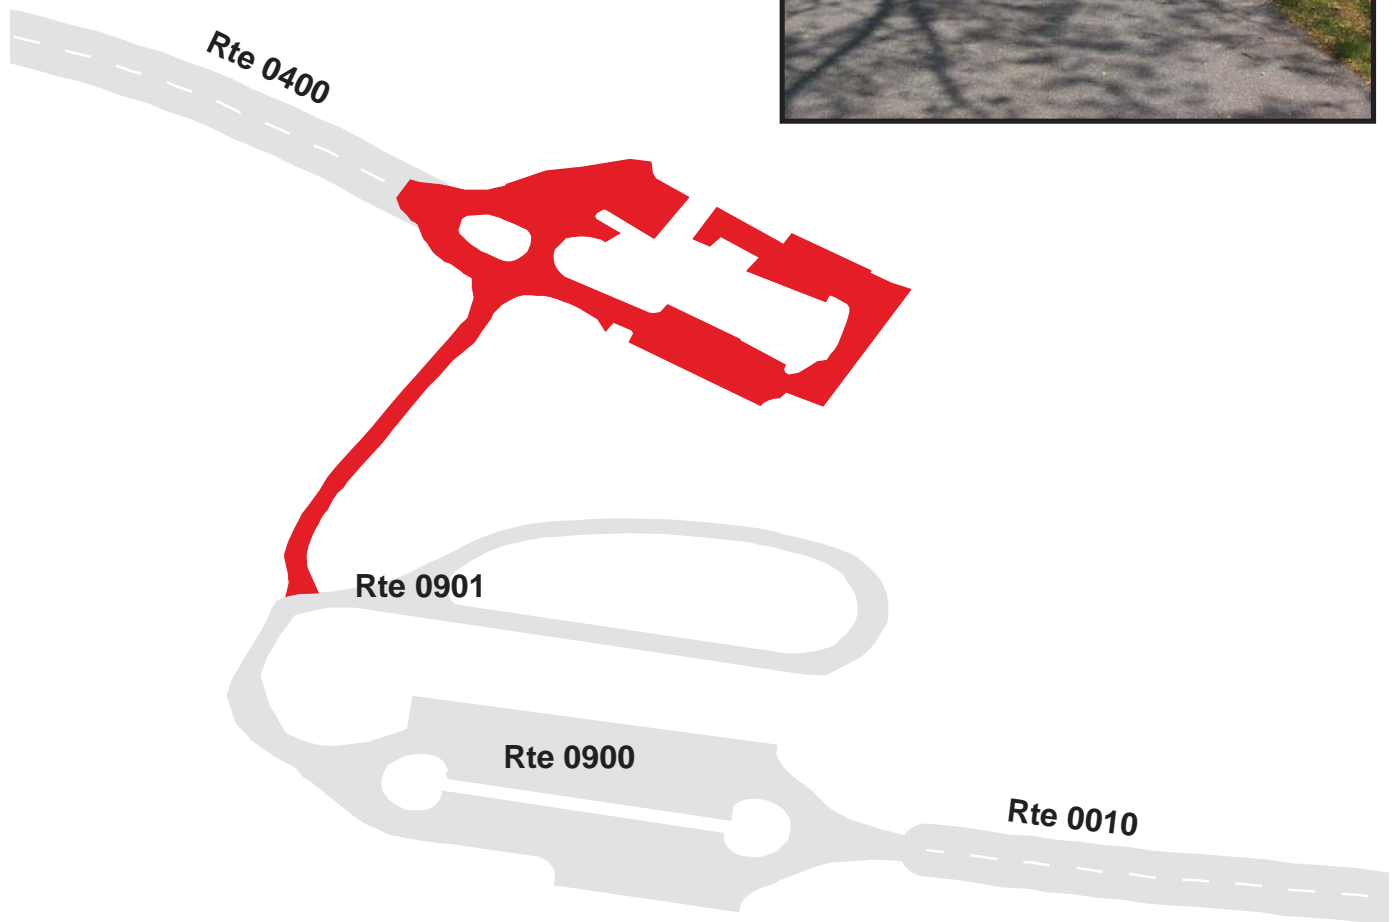
## Route 0903

| Route | Public / NonPublic | Date Visited | Area (sq ft) | Lane Miles * | Surface Type | Condition / PCR |
|---|---|---|---|---|---|---|
| 0903 | NonPublic | 5/7/2002 | 21468 | 0.37 | AS | GOOD / 90 |
