The Road Inventory of Homestead National Monument of America HOME - 6480

Road Inventory Program

Prepared By:
Federal Highway Administration
Eastern Federal Lands Highway Division
Cycle 3

Homestead National Monument of America in Nebraska

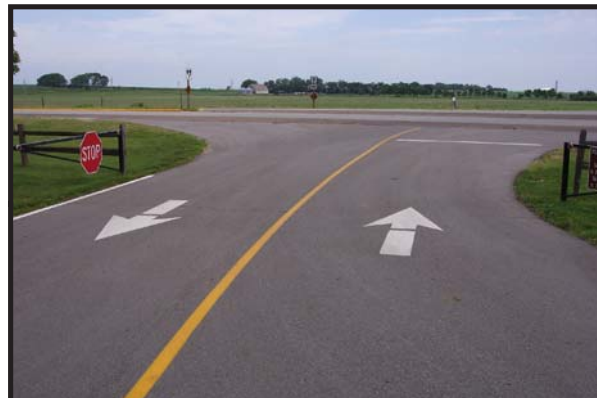
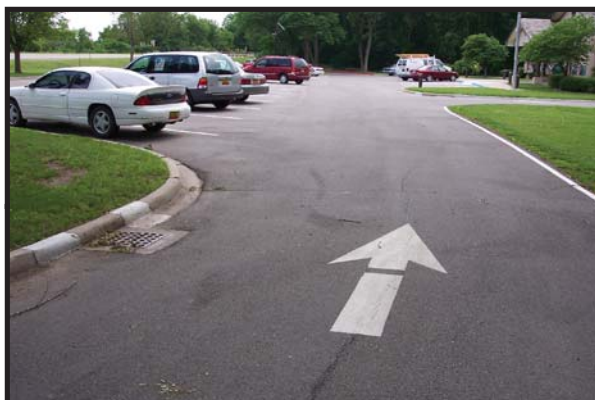
Route 0900

Route	Public / NonPublic	Date Visited	Area (sq ft)	Lane Miles *	Surface Type	Condition / PCR
0900	Public	6/24/2003	31366	0.54	AS	FAIR / 73

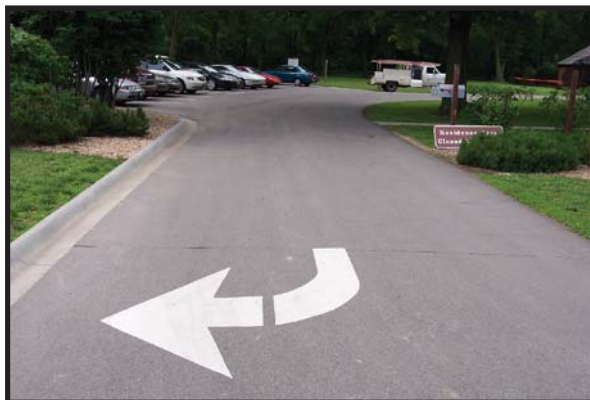
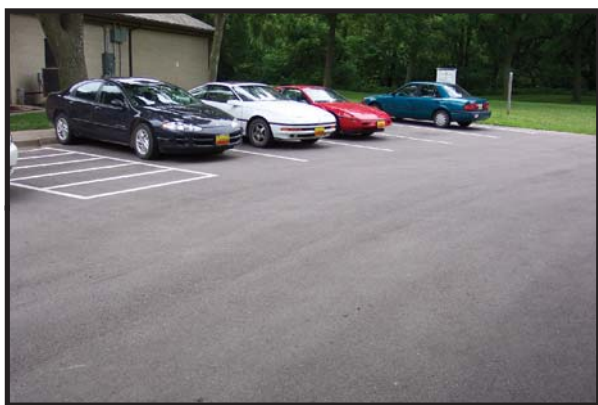
Route 0901A

Route	Public / NonPublic	Date Visited	Area (sq ft)	Lane Miles *	Surface Type	Condition / PCR
0901A	Public	6/24/2003	678	0.01	OC	FAIR / 73

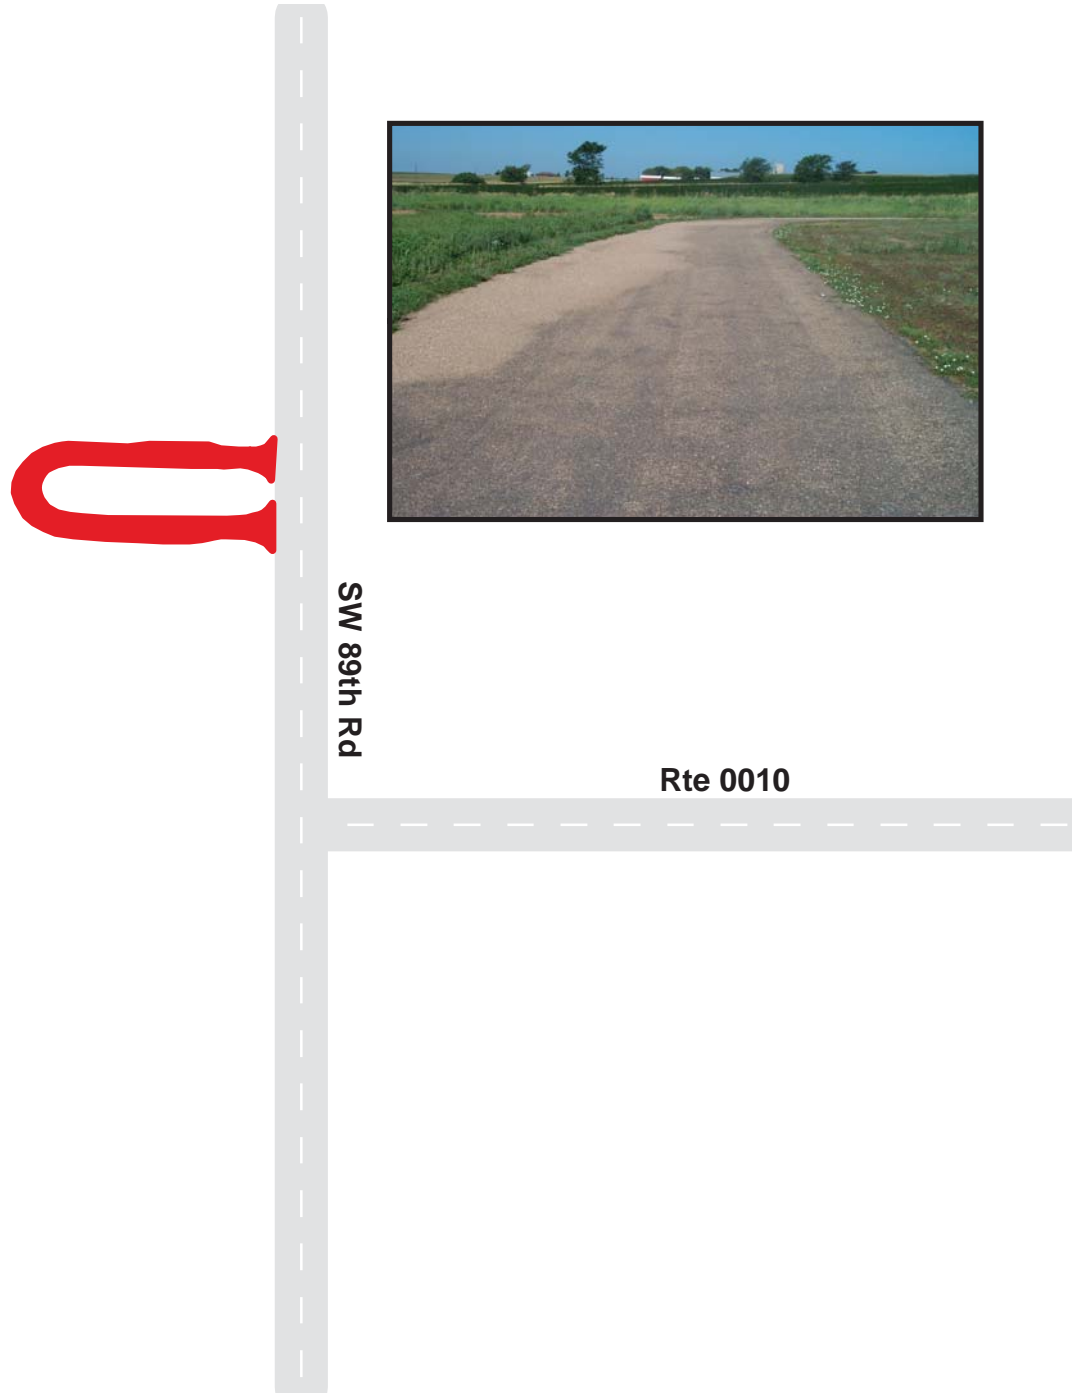
Route 0901B

Route	Public / NonPublic	Date Visited	Area (sq ft)	Lane Miles *	Surface Type	Condition / PCR
0901B	Public	6/24/2003	8012	0.14	OC	FAIR / 73

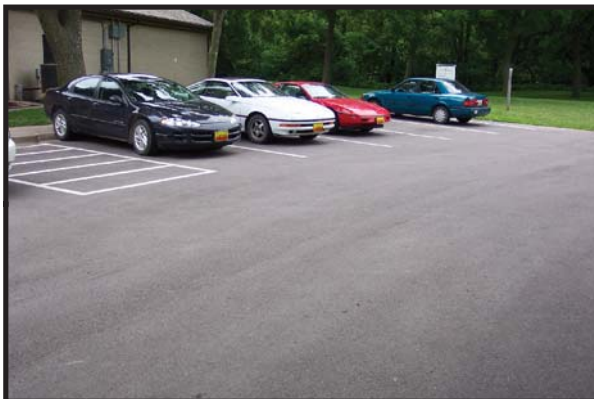
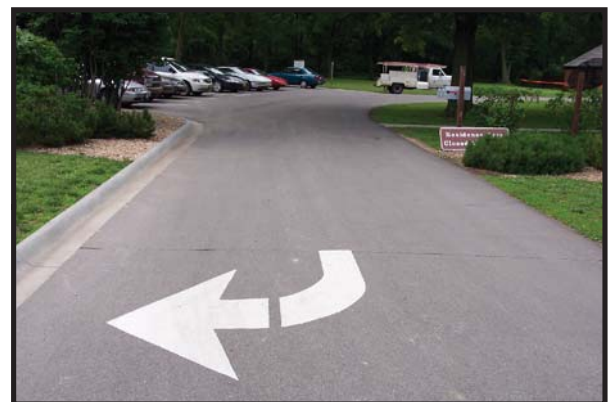
Route 0902

Route	Public / NonPublic	Date Visited	Area (sq ft)	Lane Miles *	Surface Type	Condition / PCR
0902	NonPublic	6/24/2003	12261	0.21	AS	GOOD / 90
