# The Road Inventory of Hot Springs National Park HOSP - 7300

## Road Inventory Program

Prepared By:  
Federal Highway Administration  
Eastern Federal Lands Highway Division  
Cycle 3

# Hot Springs National Park in Arkansas

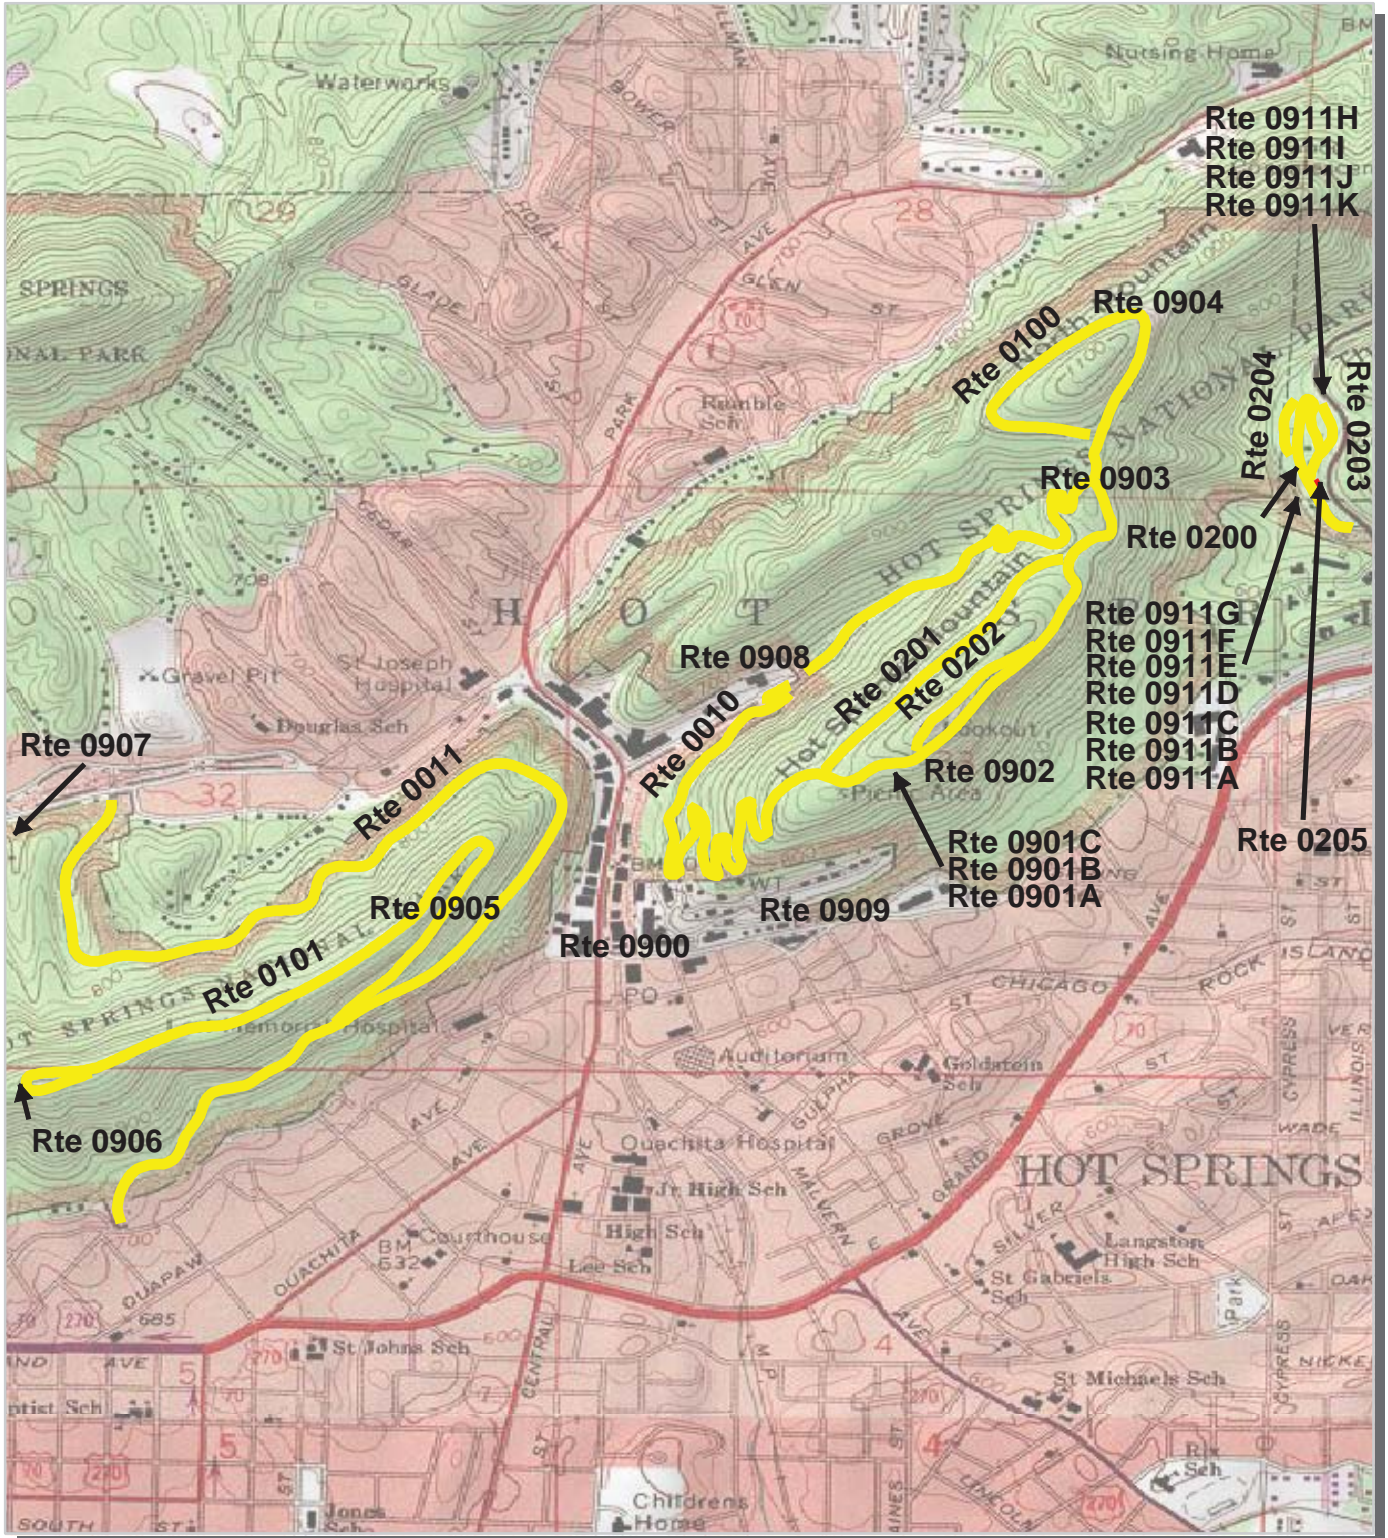
# Hot Springs National Park Route Condition Key Map PCR - Mile by Mile

PCR	Poor	(<=60)	Fair	(61 - 84)	Good	(85 - 94)	Excellent	(95 - 100)
-----	------	--------	------	-----------	------	-----------	-----------	------------

\* If the PCR rating is not available for a section, the SCR rating will be displayed. See appendix for definitions and formulas.

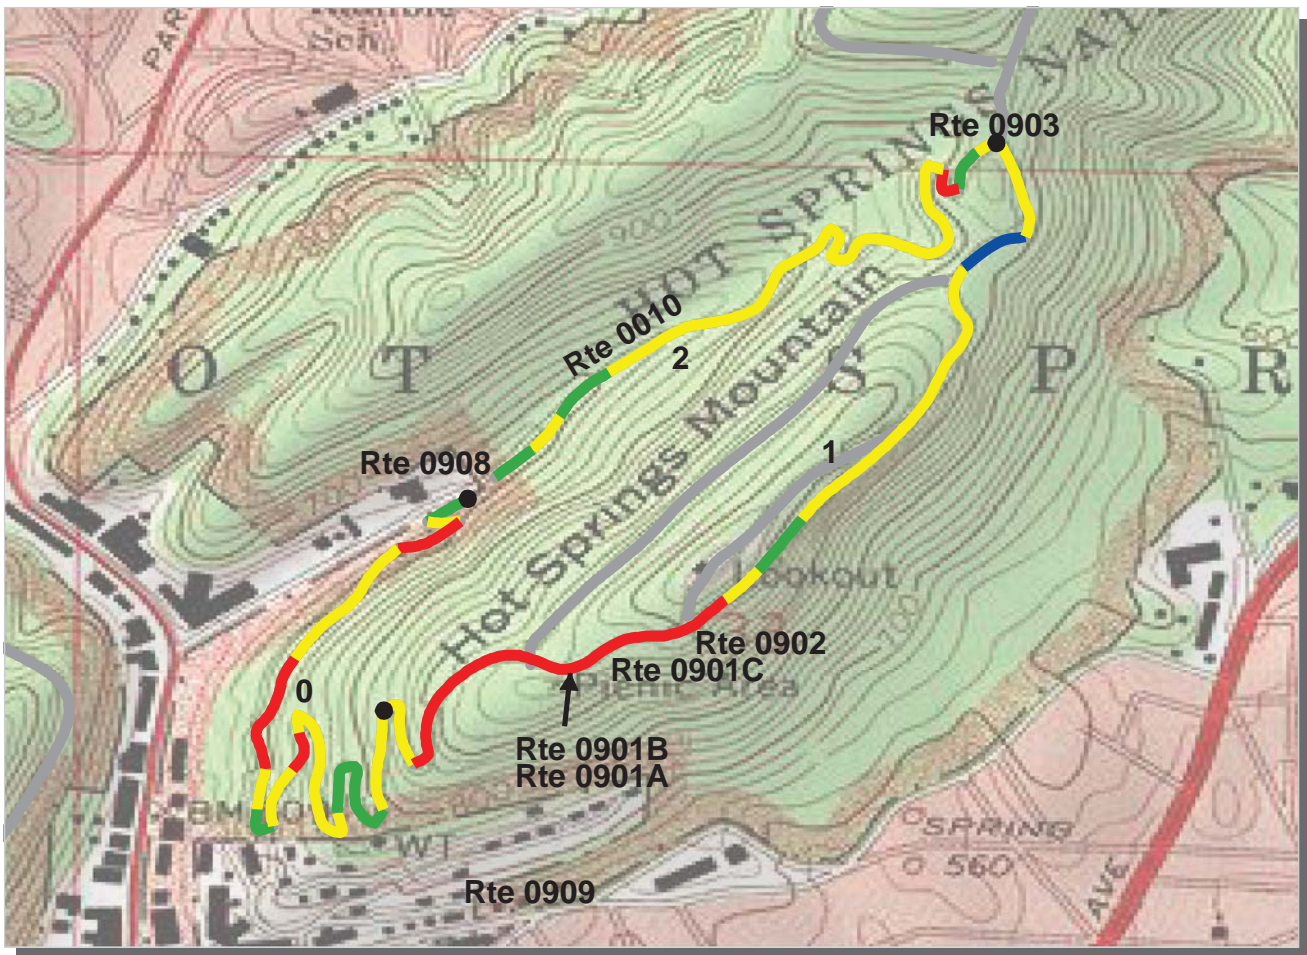
ROUTE: 0010 Hot Springs Mountain Drive

Section Number	0	1	2		
Section Length (mi)	1.00	1.00	0.75		
AADT	**				
SADT	**				
ADT Date	**				
<b>Cross Section Information</b>					
Number of Lanes	1	1	1		
Paved Width (ft)	13	13	11		
Lane Width (ft)	13	13	11		
Shoulder Width (ft)	0	0	3		
<b>Roadway Condition Information</b>					
PCR (Pavement Condition Rating)	69	67	77		
RCI (Roughness Condition Index)	21	54	70		
SCR (Surface Condition Rating)	77	72	81		
Alligator Cracking Index	100	97	99		
Rutting Index	78	81	82		
Patching Index	98	99	100		
Transverse Cracking Index	99	97	99		
Longitudinal Cracking Index	100	97	99		
Shoulder Condition Rating	N/A	N/A	GOOD		
Drainage Condition Rating	GOOD	GOOD	GOOD

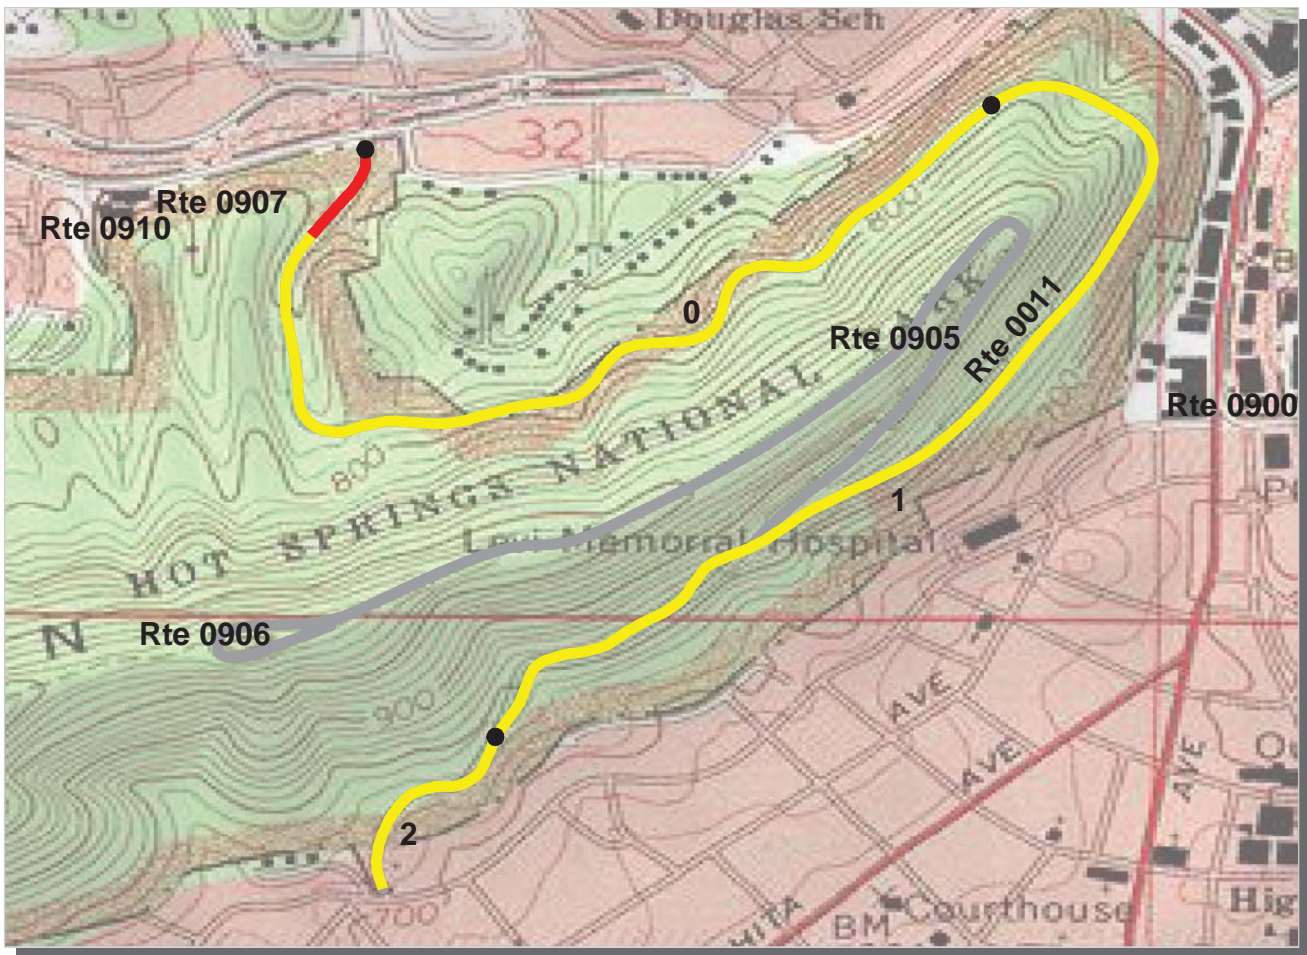
ROUTE: 0011 West Mountain Drive

Section Number	0	1	2		
Section Length (mi)	1.00	1.00	0.22		
AADT	**				
SADT	**				
ADT Date	**				
<b>Cross Section Information</b>					
Number of Lanes	2	2	2		
Paved Width (ft)	18	18	18		
Lane Width (ft)	9	9	9		
Shoulder Width (ft)	0	4	6		
<b>Roadway Condition Information</b>					
PCR (Pavement Condition Rating)	73	74	75		
RCI (Roughness Condition Index)	88	86	83		
SCR (Surface Condition Rating)	63	66	70		
Alligator Cracking Index	100	100	100		
Rutting Index	64	66	70		
Patching Index	99	100	100		
Transverse Cracking Index	99	99	100		
Longitudinal Cracking Index	99	99	100		
Shoulder Condition Rating	N/A	GOOD	GOOD		
Drainage Condition Rating	GOOD	GOOD	GOOD

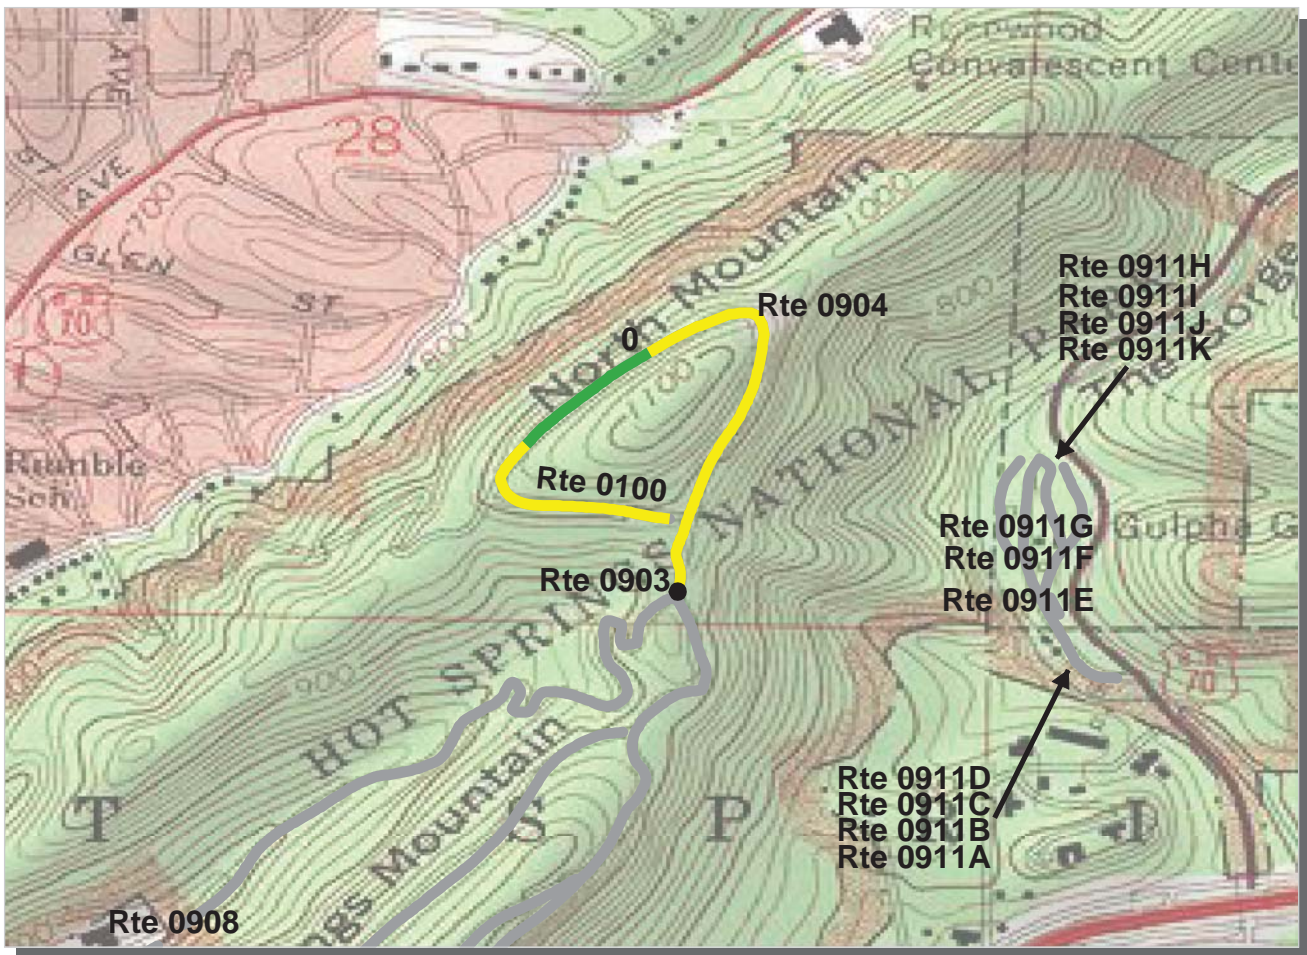
ROUTE: 0100 North Mountain Loop Road

Section Number	0				
Section Length (mi)	0.76				
AADT	**				
SADT	**				
ADT Date	**				
<b>Cross Section Information</b>					
Number of Lanes	2				
Paved Width (ft)	17				
Lane Width (ft)	9				
Shoulder Width (ft)	6				
<b>Roadway Condition Information</b>					
PCR (Pavement Condition Rating)	74				
RCI (Roughness Condition Index)	58				
SCR (Surface Condition Rating)	84				
Alligator Cracking Index	99				
Rutting Index	89				
Patching Index	100				
Transverse Cracking Index	97				
Longitudinal Cracking Index	97				
Shoulder Condition Rating	GOOD				
Drainage Condition Rating	GOOD

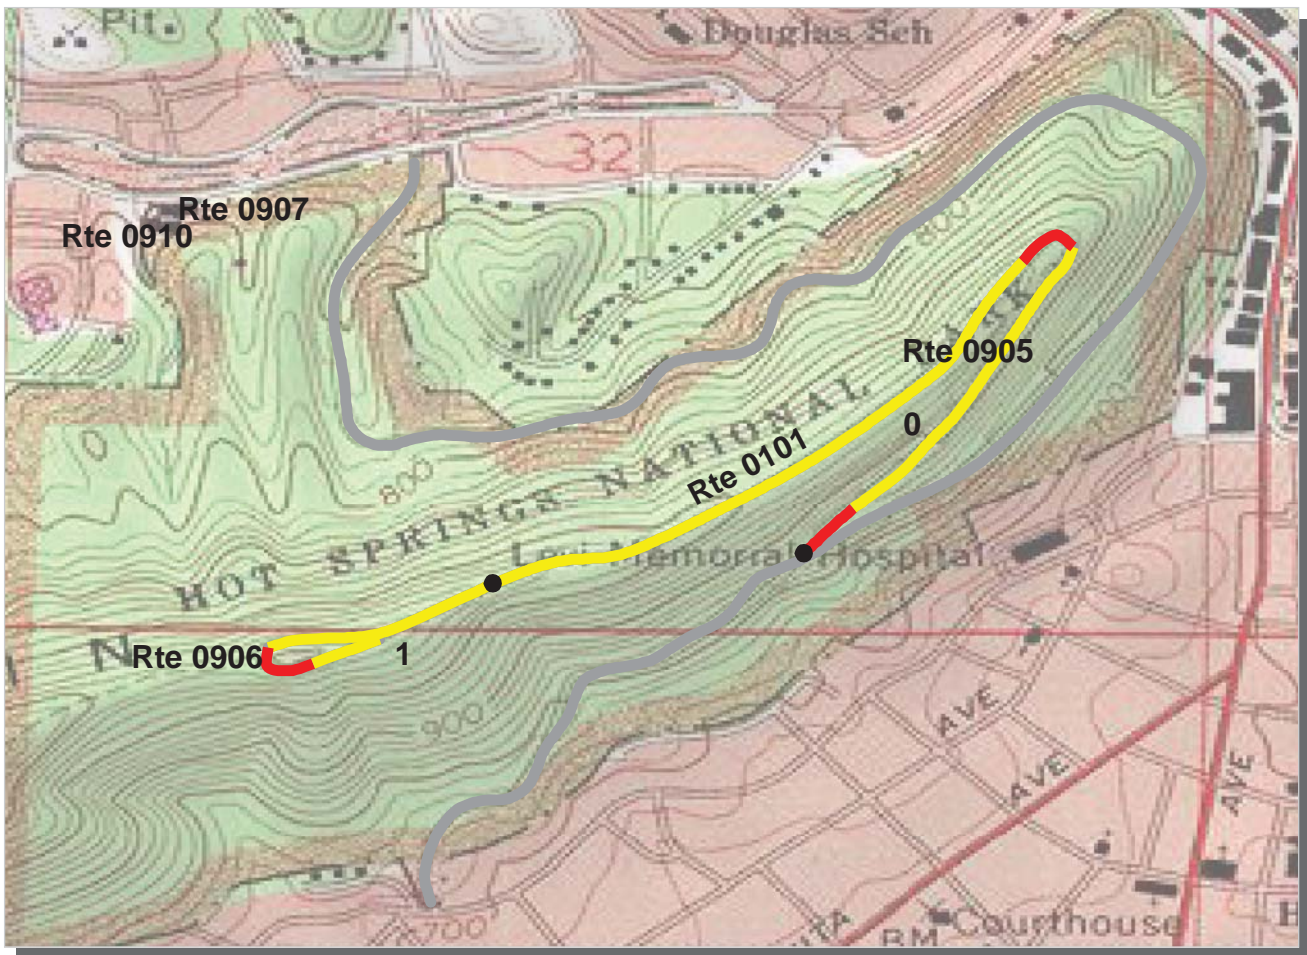
ROUTE: 0101 Summit Road

Section Number	0	1			
Section Length (mi)	1.00	0.33			
AADT	**				
SADT	**				
ADT Date	**				
<b>Cross Section Information</b>					
Number of Lanes	2	2			
Paved Width (ft)	17	18			
Lane Width (ft)	8	9			
Shoulder Width (ft)	4	5			
<b>Roadway Condition Information</b>					
PCR (Pavement Condition Rating)	71	64			
RCI (Roughness Condition Index)	86	66			
SCR (Surface Condition Rating)	63	63			
Alligator Cracking Index	100	100			
Rutting Index	63	64			
Patching Index	100	99			
Transverse Cracking Index	99	99			
Longitudinal Cracking Index	99	99			
Shoulder Condition Rating	GOOD	GOOD			
Drainage Condition Rating	GOOD	GOOD

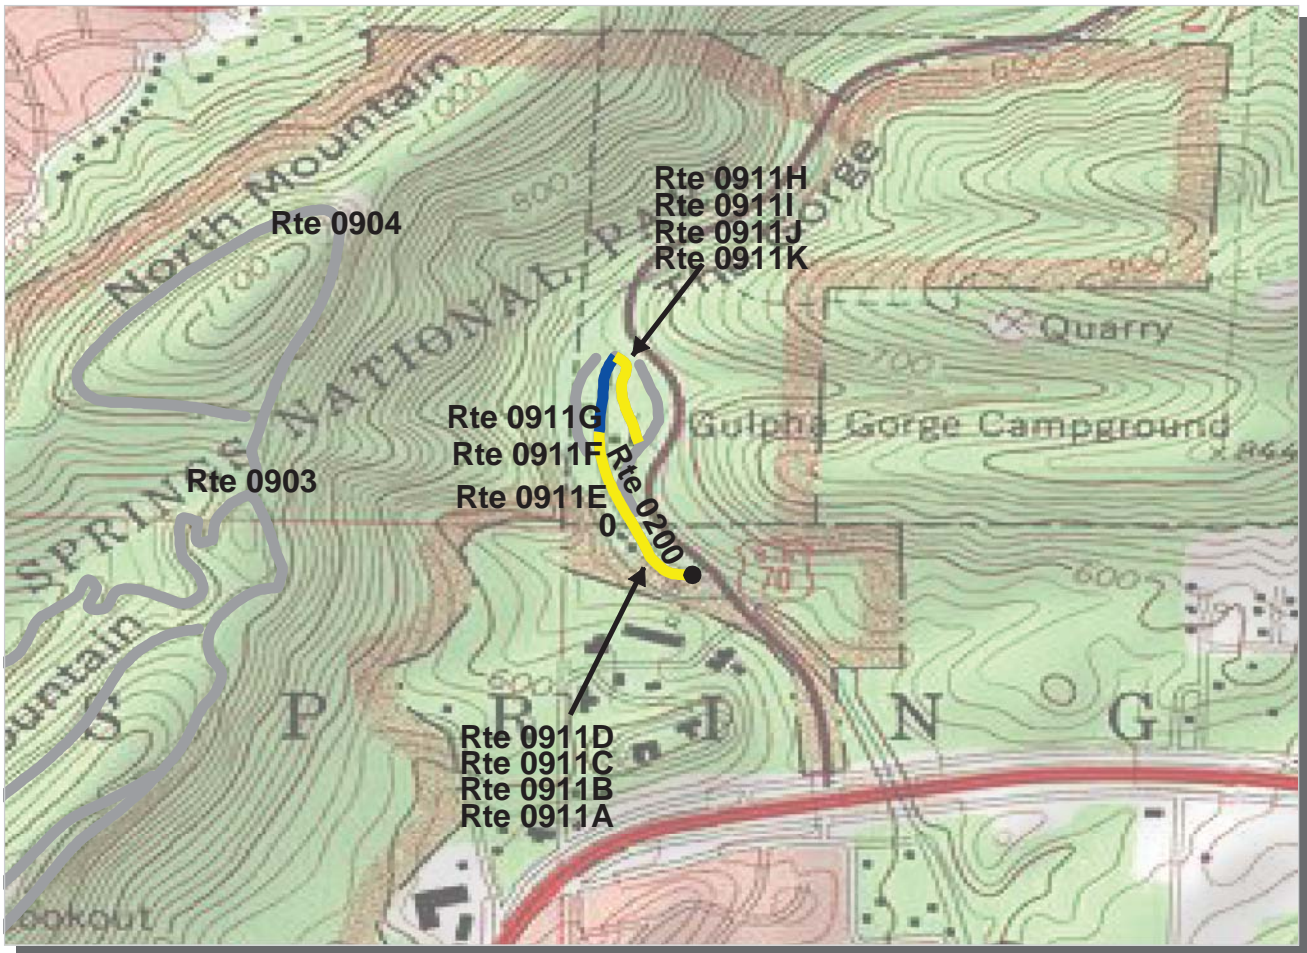
**ROUTE: 0200 Gulpha Gorge Campground Road**

Section Number	0			
Section Length (mi)	0.37			
AADT	**			
SADT	**			
ADT Date	**			
<b>Cross Section Information</b>				
Number of Lanes	2			
Paved Width (ft)	17			
Lane Width (ft)	9			
Shoulder Width (ft)	6			
<b>Roadway Condition Information</b>				
PCR (Pavement Condition Rating)	82			
RCI (Roughness Condition Index)	NC			
SCR (Surface Condition Rating)	82			
Alligator Cracking Index	99			
Rutting Index	86			
Patching Index	98			
Transverse Cracking Index	98			
Longitudinal Cracking Index	99			
Shoulder Condition Rating	GOOD			
Drainage Condition Rating	GOOD

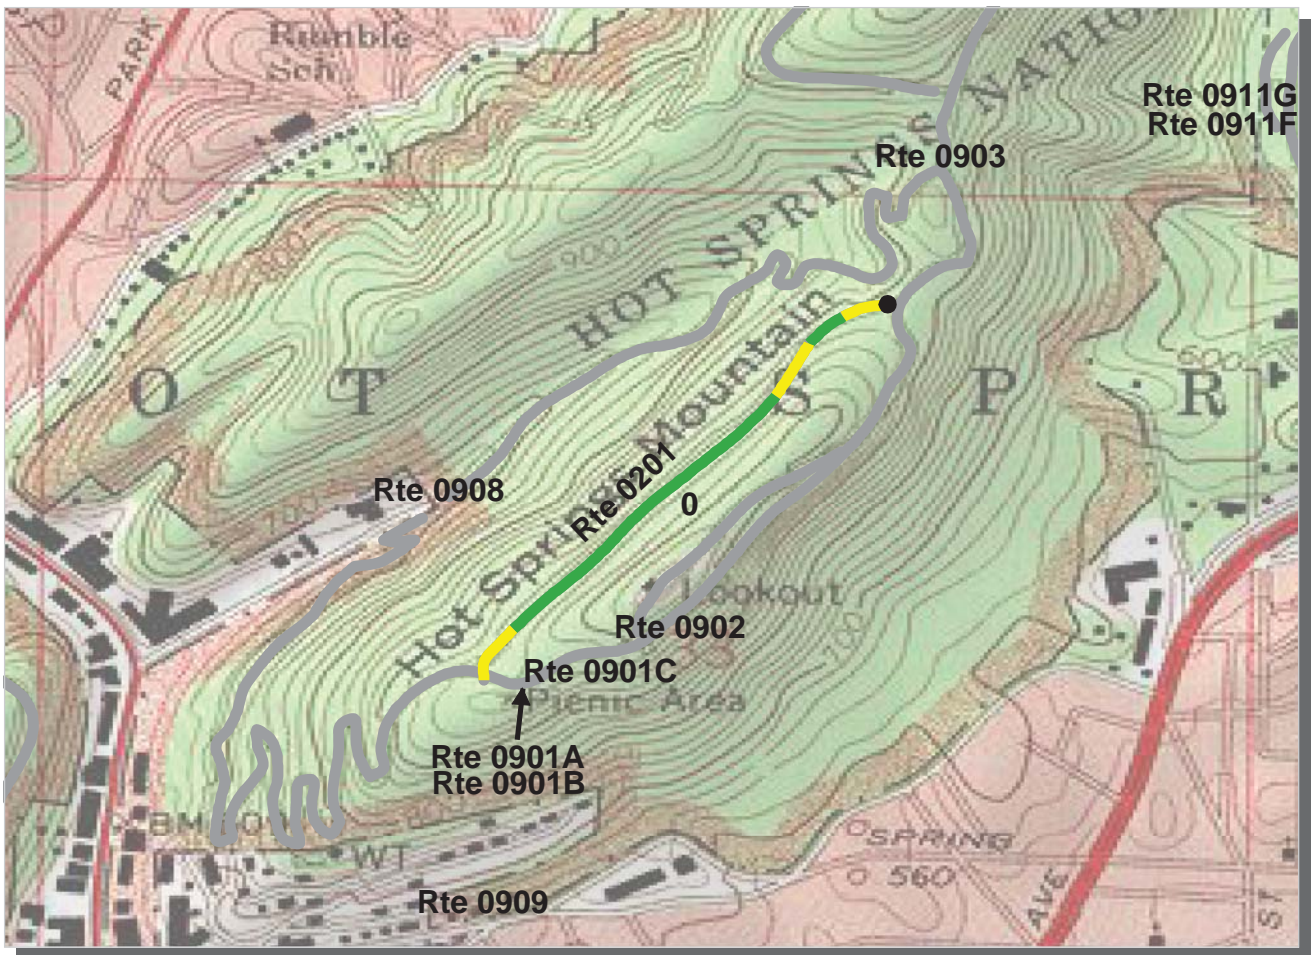
ROUTE: 0201 Tower Return Road

Section Number	0				
Section Length (mi)	0.53				
AADT	**				
SADT	**				
ADT Date	**				
<b>Cross Section Information</b>					
Number of Lanes	1				
Paved Width (ft)	11				
Lane Width (ft)	11				
Shoulder Width (ft)	0				
<b>Roadway Condition Information</b>					
PCR (Pavement Condition Rating)	80				
RCI (Roughness Condition Index)	82				
SCR (Surface Condition Rating)	80				
Alligator Cracking Index	99				
Rutting Index	92				
Patching Index	100				
Transverse Cracking Index	93				
Longitudinal Cracking Index	95				
Shoulder Condition Rating	N/A				
Drainage Condition Rating	GOOD

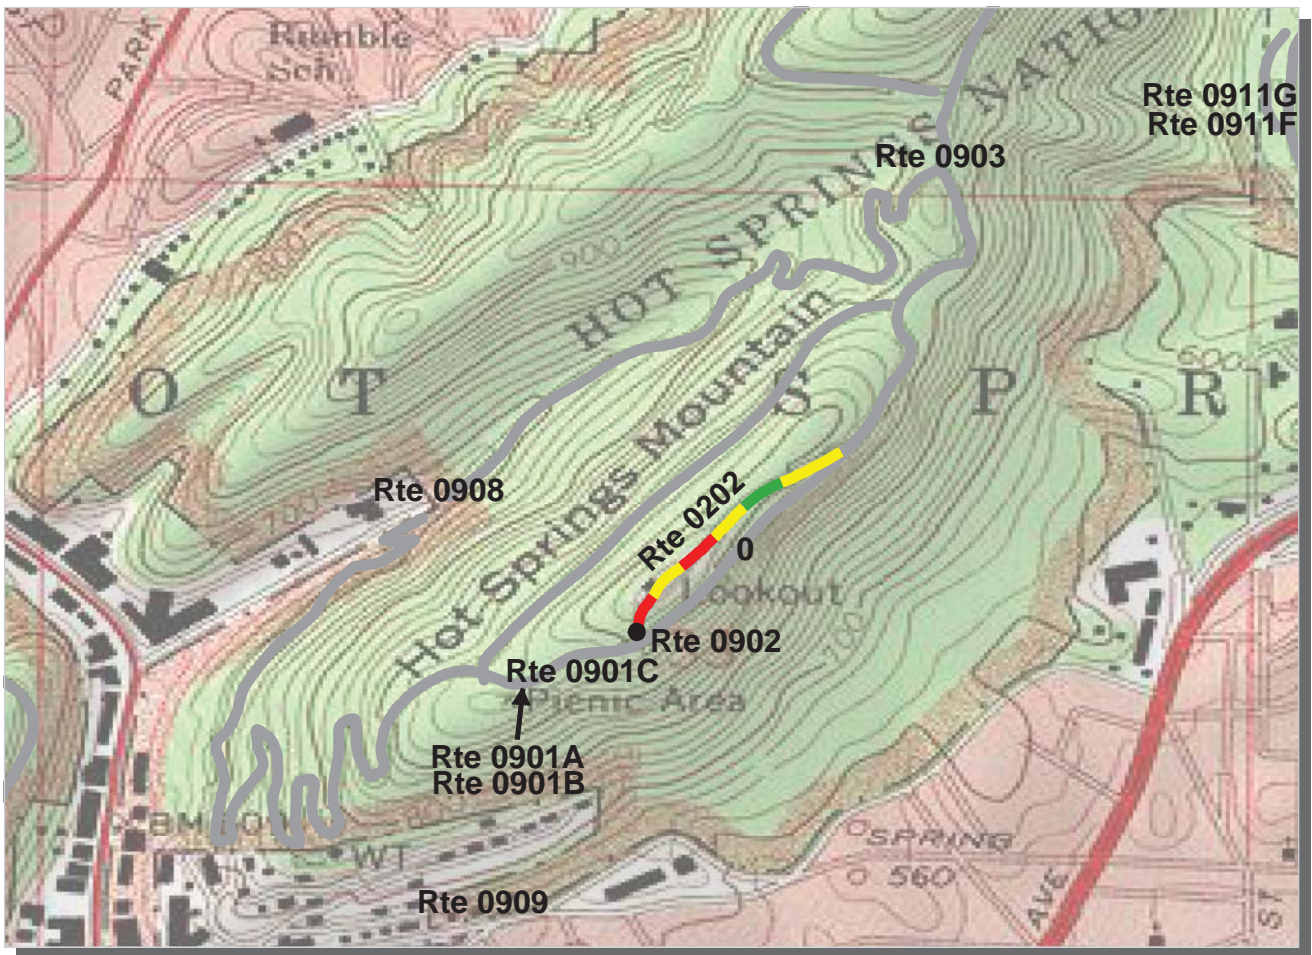
ROUTE: 0202 Tower Loop Road

Section Number	0				
Section Length (mi)	0.27				
AADT	**				
SADT	**				
ADT Date	**				
<b>Cross Section Information</b>					
Number of Lanes	1				
Paved Width (ft)	11				
Lane Width (ft)	11				
Shoulder Width (ft)	0				
<b>Roadway Condition Information</b>					
PCR (Pavement Condition Rating)	70				
RCI (Roughness Condition Index)	89				
SCR (Surface Condition Rating)	67				
Alligator Cracking Index	99				
Rutting Index	85				
Patching Index	99				
Transverse Cracking Index	90				
Longitudinal Cracking Index	92				
Shoulder Condition Rating	N/A				
Drainage Condition Rating	GOOD

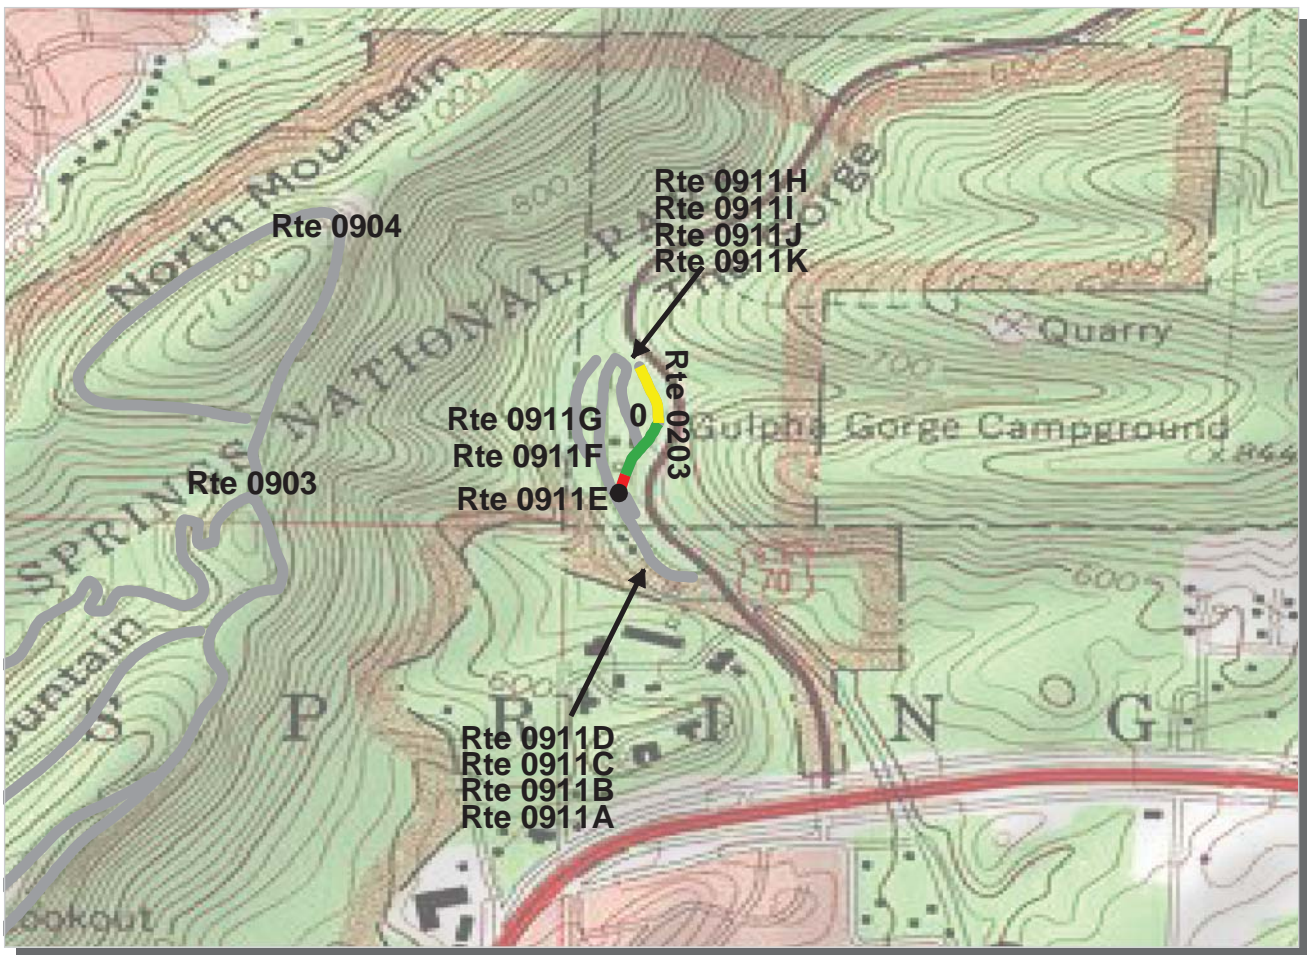
**ROUTE: 0203 Gulpha Gorge Amphitheater Road**

Section Number	0			
Section Length (mi)	0.16			
AADT	**			
SADT	**			
ADT Date	**			
<b>Cross Section Information</b>				
Number of Lanes	1			
Paved Width (ft)	17			
Lane Width (ft)	17			
Shoulder Width (ft)	0			
<b>Roadway Condition Information</b>				
PCR (Pavement Condition Rating)	71			
RCI (Roughness Condition Index)	53			
SCR (Surface Condition Rating)	84			
Alligator Cracking Index	100			
Rutting Index	90			
Patching Index	98			
Transverse Cracking Index	97			
Longitudinal Cracking Index	98			
Shoulder Condition Rating	N/A			
Drainage Condition Rating	GOOD

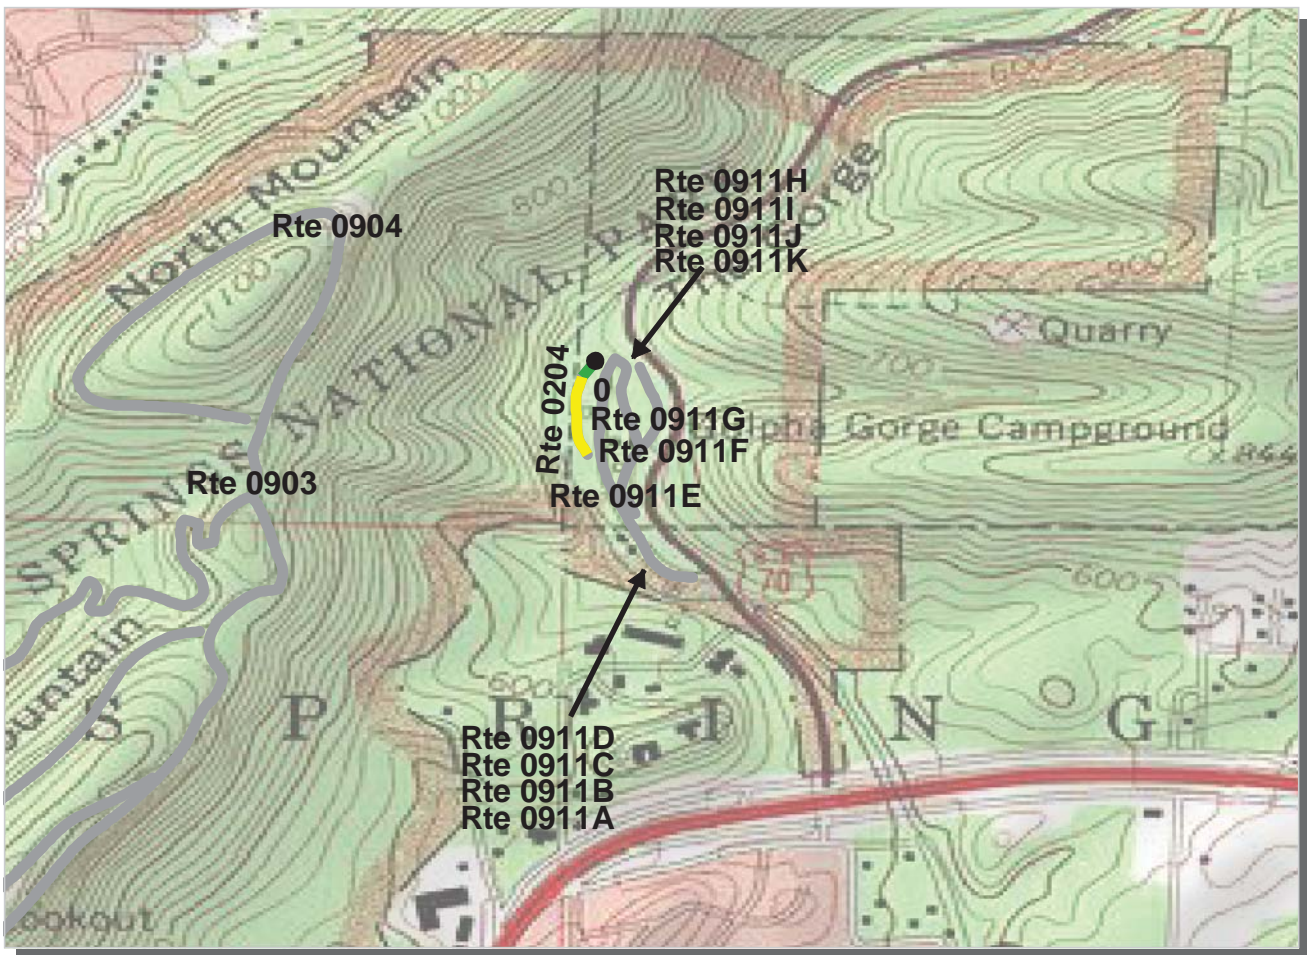
**ROUTE: 0204 Gulpha Gorge Campground Access Rd**

Section Number	0			
Section Length (mi)	0.12			
AADT	**			
SADT	**			
ADT Date	**			
<b>Cross Section Information</b>				
Number of Lanes	1			
Paved Width (ft)	12			
Lane Width (ft)	12			
Shoulder Width (ft)	5			
<b>Roadway Condition Information</b>				
PCR (Pavement Condition Rating)	75			
RCI (Roughness Condition Index)	41			
SCR (Surface Condition Rating)	86			
Alligator Cracking Index	100			
Rutting Index	89			
Patching Index	99			
Transverse Cracking Index	98			
Longitudinal Cracking Index	99			
Shoulder Condition Rating	GOOD			
Drainage Condition Rating	POOR

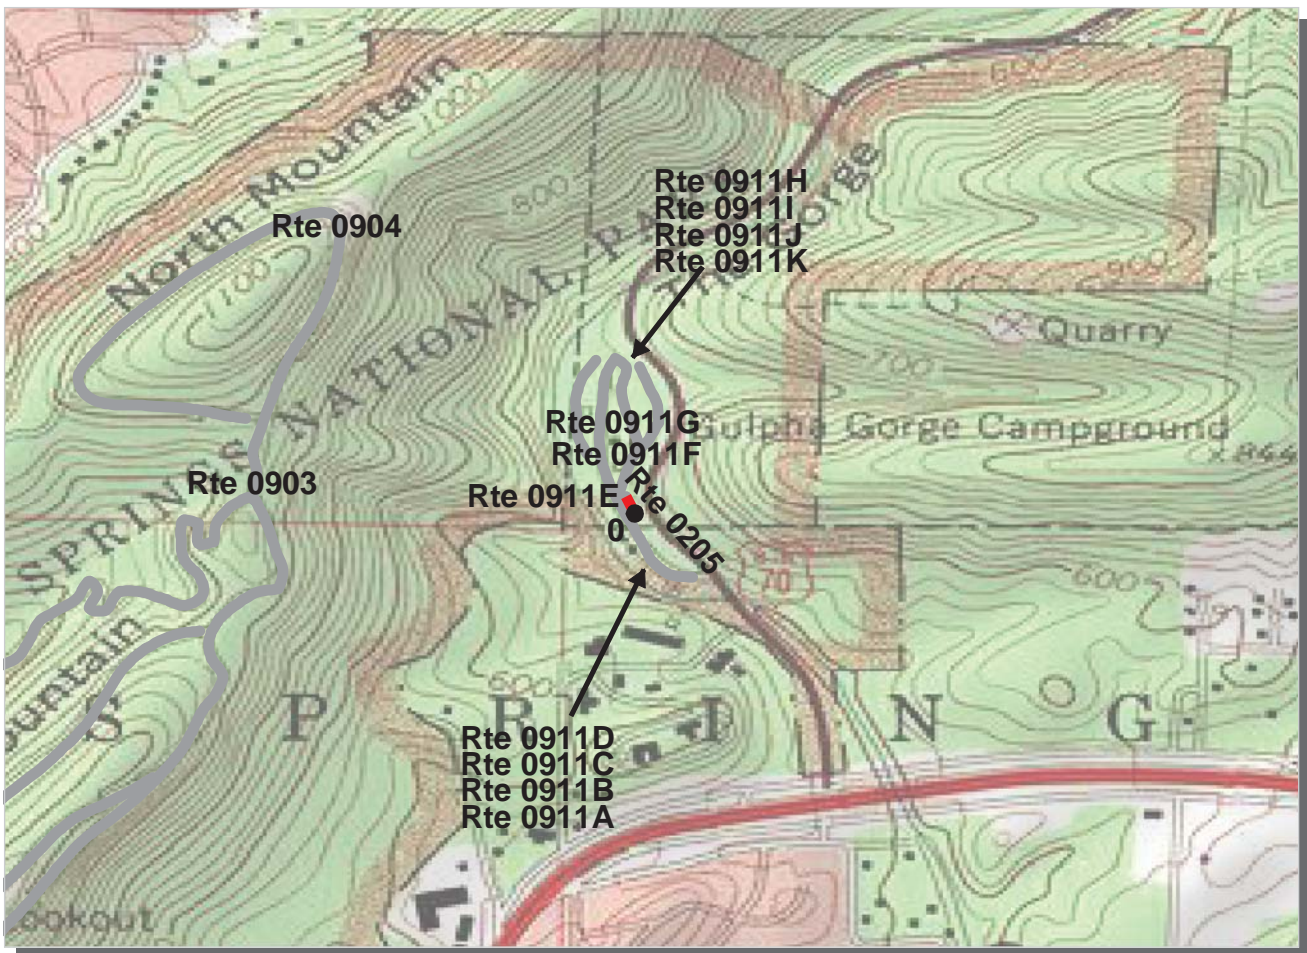
**ROUTE: 0205 Gulpha Gorge Dump Station Road** **TOTAL LENGTH: 0.03 Miles**

Section Number	0			
Section Length (mi)	0.03			
AADT	**			
SADT	**			
ADT Date	**			
<b>Cross Section Information</b>				
Number of Lanes	1			
Paved Width (ft)	14			
Lane Width (ft)	14			
Shoulder Width (ft)	0			
<b>Roadway Condition Information</b>				
PCR (Pavement Condition Rating)	55			
RCI (Roughness Condition Index)	NC			
SCR (Surface Condition Rating)	55			
Alligator Cracking Index	100			
Rutting Index	57			
Patching Index	99			
Transverse Cracking Index	99			
Longitudinal Cracking Index	99			
Shoulder Condition Rating	N/A			
Drainage Condition Rating	GOOD
