# The Road Inventory of Hovenweep National Monument HOVE - 1498

## Road Inventory Program

Prepared By:  
Federal Highway Administration  
Eastern Federal Lands Highway Division  
Cycle 3

# Hovenweep National Monument in Colorado

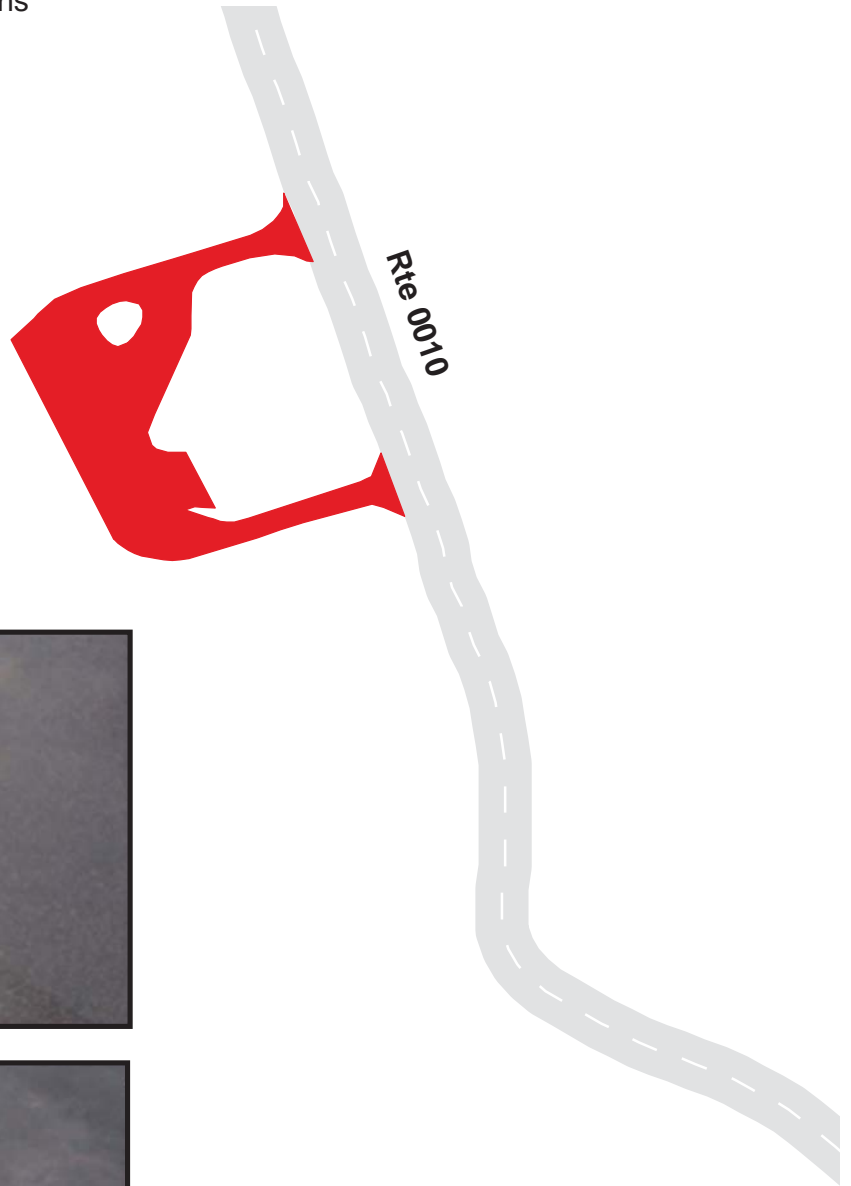
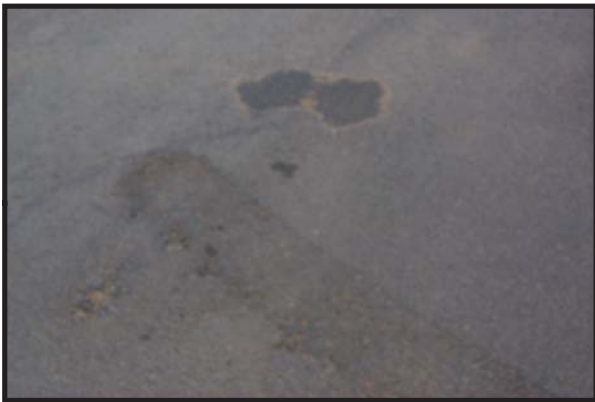
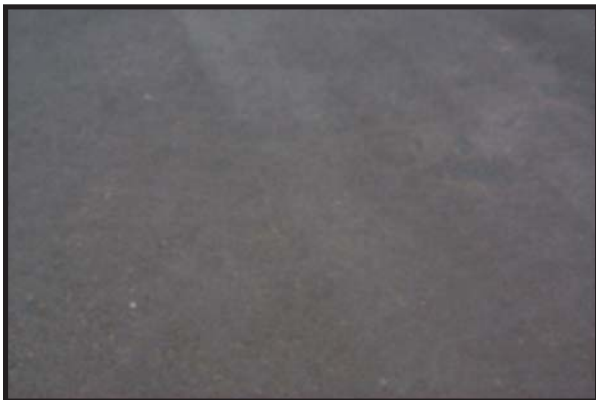
Route	Public / NonPublic	Date Visited	Area (sq ft)	Lane Miles *	Surface Type	Condition / PCR
0900	Public	4/23/2003	26356	0.45	AS	GOOD / 90

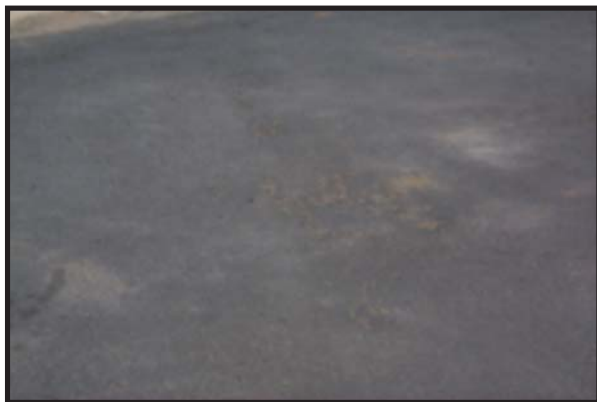
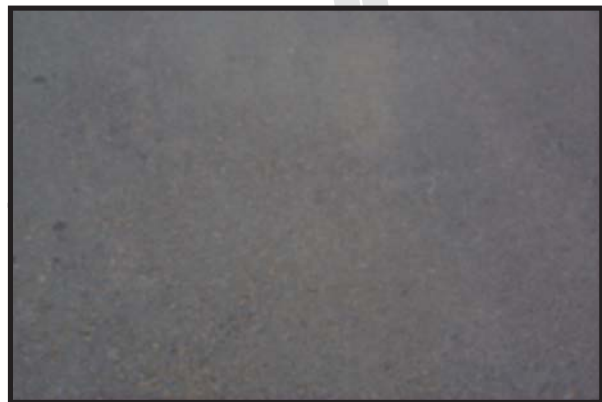
## Route 0901

Route	Public / NonPublic	Date Visited	Area (sq ft)	Lane Miles *	Surface Type	Condition / PCR
0901	NonPublic	4/23/2003	2712	0.05	AS	GOOD / 90
