The Road Inventory of Harry S Truman National Historic Site HSTR - 6460

Road Inventory Program

Prepared By:
Federal Highway Administration
Eastern Federal Lands Highway Division
Cycle 3

Harry S Truman National Historic Site in Missouri

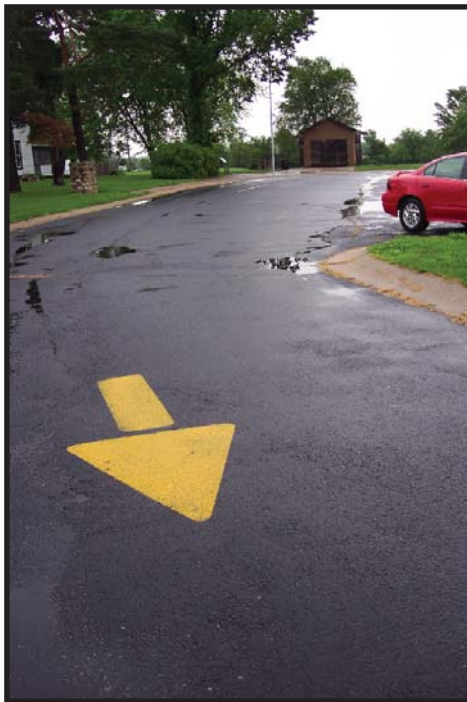
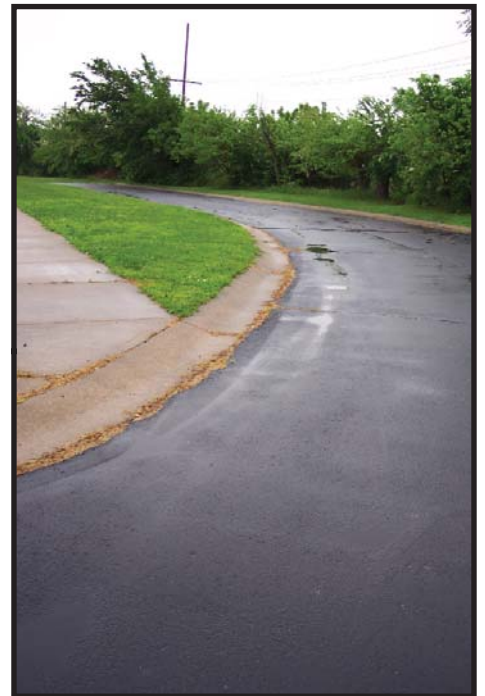
Route 0900

Farm Home Parking
From Blue Ridge Boulevard

Route	Public / NonPublic	Date Visited	Area (sq ft)	Lane Miles *	Surface Type	Condition / PCR
0900	Public	5/13/2004	17533	0.30	AS	FAIR / 73
