The Road Inventory of Independence National Historical Park INDE - 4450

Road Inventory Program

Prepared By:
Federal Highway Administration
Eastern Federal Lands Highway Division
Cycle 3

Independence National Historical Park in Pennsylvania

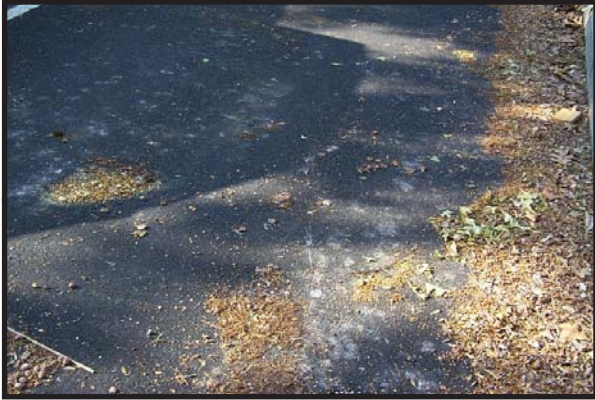
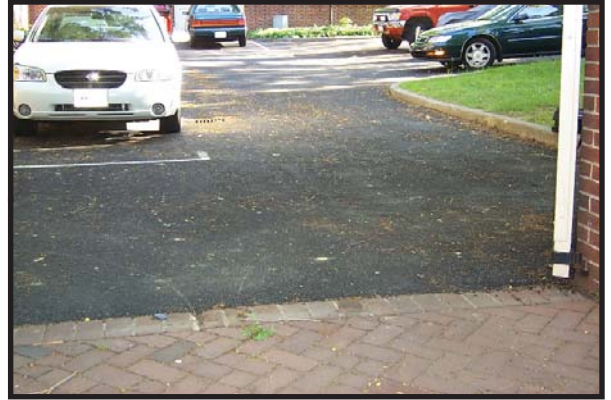
Route 0900

QUARTERS PARKING FROM LOCUST STREET

Route	Public / NonPublic	Date Visited	Area (sq ft)	Lane Miles *	Surface Type	Condition / PCR
0900	NonPublic	5/8/2002	2334	0.04	AS	EXCELLENT / 97

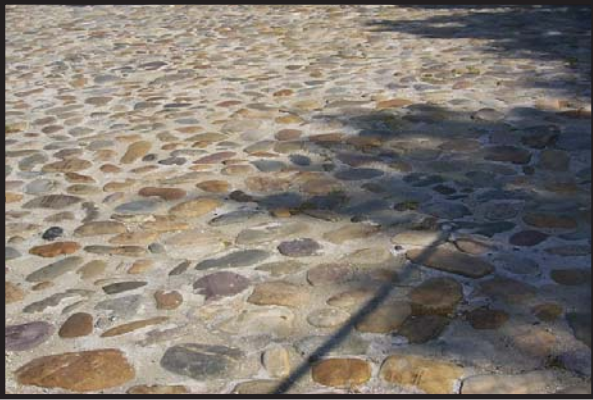
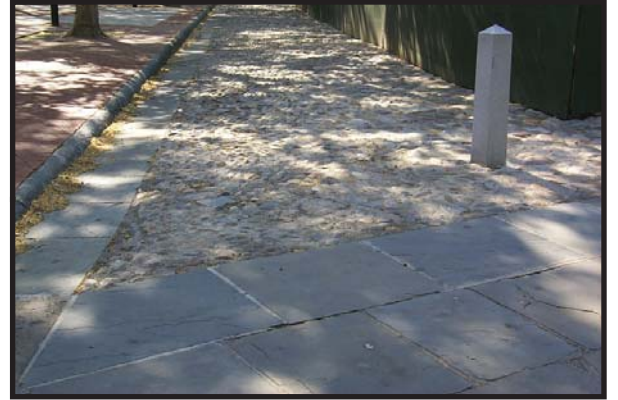
Route 0901

DOCK STREET
FROM WALNUT STREET

Route	Public / NonPublic	Date Visited	Area (sq ft)	Lane Miles *	Surface Type	Condition / PCR
0901	NonPublic	5/8/2002	23735	0.41	CB	GOOD / 90

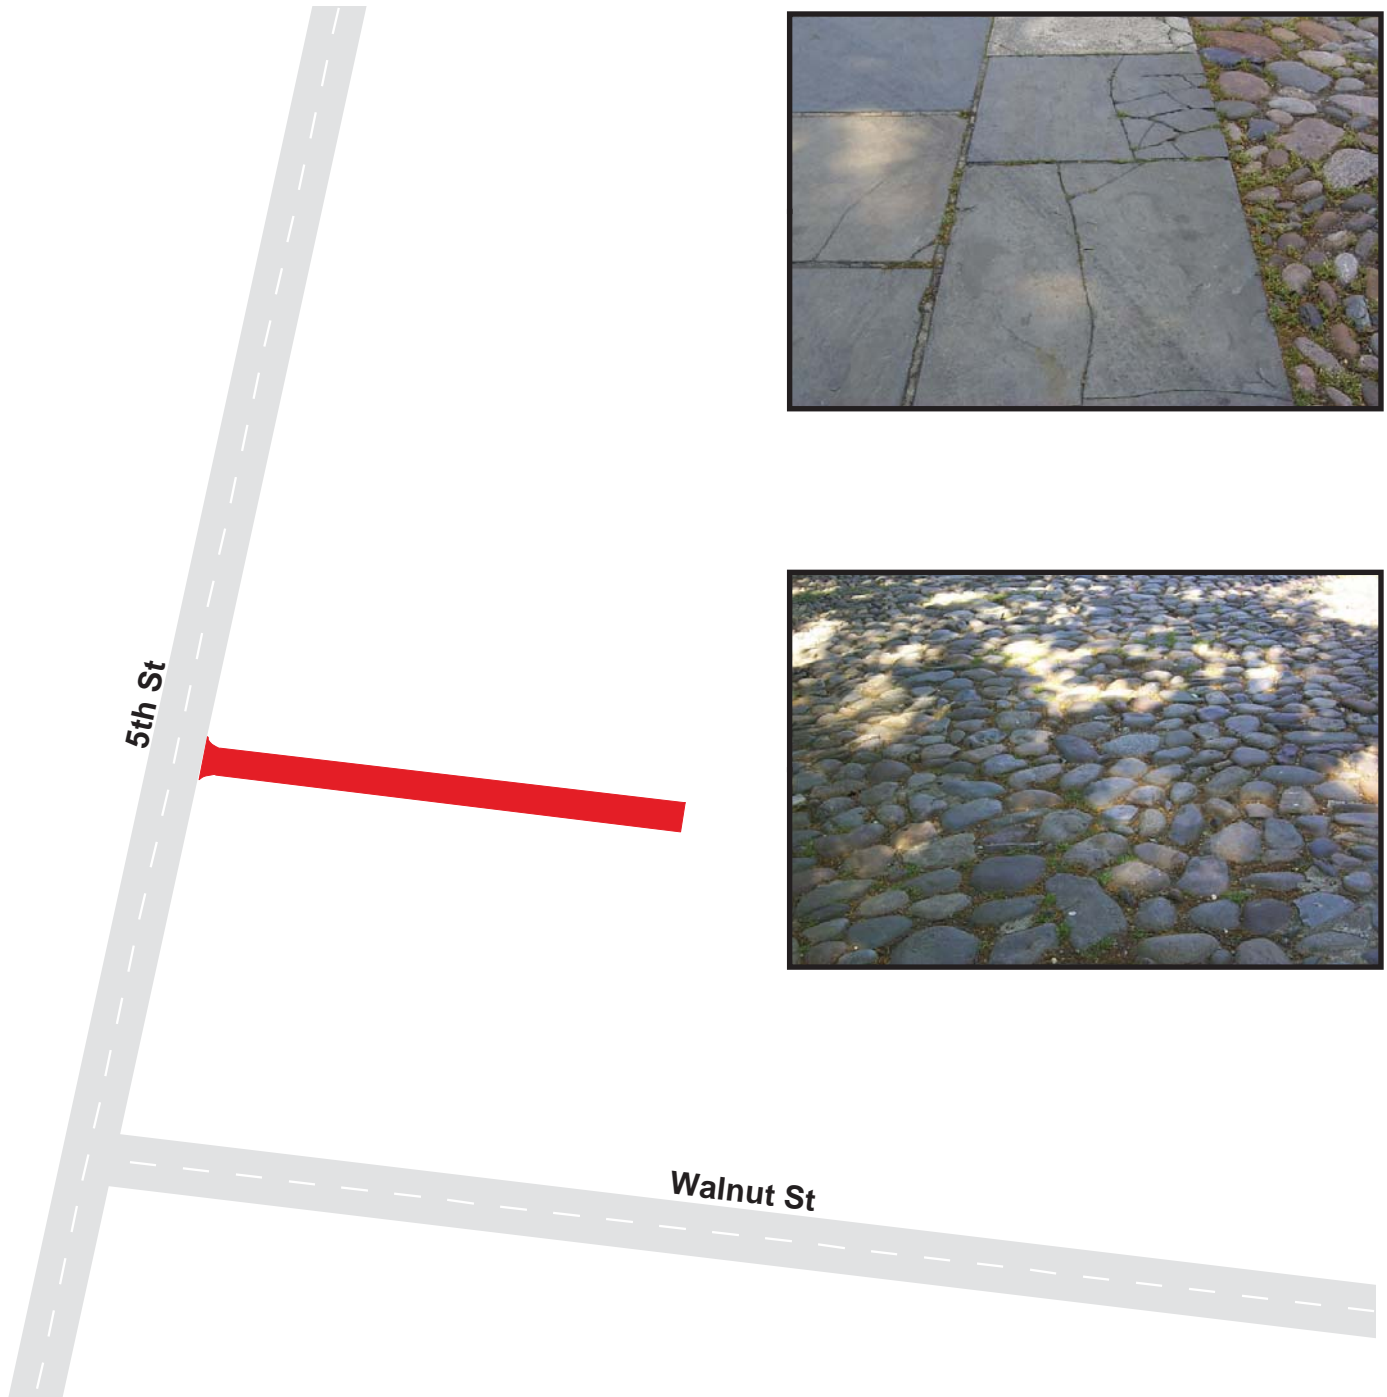
Route 0902

LIBRARY STREET
FROM 5TH STREET

Route	Public / NonPublic	Date Visited	Area (sq ft)	Lane Miles *	Surface Type	Condition / PCR
0902	NonPublic	5/8/2002	7121	0.12	CB	GOOD / 90

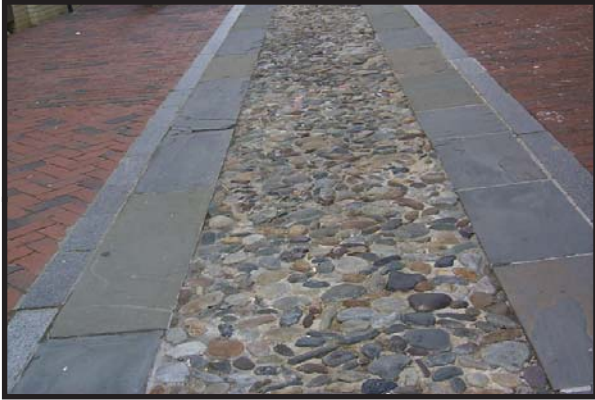
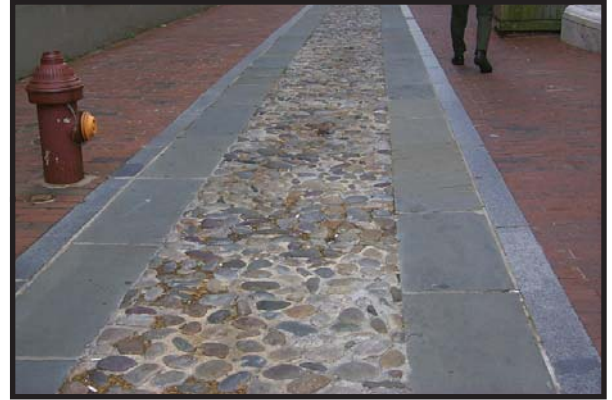
Route 0903

ORIANNA STREET
FROM CHESTNUT STREET

Route	Public / NonPublic	Date Visited	Area (sq ft)	Lane Miles *	Surface Type	Condition / PCR
0903	NonPublic	5/8/2002	2330	0.04	CB	GOOD / 90

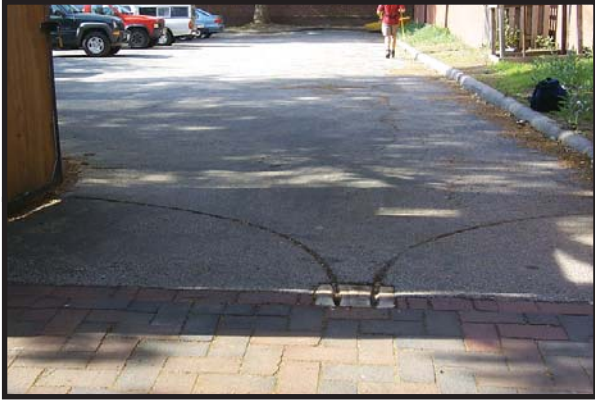
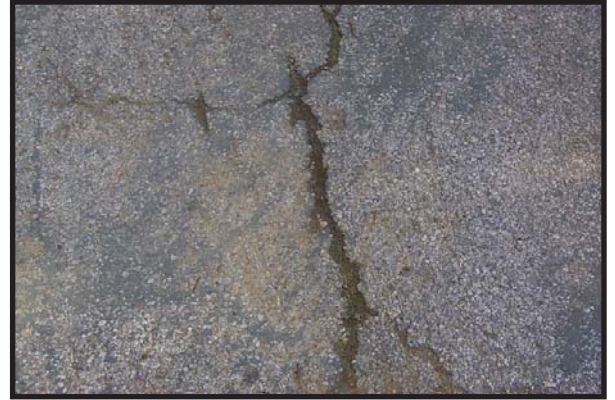
Route 0904

CHRIST CHURCH PARKING FROM CHURCH STREET

Route	Public / NonPublic	Date Visited	Area (sq ft)	Lane Miles *	Surface Type	Condition / PCR
0904	Public	5/8/2002	6212	0.11	AS	FAIR / 73

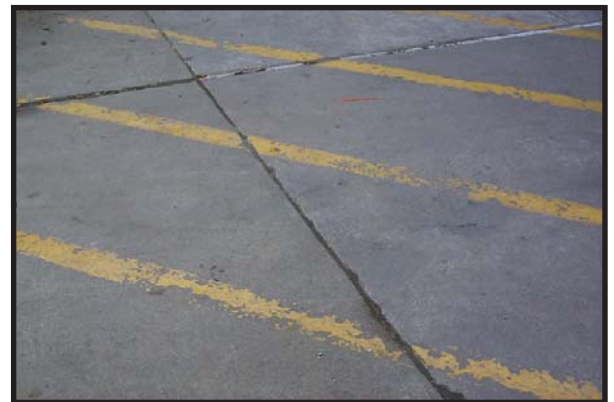
Route 0905

MAINTENANCE AREA
FROM 5TH STREET

Route	Public / NonPublic	Date Visited	Area (sq ft)	Lane Miles *	Surface Type	Condition / PCR
0905	NonPublic	5/8/2002	4589	0.08	CO	GOOD / 90
