# The Road Inventory of Indiana Dunes National Lakeshore INDU - 6300

## Road Inventory Program

Prepared By:  
Federal Highway Administration  
Eastern Federal Lands Highway Division  
Cycle 3

# Indiana Dunes National Lakeshore in Indiana

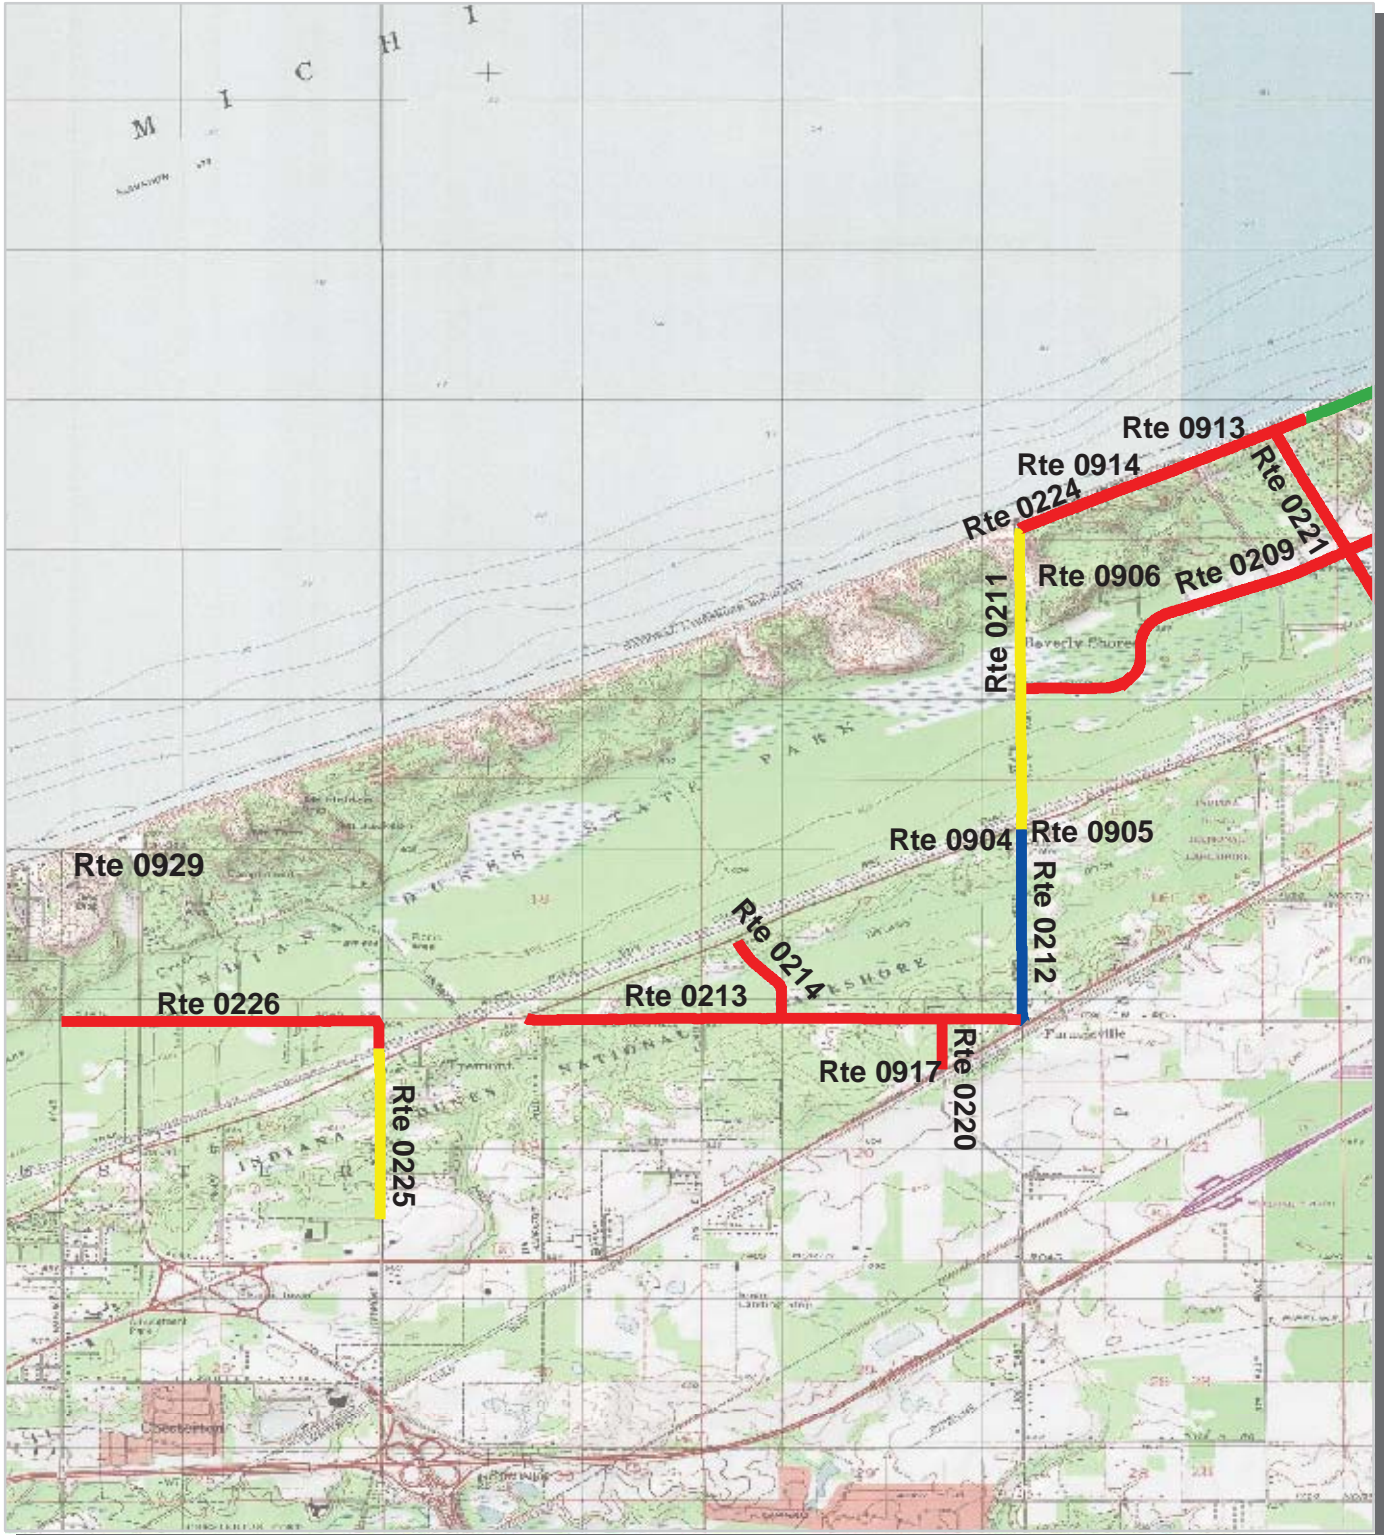
# Indiana Dunes National Lakeshore Route Condition Area Map 3 PCR - Mile by Mile

PCR	Poor	Fair	Good	Excellent
	(≤60)	(61 - 84)	(85 - 94)	(95 - 100)

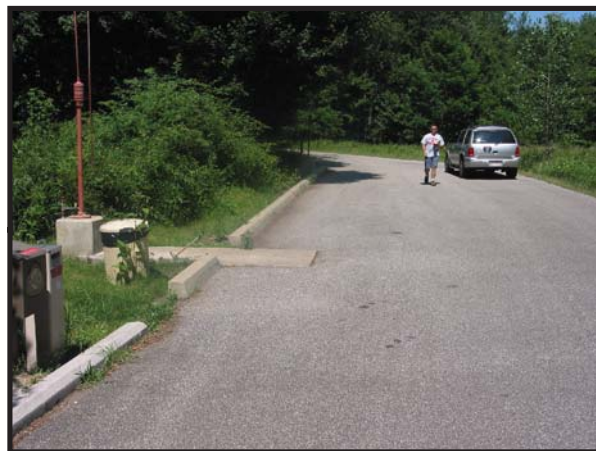
**Indiana Dunes National Lakeshore**  
**Route 0902**  
 DUNEWOOD CAMPGROUND HOST PARKING  
 Adjacent to Route 0223

Route	Public / NonPublic	Date Visited	Area (sq ft)	Lane Miles *	Surface Type	Condition / PCR
0902	Public	7/1/2003	1517	0.03	AS	GOOD / 90

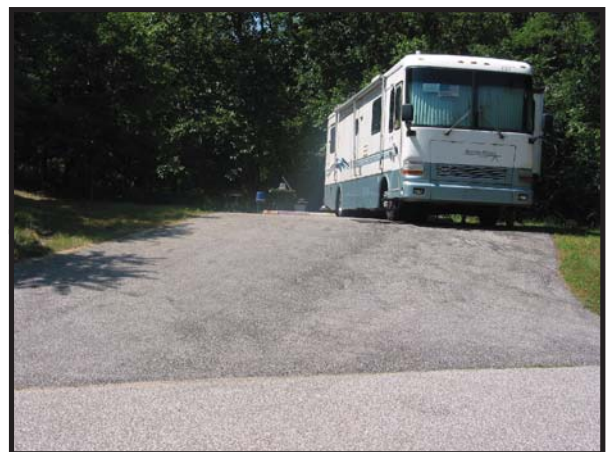
**Indiana Dunes National Lakeshore**  
**Route 0903**  
 DUNEWOOD-DOUGLAS WALK-IN PARKING  
 Adjacent to Route 0237

Route	Public / NonPublic	Date Visited	Area (sq ft)	Lane Miles *	Surface Type	Condition / PCR
0903	Public	7/2/2003	4687	0.08	AS	GOOD / 90

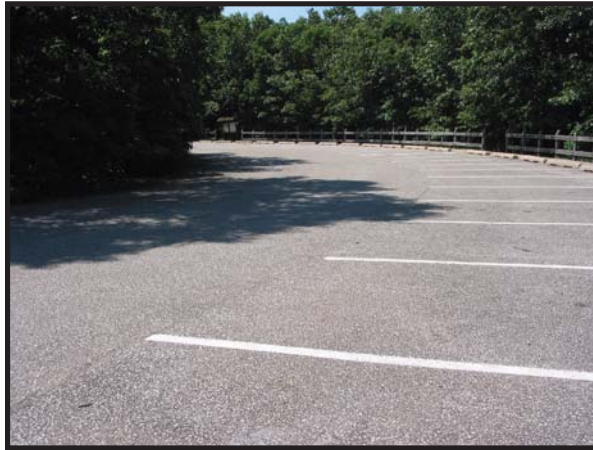
**Indiana Dunes National Lakeshore**  
**Route 0904**  
 DORTHY BUELL VISITOR CENTER PARKING  
 Adjacent to Route 0212

Route	Public / NonPublic	Date Visited	Area (sq ft)	Lane Miles *	Surface Type	Condition / PCR
0904	Public	7/2/2003	16710	0.29	OC	GOOD / 90

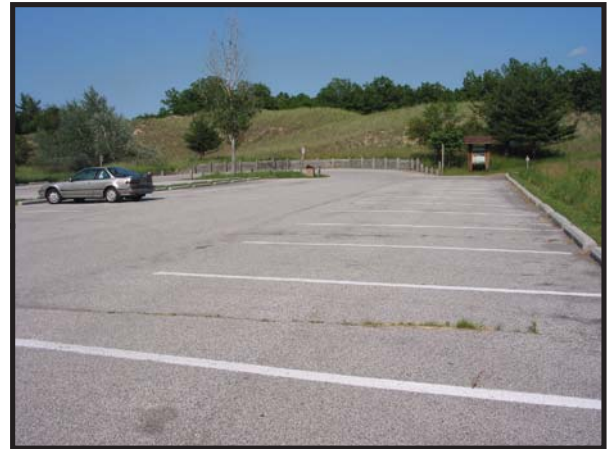
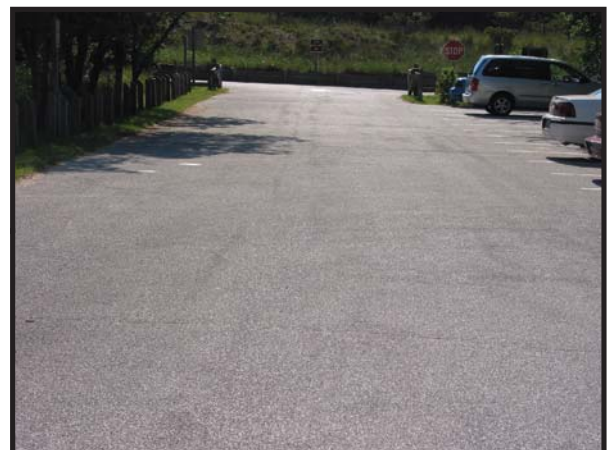
## Route 0906

Route	Public / NonPublic	Date Visited	Area (sq ft)	Lane Miles *	Surface Type	Condition / PCR
0906	Public	7/2/2003	37732	0.65	OC	FAIR / 73

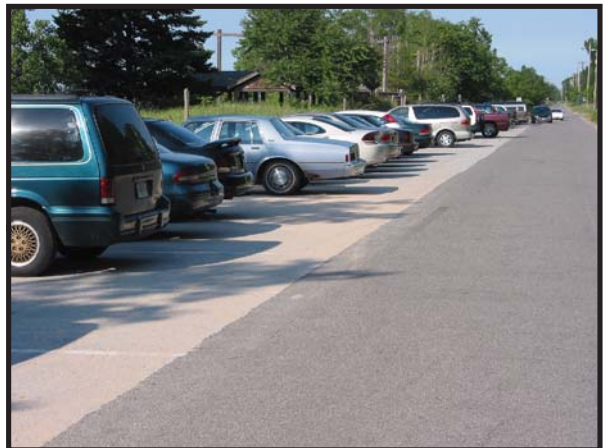
## Route 0914

ROSTONE HOUSE PARKING AREA

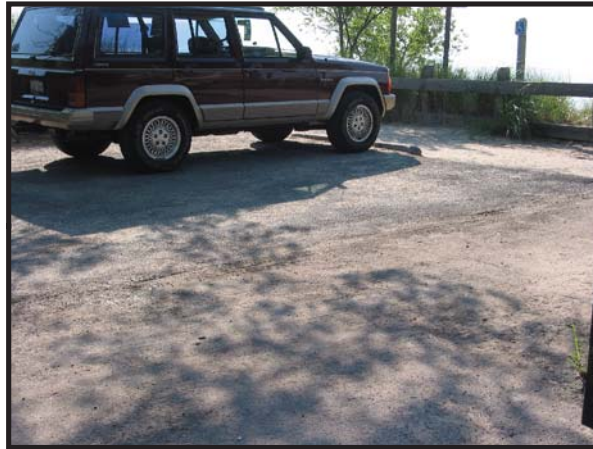
Route	Public / NonPublic	Date Visited	Area (sq ft)	Lane Miles *	Surface Type	Condition / PCR
0914	Public	6/30/2003	1992	0.03	AS	POOR / 45

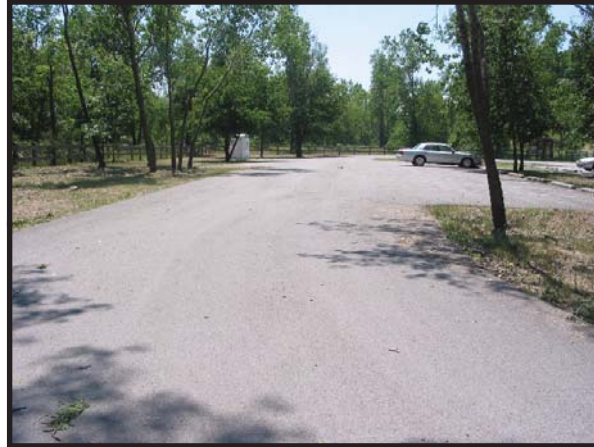
**Indiana Dunes National Lakeshore**  
**Route 0923**  
 WEST BEACH VISITOR CENTER PARKING  
 Adjacent to Route 0014

Route	Public / NonPublic	Date Visited	Area (sq ft)	Lane Miles *	Surface Type	Condition / PCR
0923	Public	7/1/2003	325671	5.61	AS	EXCELLENT / 97

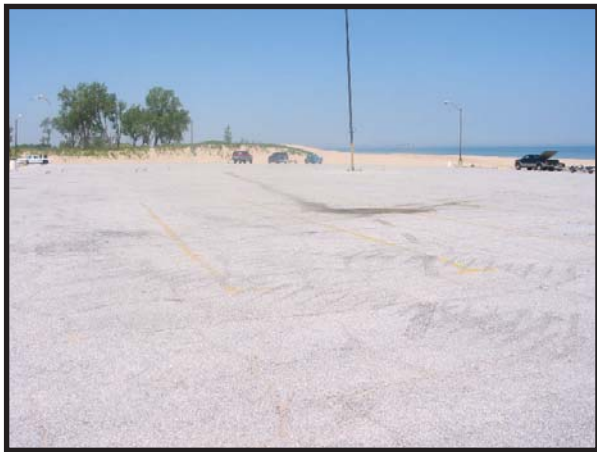
Route	Public / NonPublic	Date Visited	Area (sq ft)	Lane Miles *	Surface Type	Condition / PCR
0926	Public	6/30/2003	100609	1.73	OC	POOR / 45

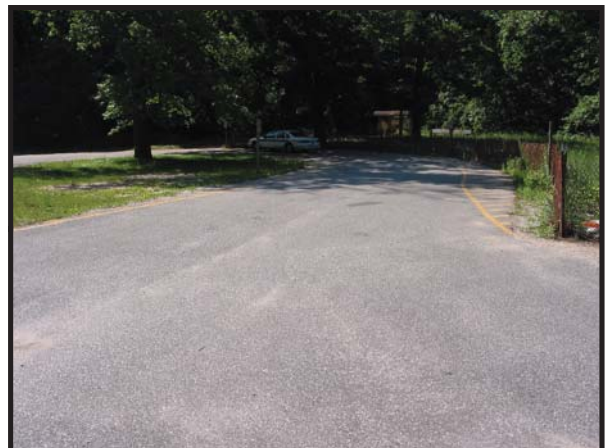
**Indiana Dunes National Lakeshore**  
**Route 0938**  
DUNBAR PARKING AREA  
Adjacent to Dunbar Street off of Route 0224

<b>Route</b>	<b>Public / NonPublic</b>	<b>Date Visited</b>	<b>Area (sq ft)</b>	<b>Lane Miles *</b>	<b>Surface Type</b>	<b>Condition / PCR</b>
0938	Public	6/30/2003	0	0.00	OC	GOOD / 90

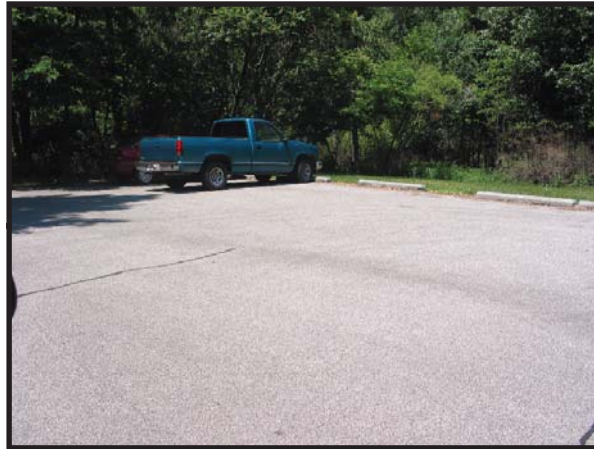
## Route 0948

Route	Public / NonPublic	Date Visited	Area (sq ft)	Lane Miles *	Surface Type	Condition / PCR
0948	Public	7/1/2003	1269	0.02	AS	GOOD / 90
