The Road Inventory of Isle Royale National Park ISRO – 6310

Prepared By:
Federal Highway Administration
Eastern Federal Lands Highway Division
Cycle 3

Isle Royale National Park in Michigan

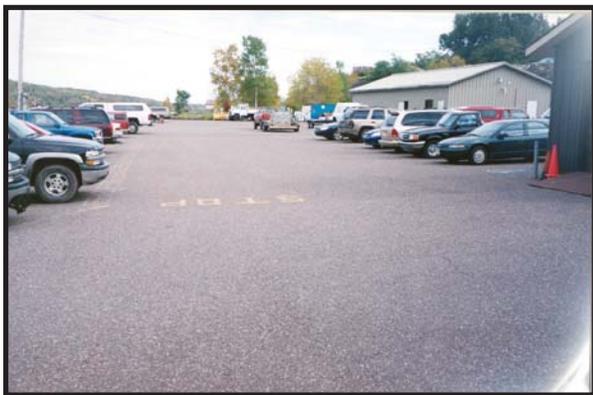
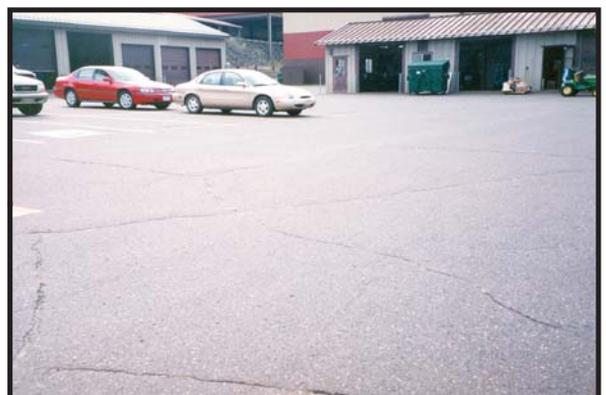
Isle Royale National Park
Route 0900
 ISLE ROYALE HEADQUARTERS PARKING AREA
 From Lake Street

Route	Public / NonPublic	Date Visited	Area (sq ft)	Lane Miles *	Surface Type	Condition / PCR
0900	Public	10/12/2004	65533	1.13	AS	GOOD / 90

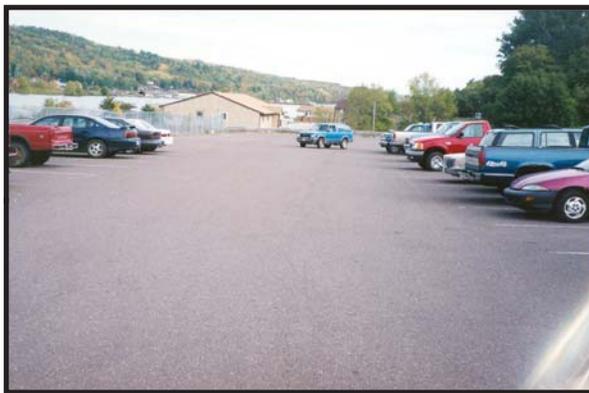
Isle Royale National Park
Route 0902
 ISLE ROYALE UPPER PARKING AREA
 From Lake Street

Route	Public / NonPublic	Date Visited	Area (sq ft)	Lane Miles *	Surface Type	Condition / PCR
0902	Public	10/12/2004	13486	0.23	AS	FAIR / 73
