**The Road Inventory  
of  
James A. Garfield National Historic Site  
JAGA - 6380**

**Road Inventory Program**

Prepared By:  
Federal Highway Administration  
Eastern Federal Lands Highway Division  
Cycle 3

# James A. Garfield National Historic Site in Ohio

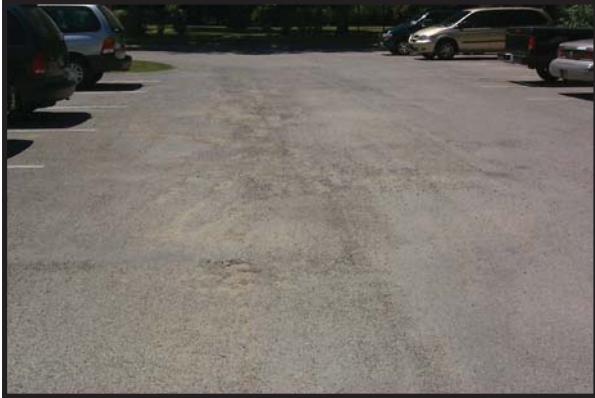
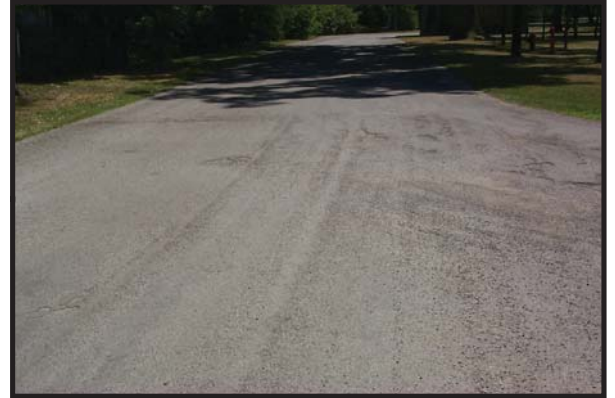
## Route 0900

VISITOR CENTER PARKING  
FROM US20 (MENTOR AVENUE)

Route	Public / NonPublic	Date Visited	Area (sq ft)	Lane Miles *	Surface Type	Condition / PCR
0900	Public	7/13/2001	24773	0.43	AS	FAIR / 73
