The Road Inventory of Jewel Cave National Monument JECA – 1569

Road Inventory Program

Prepared By:
Federal Highway Administration
Eastern Federal Lands Highway Division
Cycle 3

Jewel Cave National Monument in South Dakota

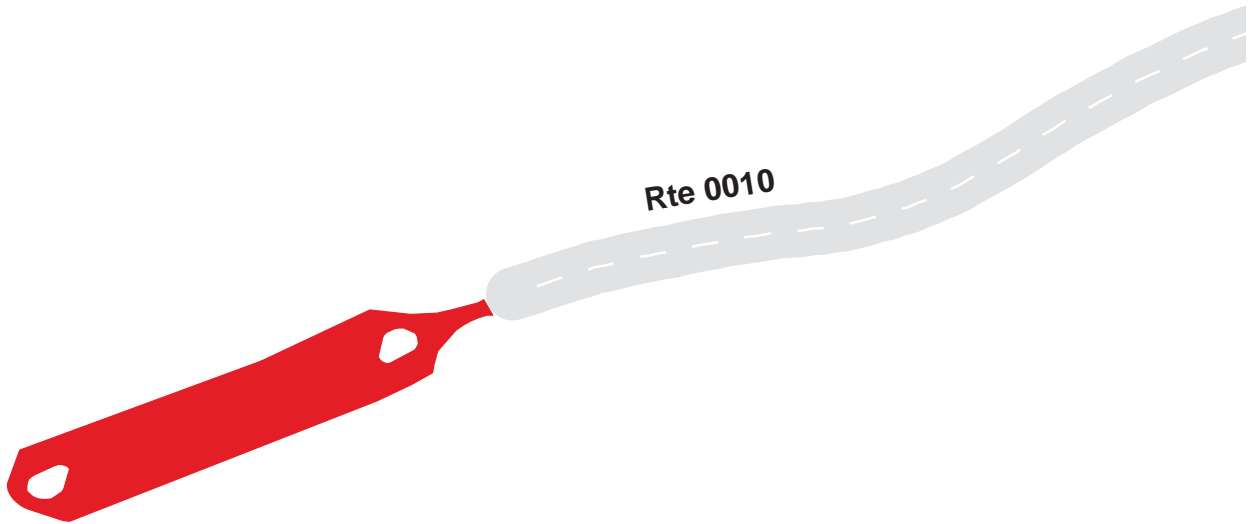
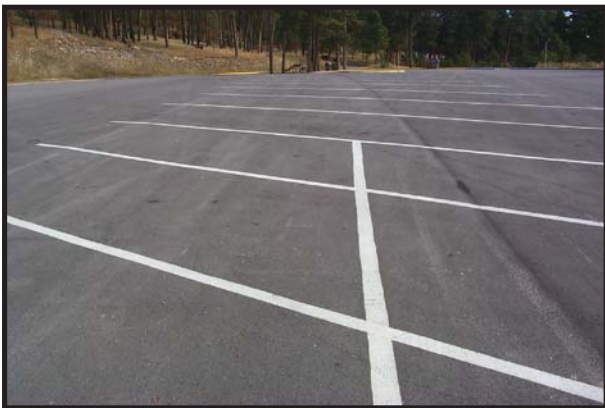
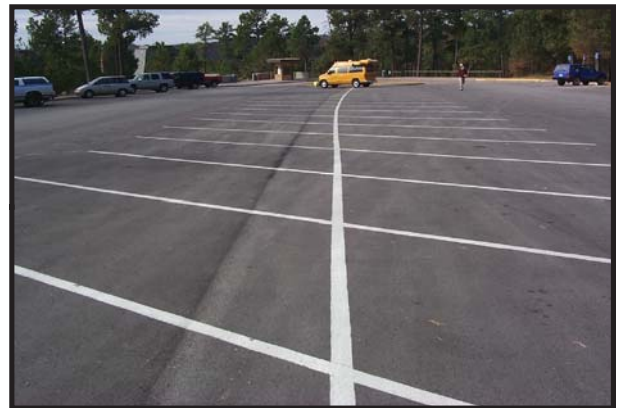
| Route | Public / NonPublic | Date Visited | Area (sq ft) | Lane Miles * | Surface Type | Condition / PCR |
|---|---|---|---|---|---|---|
| 0900 | Public | 10/14/2001 | 68854 | 1.19 | AS | GOOD / 90 |

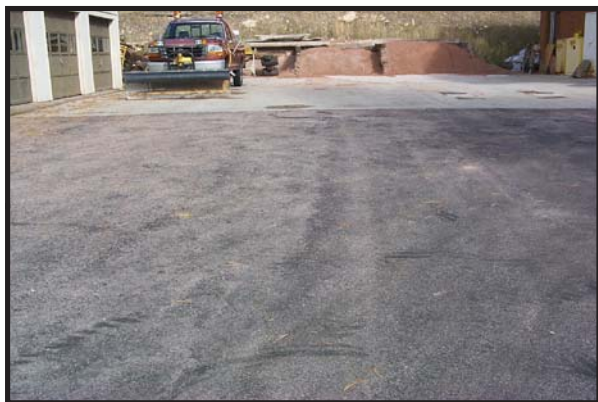
Route 0901

| Route | Public / NonPublic | Date Visited | Area (sq ft) | Lane Miles * | Surface Type | Condition / PCR |
|---|---|---|---|---|---|---|
| 0901 | NonPublic | 10/14/2001 | 8950 | 0.15 | OC | FAIR / 73 |

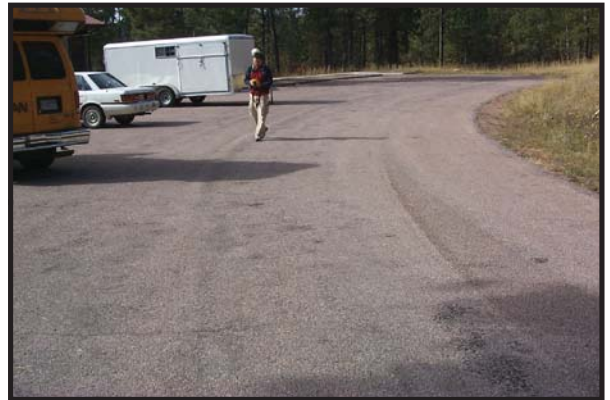
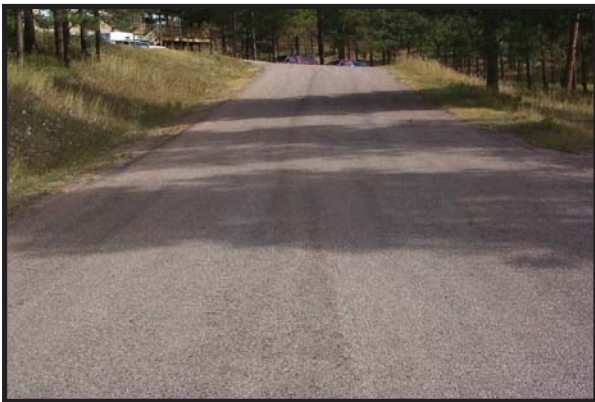
Route 0902

| Route | Public / NonPublic | Date Visited | Area (sq ft) | Lane Miles * | Surface Type | Condition / PCR |
|---|---|---|---|---|---|---|
| 0902 | NonPublic | 10/14/2001 | 11227 | 0.19 | OC | FAIR / 73 |

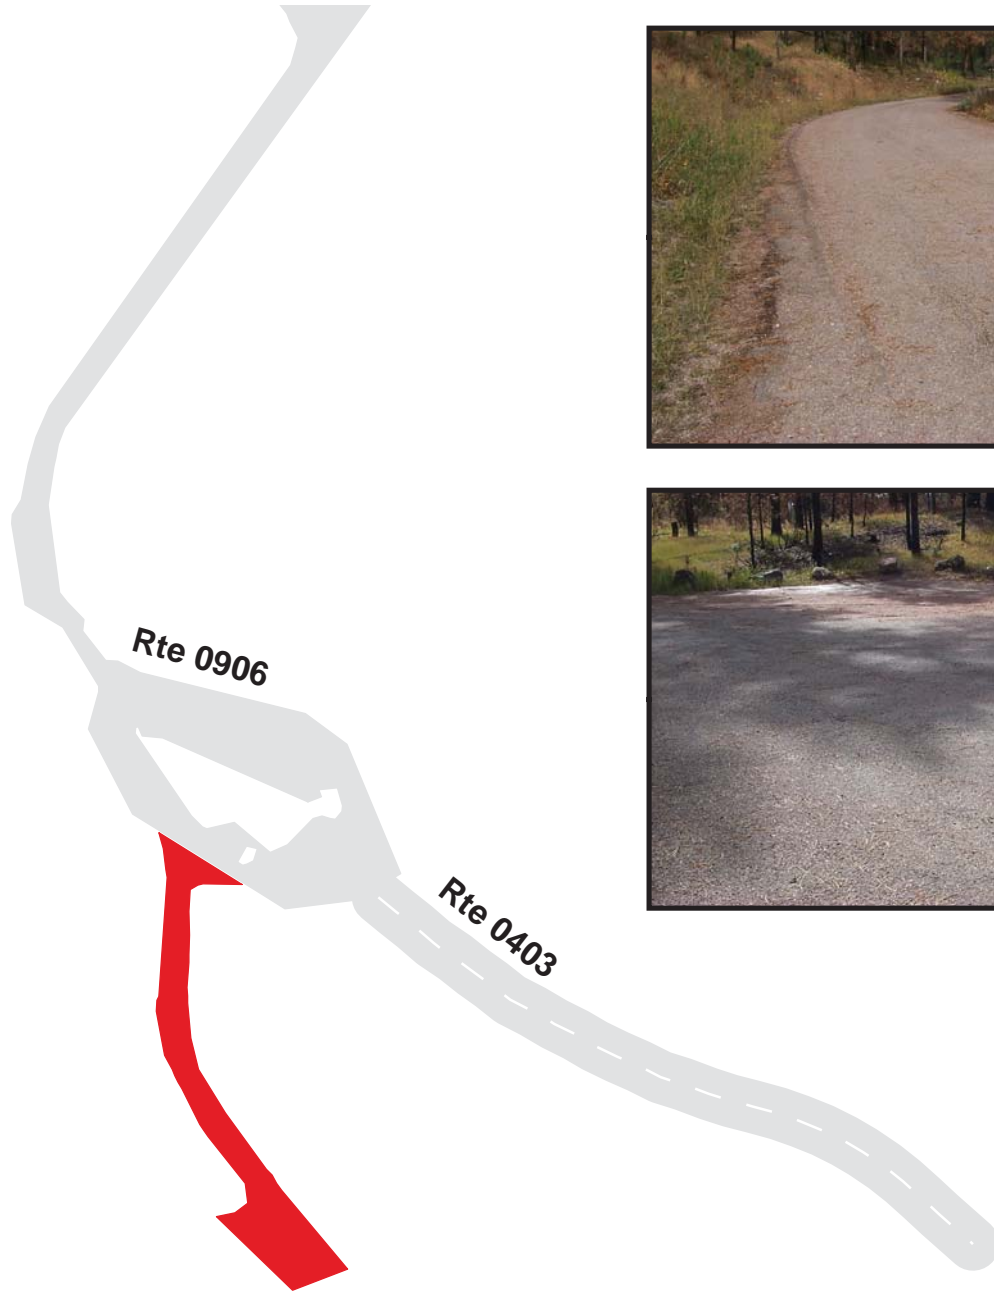
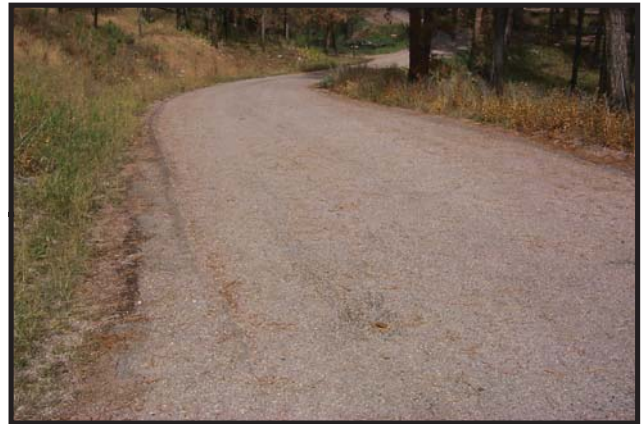
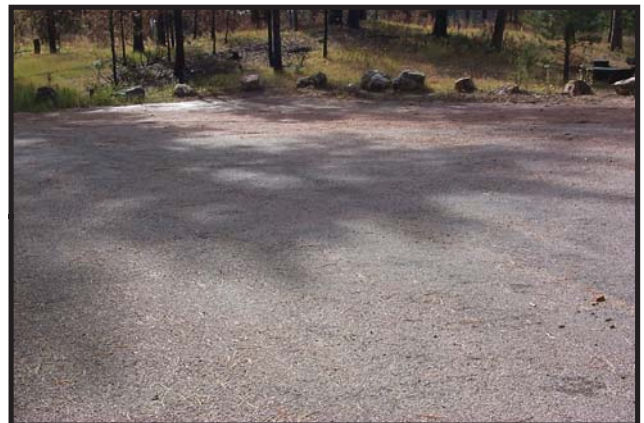
Route 0905

| Route | Public / NonPublic | Date Visited | Area (sq ft) | Lane Miles * | Surface Type | Condition / PCR |
|---|---|---|---|---|---|---|
| 0905 | Public | 10/14/2001 | 7190 | 0.12 | OC | FAIR / 73 |

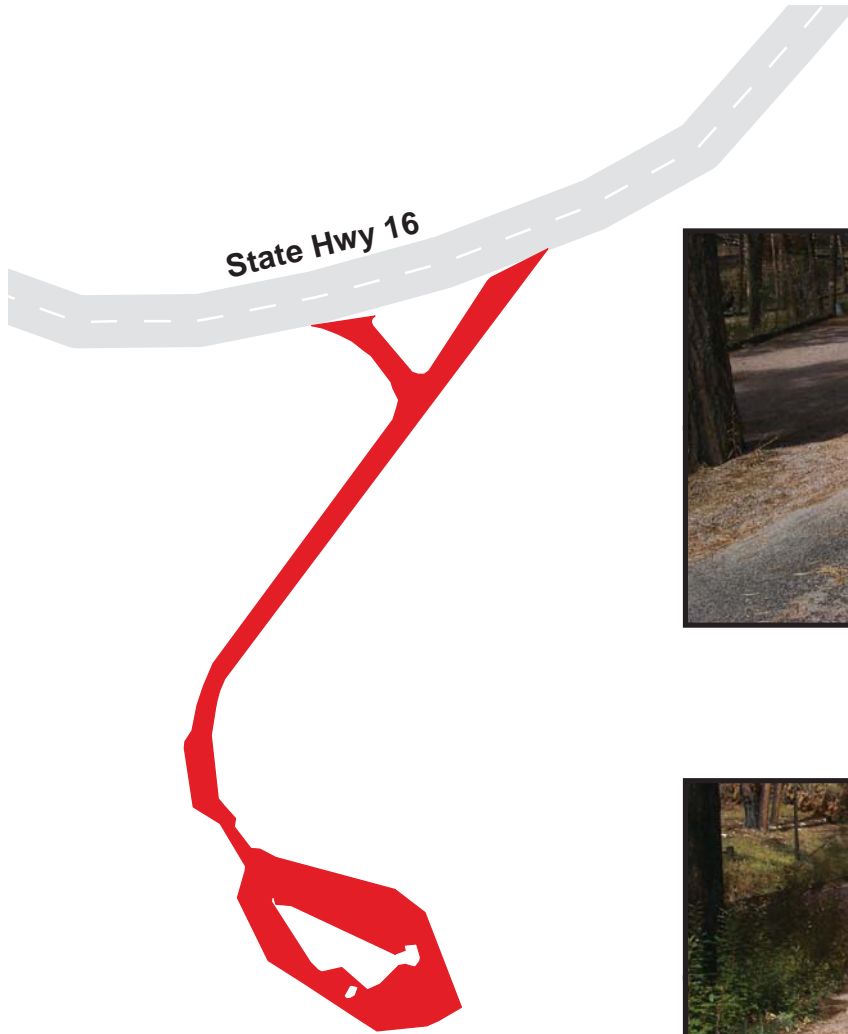
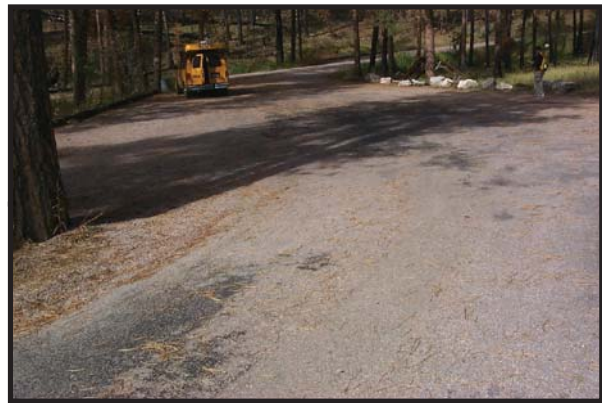
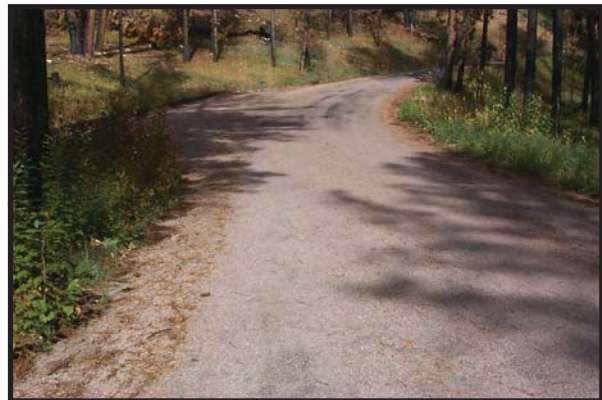
Route 0906

| Route | Public / NonPublic | Date Visited | Area (sq ft) | Lane Miles * | Surface Type | Condition / PCR |
|---|---|---|---|---|---|---|
| 0906 | Public | 10/14/2001 | 29126 | 0.50 | OC | FAIR / 73 |
