The Road Inventory of Jefferson National Expansion Memorial JEFF - 6520

Road Inventory Program

Prepared By:
Federal Highway Administration
Eastern Federal Lands Highway Division
Cycle 3

Jefferson Nation Expansion Memorial in Missouri

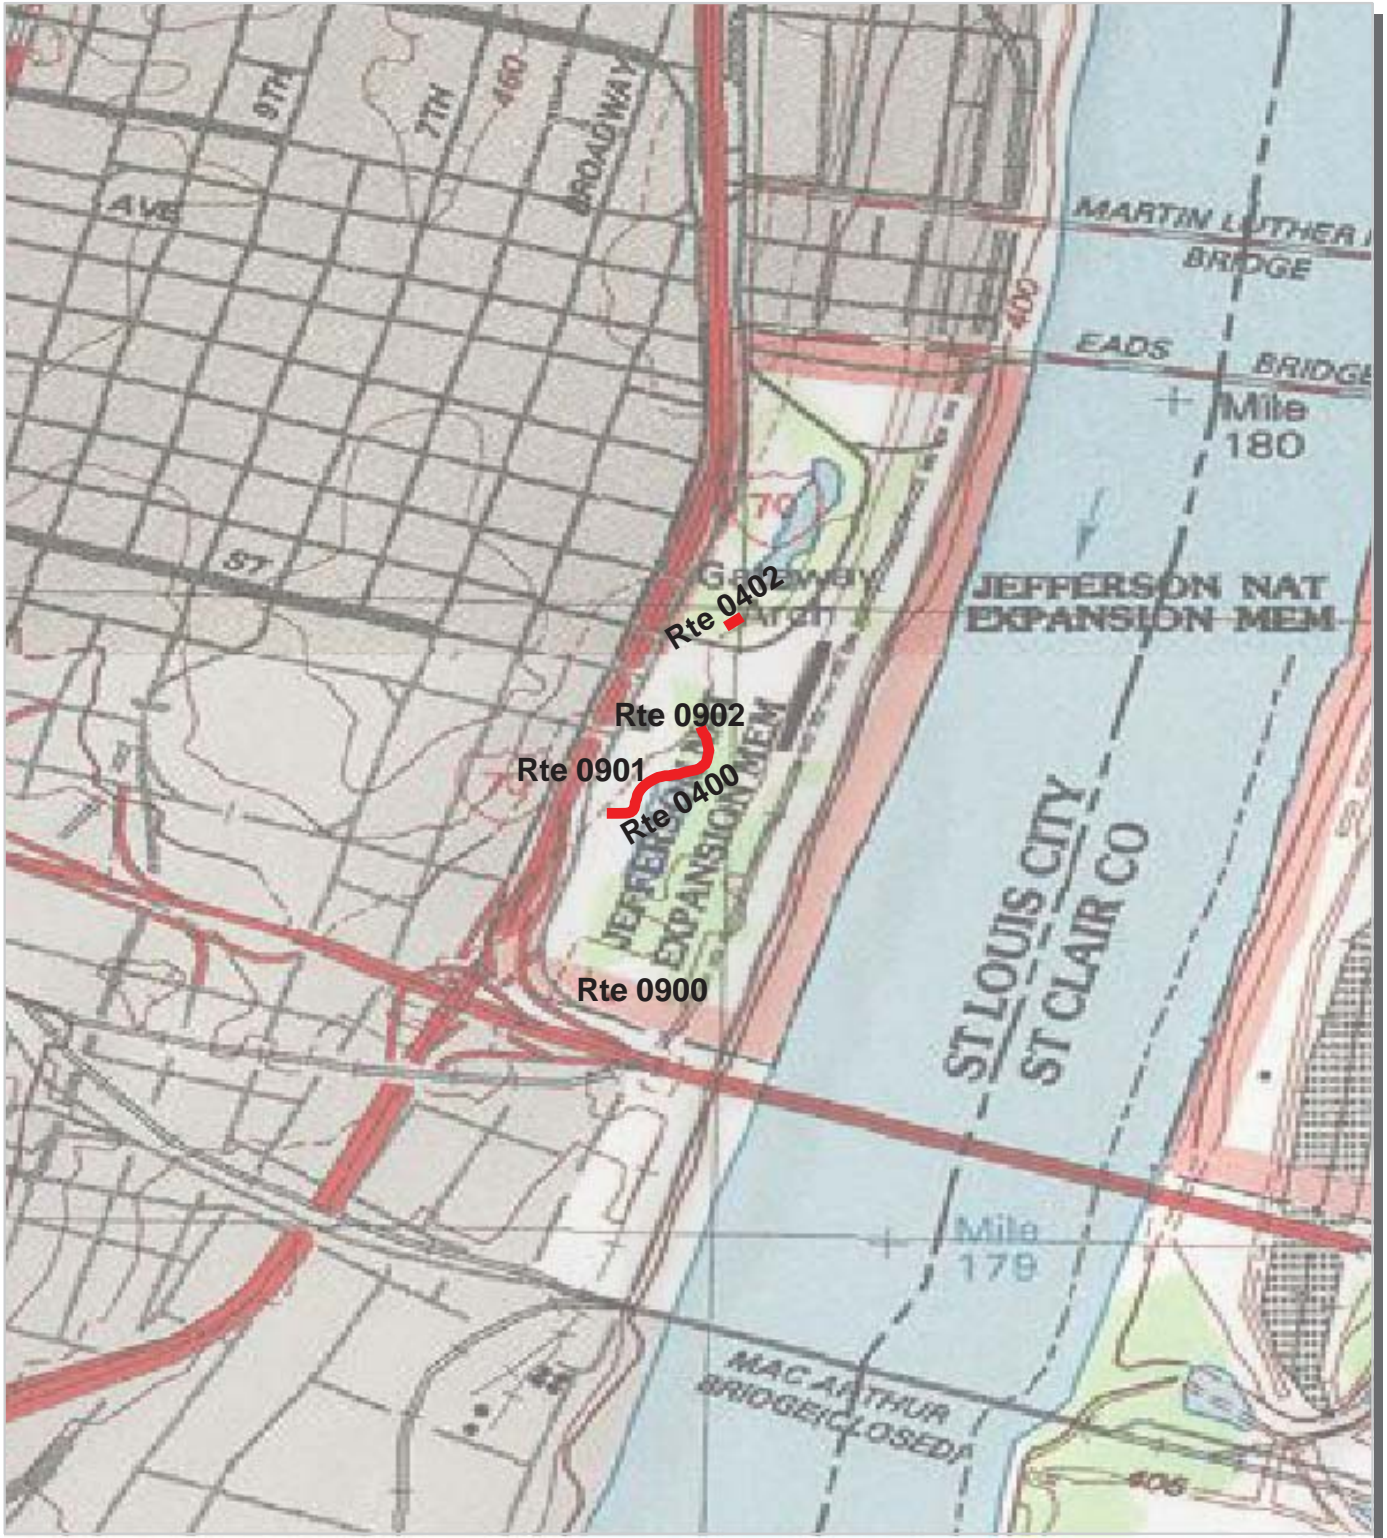
Jefferson National Expansion Memorial Route Condition Key Map PCR - Mile by Mile

PCR	Poor	Fair	Good	Excellent

(<=60)	(61 - 84)	(85 - 94)	(95 - 100)

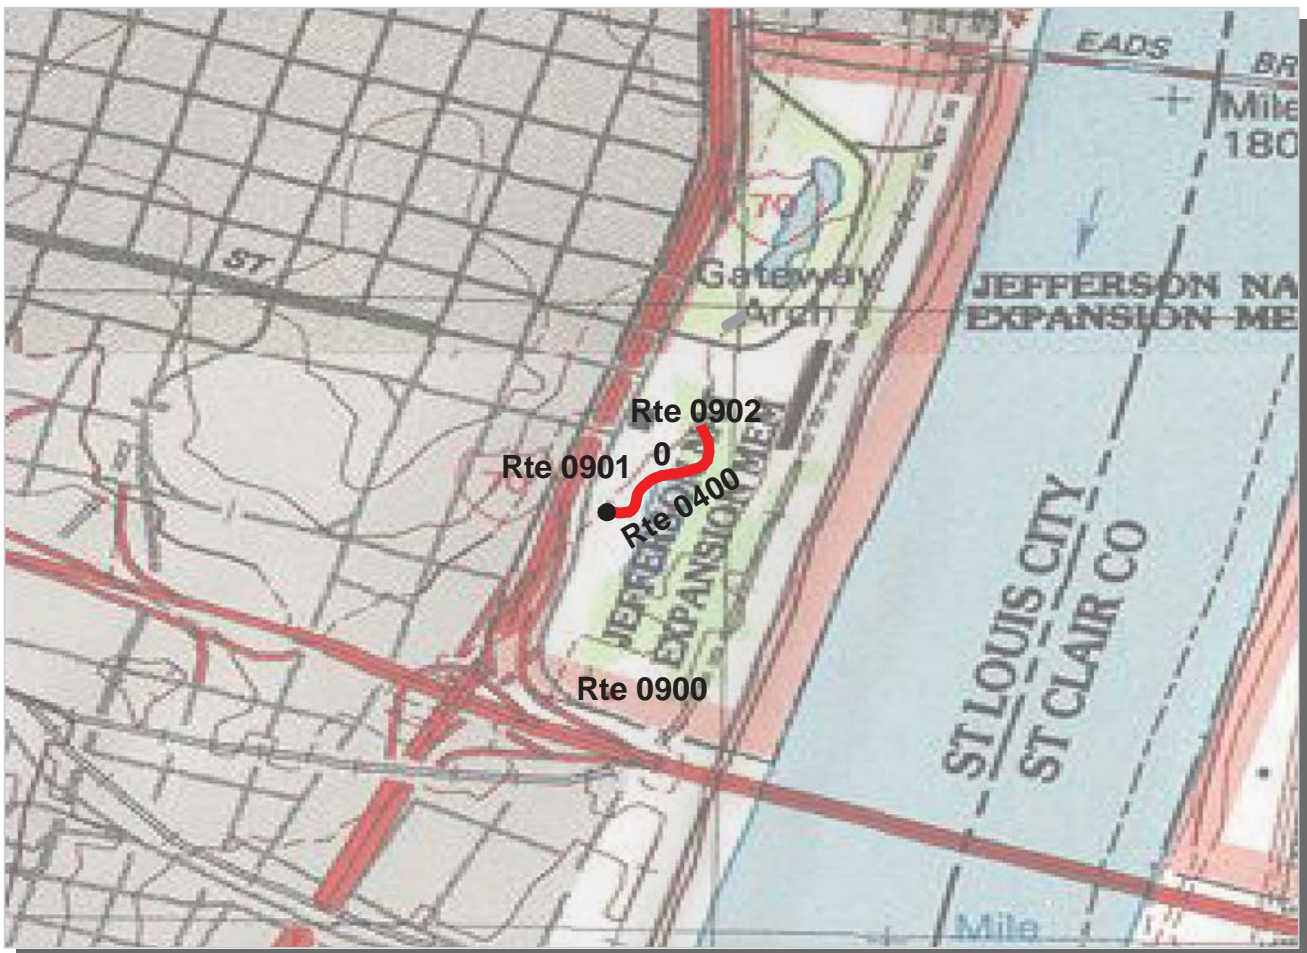
ROUTE: 0400 Visitor Center Service Road

Section Number	0				
Section Length (mi)	0.16				
AADT	**				
SADT	**				
ADT Date	**				
Cross Section Information					
Number of Lanes	1				
Paved Width (ft)	12				
Lane Width (ft)	12				
Shoulder Width (ft)	0				
Roadway Condition Information					
PCR (Pavement Condition Rating)	4				
RCI (Roughness Condition Index)	22				
SCR (Surface Condition Rating)	2				
Alligator Cracking Index	100				
Rutting Index	2				
Patching Index	99				
Transverse Cracking Index	100				
Longitudinal Cracking Index	100				
Shoulder Condition Rating	N/A				
Drainage Condition Rating	GOOD

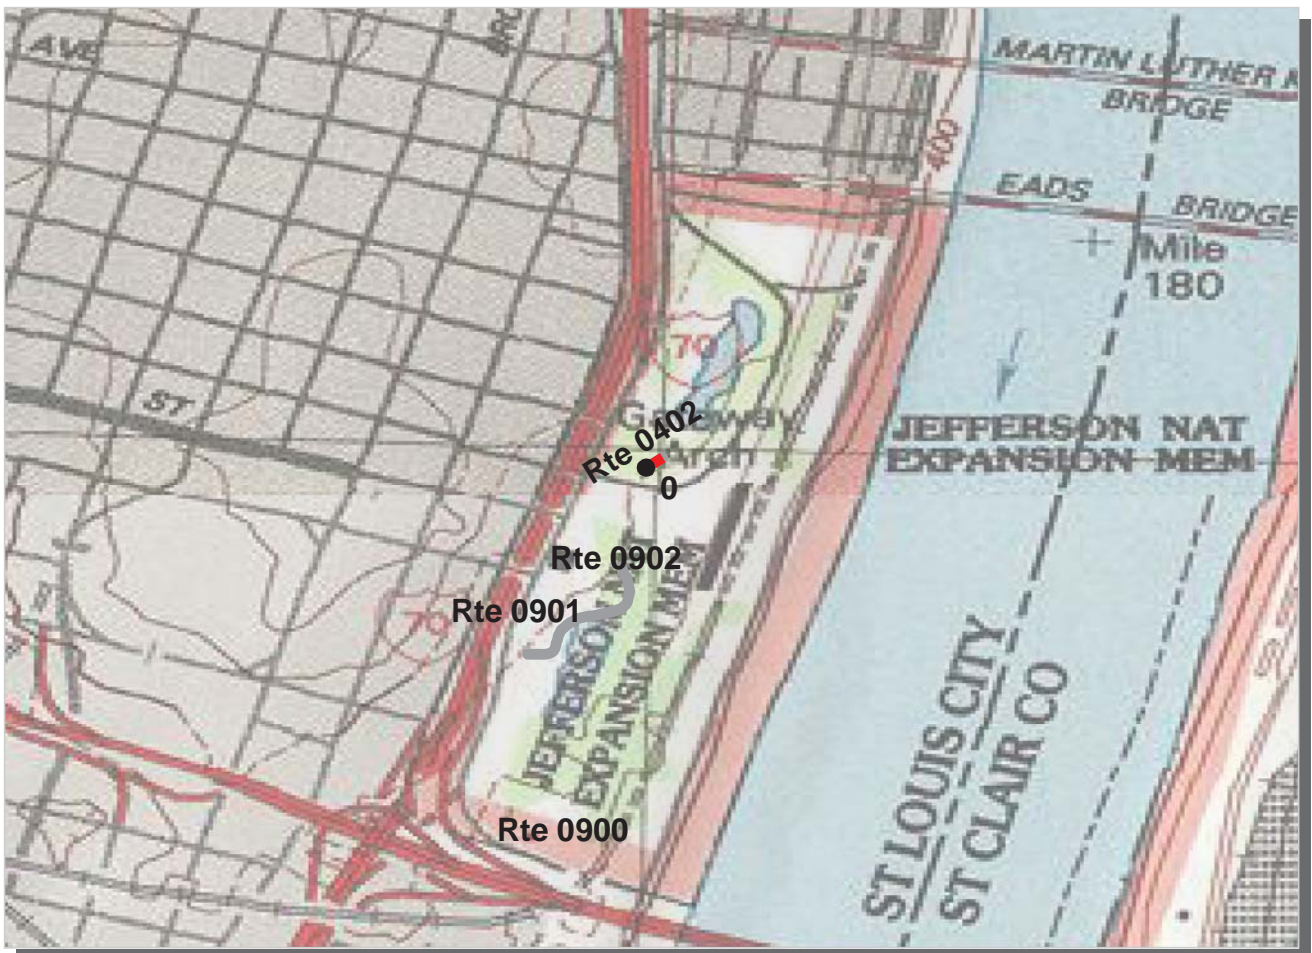
Section Number	0				
Section Length (mi)	0.03				
AADT	**				
SADT	**				
ADT Date	**				
Cross Section Information					
Number of Lanes	1				
Paved Width (ft)	9				
Lane Width (ft)	9				
Shoulder Width (ft)	0				
Roadway Condition Information					
PCR (Pavement Condition Rating)	27				
RCI (Roughness Condition Index)	NC				
SCR (Surface Condition Rating)	27				
Alligator Cracking Index	100				
Rutting Index	27				
Patching Index	100				
Transverse Cracking Index	100				
Longitudinal Cracking Index	100				
Shoulder Condition Rating	N/A				
Drainage Condition Rating	GOOD

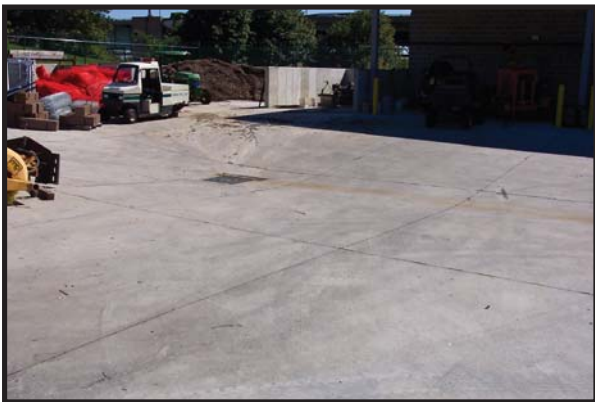
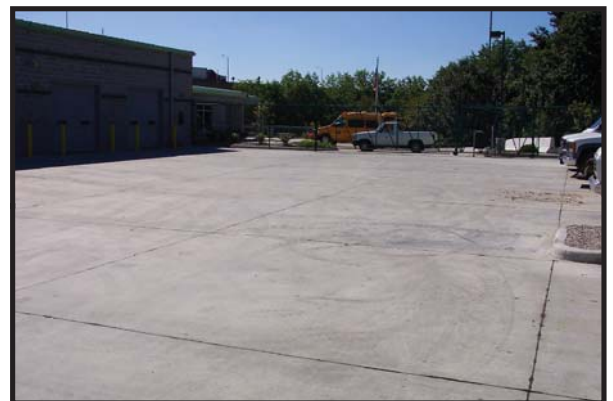
Route	Public / NonPublic	Date Visited	Area (sq ft)	Lane Miles *	Surface Type	Condition / PCR
0900	NonPublic	9/5/2003	19783	0.34	CO	GOOD / 90

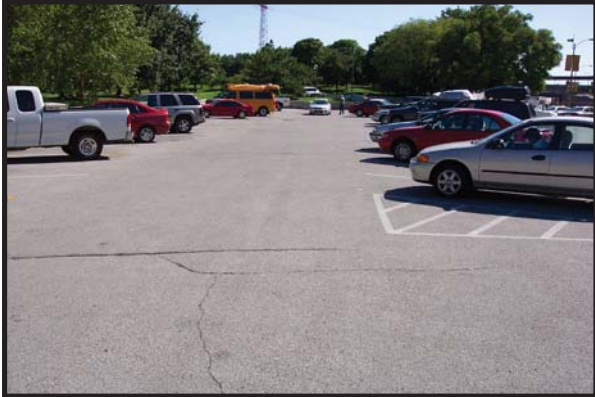
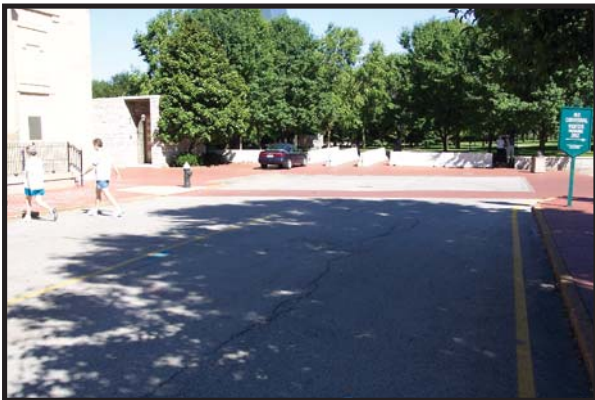
Route 0901

Route	Public / NonPublic	Date Visited	Area (sq ft)	Lane Miles *	Surface Type	Condition / PCR
0901	Public	9/5/2003	32546	0.56	AS	FAIR / 73

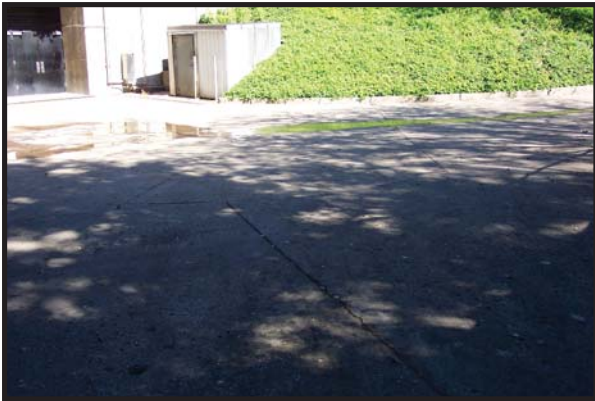
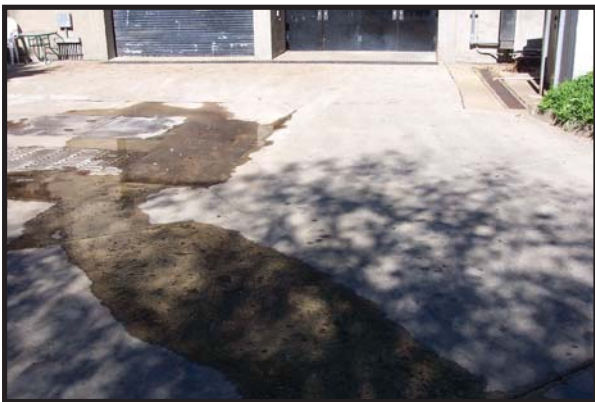
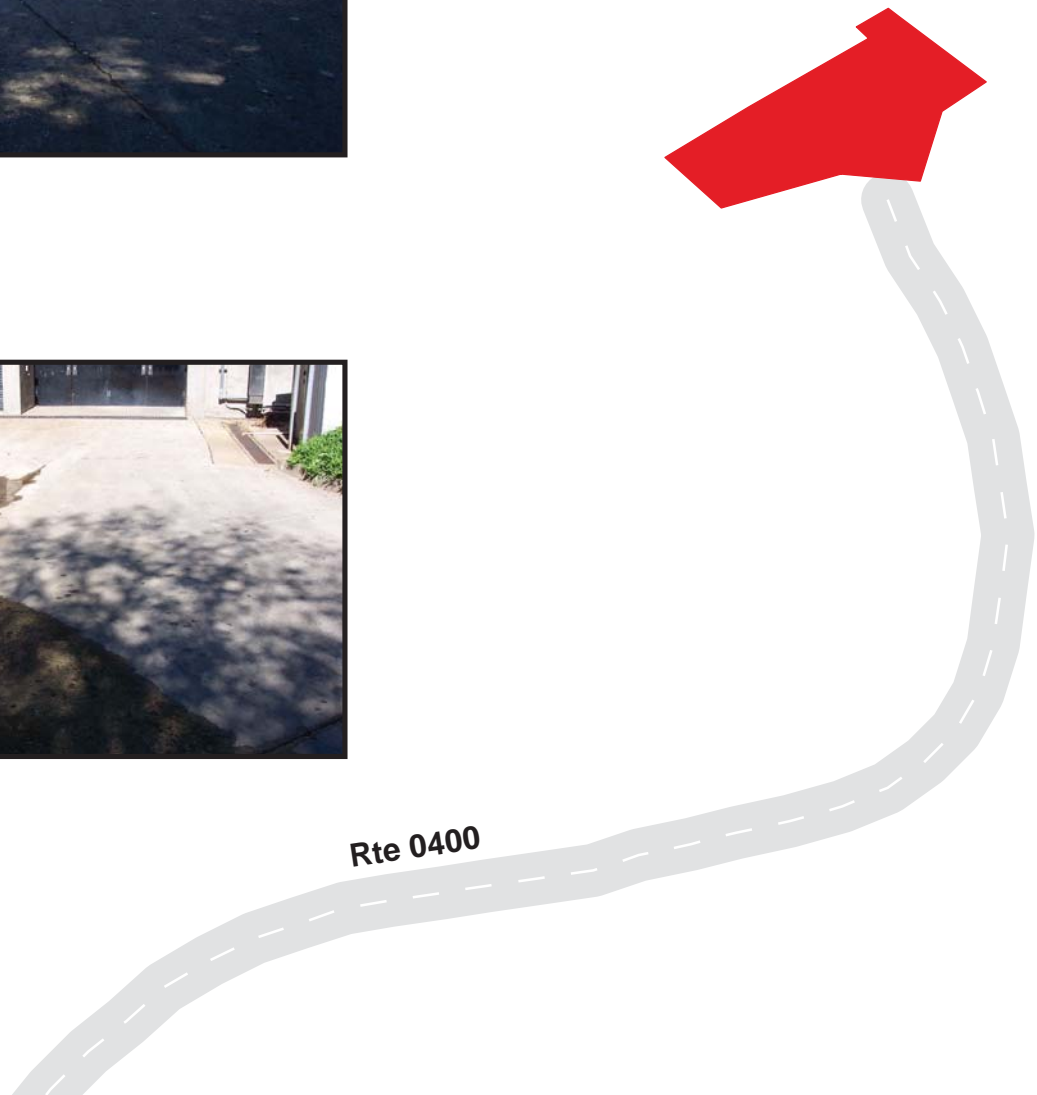
Route 0902

Route	Public / NonPublic	Date Visited	Area (sq ft)	Lane Miles *	Surface Type	Condition / PCR
0902	NonPublic	9/5/2003	3232	0.06	CO	GOOD / 90
