**The Road Inventory
of
Jean Lafitte National Historical Park & Preserve
JELA - 7530**

Road Inventory Program

Prepared By:
Federal Highway Administration
Eastern Federal Lands Highway Division
Cycle 3

Jean Lafitte National Historic Park and Preserve in Louisiana

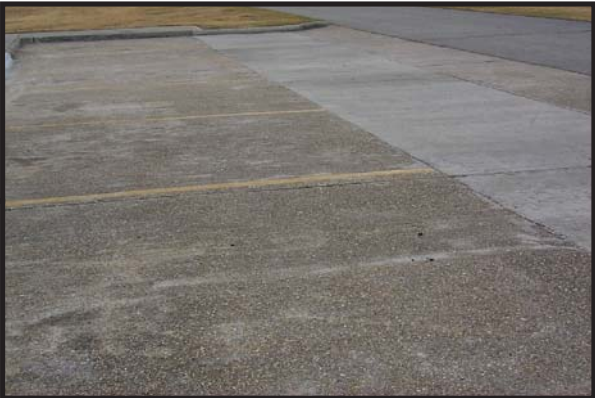
Route	Public / NonPublic	Date Visited	Area (sq ft)	Lane Miles *	Surface Type	Condition / PCR
0900	Public	1/11/2002	2125	0.04	CO	FAIR / 73

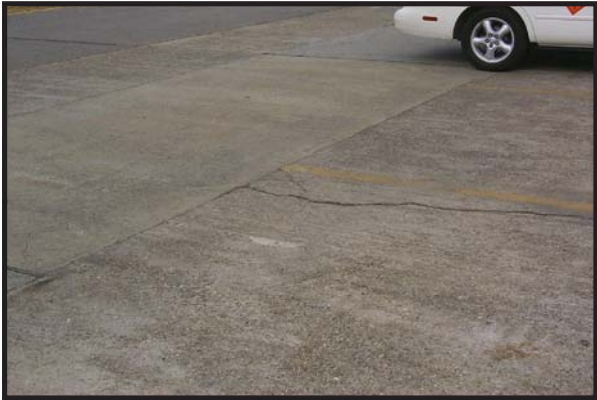
Route 0901

Route	Public / NonPublic	Date Visited	Area (sq ft)	Lane Miles *	Surface Type	Condition / PCR
0901	Public	1/11/2002	1543	0.03	CO	FAIR / 73

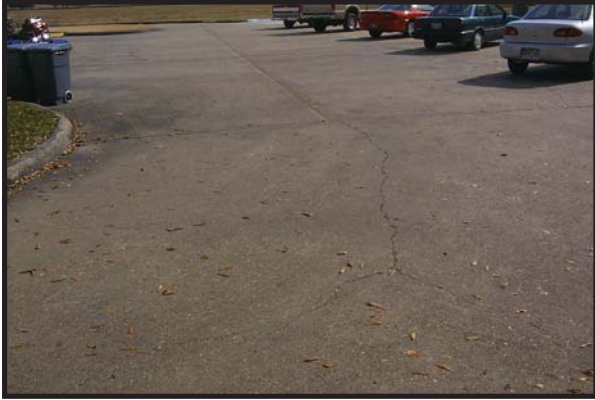
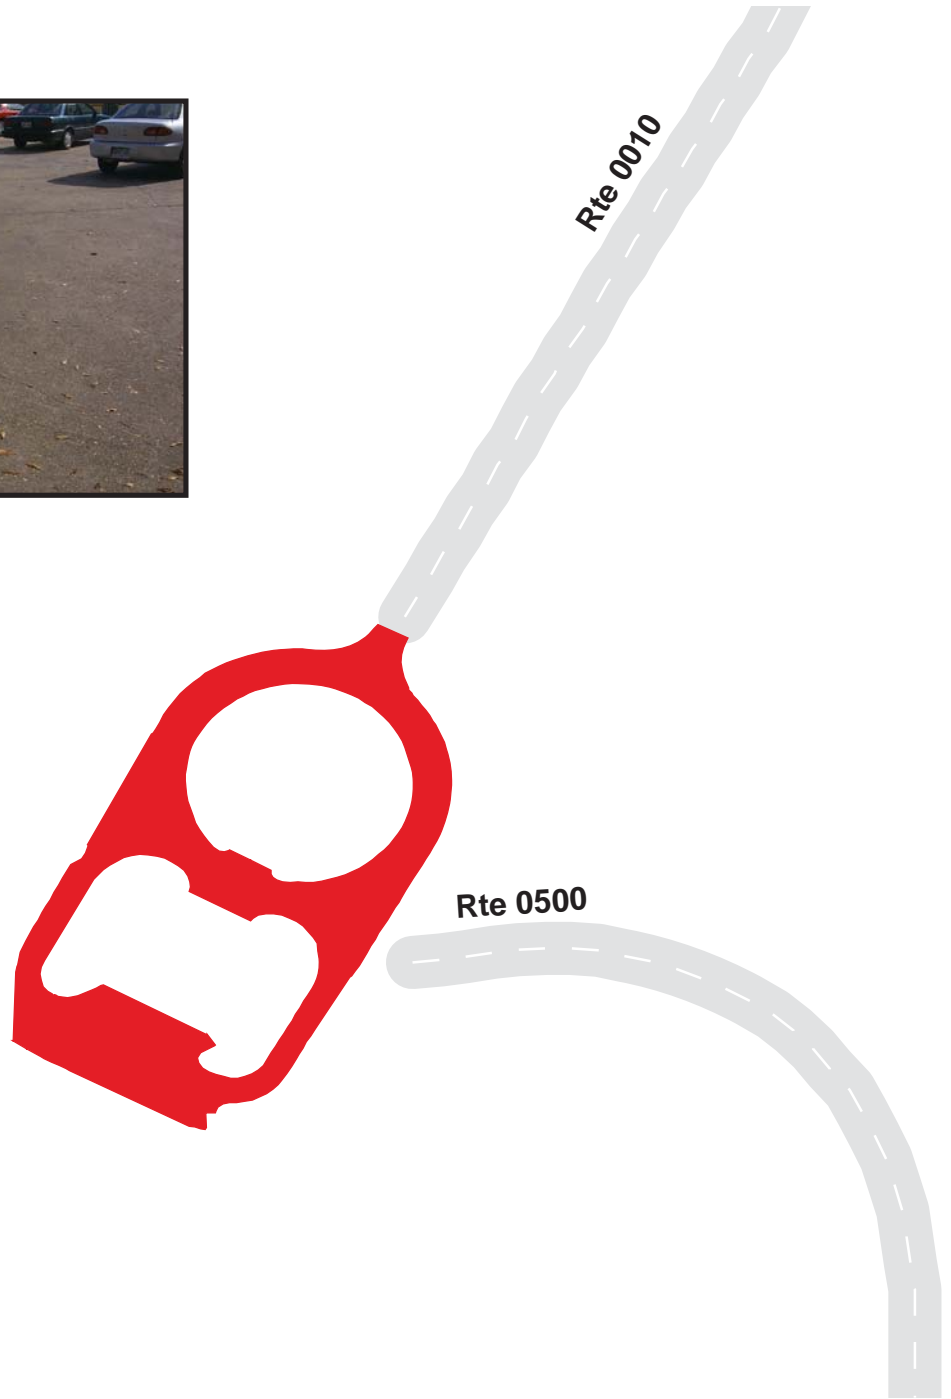
Jean Lafitte National Historical Park & Preserve
Route 0902
 CHALMETTE BATTLEFIELD VISITORS CENTER PARKING
 From Route 0010

Route	Public / NonPublic	Date Visited	Area (sq ft)	Lane Miles *	Surface Type	Condition / PCR
0902	Public	1/11/2002	27424	0.47	CO	FAIR / 73

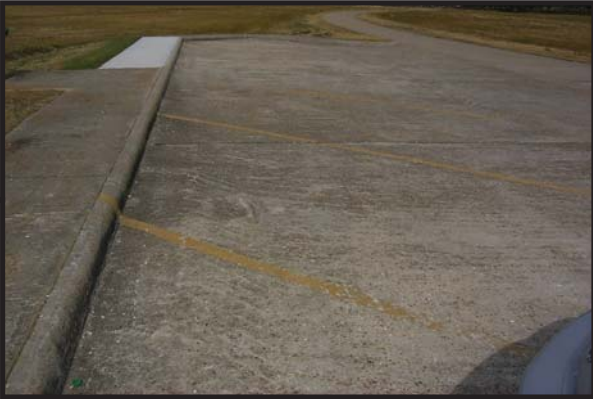
Route 0904

Route	Public / NonPublic	Date Visited	Area (sq ft)	Lane Miles *	Surface Type	Condition / PCR
0904	Public	1/11/2002	2126	0.04	CO	GOOD / 90

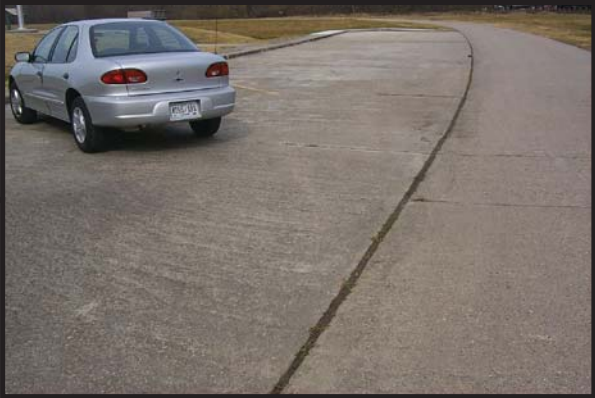
Route	Public / NonPublic	Date Visited	Area (sq ft)	Lane Miles *	Surface Type	Condition / PCR
0905	Public	1/11/2002	3484	0.06	CO	GOOD / 90

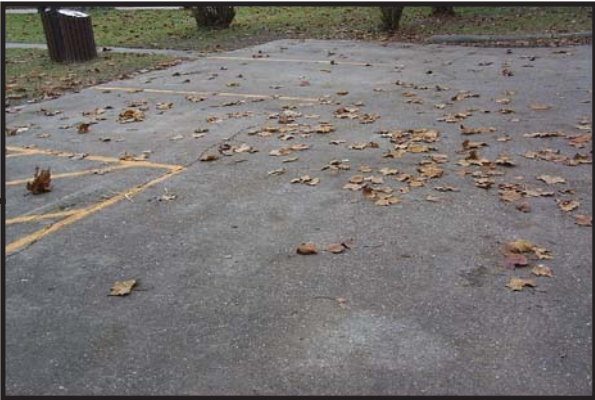
Route 0906

Route	Public / NonPublic	Date Visited	Area (sq ft)	Lane Miles *	Surface Type	Condition / PCR
0906	NonPublic	1/11/2002	896	0.02	CO	GOOD / 90

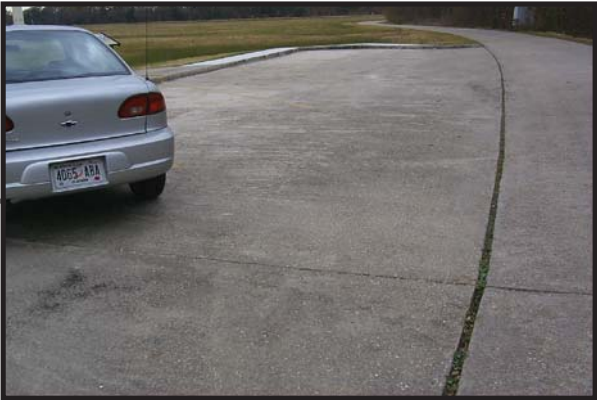
Route 0907

Route	Public / NonPublic	Date Visited	Area (sq ft)	Lane Miles *	Surface Type	Condition / PCR
0907	Public	1/11/2002	2085	0.04	CO	GOOD / 90

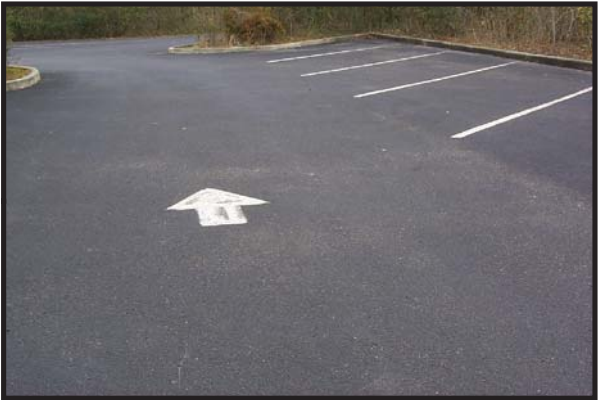
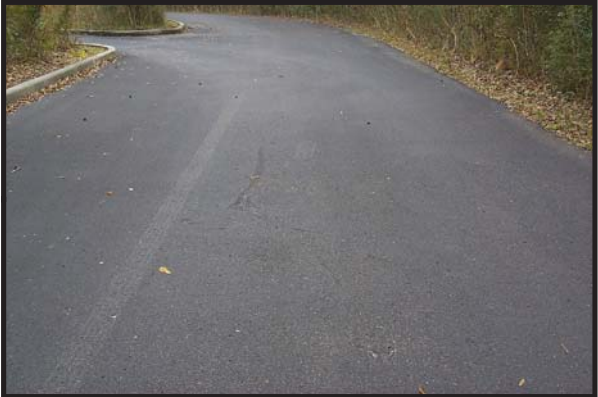
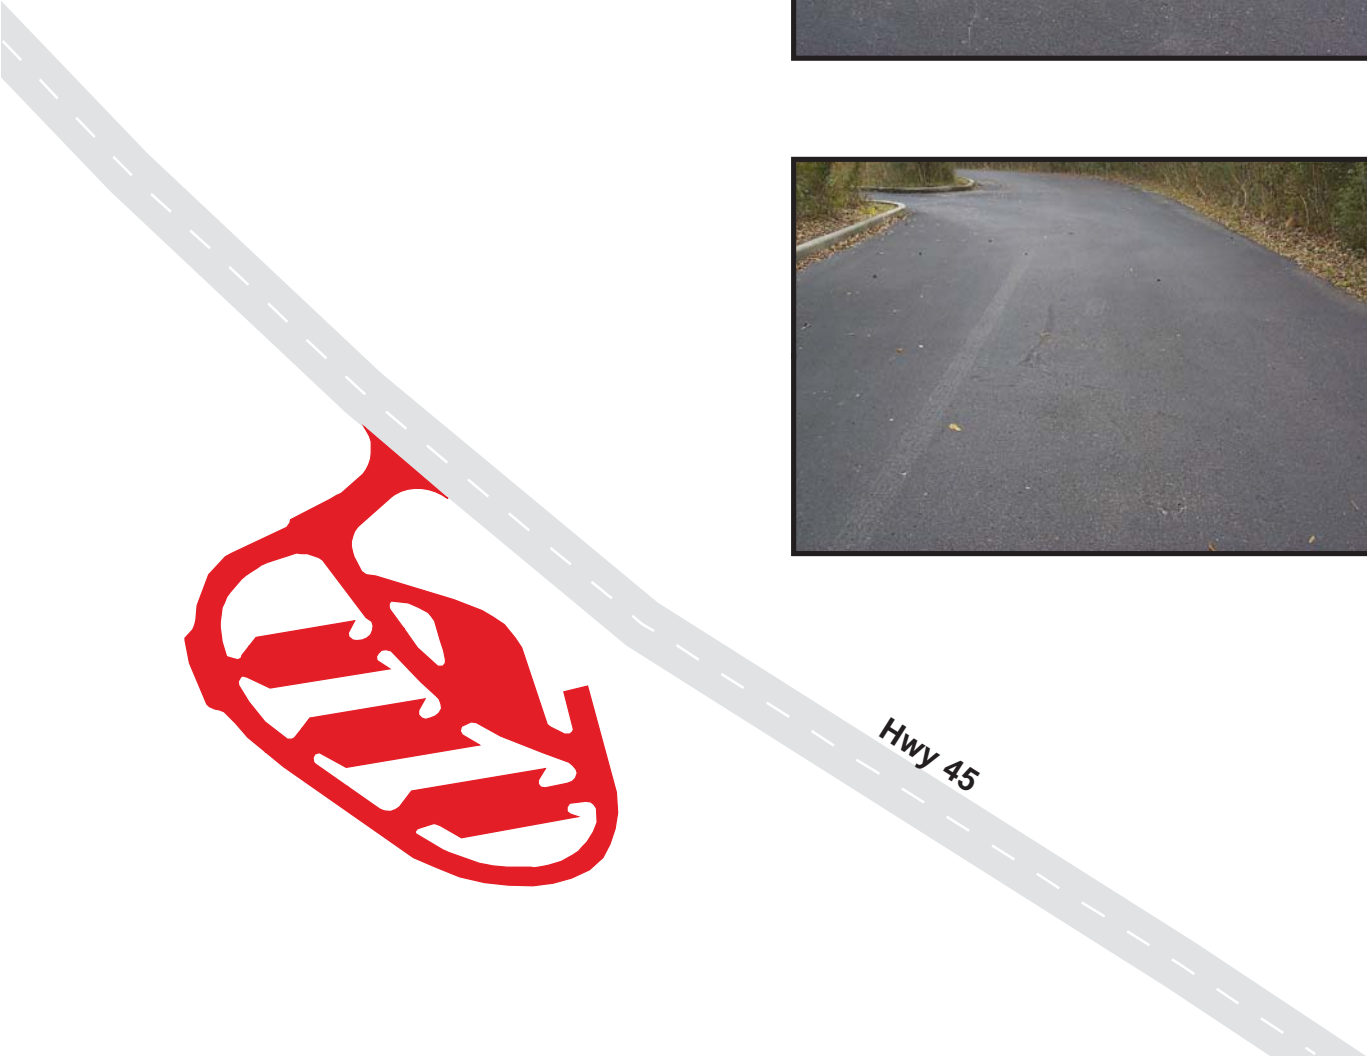
Route 0909

Route	Public / NonPublic	Date Visited	Area (sq ft)	Lane Miles *	Surface Type	Condition / PCR
0909	Public	1/11/2002	47086	0.81	AS	EXCELLENT / 97

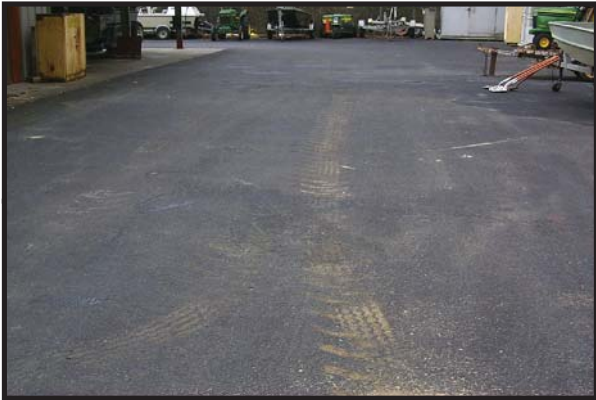
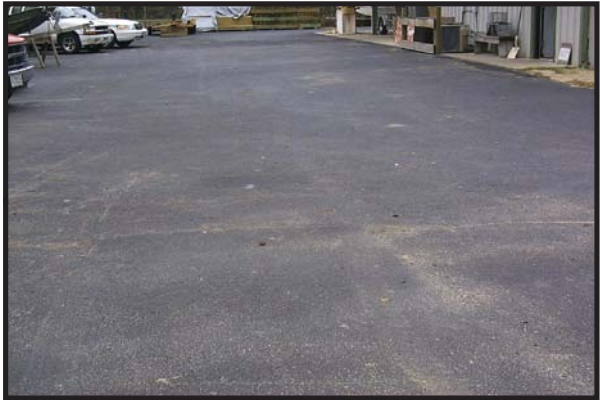
Route 0910

Route	Public / NonPublic	Date Visited	Area (sq ft)	Lane Miles *	Surface Type	Condition / PCR
0910	NonPublic	1/11/2002	24362	0.42	AS	GOOD / 90

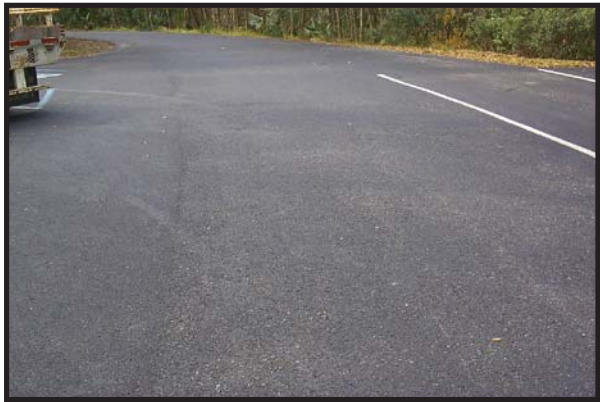
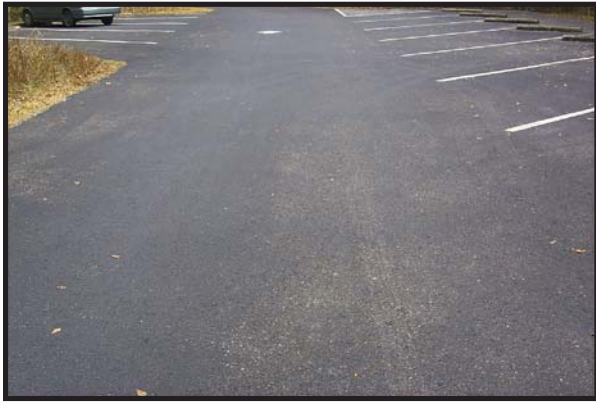
Route 0911

Route	Public / NonPublic	Date Visited	Area (sq ft)	Lane Miles *	Surface Type	Condition / PCR
0911	Public	1/11/2002	36269	0.62	AS	GOOD / 90

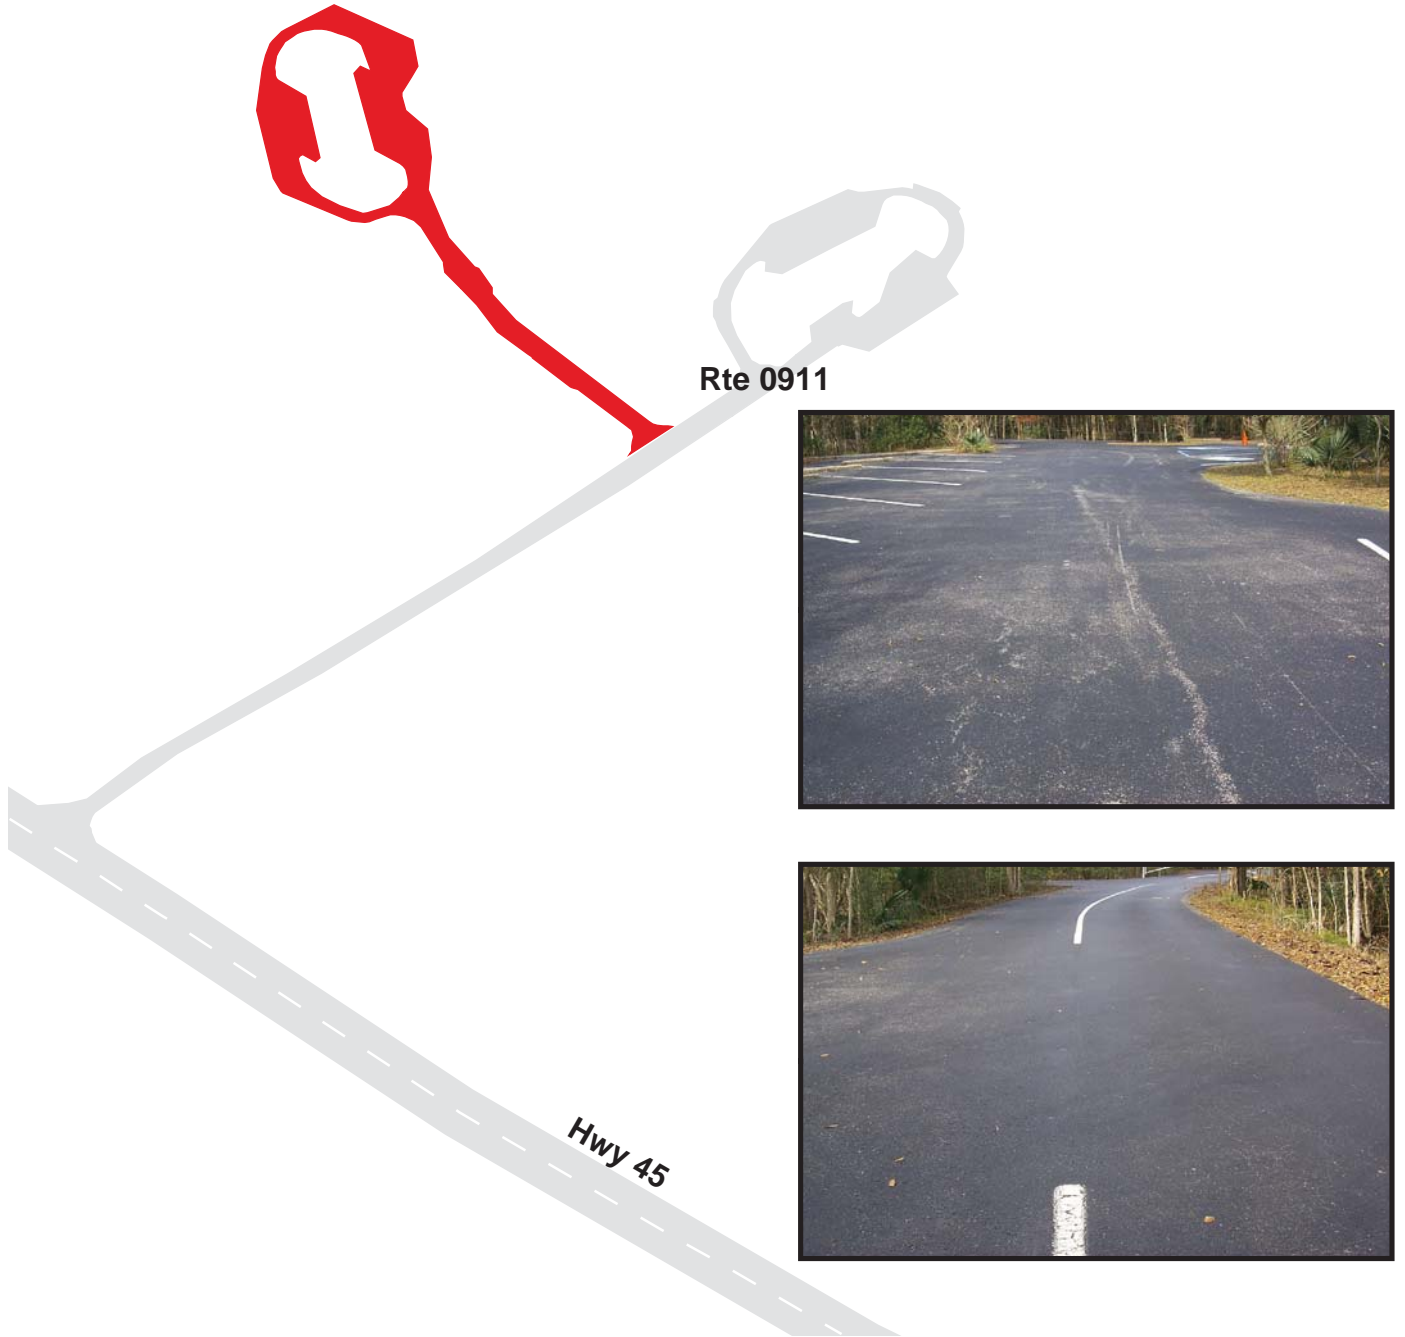
Route 0912

Route	Public / NonPublic	Date Visited	Area (sq ft)	Lane Miles *	Surface Type	Condition / PCR
0912	Public	1/11/2002	25624	0.44	AS	GOOD / 90

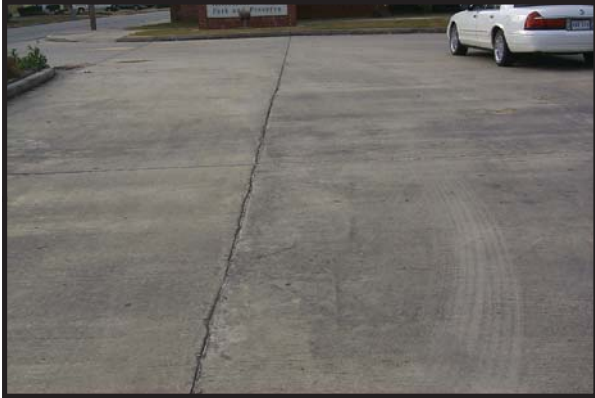
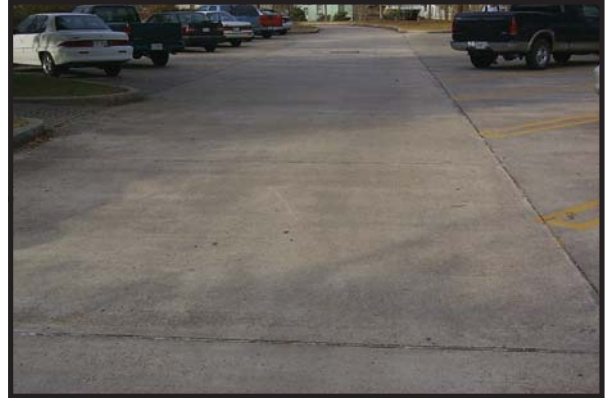
Route 0917

Route	Public / NonPublic	Date Visited	Area (sq ft)	Lane Miles *	Surface Type	Condition / PCR
0917	Public	1/11/2002	22594	0.39	CO	GOOD / 90

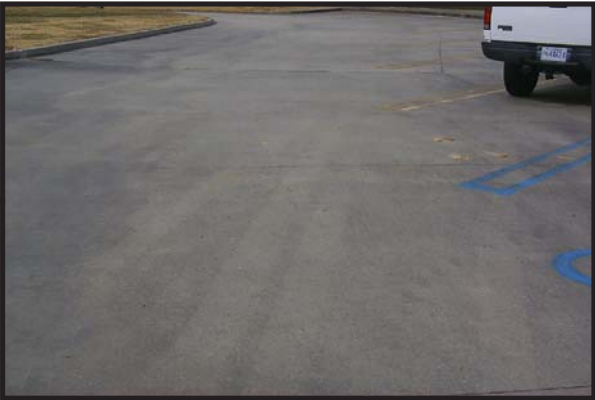
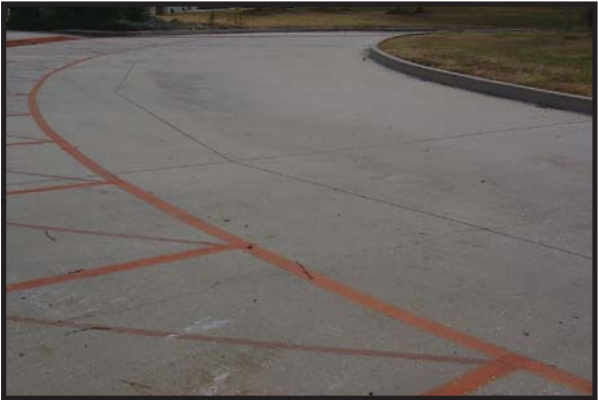
Route 0918

Route	Public / NonPublic	Date Visited	Area (sq ft)	Lane Miles *	Surface Type	Condition / PCR
0918	Public	1/11/2002	32164	0.55	CO	GOOD / 90

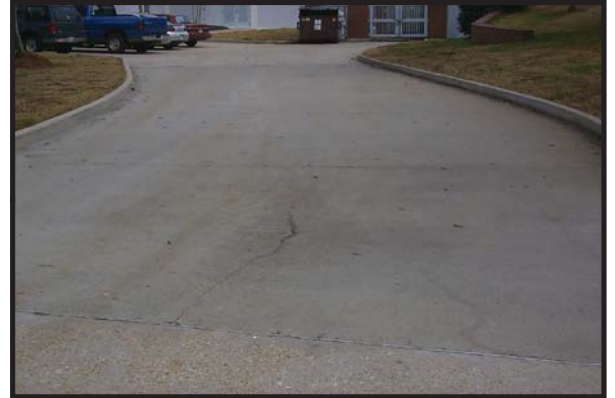
Route 0919

Route	Public / NonPublic	Date Visited	Area (sq ft)	Lane Miles *	Surface Type	Condition / PCR
0919	NonPublic	1/11/2002	4935	0.08	CO	GOOD / 90

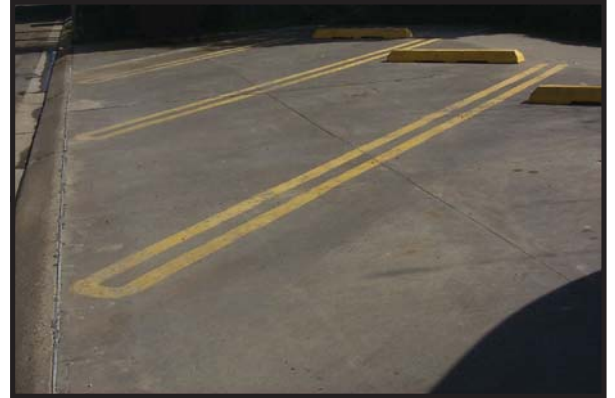
Route 0920

Route	Public / NonPublic	Date Visited	Area (sq ft)	Lane Miles *	Surface Type	Condition / PCR
0920	NonPublic	1/11/2002	2419	0.04	CO	EXCELLENT / 97
