# **The Road Inventory of Jimmy Carter National Historic Site JICA - 5690**

## **Road Inventory Program**

Prepared By:  
Federal Highway Administration  
Eastern Federal Lands Highway Division  
Cycle 3

# Jimmy Carter National Historic Site in Georgia

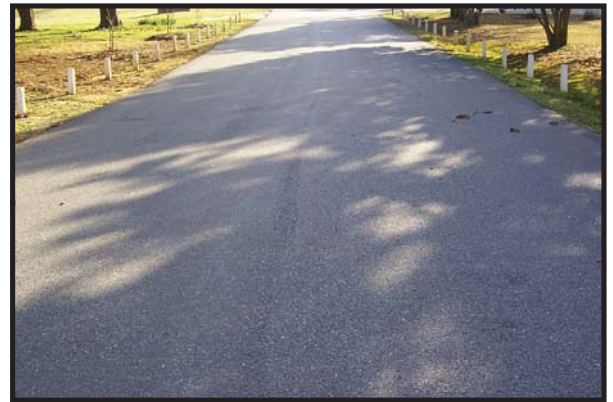
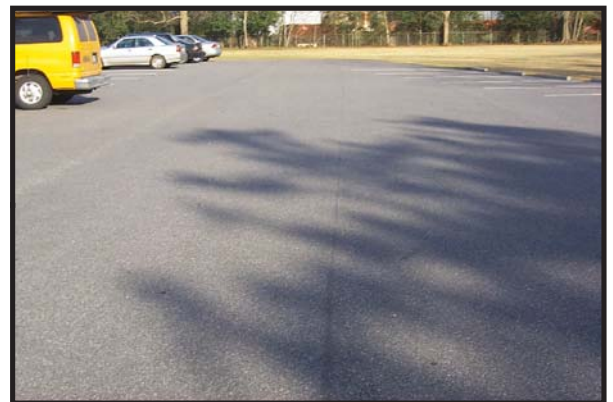
## Route 0900

FRONT HIGH SCHOOL PARKING  
FROM BOND STREET

Route	Public / NonPublic	Date Visited	Area (sq ft)	Lane Miles *	Surface Type	Condition / PCR
0900	Public	2/24/2003	21187	0.36	AS	GOOD / 90

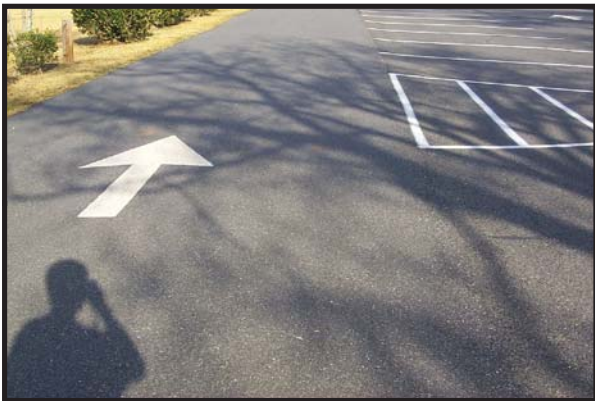
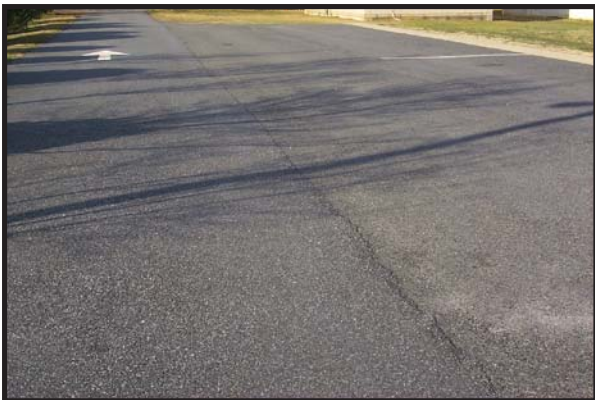
## Route 0901

REAR HIGH SCHOOL PARKING  
FROM BOND STREET

Route	Public / NonPublic	Date Visited	Area (sq ft)	Lane Miles *	Surface Type	Condition / PCR
0901	Public	2/24/2003	19128	0.33	AS	GOOD / 90

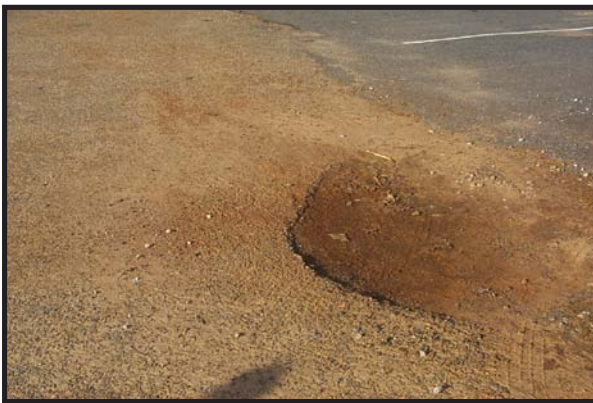
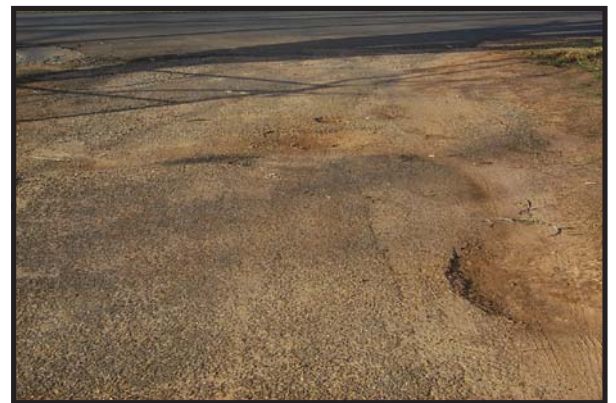
## Route 0902

MAINTENANCE AREA  
FROM HOSPITAL STREET

Route	Public / NonPublic	Date Visited	Area (sq ft)	Lane Miles *	Surface Type	Condition / PCR
0902	NonPublic	2/24/2003	2535	0.04	AS	POOR / 45

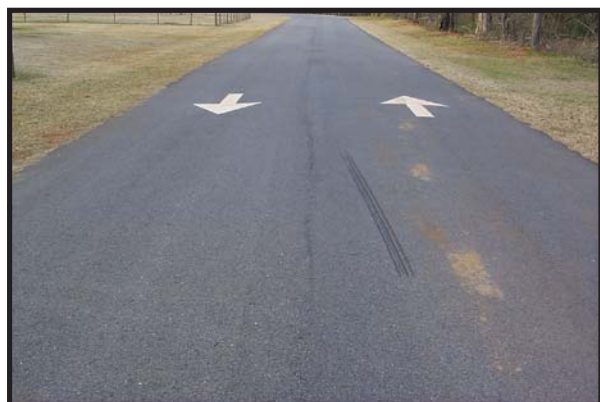
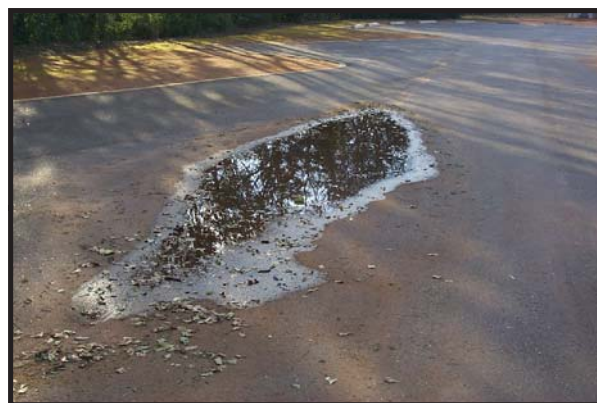
## Route 0903

COMFORT STATION PARKING  
FROM OLD PLAINS HIGHWAY

Route	Public / NonPublic	Date Visited	Area (sq ft)	Lane Miles *	Surface Type	Condition / PCR
0903	Public	2/24/2003	35484	0.61	AS	FAIR / 73

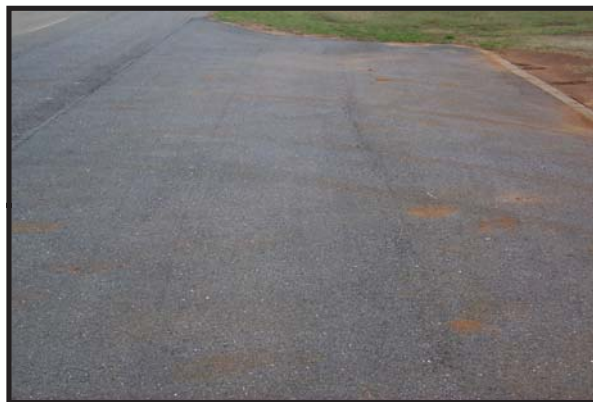
## Route 0904

HANDICAP PARKING  
FROM OLD PLAINS HIGHWAY

Route	Public / NonPublic	Date Visited	Area (sq ft)	Lane Miles *	Surface Type	Condition / PCR
0904	Public	2/24/2003	897	0.02	AS	FAIR / 73

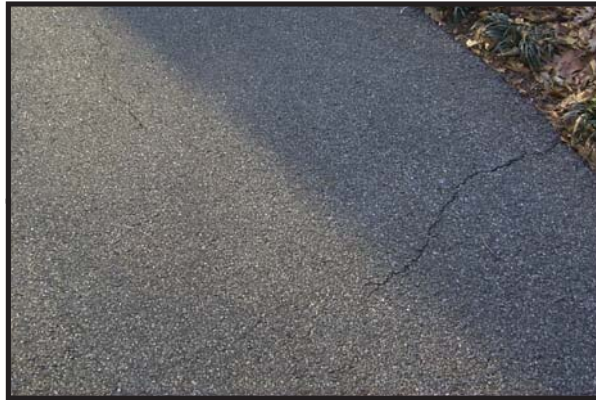
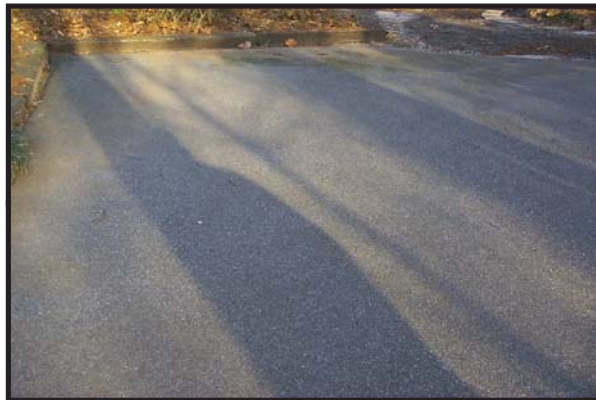
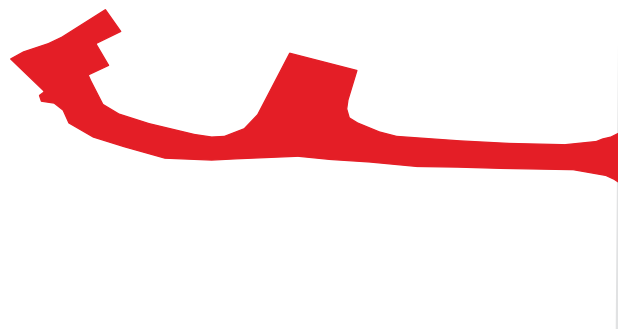
## Route 0905

CARTER RESIDENCE  
FROM WOODLAND DRIVE

Route	Public / NonPublic	Date Visited	Area (sq ft)	Lane Miles *	Surface Type	Condition / PCR
0905	NonPublic	2/25/2003	4198	0.07	AS	FAIR / 73
