**The Road Inventory  
of  
John Day Fossil Beds National Monument  
JODA - 9325**

**Road Inventory Program**

Prepared By:  
Federal Highway Administration  
Eastern Federal Lands Highway Division  
Cycle 3

# John Day Fossil Beds National Monument in Oregon

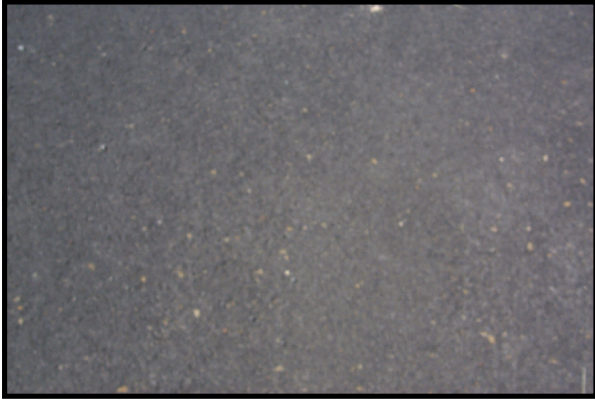
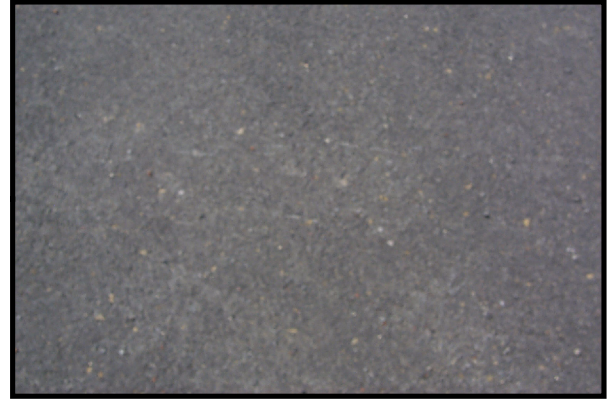
Route	Public / NonPublic	Date Visited	Area (sq ft)	Lane Miles *	Surface Type	Condition / PCR
0900	Public	5/13/2003	36652	0.63	AS	GOOD / 90

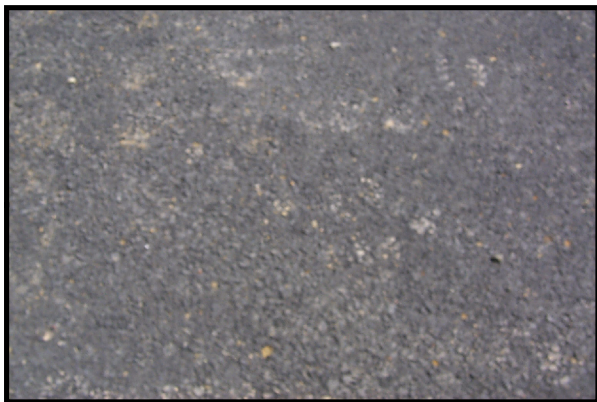
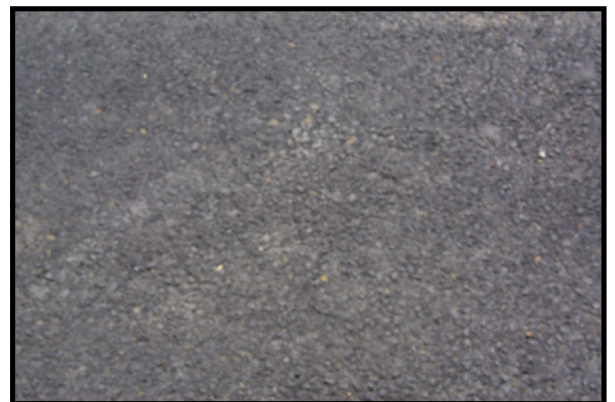
## Route 0901

Route	Public / NonPublic	Date Visited	Area (sq ft)	Lane Miles *	Surface Type	Condition / PCR
0901	NonPublic	5/13/2003	883	0.02	AS	GOOD / 90

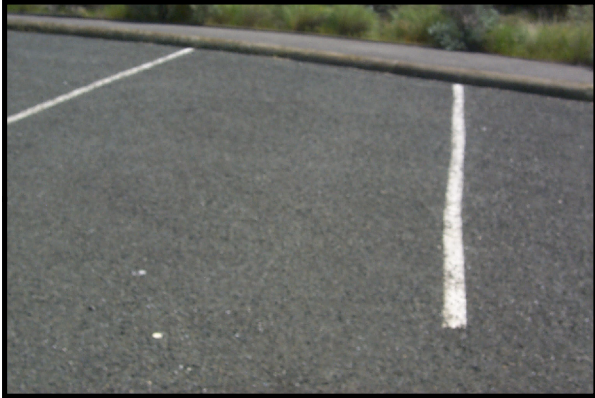
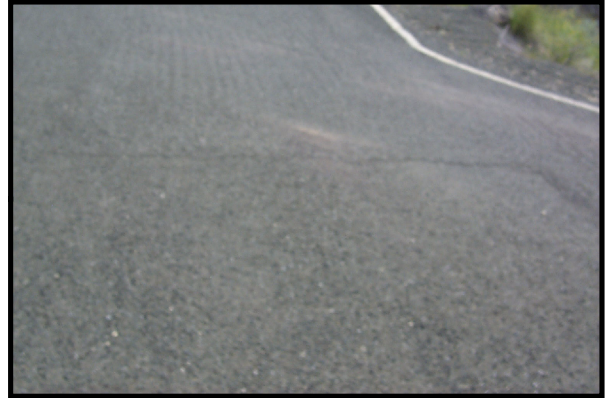
## Route 0909

Route	Public / NonPublic	Date Visited	Area (sq ft)	Lane Miles *	Surface Type	Condition / PCR
0909	Public	5/13/2003	15765	0.27	AS	GOOD / 90

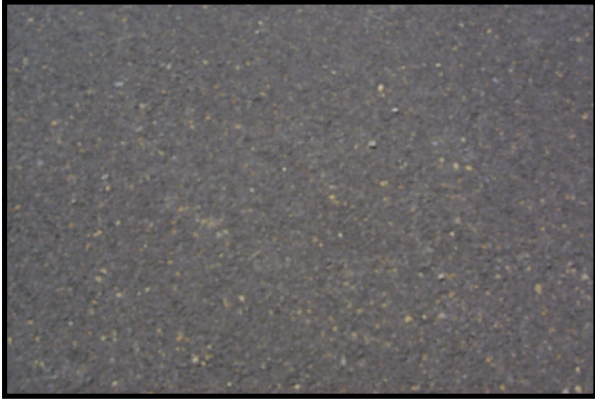
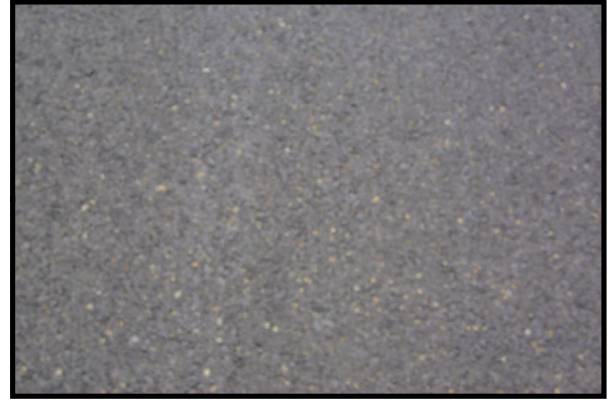
## Route 0911

Route	Public / NonPublic	Date Visited	Area (sq ft)	Lane Miles *	Surface Type	Condition / PCR
0911	NonPublic	5/13/2003	16260	0.28	AS	GOOD / 90

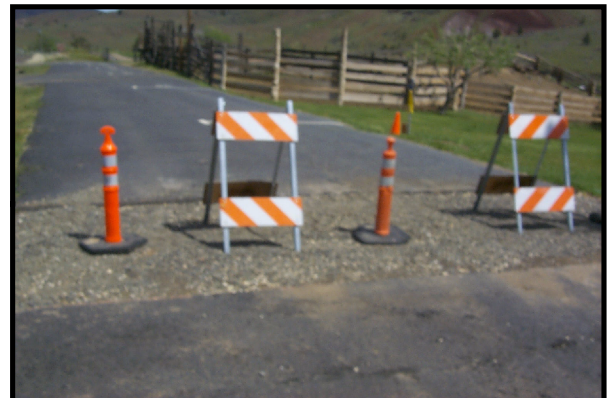
## Route 0913

Route	Public / NonPublic	Date Visited	Area (sq ft)	Lane Miles *	Surface Type	Condition / PCR
0913	Public	5/13/2003	5944	0.10	AS	POOR / 45

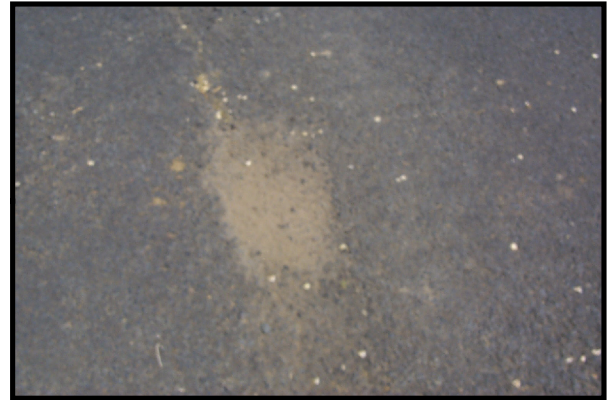
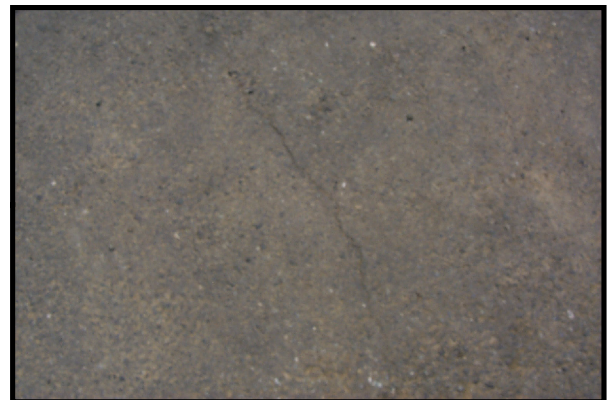
## Route 0914

Route	Public / NonPublic	Date Visited	Area (sq ft)	Lane Miles *	Surface Type	Condition / PCR
0914	Public	5/13/2003	9858	0.17	AS	FAIR / 73
