The Road Inventory of Johnstown Flood National Memorial JOFL - 4150

Road Inventory Program

Prepared By:
Federal Highway Administration
Eastern Federal Lands Highway Division
Cycle 3

Johnstown Flood National Memorial in Pennsylvania

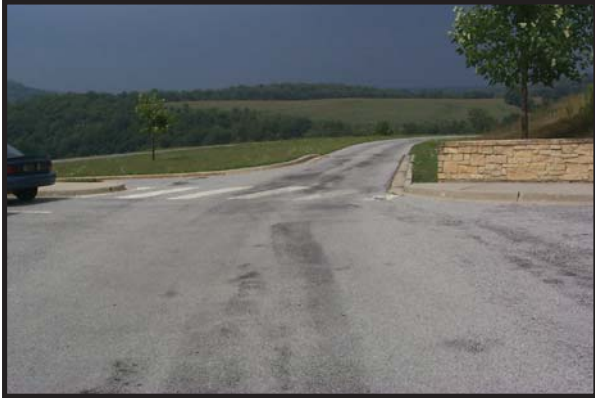
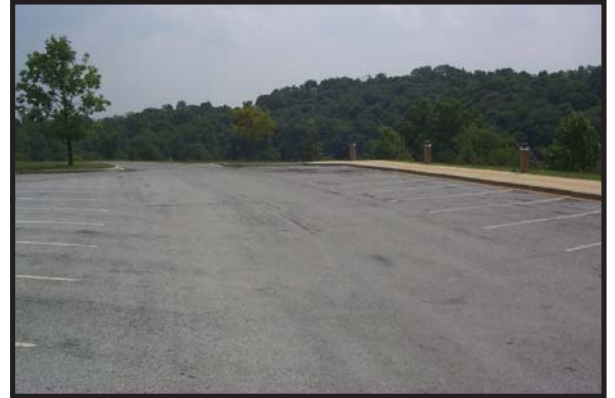
Route 0900

Route	Public / NonPublic	Date Visited	Area (sq ft)	Lane Miles *	Surface Type	Condition / PCR
0900	Public	8/26/2001	43563	0.75	OC	GOOD / 90

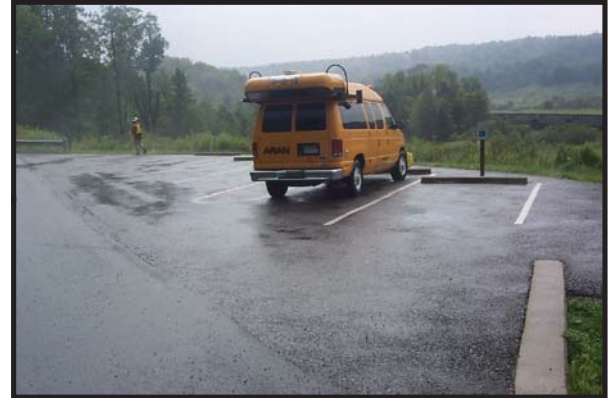
Route 0901

Route	Public / NonPublic	Date Visited	Area (sq ft)	Lane Miles *	Surface Type	Condition / PCR
0901	Public	8/26/2001	4245	0.07	AS	EXCELLENT / 97

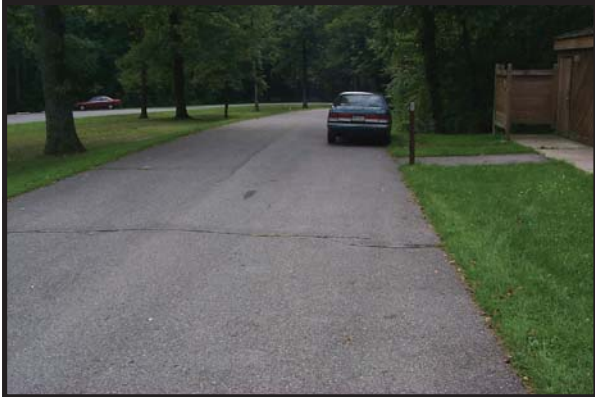
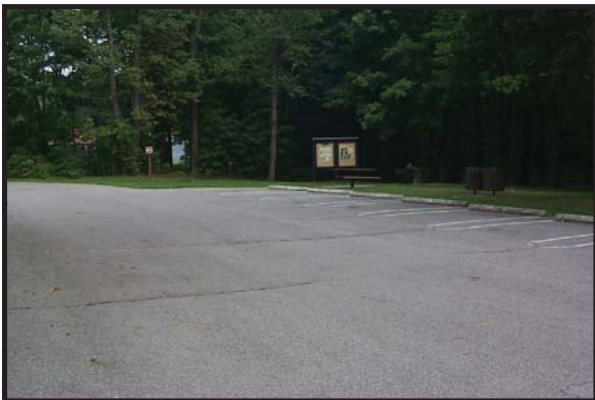
Route 0902

Route	Public / NonPublic	Date Visited	Area (sq ft)	Lane Miles *	Surface Type	Condition / PCR
0902	Public	8/26/2001	19988	0.34	AS	FAIR / 73

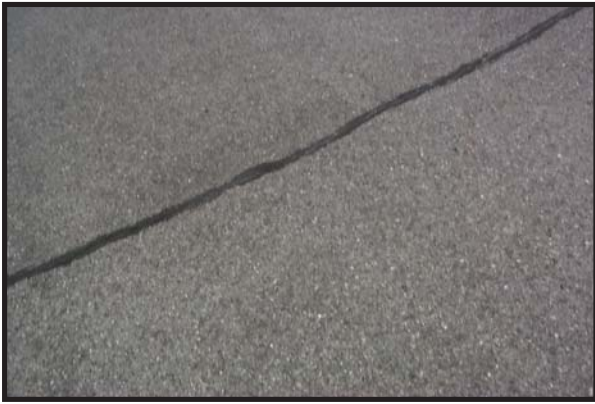
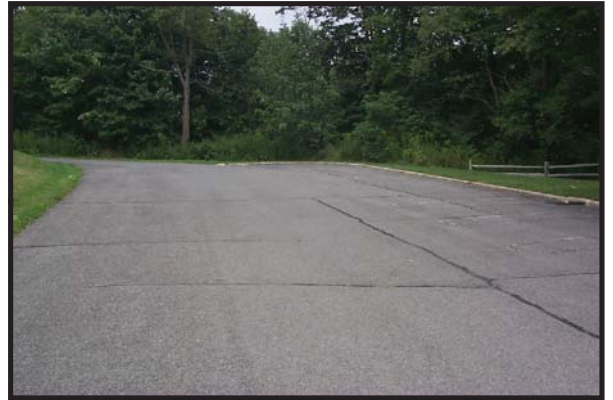
Route 0903

Route	Public / NonPublic	Date Visited	Area (sq ft)	Lane Miles *	Surface Type	Condition / PCR
0903	Public	8/26/2001	20895	0.36	AS	GOOD / 90

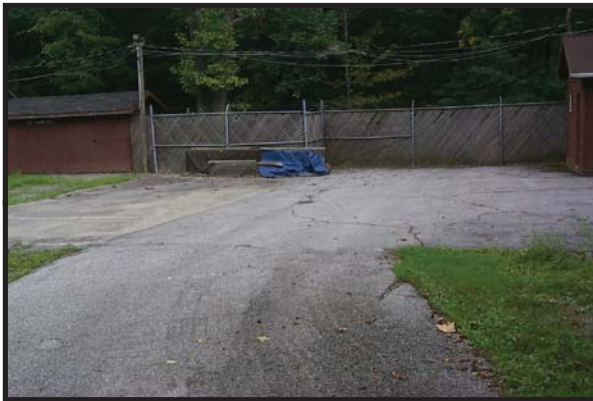
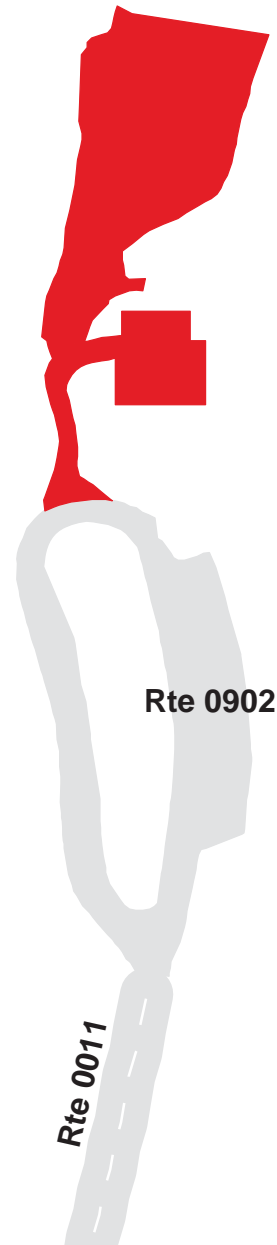
Route 0904A

Route	Public / NonPublic	Date Visited	Area (sq ft)	Lane Miles *	Surface Type	Condition / PCR
0904A	NonPublic	8/26/2001	5612	0.10	AS	FAIR / 73
