The Road Inventory of John Muir National Historic Site JOMU - 8510

Road Inventory Program

Prepared By:
Federal Highway Administration
Eastern Federal Lands Highway Division
Cycle 3

John Muir National Historic Site in California

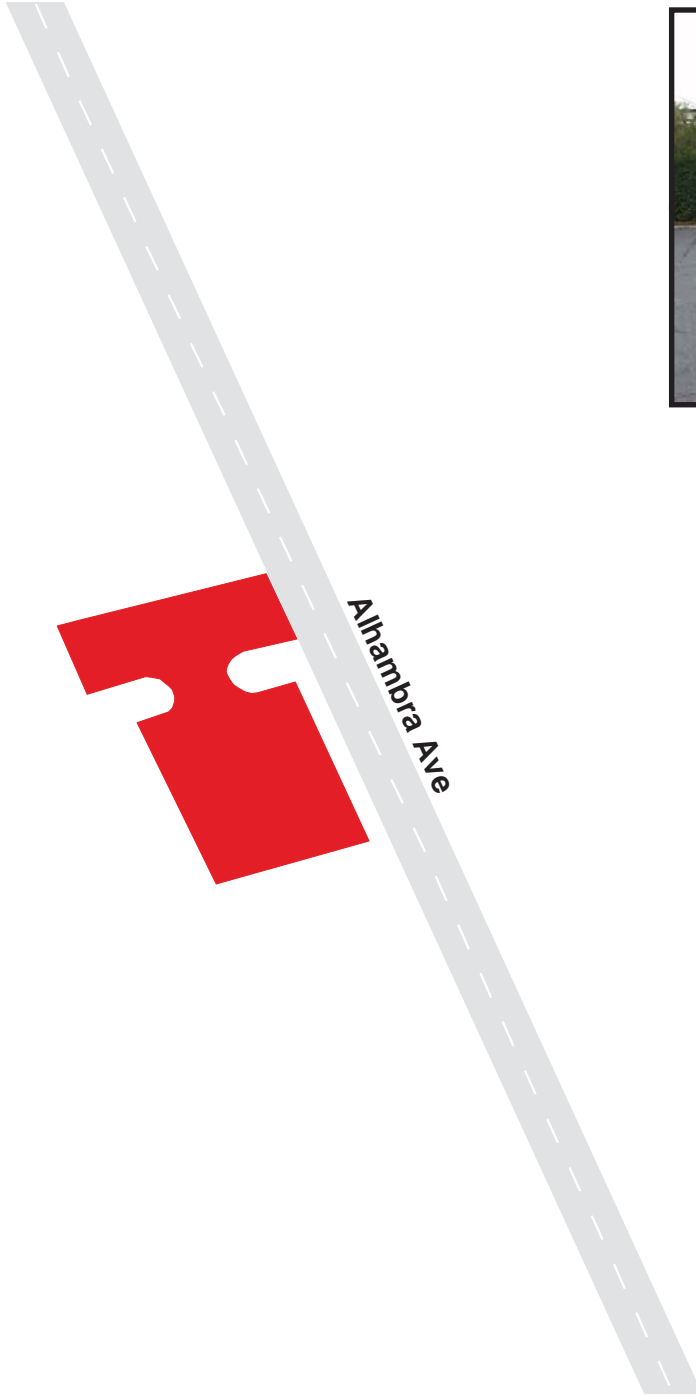
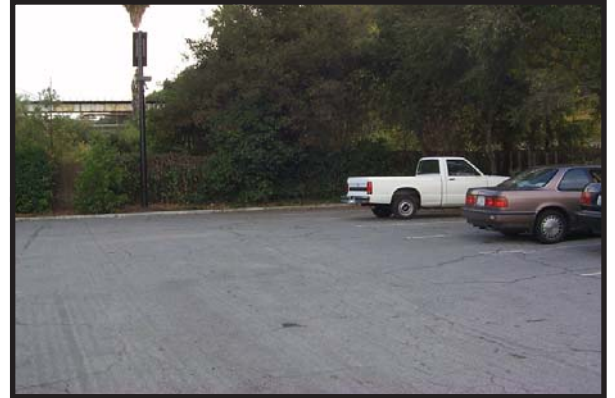
Route	Public / NonPublic	Date Visited	Area (sq ft)	Lane Miles *	Surface Type	Condition / PCR
0900	Public	11/2/2001	9013	0.16	AS	FAIR / 73

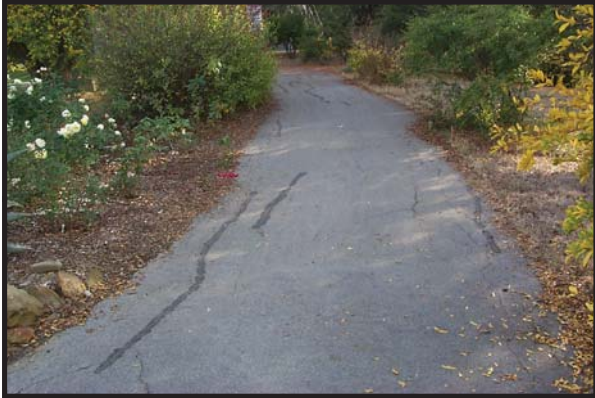
Route 0901

Route	Public / NonPublic	Date Visited	Area (sq ft)	Lane Miles *	Surface Type	Condition / PCR
0901	NonPublic	11/2/2001	4187	0.07	AS	POOR / 45

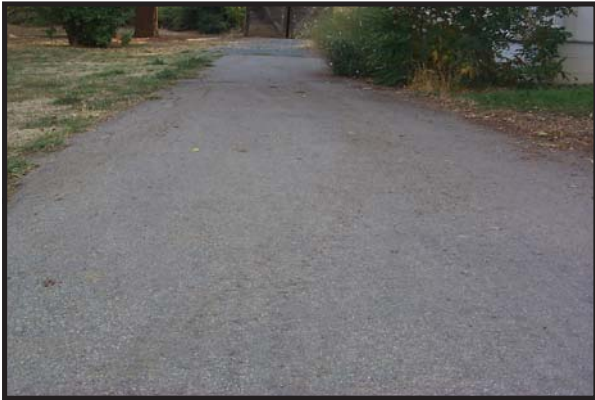
John Muir National Historic Site
Route 0902
MARTINEZ ADOBE ACCESS PARKING
From Route 0010

Route	Public / NonPublic	Date Visited	Area (sq ft)	Lane Miles *	Surface Type	Condition / PCR
0902	NonPublic	11/2/2001	628	0.01	AS	FAIR / 73

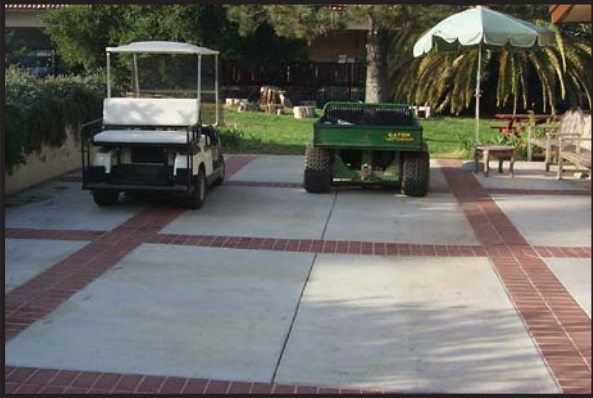
John Muir National Historic Site
Route 0903A
 VISITOR CENTER PATIO HANDICAP ACCESS
 From Route 0903B

Route	Public / NonPublic	Date Visited	Area (sq ft)	Lane Miles *	Surface Type	Condition / PCR
0903A	Public	11/2/2001	1033	0.02	CO	FAIR / 73

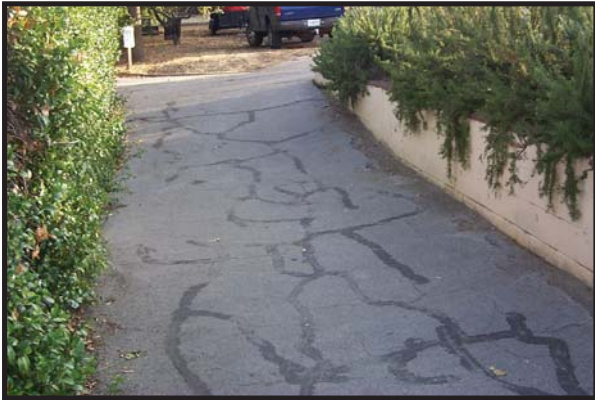
John Muir National Historic Site
Route 0903B
 VISITOR CENTER PATIO HANDICAP ACCESS
 From Route 0900 and Route 0010

Route	Public / NonPublic	Date Visited	Area (sq ft)	Lane Miles *	Surface Type	Condition / PCR
0903B	Public	11/2/2001	649	0.01	AS	FAIR / 73

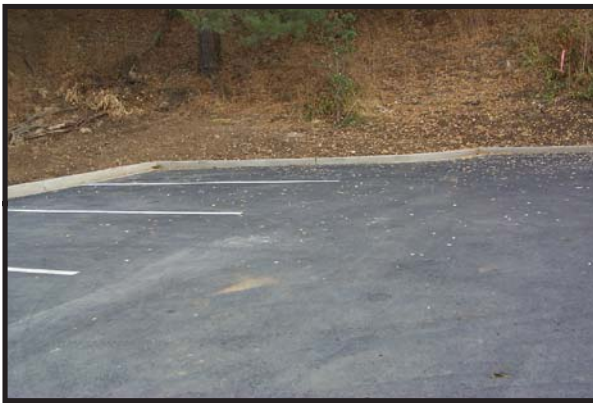
Route 0904A

Route	Public / NonPublic	Date Visited	Area (sq ft)	Lane Miles *	Surface Type	Condition / PCR
0904A	NonPublic	11/2/2001	2737	0.05	NC	GOOD / 90

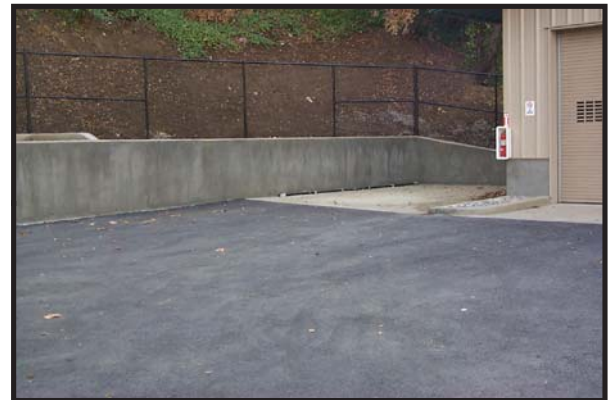
Route 0904B

Route	Public / NonPublic	Date Visited	Area (sq ft)	Lane Miles *	Surface Type	Condition / PCR
0904B	NonPublic	11/2/2001	2377	0.04	NC	GOOD / 90
