The Road Inventory of Joshua Tree National Park JOTR - 8330

Road Inventory Program

Prepared By:
Federal Highway Administration
Eastern Federal Lands Highway Division
Cycle 3

Joshua Tree National Park in California

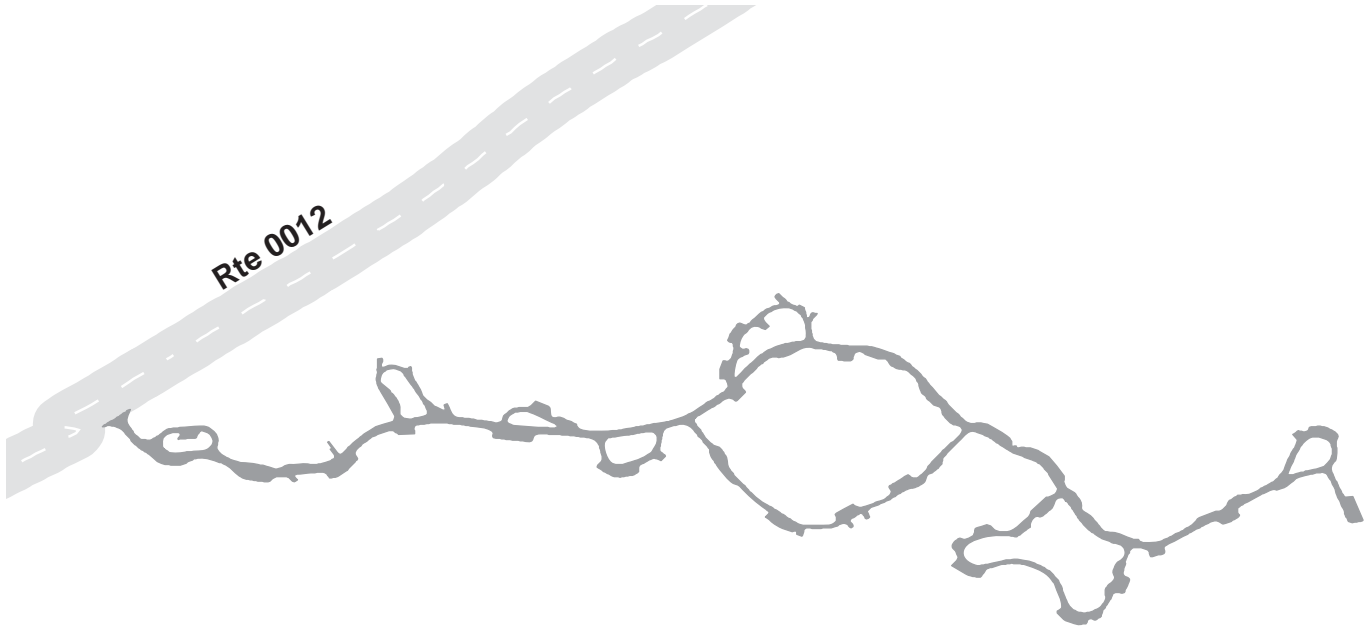
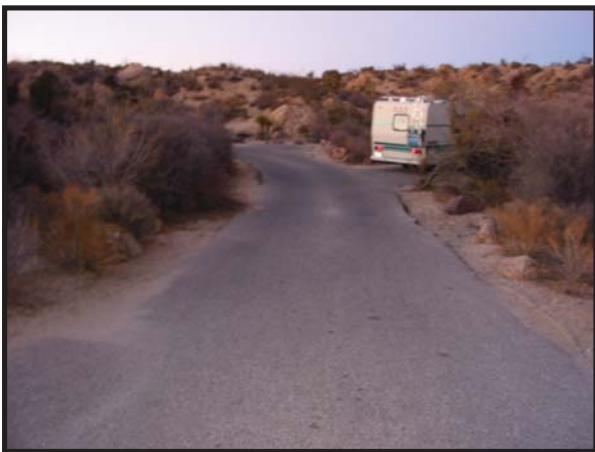
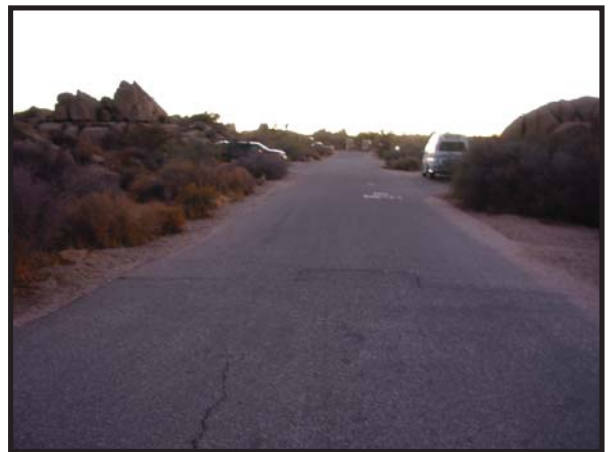
Joshua Tree National Park Route 0203

Jumbo Rocks Campground Road
From Route 0012 at MP 8.1

Route	Length (mi)	Width (ft)	Area (sq ft)	Lane Miles *	Condition / PCR	Surface Type
0203	2.04	0.00	179603	3.09	GOOD / 90	AS

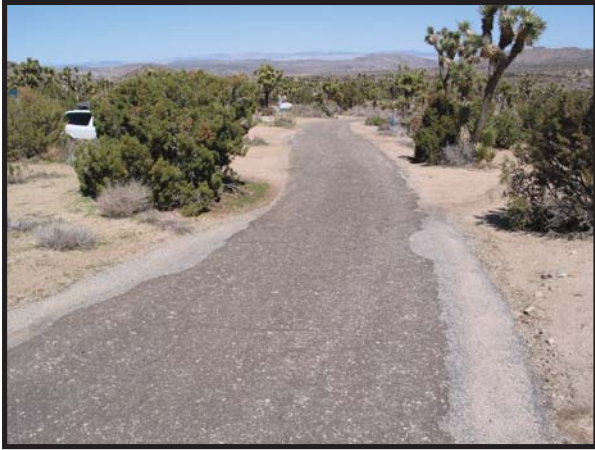
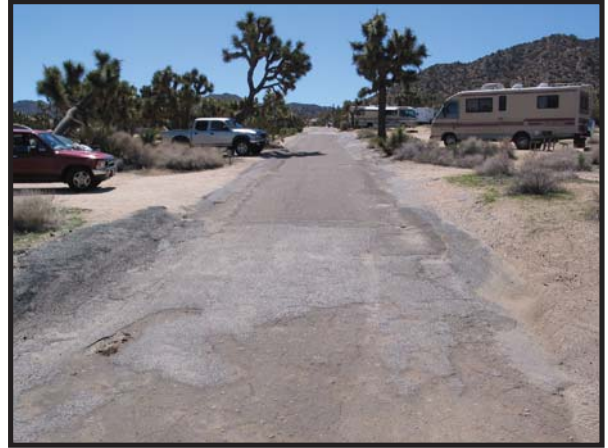
Route 0214

Route	Length (mi)	Width (ft)	Area (sq ft)	Lane Miles *	Condition / PCR	Surface Type
0214	1.97	0.00	0	0.00	FAIR / 73	AS

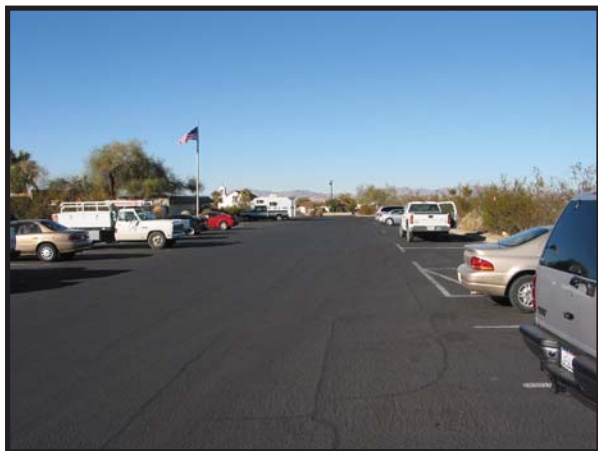
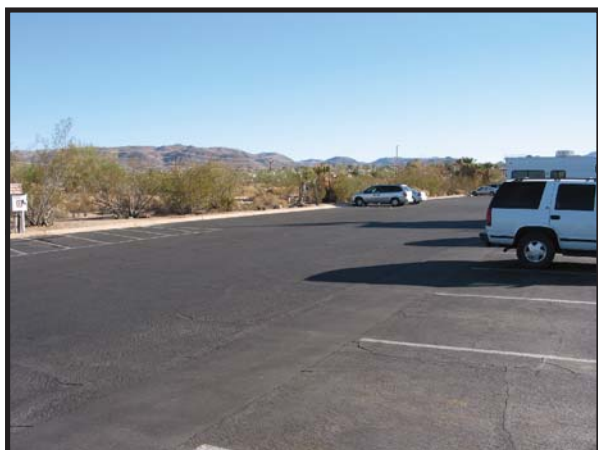
Route 0901

Route	Public / NonPublic	Date Visited	Area (sq ft)	Lane Miles *	Surface Type	Condition / PCR
0901	NonPublic	11/13/2002	42891	0.74	AS	FAIR / 73

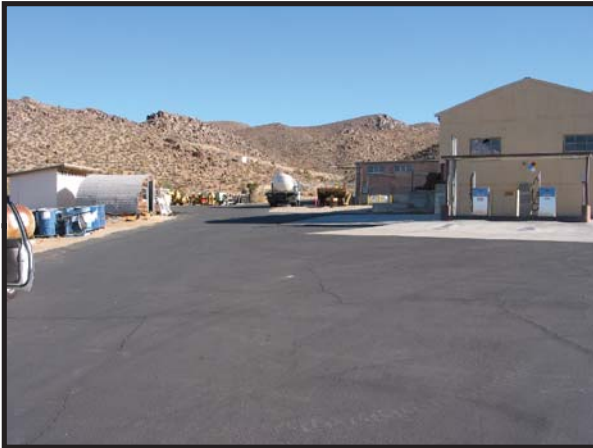
Route 0902

Route	Public / NonPublic	Date Visited	Area (sq ft)	Lane Miles *	Surface Type	Condition / PCR
0902	Public	11/13/2002	23562	0.41	OC	FAIR / 73

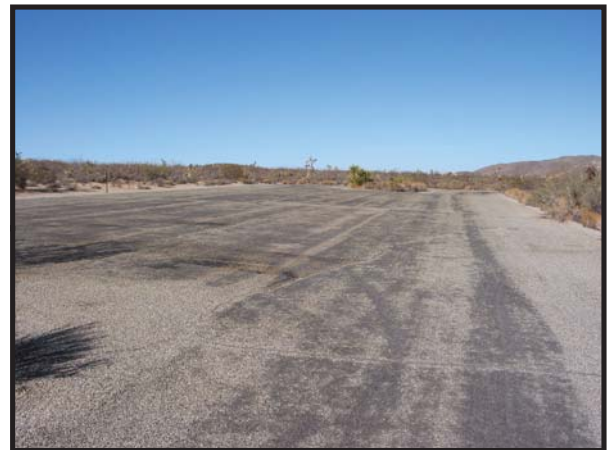
Route 0903

Route	Public / NonPublic	Date Visited	Area (sq ft)	Lane Miles *	Surface Type	Condition / PCR
0903	Public	11/13/2002	6267	0.11	OC	FAIR / 73

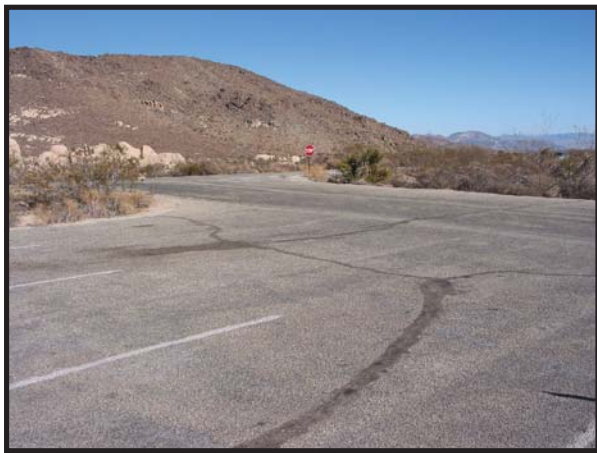
Route 0904

Route	Public / NonPublic	Date Visited	Area (sq ft)	Lane Miles *	Surface Type	Condition / PCR
0904	Public	11/13/2002	18492	0.32	AS	FAIR / 73

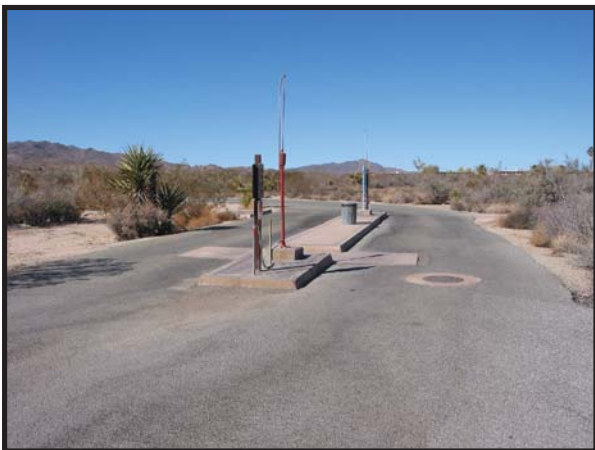
Route 0907A

Route	Public / NonPublic	Date Visited	Area (sq ft)	Lane Miles *	Surface Type	Condition / PCR
0907A	Public	11/13/2002	8024	0.14	AS	FAIR / 73

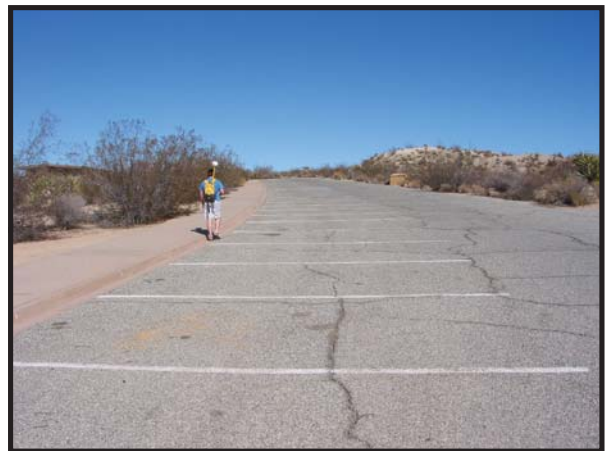
Route 0907B

Route	Public / NonPublic	Date Visited	Area (sq ft)	Lane Miles *	Surface Type	Condition / PCR
0907B	Public	11/13/2002	884	0.02	AS	FAIR / 73

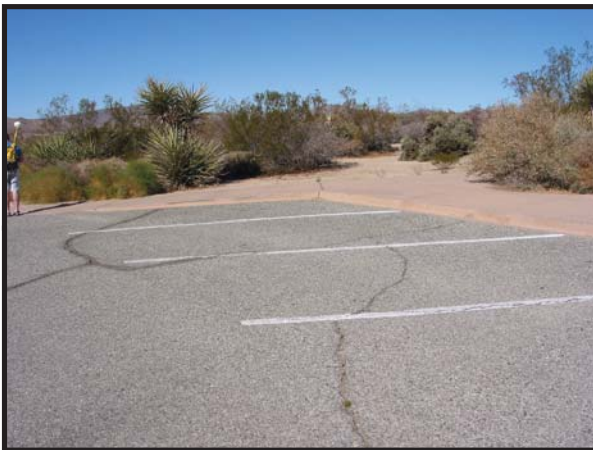
Route 0907C

Route	Public / NonPublic	Date Visited	Area (sq ft)	Lane Miles *	Surface Type	Condition / PCR
0907C	Public	11/13/2002	952	0.02	AS	GOOD / 90

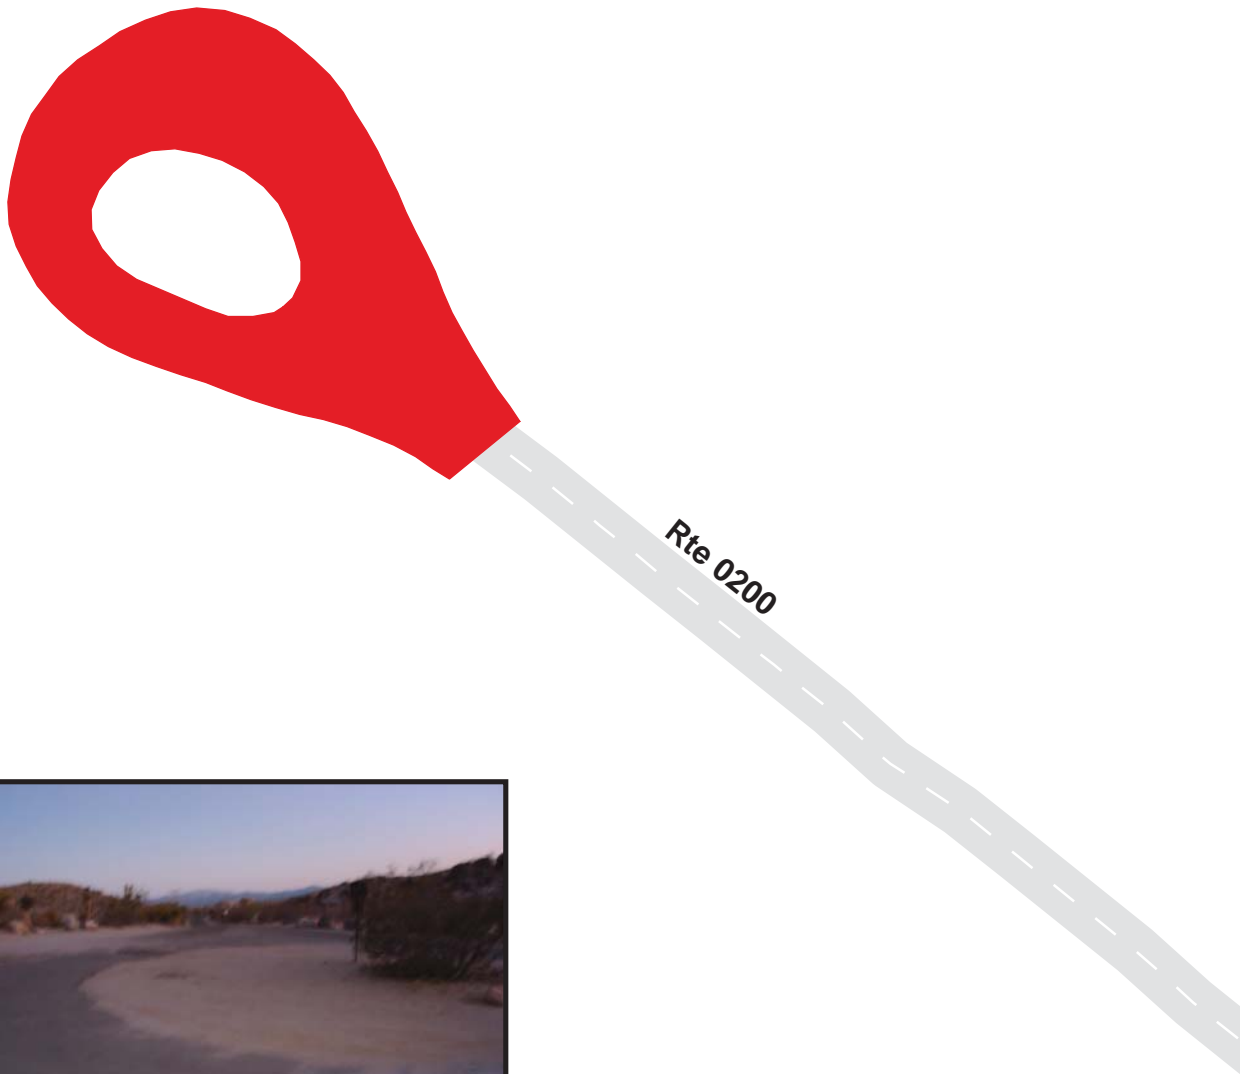
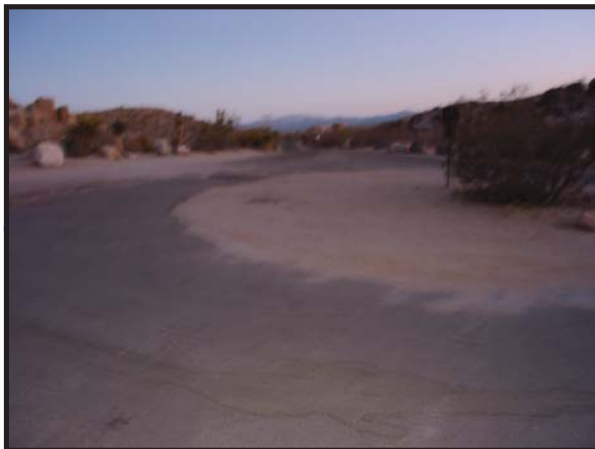
Route 0910

Route	Public / NonPublic	Date Visited	Area (sq ft)	Lane Miles *	Surface Type	Condition / PCR
0910	Public	11/14/2002	5367	0.09	AS	POOR / 45

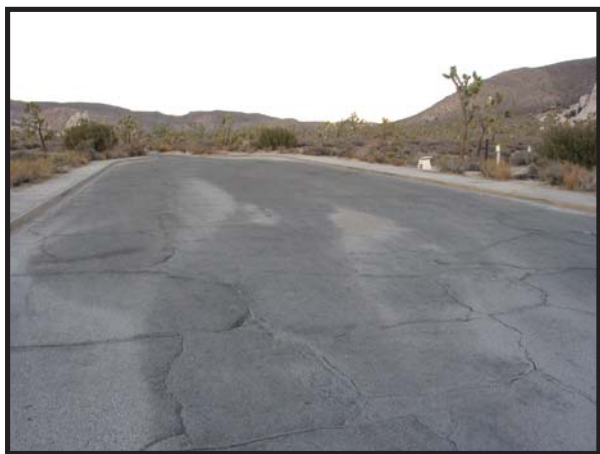
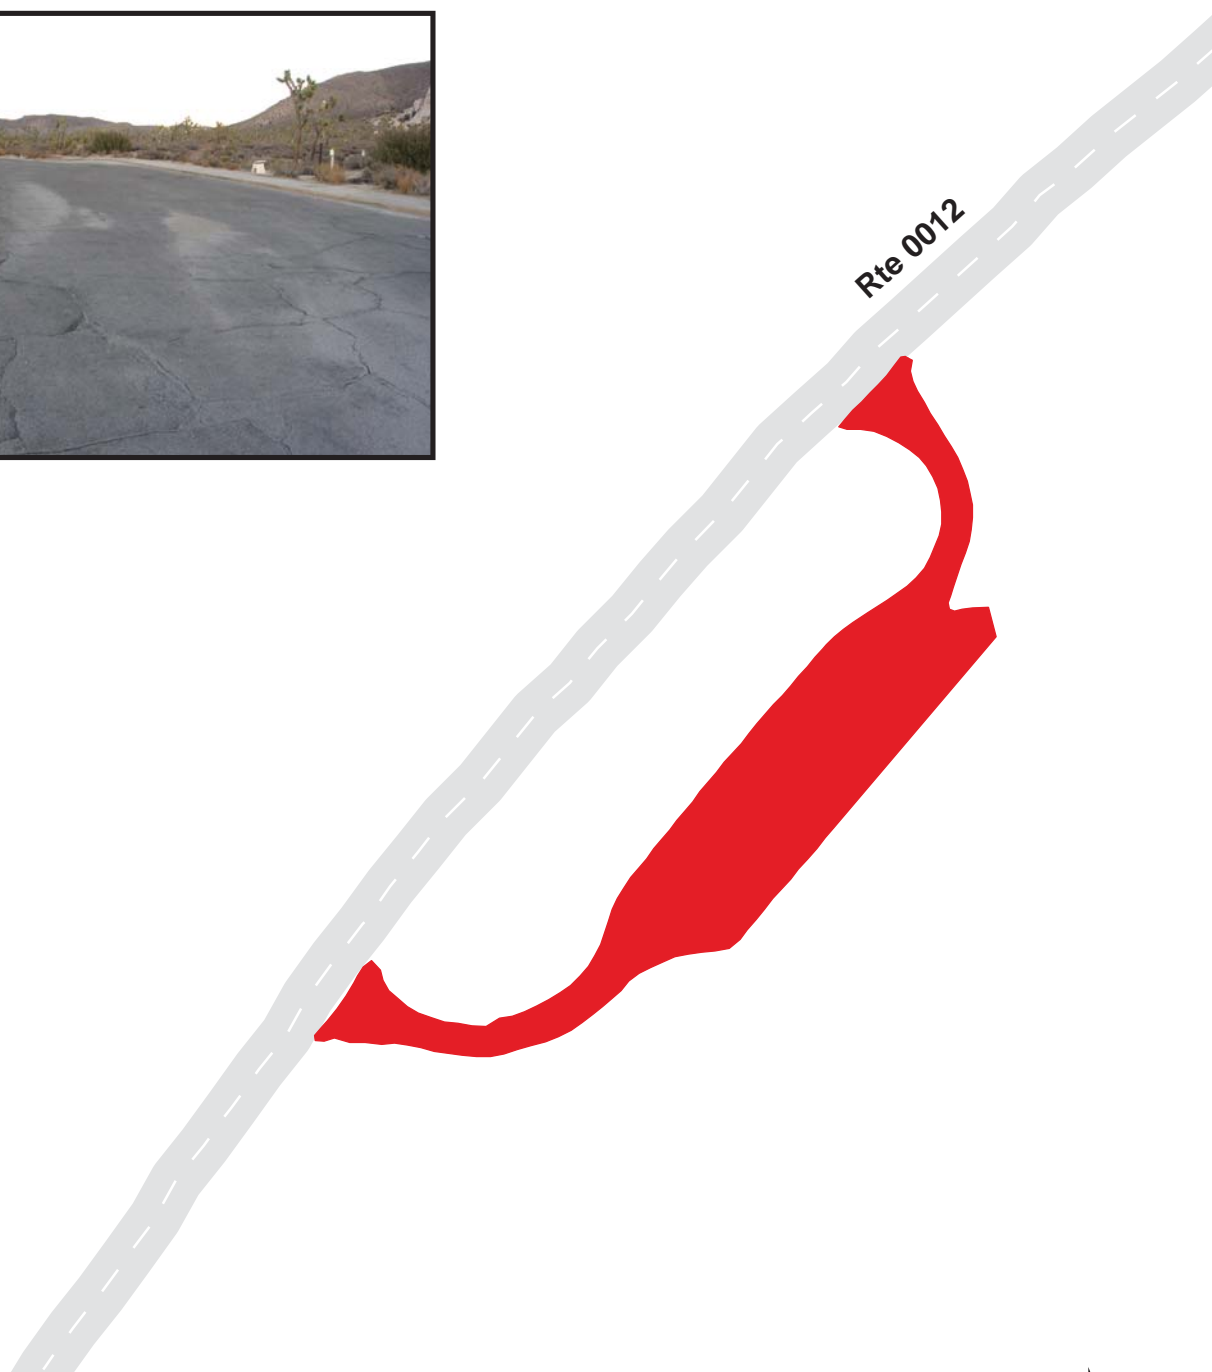
Route 0911

Route	Public / NonPublic	Date Visited	Area (sq ft)	Lane Miles *	Surface Type	Condition / PCR
0911	Public	11/14/2002	10604	0.18	AS	POOR / 45

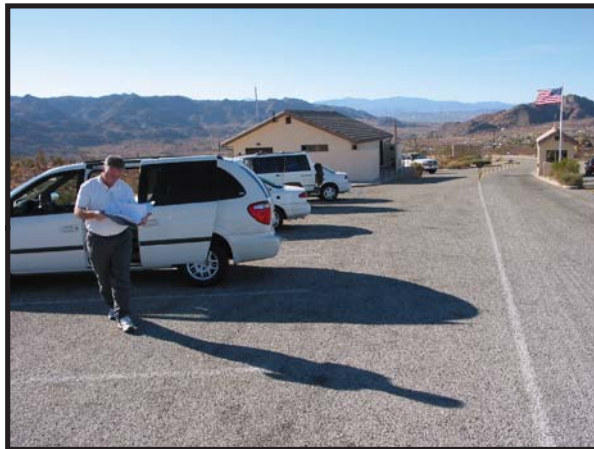
Route 0915

Route	Public / NonPublic	Date Visited	Area (sq ft)	Lane Miles *	Surface Type	Condition / PCR
0915	Public	3/21/2003	22678	0.39	AS	FAIR / 73

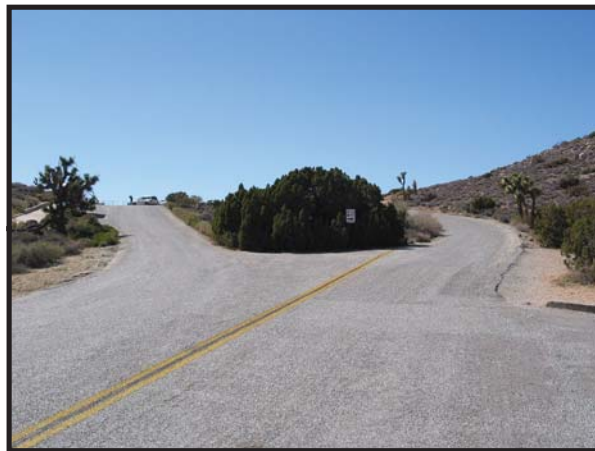
Route 0916

Route	Public / NonPublic	Date Visited	Area (sq ft)	Lane Miles *	Surface Type	Condition / PCR
0916	Public	11/13/2002	11616	0.20	AS	EXCELLENT / 97

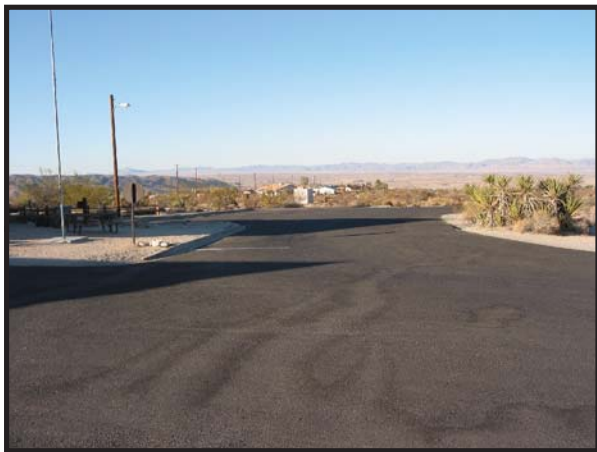
Route 0917

Route	Public / NonPublic	Date Visited	Area (sq ft)	Lane Miles *	Surface Type	Condition / PCR
0917	Public	11/14/2002	23485	0.40	OC	FAIR / 73

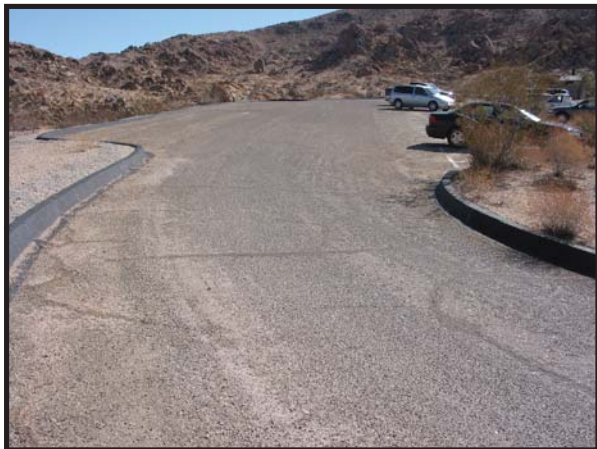
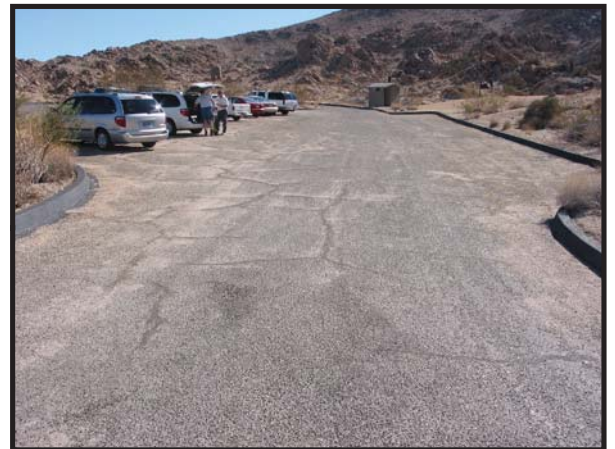
Route 0918

Route	Public / NonPublic	Date Visited	Area (sq ft)	Lane Miles *	Surface Type	Condition / PCR
0918	Public	11/14/2002	101531	1.75	AS	EXCELLENT / 97

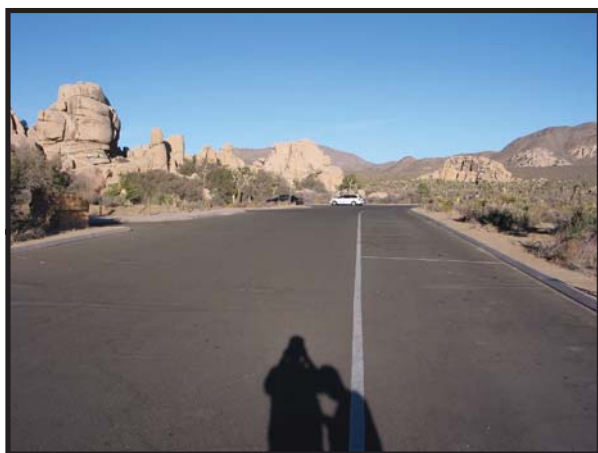
Route 0919

Route	Public / NonPublic	Date Visited	Area (sq ft)	Lane Miles *	Surface Type	Condition / PCR
0919	Public	11/14/2002	3062	0.05	AS	GOOD / 90

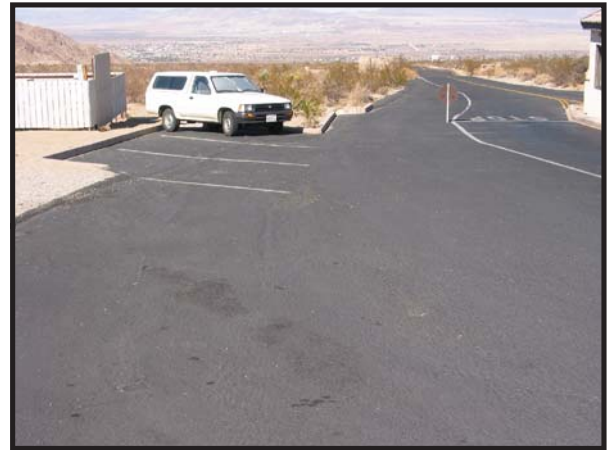
Joshua Tree National Park
Route 0920
 Coyote Parking
 Adjacent To Route 0012 at MP 15.2

Route	Public / NonPublic	Date Visited	Area (sq ft)	Lane Miles *	Surface Type	Condition / PCR
0920	Public	11/14/2002	13741	0.24	AS	EXCELLENT / 97

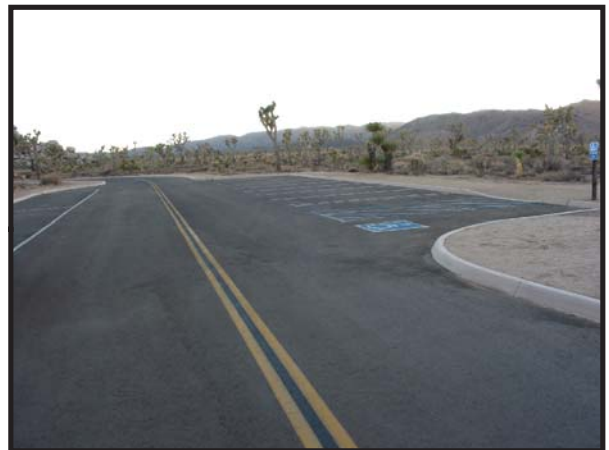
Route 0921

Route	Public / NonPublic	Date Visited	Area (sq ft)	Lane Miles *	Surface Type	Condition / PCR
0921	Public	11/14/2002	18057	0.31	AS	EXCELLENT / 97

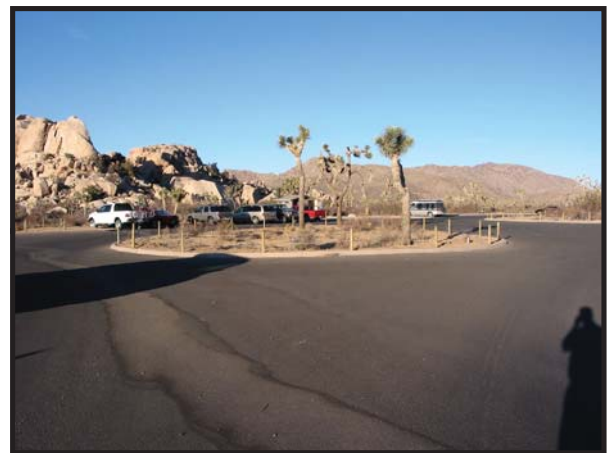
Route 0924A

Route	Public / NonPublic	Date Visited	Area (sq ft)	Lane Miles *	Surface Type	Condition / PCR
0924A	Public	10/30/2002	2783	0.05	AS	POOR / 45

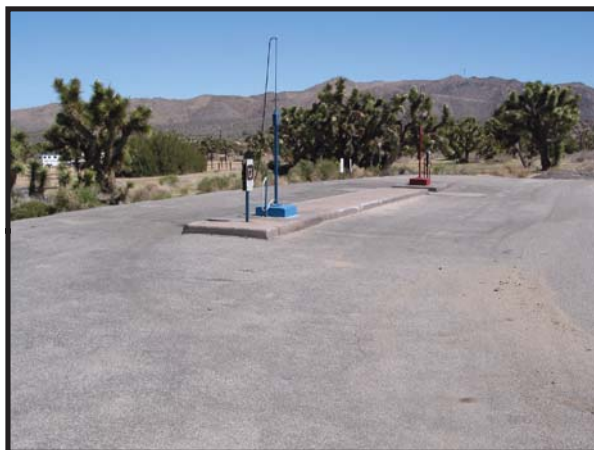
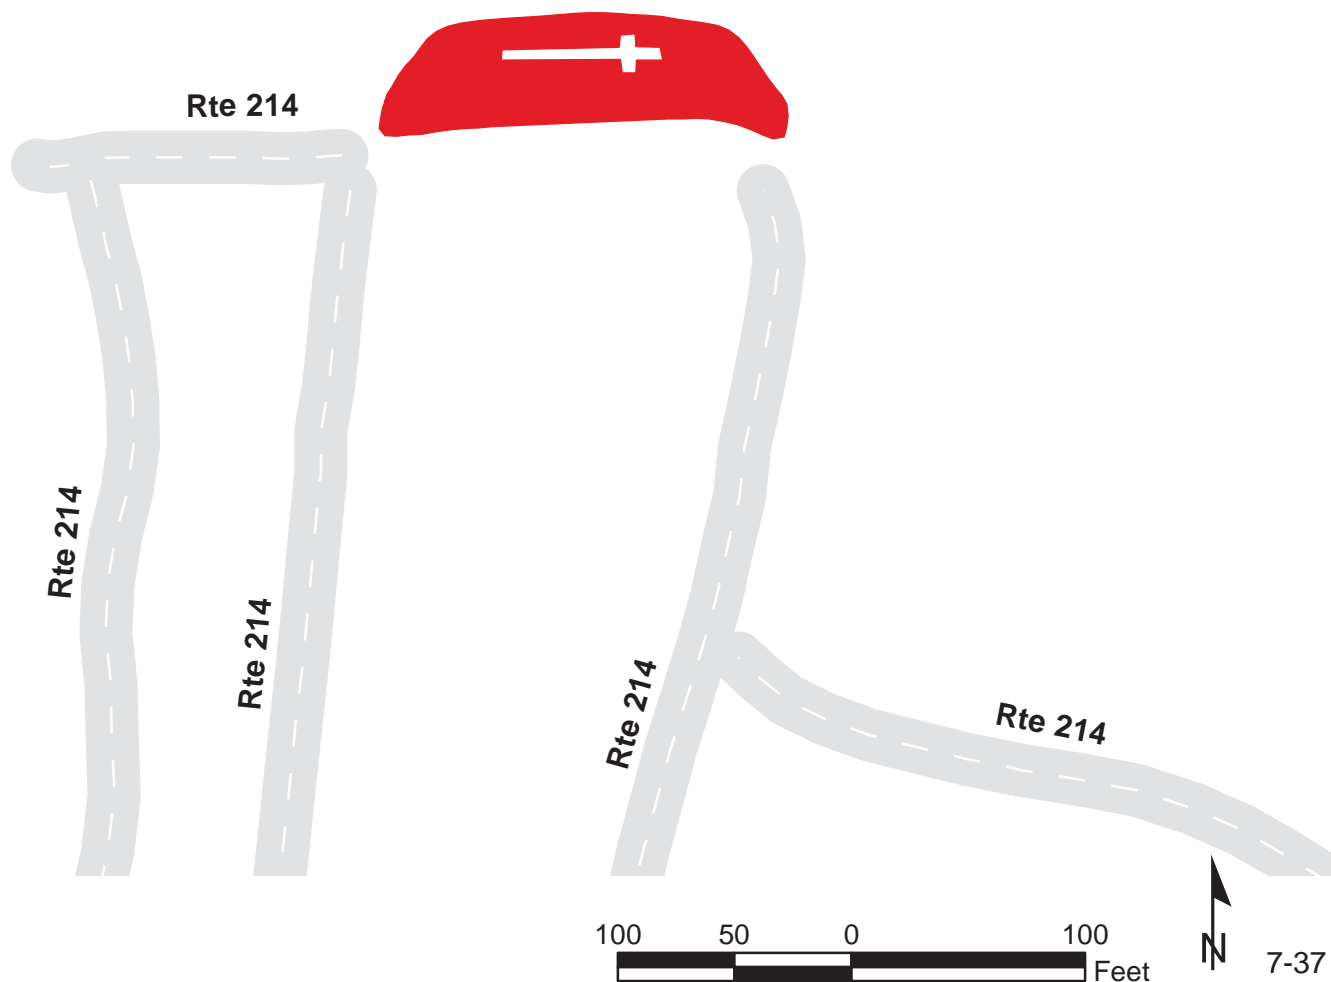
Route 0925

Route	Public / NonPublic	Date Visited	Area (sq ft)	Lane Miles *	Surface Type	Condition / PCR
0925	Public	3/22/2003	5495	0.09	AS	POOR / 45

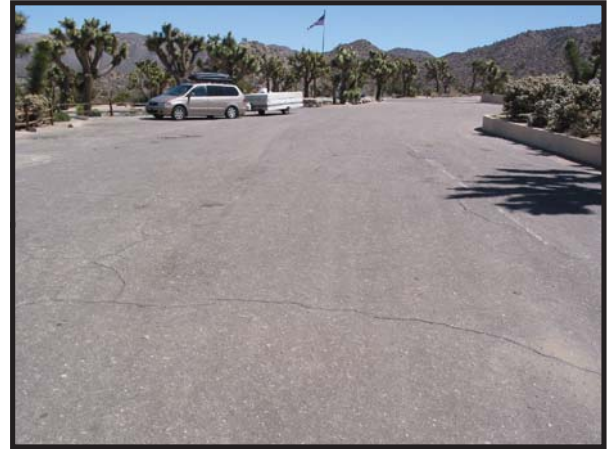
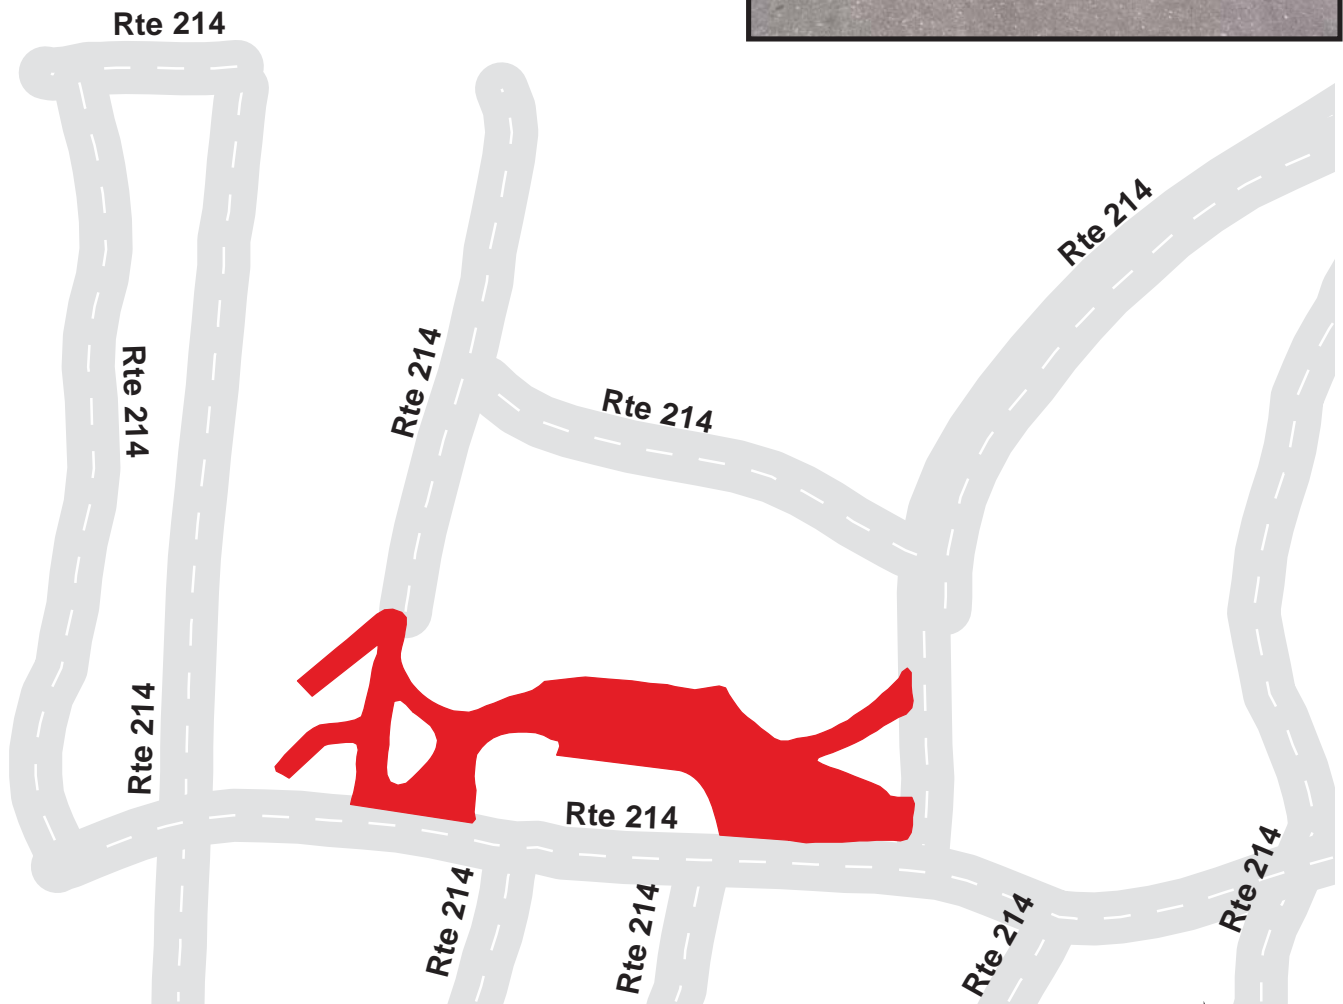
Route 0926

Route	Public / NonPublic	Date Visited	Area (sq ft)	Lane Miles *	Surface Type	Condition / PCR
0926	Public	3/22/2003	20840	0.36	AS	POOR / 45
