**The Road Inventory  
of  
Kaloko-Honokohau National Historical Park  
KAHO - 8320**

**Road Inventory Program**

Prepared By:  
Federal Highway Administration  
Eastern Federal Lands Highway Division  
Cycle 3

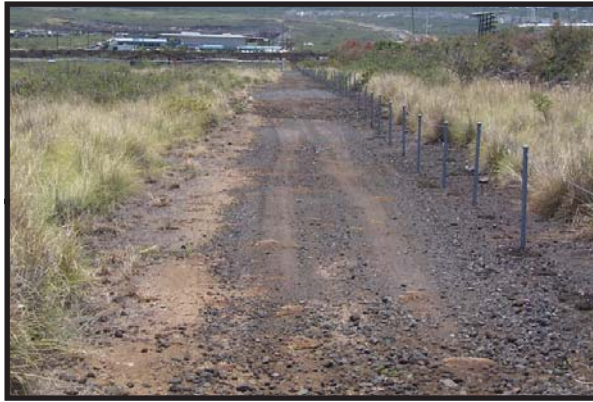
## Route 0400

Maintenance Yard Access Road

From State Route 270

Route	Length (mi)	Width (ft)	Area (sq ft)	Lane Miles *	Condition / PCR	Surface Type
0400	0.00	12.00	13679	0.24	NC / -1	DT

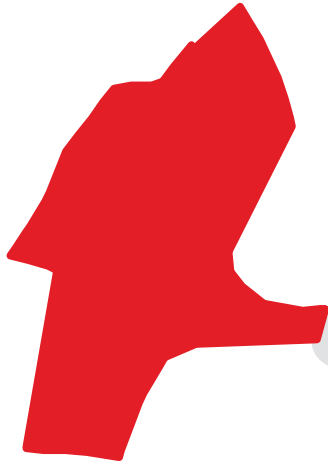
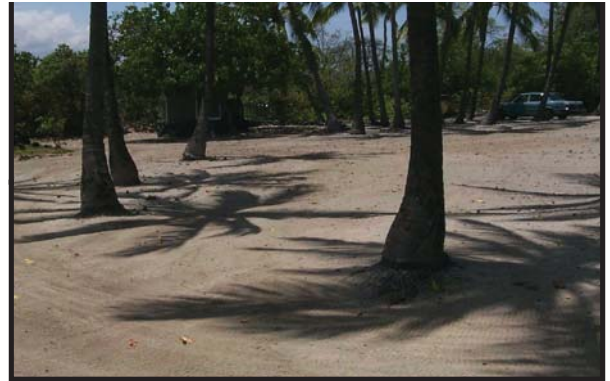
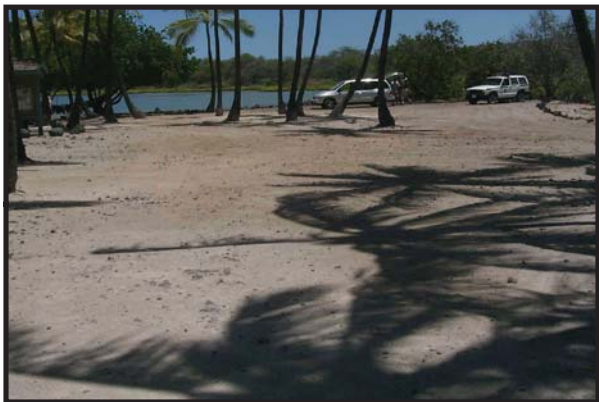
## Route 0900

Kaloko Fishpond Parking

At End of Route 0010

Route	Public / NonPublic	Date Visited	Area (sq ft)	Lane Miles *	Surface Type	Condition / PCR
0900	Public	5/11/2001	14530	0.25	SA	NO RATING

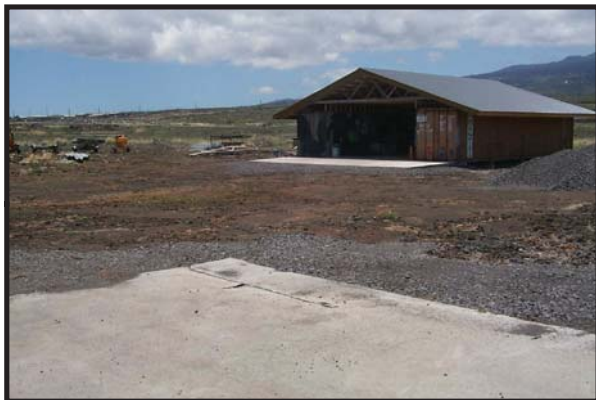
## Route 0901

Maintenance Yard and Parking

At End of Route 0400

Route	Public / NonPublic	Date Visited	Area (sq ft)	Lane Miles *	Surface Type	Condition / PCR
0901	Public	5/11/2001	34781	0.60	DT	NO RATING
