The Road Inventory of Kenai Fjords National Park KEFJ – 9845

Road Inventory Program

Prepared By:
Federal Highway Administration
Eastern Federal Lands Highway Division
Cycle 3

Kenai Fjords National Park in Alaska

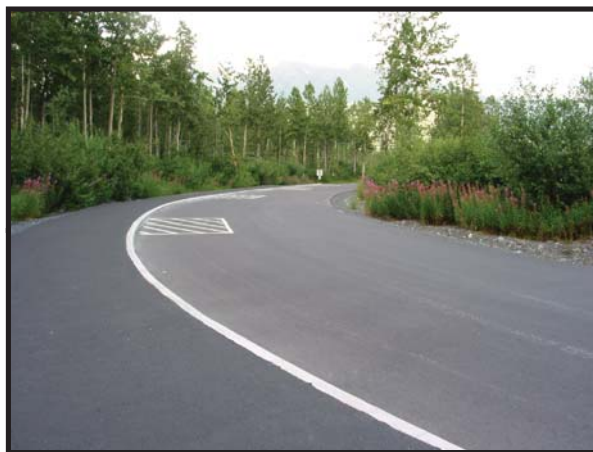
Route	Public / NonPublic	Date Visited	Area (sq ft)	Lane Miles *	Surface Type	Condition / PCR
0900A	Public	8/18/2002	10427	0.18	AS	EXCELLENT / 97

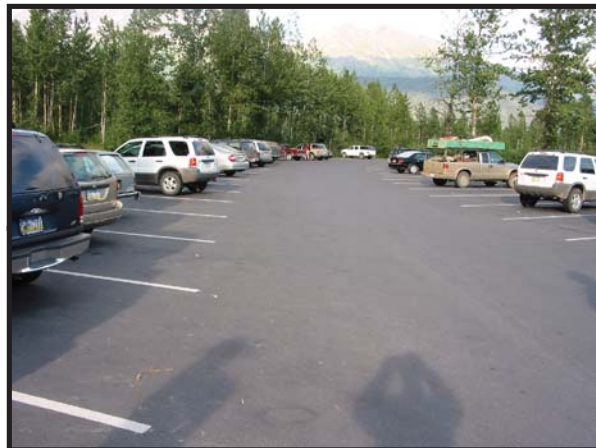
Route 0900B

Route	Public / NonPublic	Date Visited	Area (sq ft)	Lane Miles *	Surface Type	Condition / PCR
0900B	Public	8/18/2002	29827	0.51	AS	EXCELLENT / 97

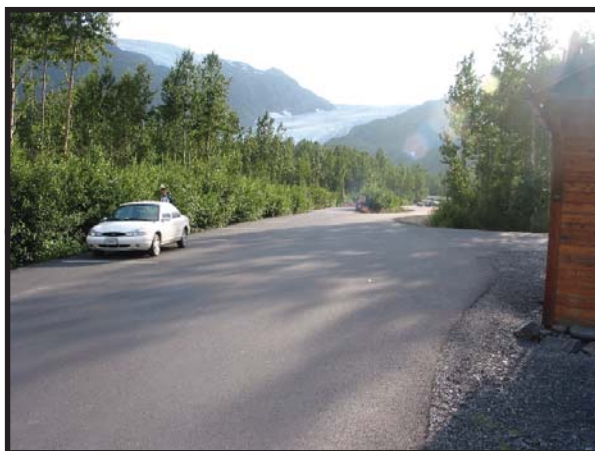
Route 0900E

Route	Public / NonPublic	Date Visited	Area (sq ft)	Lane Miles *	Surface Type	Condition / PCR
0900E	Public	8/18/2002	1300	0.02	AS	EXCELLENT / 97

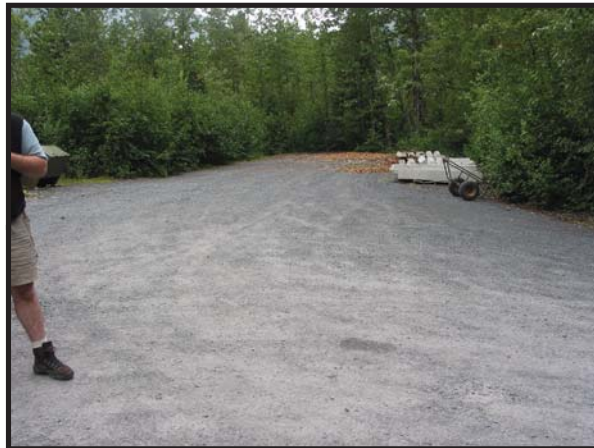
Kenai Fjords National Park
Route 0901
 EXIT GLACIER RESIDENCE PARKING
 AT END OF ROUTE 0401

Route	Public / NonPublic	Date Visited	Area (sq ft)	Lane Miles *	Surface Type	Condition / PCR
0901	NonPublic	8/19/2002	5499	0.09	GR	FAIR / 73

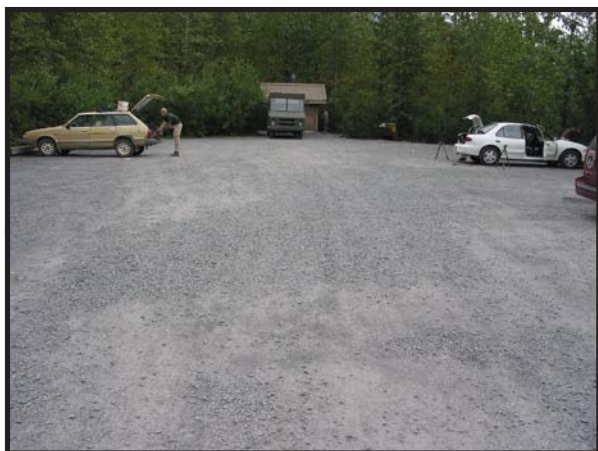
Kenai Fjords National Park
Route 0902
 EXIT GLACIER TENT CAMPGROUND PARKING
 AT END OF ROUTE 0201

Route	Public / NonPublic	Date Visited	Area (sq ft)	Lane Miles *	Surface Type	Condition / PCR
0902	Public	8/19/2002	6955	0.12	GR	FAIR / 73
