**The Road Inventory
of
Kennesaw Mountain National Battlefield Park
KEMO – 5490**

Road Inventory Program

Prepared By:
Federal Highway Administration
Eastern Federal Lands Highway Division
Cycle 3

Kennesaw Mountain National Battlefield in Georgia

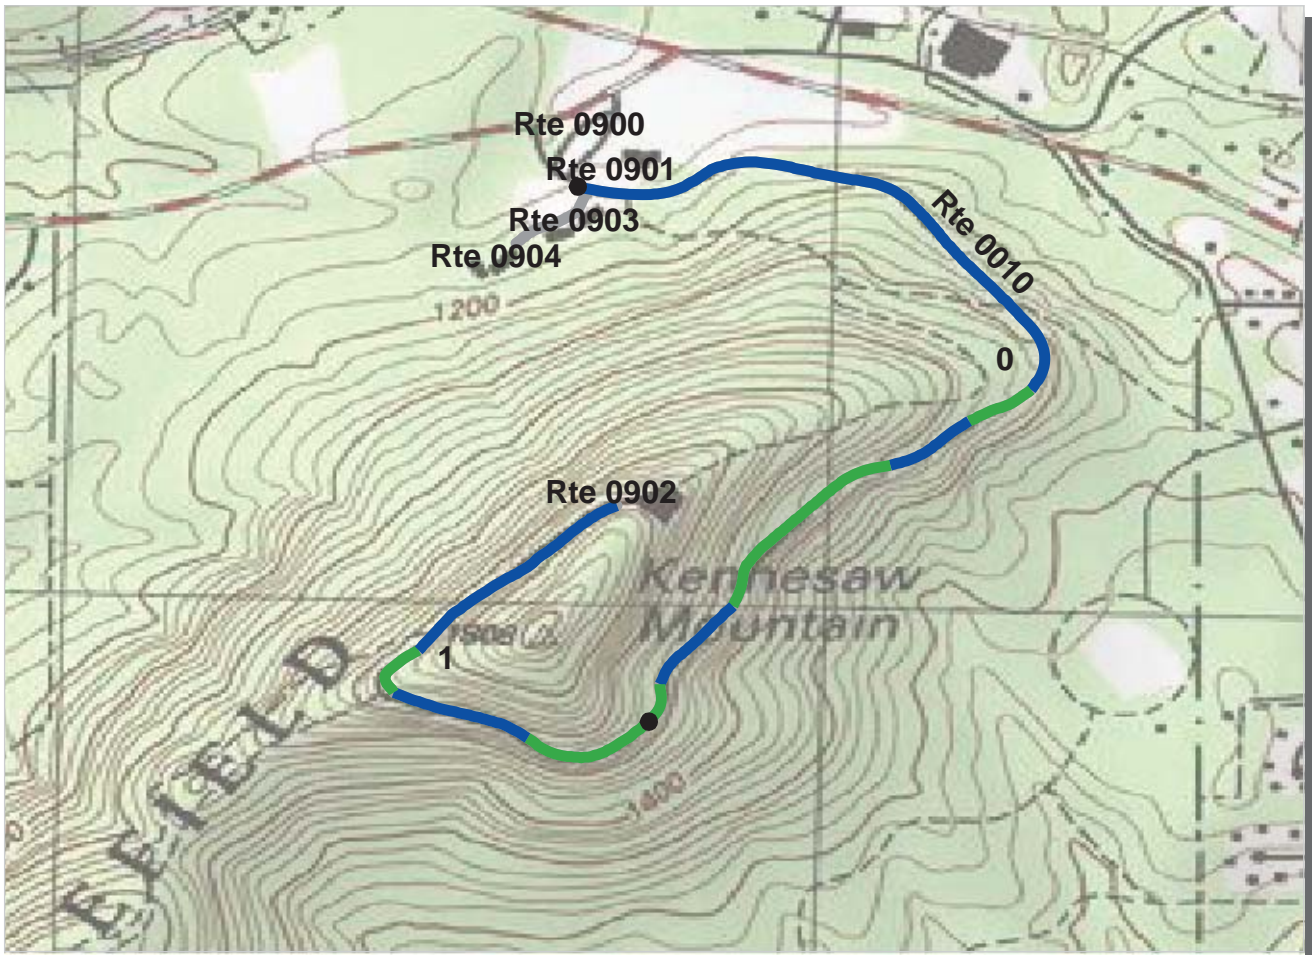
ROUTE: 0010 Kennesaw Mountain Drive **TOTAL LENGTH: 1.54 Miles**

Section Number	0	1			
Section Length (mi)	1.00	0.54			
AADT	**				
SADT	**				
ADT Date	**				
Cross Section Information					
Number of Lanes	2	2			
Paved Width (ft)	20	20			
Lane Width (ft)	10	10			
Shoulder Width (ft)	6	0			
Roadway Condition Information					
PCR (Pavement Condition Rating)	95	93			
RCI (Roughness Condition Index)	95	92			
SCR (Surface Condition Rating)	94	94			
Alligator Cracking Index	100	100			
Rutting Index	94	94			
Patching Index	100	100			
Transverse Cracking Index	99	99			
Longitudinal Cracking Index	99	99			
Shoulder Condition Rating	N/C	N/A			
Drainage Condition Rating	N/C	N/C

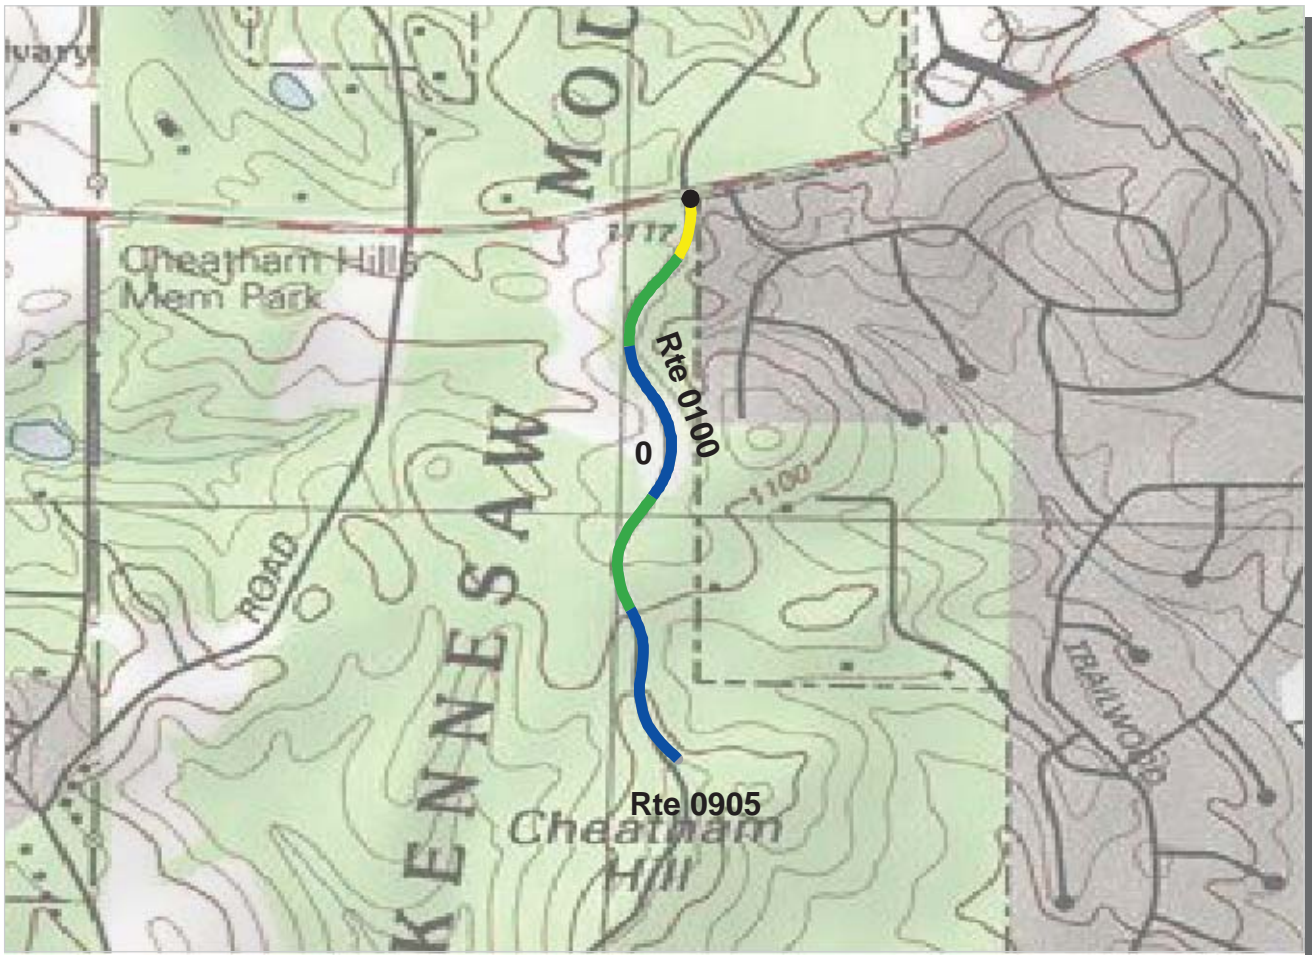
PCR	Poor	■	Fair	■	Good	■	Excellent	■
		(≤60)		(61 - 84)		(85 - 94)		(95 - 100)

* If the PCR rating is not available for a section, the SCR rating will be displayed. See appendix for definitions and formulas.

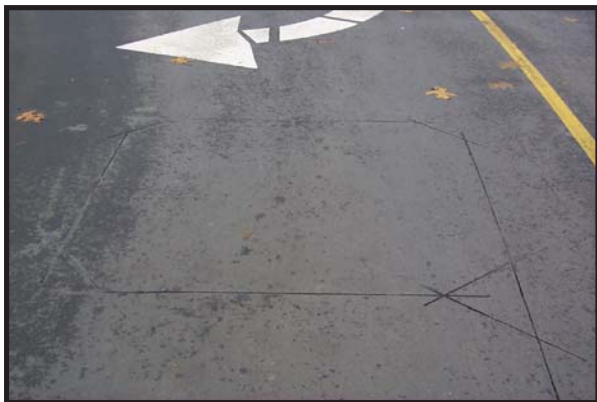
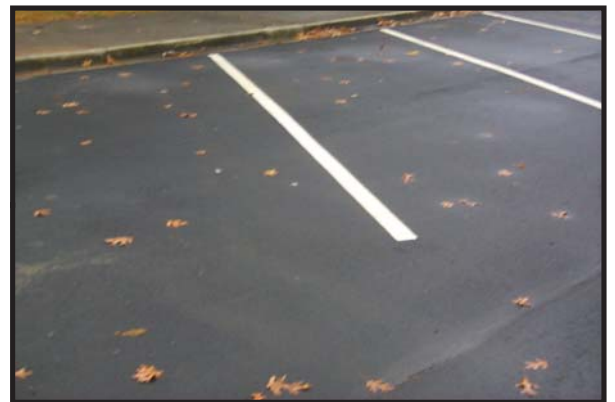
Route	Public / NonPublic	Date Visited	Area (sq ft)	Lane Miles *	Surface Type	Condition / PCR
0900	Public	12/11/2002	44518	0.77	AS	GOOD / 90

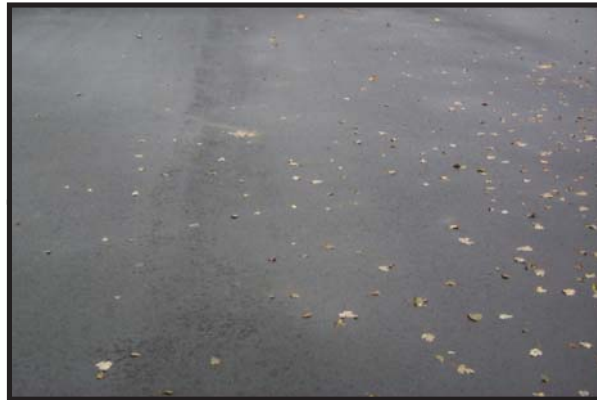
Route 0901

Route	Public / NonPublic	Date Visited	Area (sq ft)	Lane Miles *	Surface Type	Condition / PCR
0901	Public	12/11/2002	2306	0.04	AS	GOOD / 90

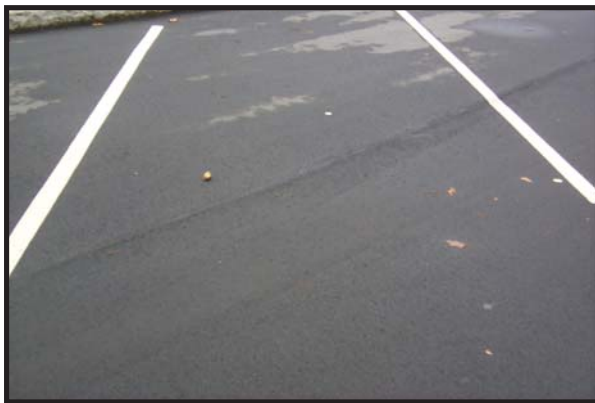
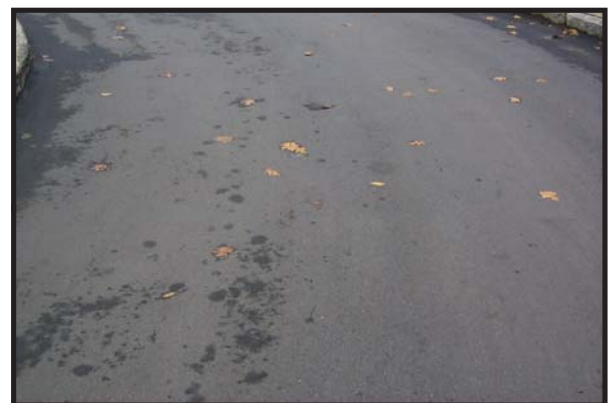
Route 0902

Route	Public / NonPublic	Date Visited	Area (sq ft)	Lane Miles *	Surface Type	Condition / PCR
0902	Public	12/11/2002	15333	0.26	AS	GOOD / 90

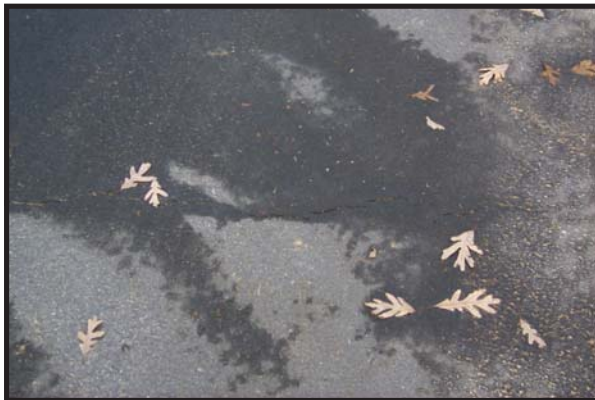
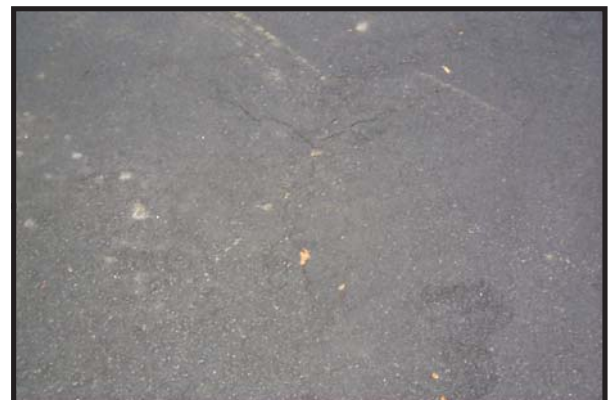
Route 0903

Route	Public / NonPublic	Date Visited	Area (sq ft)	Lane Miles *	Surface Type	Condition / PCR
0903	NonPublic	12/11/2002	2971	0.05	AS	GOOD / 90

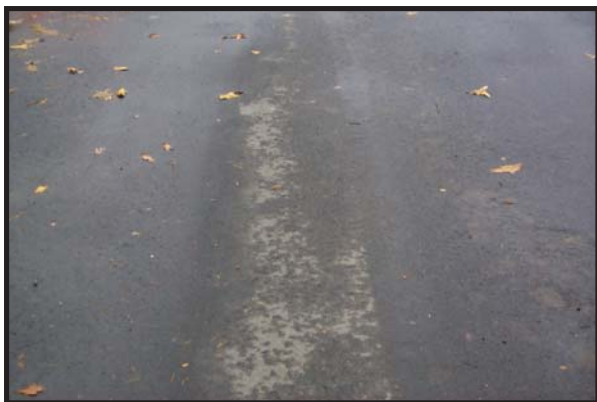
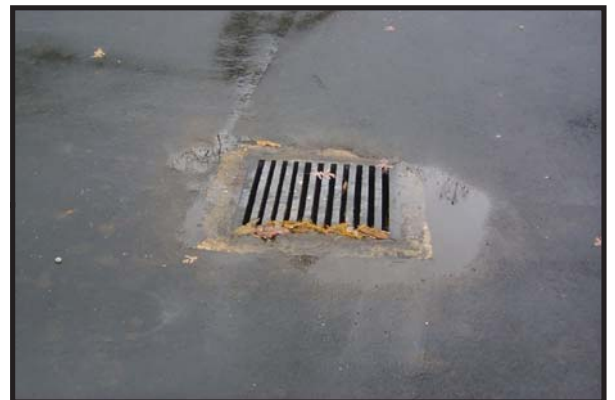
Route 0904

Route	Public / NonPublic	Date Visited	Area (sq ft)	Lane Miles *	Surface Type	Condition / PCR
0904	NonPublic	12/11/2002	14761	0.25	AS	GOOD / 90

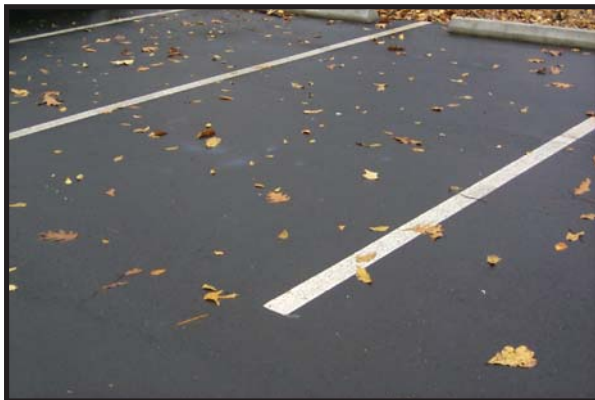
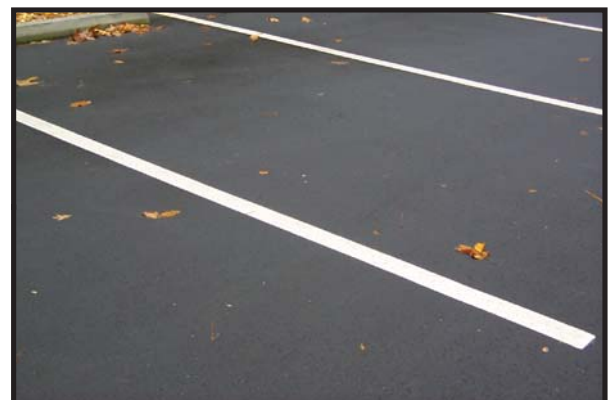
Route 0905

Route	Public / NonPublic	Date Visited	Area (sq ft)	Lane Miles *	Surface Type	Condition / PCR
0905	Public	12/11/2002	18604	0.32	AS	GOOD / 90

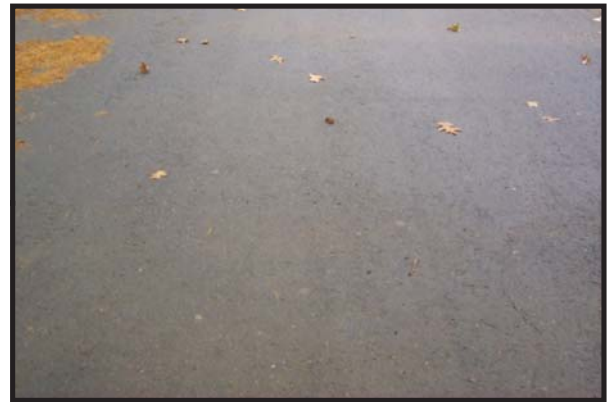
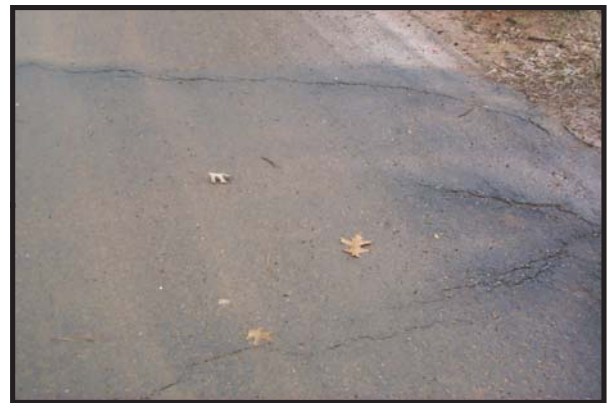
Route 0906

Route	Public / NonPublic	Date Visited	Area (sq ft)	Lane Miles *	Surface Type	Condition / PCR
0906	Public	12/11/2002	10933	0.19	AS	GOOD / 90

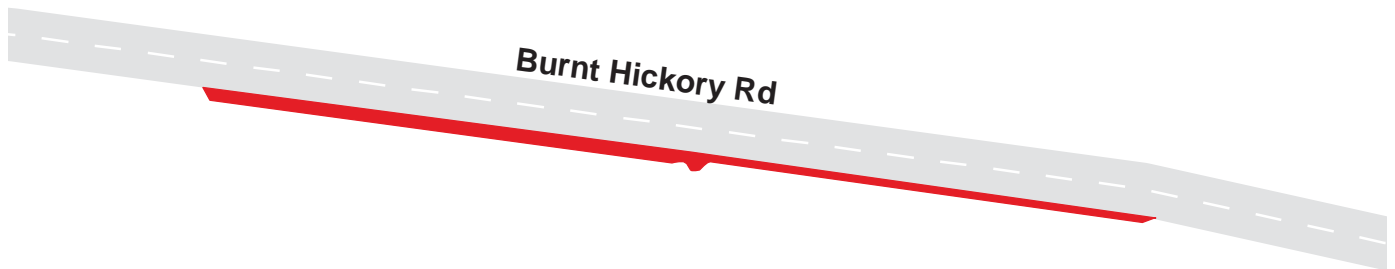
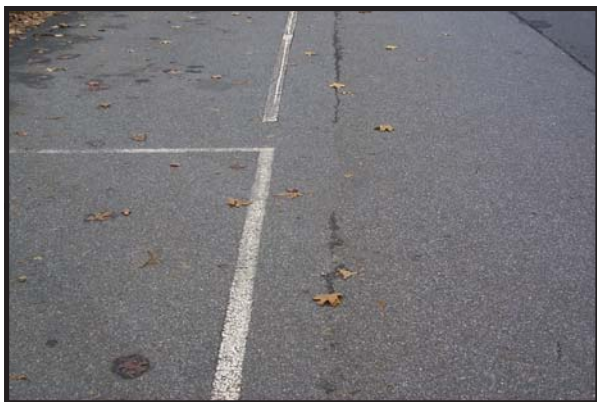
Route 0908

BURNT HICKORY PARKING

From Burnt Hickory Road

Route	Public / NonPublic	Date Visited	Area (sq ft)	Lane Miles *	Surface Type	Condition / PCR
0908	Public	12/11/2002	11880	0.20	AS	POOR / 45
