The Road Inventory of Keweenaw National Historical Park KEWE - 6410

Road Inventory Program

Prepared By:
Federal Highway Administration
Eastern Federal Lands Highway Division
Cycle 3

Keweenaw National Historical Park in Michigan

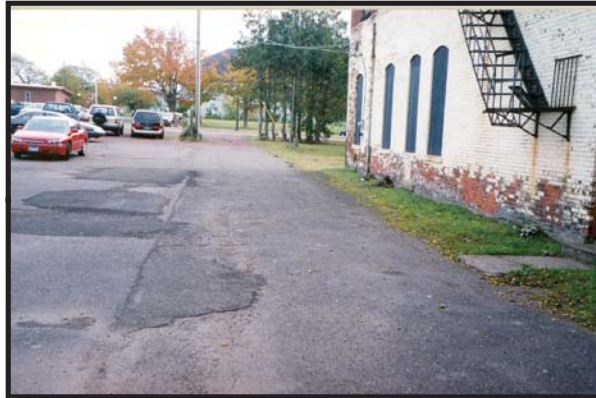
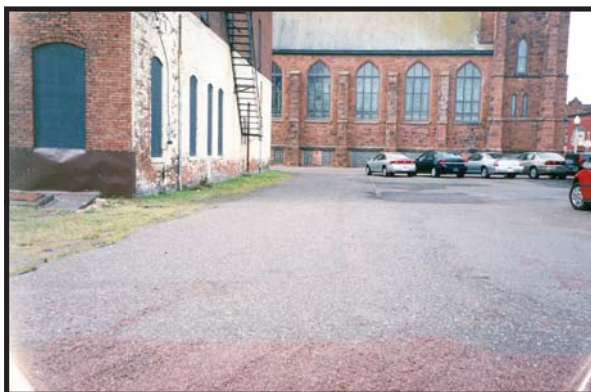
Keweenaw National Historical Park
Route 0600
 Knhp Union
 From Fifth Street

Route	Length (mi)	Width (ft)	Area (sq ft)	Lane Miles *	Condition / PCR	Surface Type
0600	0.03	0.00	1537	0.03	POOR / 45	AS

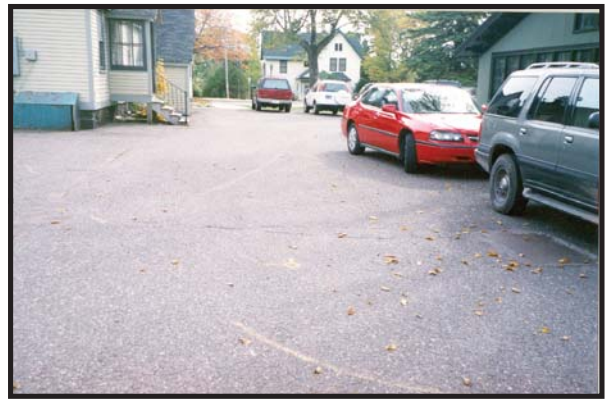
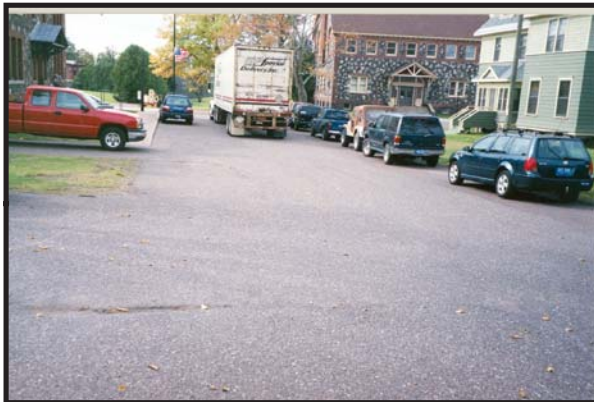
Route 0900

KNHP HEADQUARTERS

Route	Public / NonPublic	Date Visited	Area (sq ft)	Lane Miles *	Surface Type	Condition / PCR
0900	NonPublic	10/7/2004	25572	0.44	AS	POOR / 45

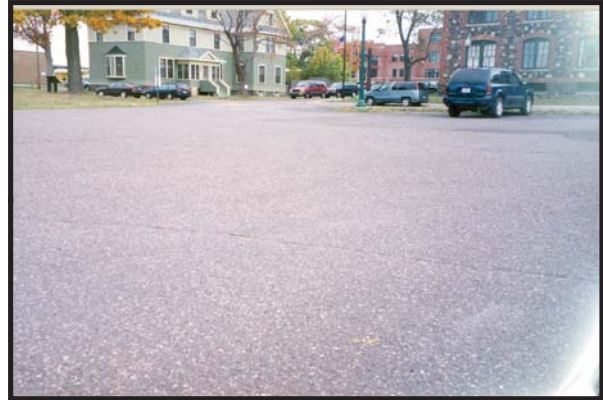
Route 0901

KEWEENAW HISTORY CENTER PARKING AREA

Route	Public / NonPublic	Date Visited	Area (sq ft)	Lane Miles *	Surface Type	Condition / PCR
0901	Public	10/7/2004	11238	0.19	AS	FAIR / 73

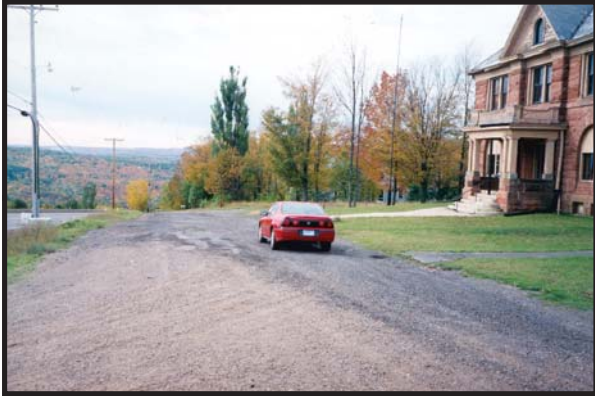
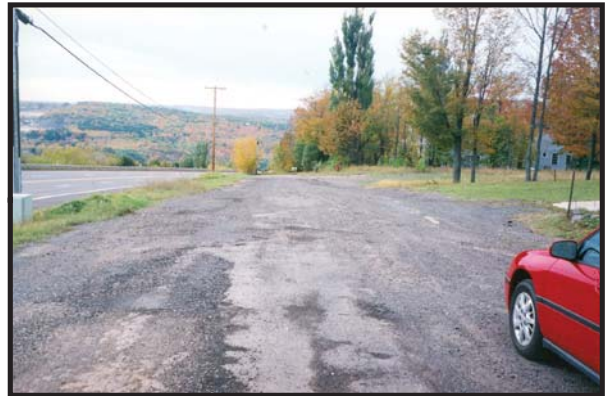
Route 0902

PAY OFFICE PARKING AREA

Route	Public / NonPublic	Date Visited	Area (sq ft)	Lane Miles *	Surface Type	Condition / PCR
0902	NonPublic	10/7/2004	12191	0.21	AS	POOR / 45
