The Road Inventory of Kings Canyon National Park KICA - 8580

Road Inventory Program

Prepared By:
Federal Highway Administration
Eastern Federal Lands Highway Division
Cycle 3

Kings Canyon National Park in California

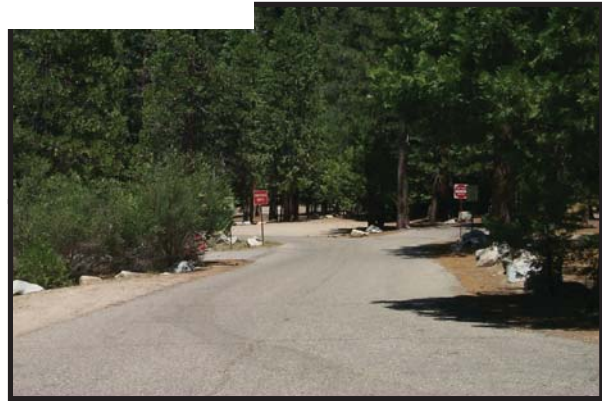
Route	Length (mi)	Width (ft)	Area (sq ft)	Lane Miles *	Condition / PCR	Surface Type
0206	2.45	0.00	142859	2.46	FAIR / 73	AS

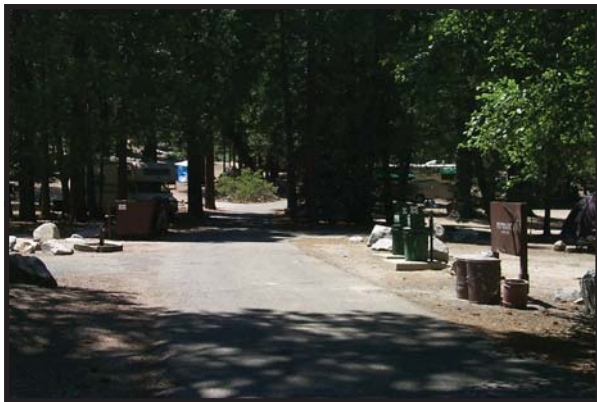
Route 0208

Route	Length (mi)	Width (ft)	Area (sq ft)	Lane Miles *	Condition / PCR	Surface Type
0208	1.58	0.00	92318	1.59	POOR / 45	AS

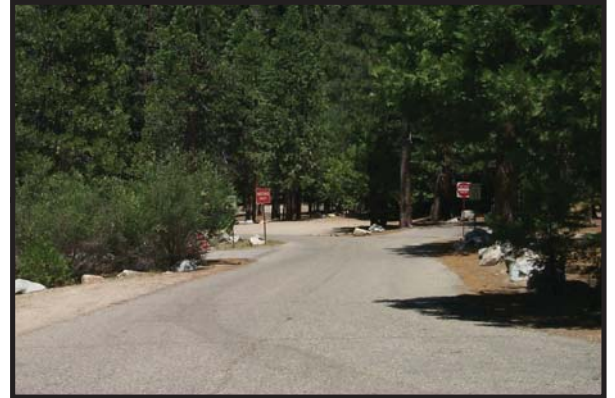
Route 0209

Route	Length (mi)	Width (ft)	Area (sq ft)	Lane Miles *	Condition / PCR	Surface Type
0209	3.72	0.00	216229	3.72	POOR / 45	AS

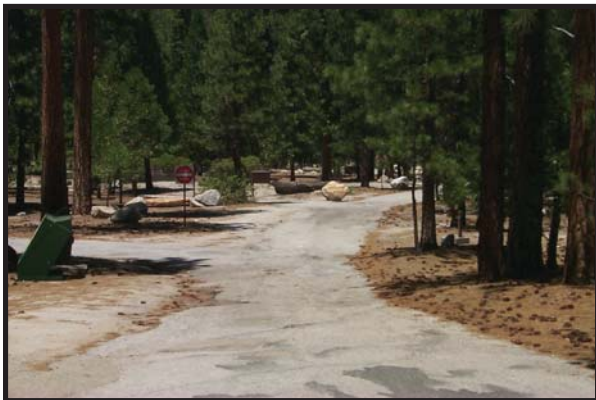
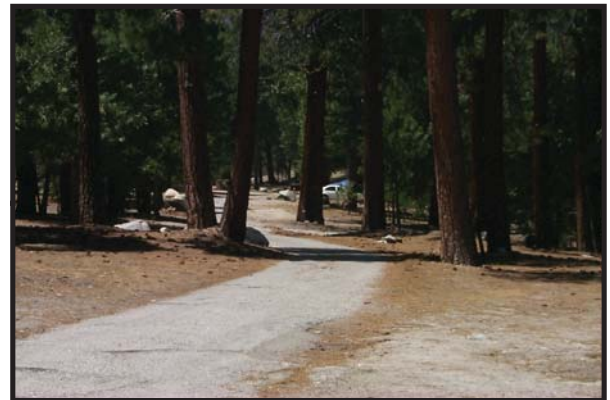
Route 0216

Route	Length (mi)	Width (ft)	Area (sq ft)	Lane Miles *	Condition / PCR	Surface Type
0216	3.51	0.00	204181	3.52	FAIR / 73	AS

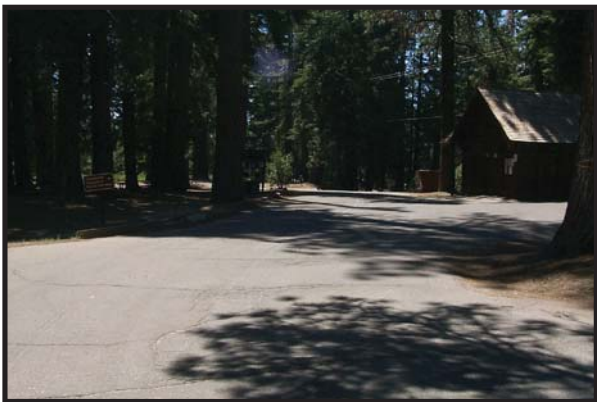
Route 0218

Route	Length (mi)	Width (ft)	Area (sq ft)	Lane Miles *	Condition / PCR	Surface Type
0218	1.87	0.00	149509	2.57	FAIR / 73	AS

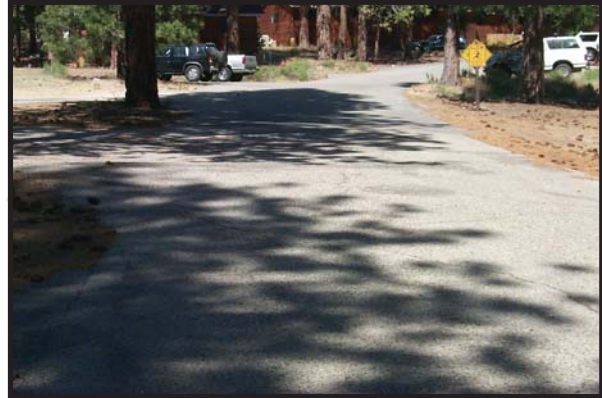
Route 0402

Route	Length (mi)	Width (ft)	Area (sq ft)	Lane Miles *	Condition / PCR	Surface Type
0402	0.64	0.00	37363	0.64	FAIR / 73	AS

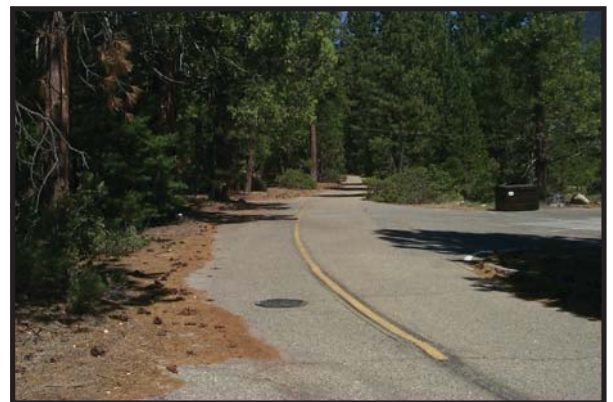
Route 0411

Route	Length (mi)	Width (ft)	Area (sq ft)	Lane Miles *	Condition / PCR	Surface Type
0411	0.32	0.00	37949	0.65	FAIR / 73	AS

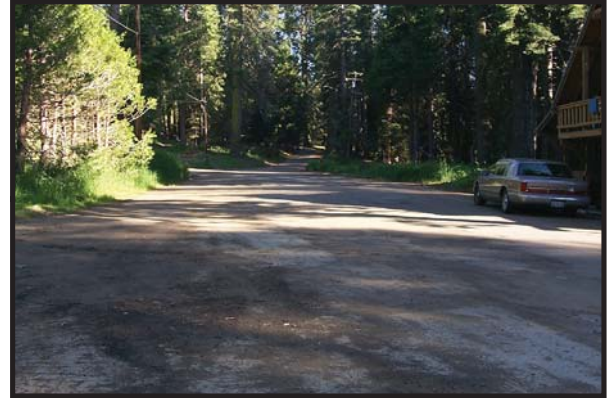
Route 0414A

Route	Length (mi)	Width (ft)	Area (sq ft)	Lane Miles *	Condition / PCR	Surface Type
0414A	0.03	0.00	3934	0.07	NC / -1	AS

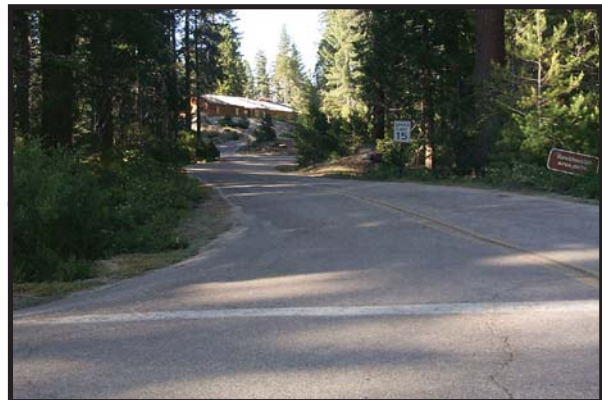
Route 0418

Route	Length (mi)	Width (ft)	Area (sq ft)	Lane Miles *	Condition / PCR	Surface Type
0418	0.23	0.00	26847	0.46	FAIR / 73	AS

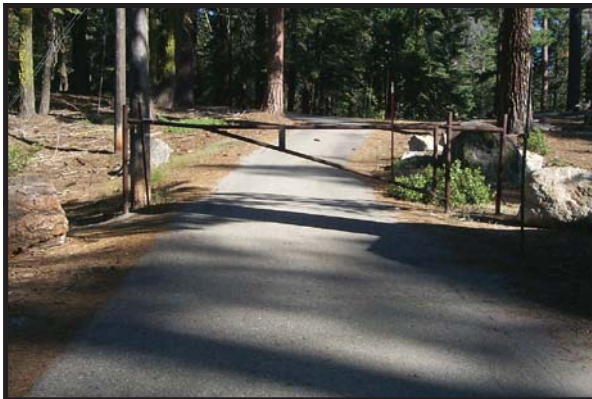
Route 0419

Route	Length (mi)	Width (ft)	Area (sq ft)	Lane Miles *	Condition / PCR	Surface Type
0419	0.26	0.00	15235	0.26	POOR / 45	AS

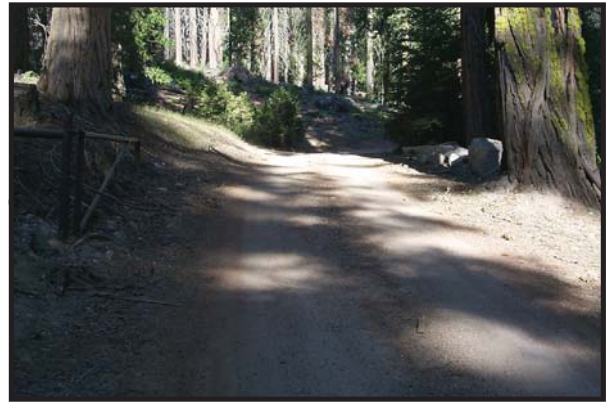
Route 0901

Route	Public / NonPublic	Date Visited	Area (sq ft)	Lane Miles *	Surface Type	Condition / PCR
0901	Public	6/25/2002	8101	0.14	AS	FAIR / 73

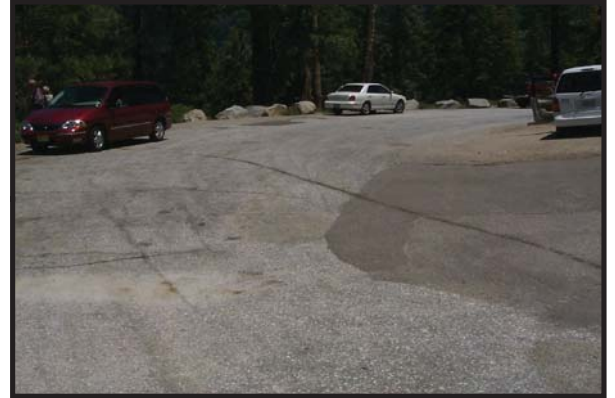
Route 0902

Route	Public / NonPublic	Date Visited	Area (sq ft)	Lane Miles *	Surface Type	Condition / PCR
0902	NonPublic	6/25/2002	38120	0.66	AS	FAIR / 73

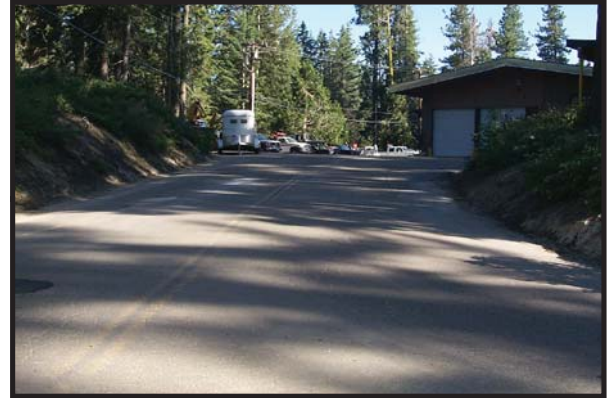
Route 0903

Route	Public / NonPublic	Date Visited	Area (sq ft)	Lane Miles *	Surface Type	Condition / PCR
0903	Public	6/25/2002	24961	0.43	AS	GOOD / 90

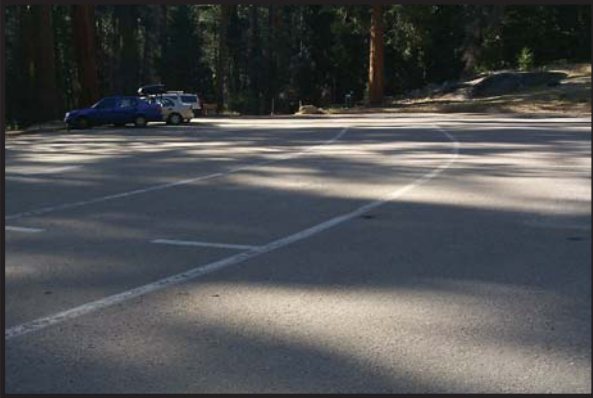
Route 0904

Route	Public / NonPublic	Date Visited	Area (sq ft)	Lane Miles *	Surface Type	Condition / PCR
0904	Public	6/25/2002	16454	0.28	AS	FAIR / 73

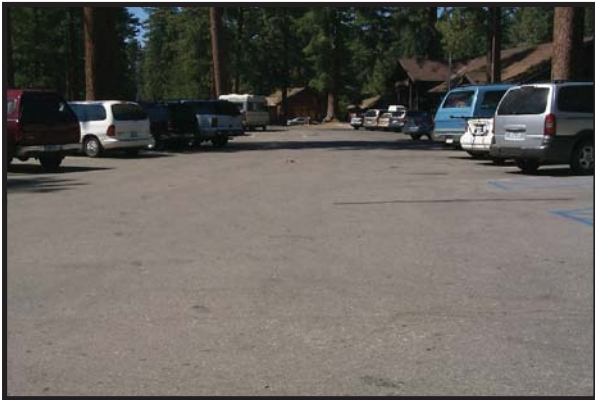
Route 0905

Route	Public / NonPublic	Date Visited	Area (sq ft)	Lane Miles *	Surface Type	Condition / PCR
0905	NonPublic	6/25/2002	8267	0.14	AS	FAIR / 73

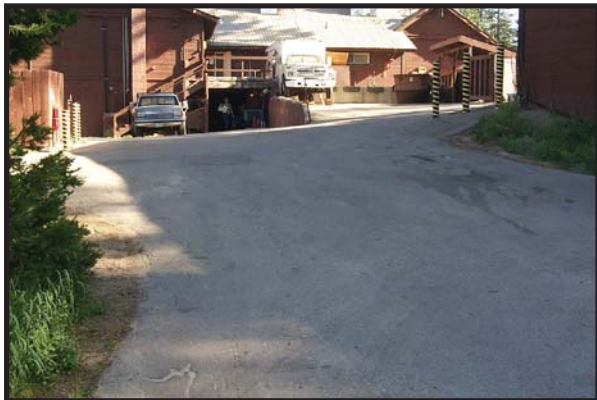
Route 0906

Route	Public / NonPublic	Date Visited	Area (sq ft)	Lane Miles *	Surface Type	Condition / PCR
0906	Public	6/25/2002	13204	0.23	AS	FAIR / 73

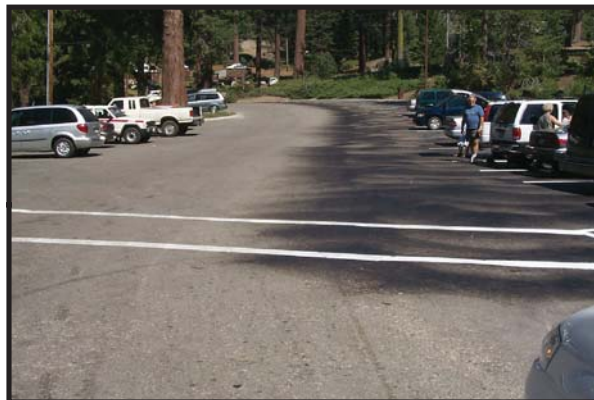
Route 0907

Route	Public / NonPublic	Date Visited	Area (sq ft)	Lane Miles *	Surface Type	Condition / PCR
0907	Public	6/25/2002	6327	0.11	AS	FAIR / 73

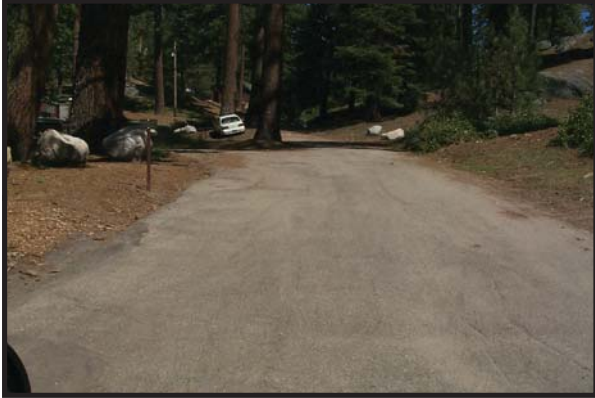
Route 0908

Route	Public / NonPublic	Date Visited	Area (sq ft)	Lane Miles *	Surface Type	Condition / PCR
0908	Public	6/25/2002	7280	0.13	AS	FAIR / 73

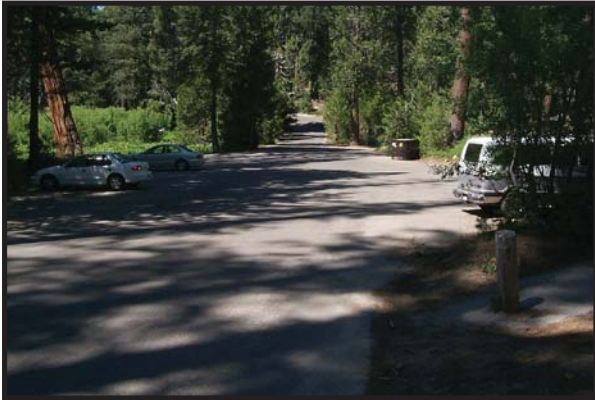
Route 0909

Route	Public / NonPublic	Date Visited	Area (sq ft)	Lane Miles *	Surface Type	Condition / PCR
0909	Public	6/25/2002	21653	0.37	AS	EXCELLENT / 97

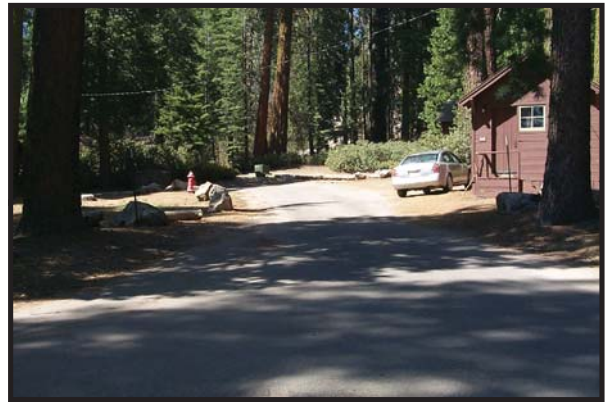
Route 0911

Route	Public / NonPublic	Date Visited	Area (sq ft)	Lane Miles *	Surface Type	Condition / PCR
0911	Public	6/25/2002	8286	0.14	AS	FAIR / 73

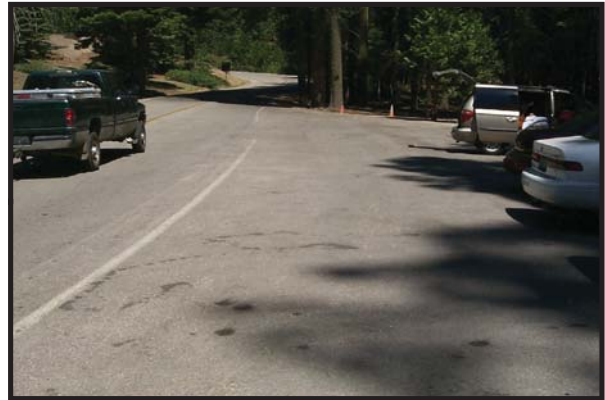
Route 0912

Route	Public / NonPublic	Date Visited	Area (sq ft)	Lane Miles *	Surface Type	Condition / PCR
0912	Public	6/25/2002	54539	0.94	AS	EXCELLENT / 97

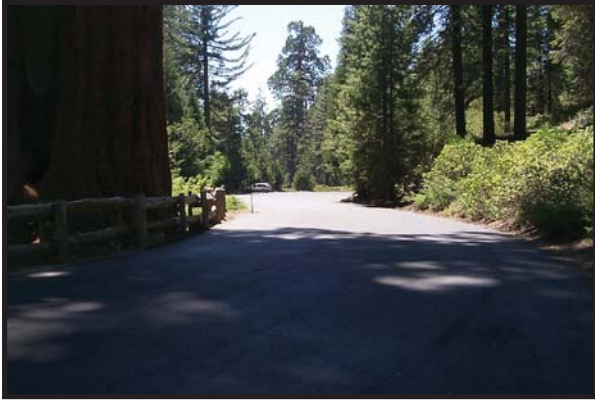
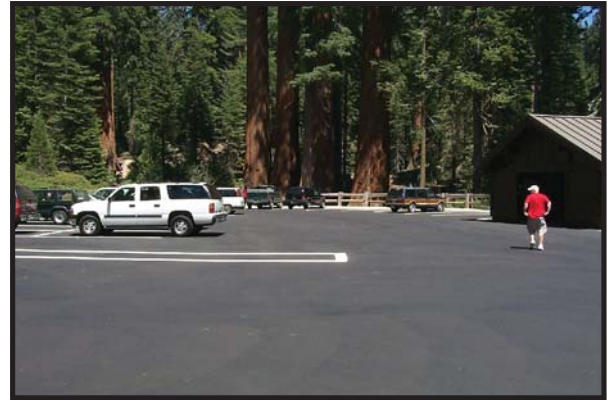
Route 0913

Route	Public / NonPublic	Date Visited	Area (sq ft)	Lane Miles *	Surface Type	Condition / PCR
0913	NonPublic	6/25/2002	11326	0.20	AS	GOOD / 90

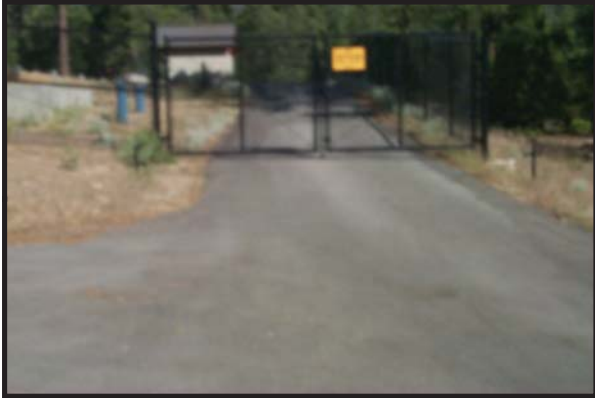
Route 0914

Route	Public / NonPublic	Date Visited	Area (sq ft)	Lane Miles *	Surface Type	Condition / PCR
0914	NonPublic	6/25/2002	15450	0.27	AS	FAIR / 73

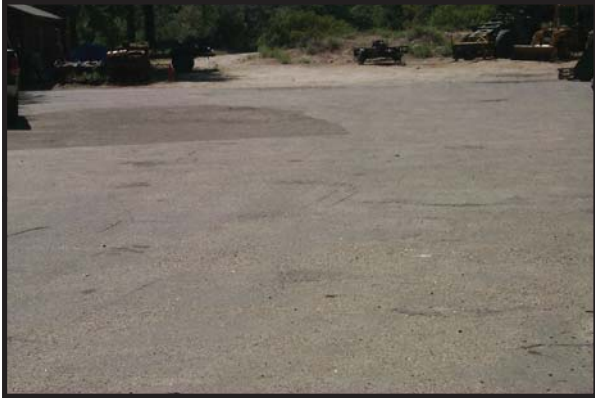
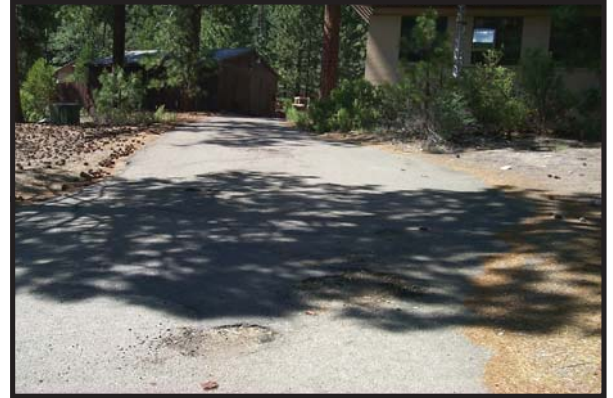
Route 0916

Route	Public / NonPublic	Date Visited	Area (sq ft)	Lane Miles *	Surface Type	Condition / PCR
0916	Public	2/17/2004	60236	1.04	AS	FAIR / 73

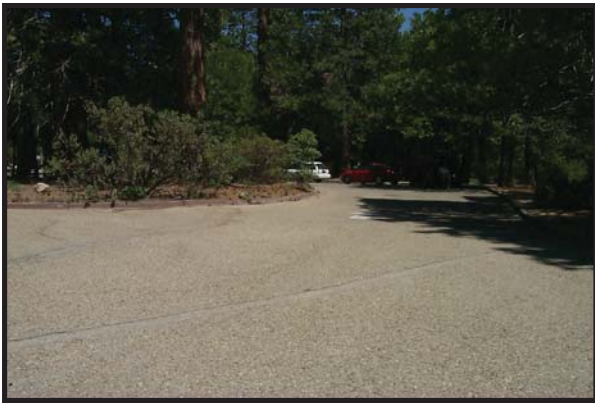
Route 0917

Route	Public / NonPublic	Date Visited	Area (sq ft)	Lane Miles *	Surface Type	Condition / PCR
0917	Public	2/17/2004	24265	0.42	AS	FAIR / 73

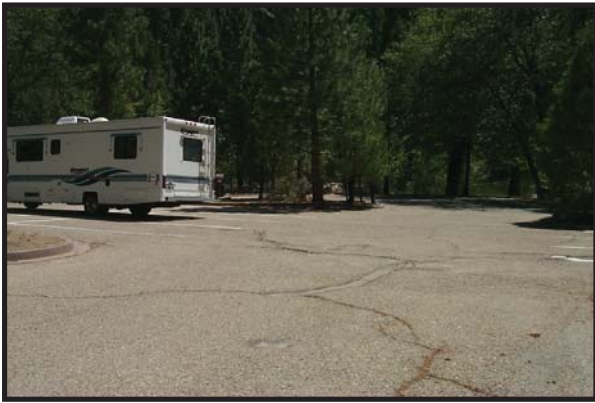
Route 0918

Route	Public / NonPublic	Date Visited	Area (sq ft)	Lane Miles *	Surface Type	Condition / PCR
0918	Public	2/17/2004	43708	0.75	AS	FAIR / 73

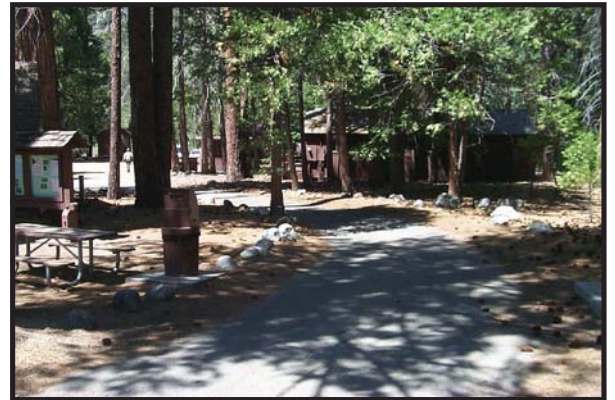
Route 0920

Route	Public / NonPublic	Date Visited	Area (sq ft)	Lane Miles *	Surface Type	Condition / PCR
0920	Public	6/25/2002	1900	0.03	AS	POOR / 45

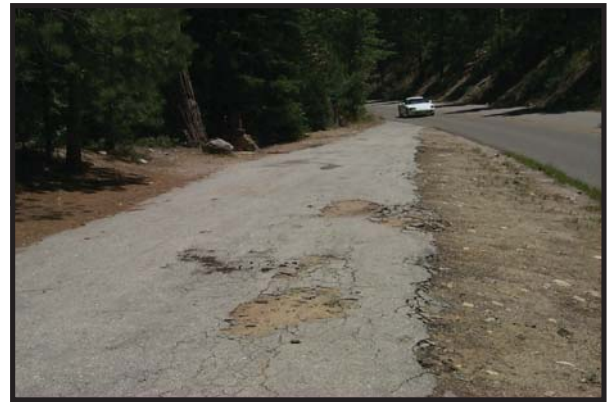
Route 0921

Route	Public / NonPublic	Date Visited	Area (sq ft)	Lane Miles *	Surface Type	Condition / PCR
0921	Public	6/25/2002	4244	0.07	AS	FAIR / 73

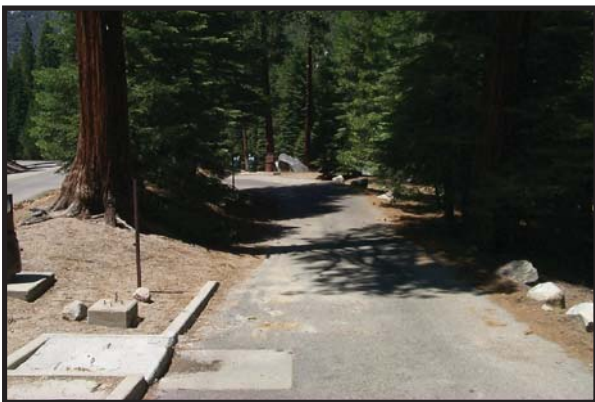
Kings Canyon National Park
Route 0922
Canyon View Parking
Adjacent to Route 0011 at MP 2.8 on Left

Route	Public / NonPublic	Date Visited	Area (sq ft)	Lane Miles *	Surface Type	Condition / PCR
0922	Public	6/25/2002	5986	0.10	AS	FAIR / 73

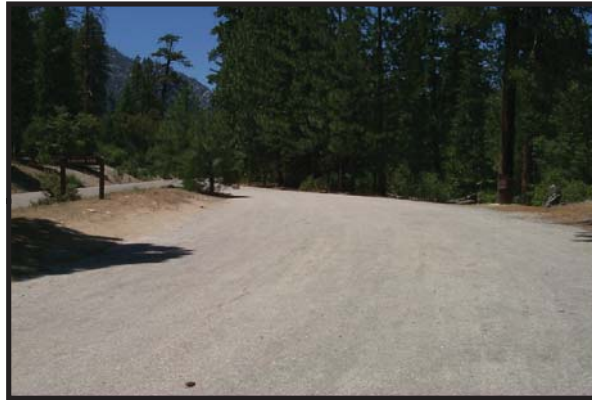
Route 0923

Route	Public / NonPublic	Date Visited	Area (sq ft)	Lane Miles *	Surface Type	Condition / PCR
0923	Public	6/25/2002	8574	0.15	AS	FAIR / 73

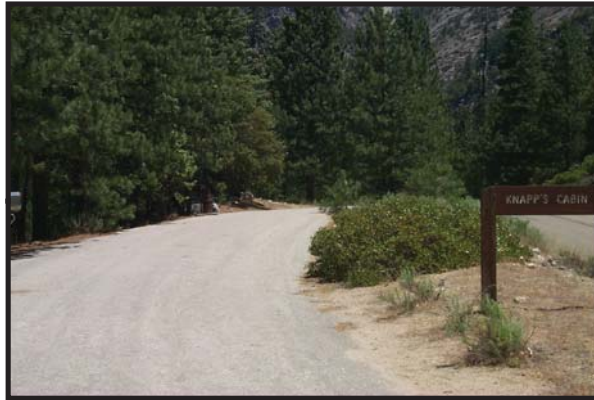
Route 0924

Route	Public / NonPublic	Date Visited	Area (sq ft)	Lane Miles *	Surface Type	Condition / PCR
0924	Public	6/25/2002	13615	0.23	AS	FAIR / 73

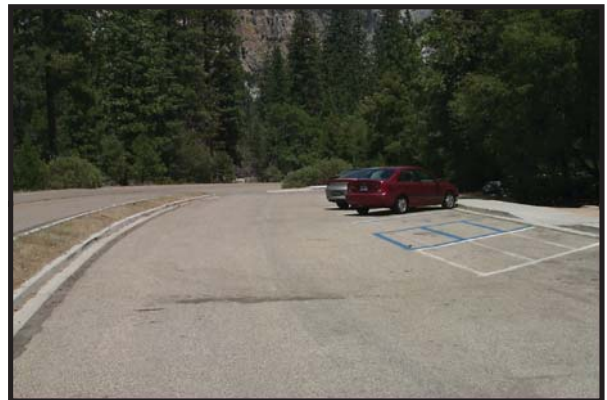
Route 0925

Route	Public / NonPublic	Date Visited	Area (sq ft)	Lane Miles *	Surface Type	Condition / PCR
0925	Public	6/25/2002	5694	0.10	AS	POOR / 45

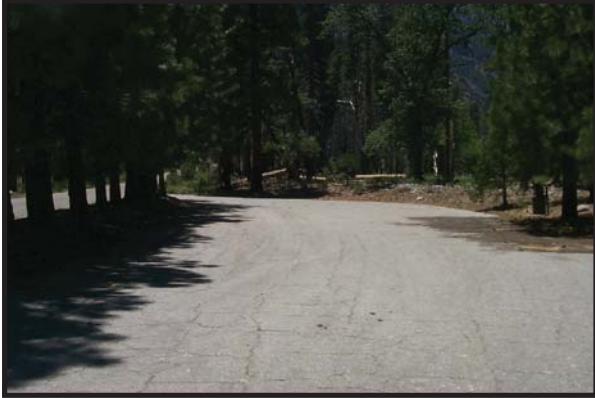
Route 0926

Route	Public / NonPublic	Date Visited	Area (sq ft)	Lane Miles *	Surface Type	Condition / PCR
0926	Public	6/25/2002	3548	0.06	AS	POOR / 45

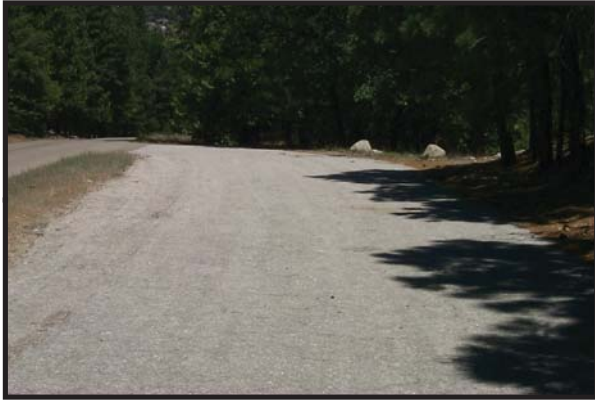
Route 0927

Route	Public / NonPublic	Date Visited	Area (sq ft)	Lane Miles *	Surface Type	Condition / PCR
0927	Public	6/25/2002	17661	0.30	AS	FAIR / 73

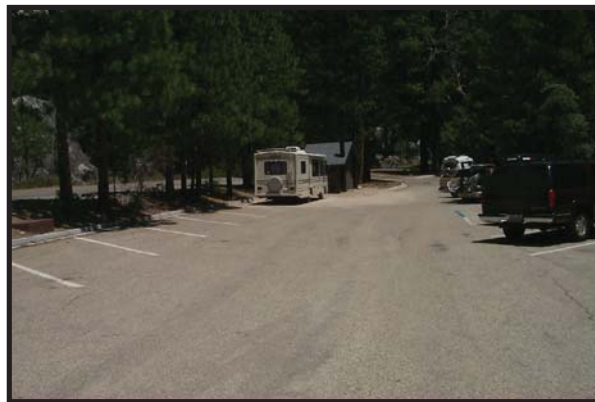
Route 0928

Route	Public / NonPublic	Date Visited	Area (sq ft)	Lane Miles *	Surface Type	Condition / PCR
0928	Public	6/25/2002	46058	0.79	AS	FAIR / 73

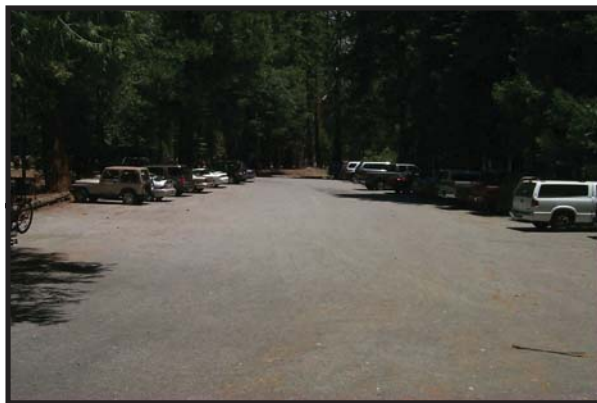
Route 0929

Route	Public / NonPublic	Date Visited	Area (sq ft)	Lane Miles *	Surface Type	Condition / PCR
0929	Public	6/25/2002	2523	0.04	AS	GOOD / 90

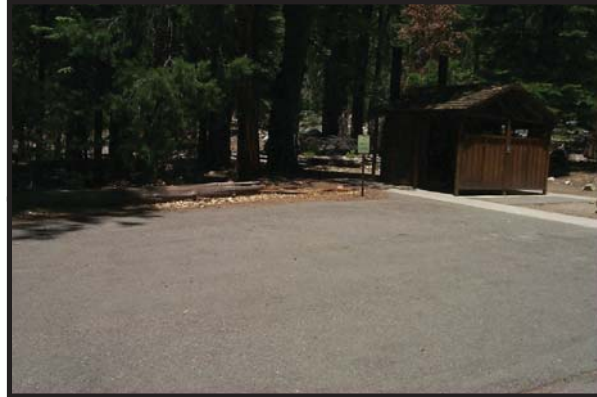
Route 0930

Route	Public / NonPublic	Date Visited	Area (sq ft)	Lane Miles *	Surface Type	Condition / PCR
0930	Public	6/25/2002	20308	0.35	AS	FAIR / 73

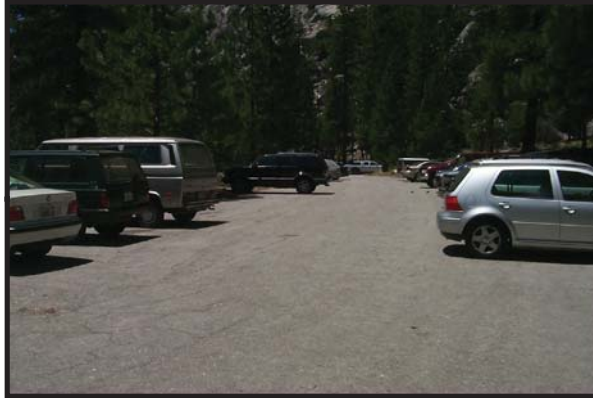
Route 0931

Route	Public / NonPublic	Date Visited	Area (sq ft)	Lane Miles *	Surface Type	Condition / PCR
0931	Public	6/25/2002	43726	0.75	AS	POOR / 45

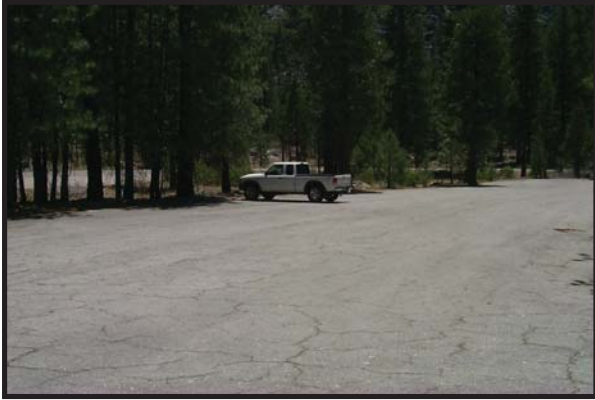
Route 0932

Route	Public / NonPublic	Date Visited	Area (sq ft)	Lane Miles *	Surface Type	Condition / PCR
0932	Public	6/25/2002	NA	NA	AS	NC / -1

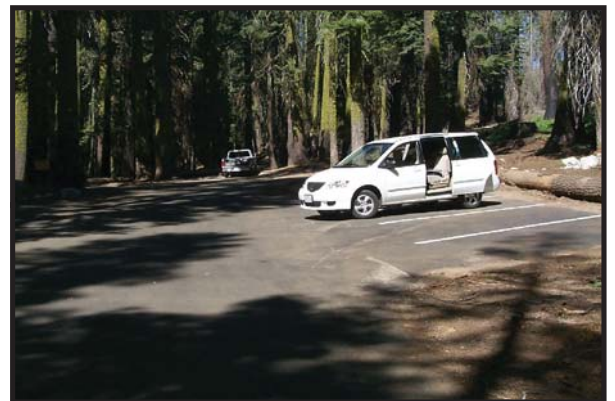
Route 0934

Route	Public / NonPublic	Date Visited	Area (sq ft)	Lane Miles *	Surface Type	Condition / PCR
0934	Public	6/25/2002	13657	0.24	AS	FAIR / 73

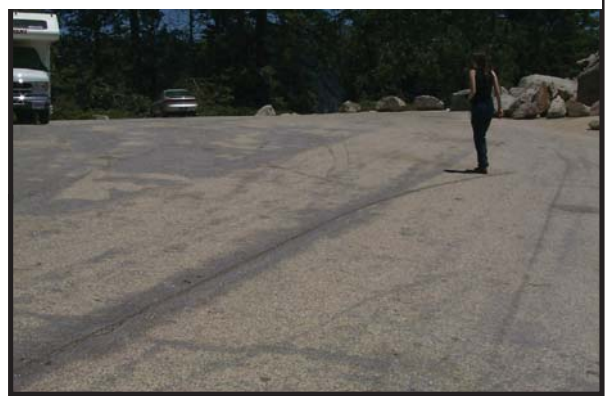
Route 0935

Route	Public / NonPublic	Date Visited	Area (sq ft)	Lane Miles *	Surface Type	Condition / PCR
0935	Public	6/25/2002	2184	0.04	AS	GOOD / 90
