# The Road Inventory of Kings Mountain National Military Park KIMO - 5500

## Road Inventory Program

Prepared By:  
Federal Highway Administration  
Eastern Federal Lands Highway Division  
Cycle 3

# Kings Mountain National Military Park in South Carolina

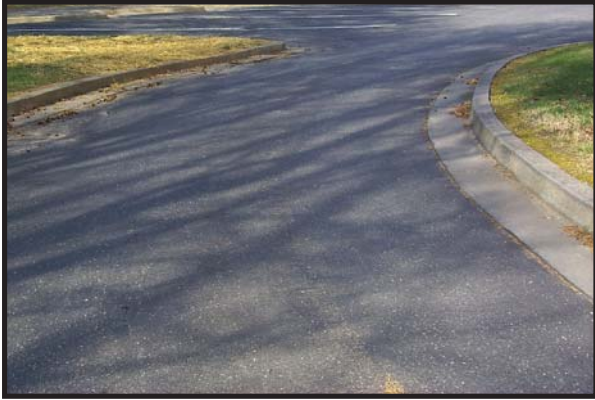
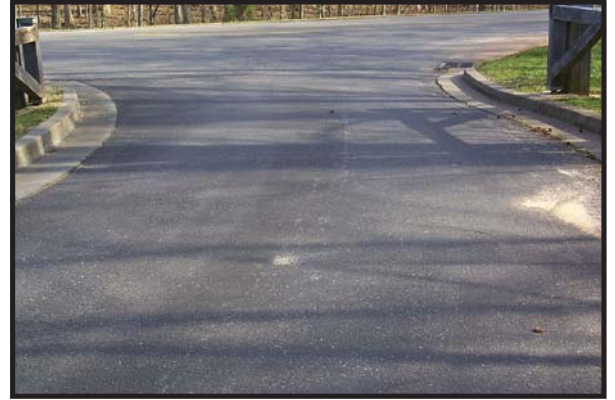
Route	Public / NonPublic	Date Visited	Area (sq ft)	Lane Miles *	Surface Type	Condition / PCR
0900	Public	3/11/2002	43977	0.76	AS	GOOD / 90

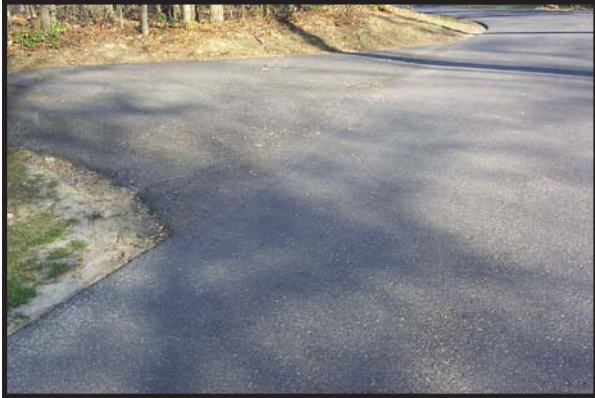
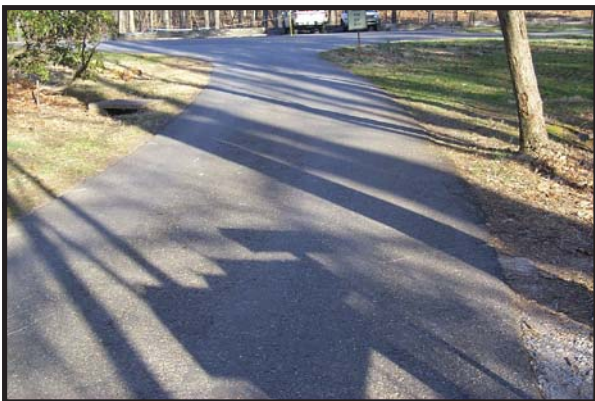
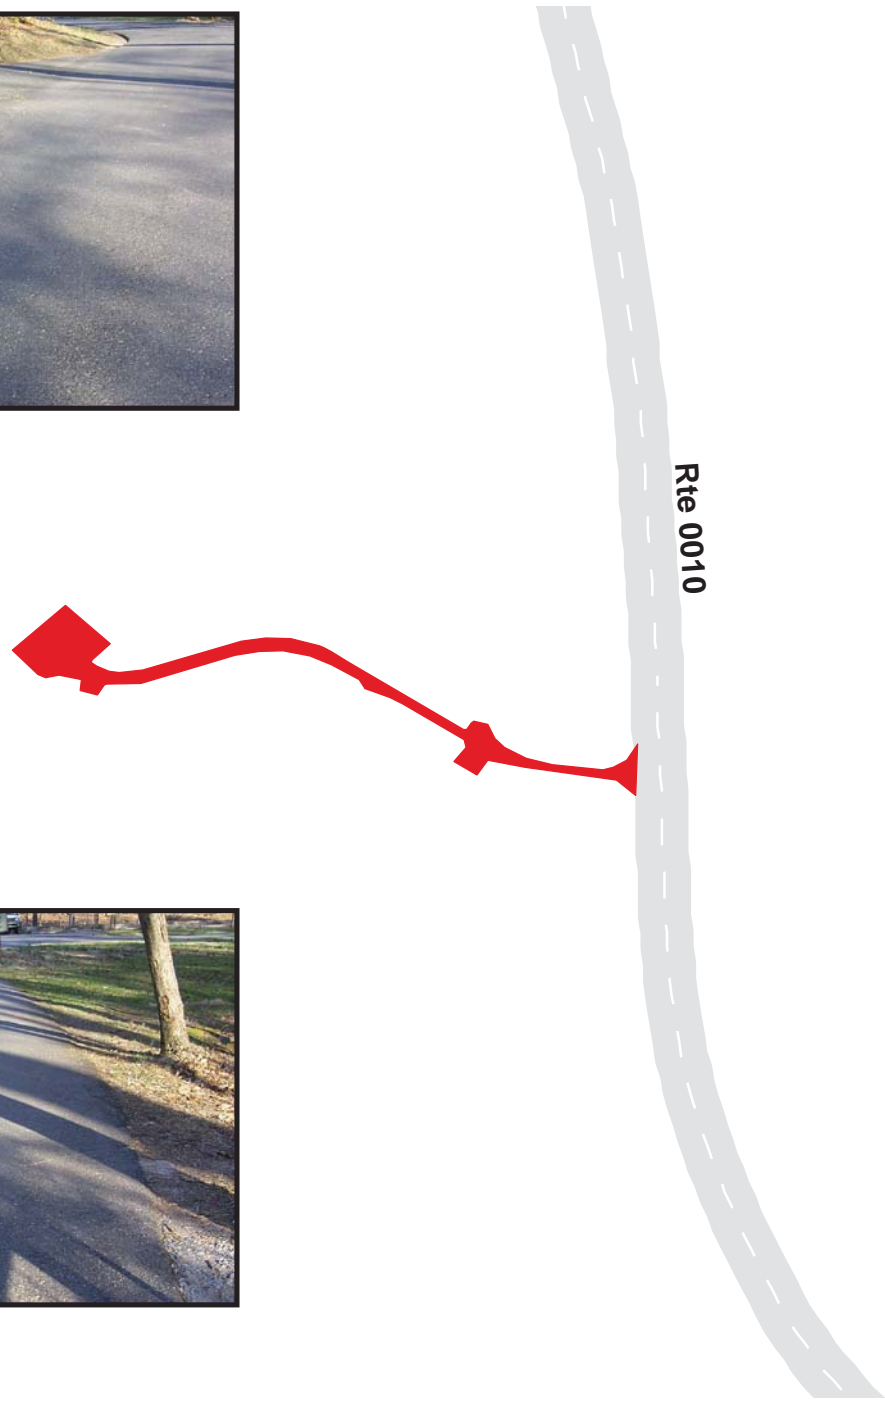
## Route 0901

Route	Public / NonPublic	Date Visited	Area (sq ft)	Lane Miles *	Surface Type	Condition / PCR
0901	NonPublic	3/11/2002	13399	0.23	AS	FAIR / 73

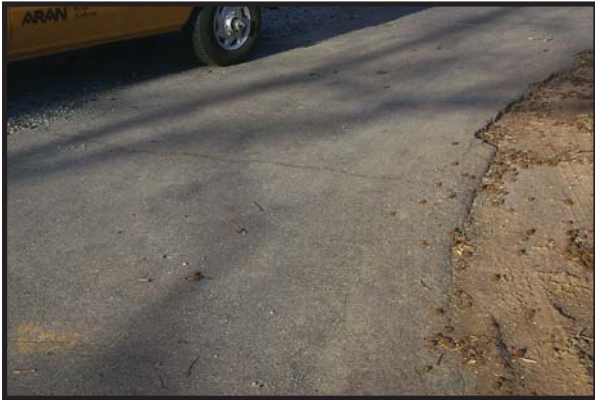
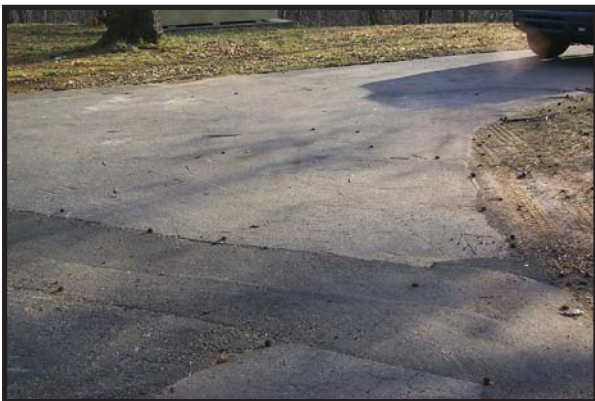
## Route 0902

Route	Public / NonPublic	Date Visited	Area (sq ft)	Lane Miles *	Surface Type	Condition / PCR
0902	NonPublic	3/11/2002	6570	0.11	AS	FAIR / 73

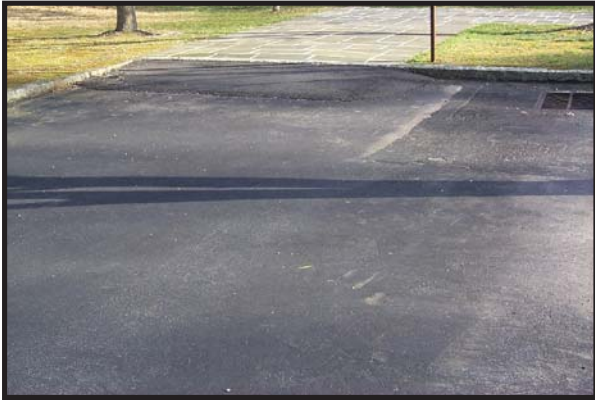
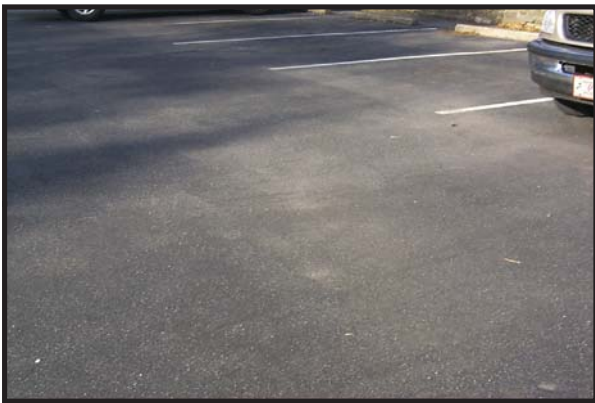
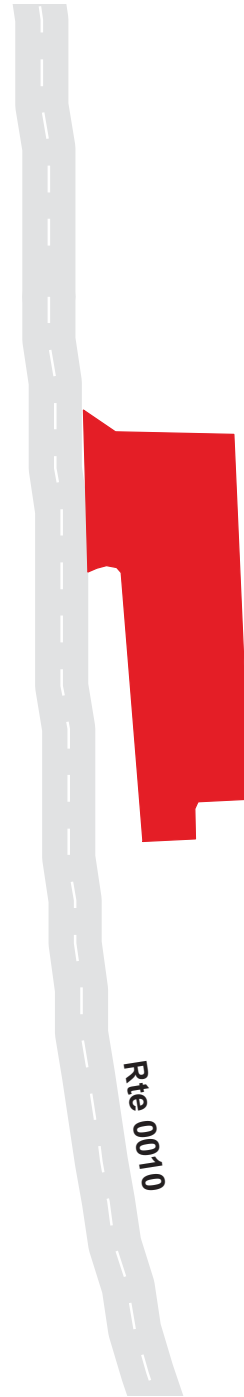
## Route 0903

Route	Public / NonPublic	Date Visited	Area (sq ft)	Lane Miles *	Surface Type	Condition / PCR
0903	Public	3/11/2002	7192	0.12	AS	GOOD / 90
