**The Road Inventory  
of  
Knife River Indian Villages National  
Historic Site  
KNRI – 1548**

Prepared By:  
Federal Highway Administration  
Eastern Federal Lands Highway Division  
Cycle 3

# Knife River Indian Villages National Historic Site in North Dakota

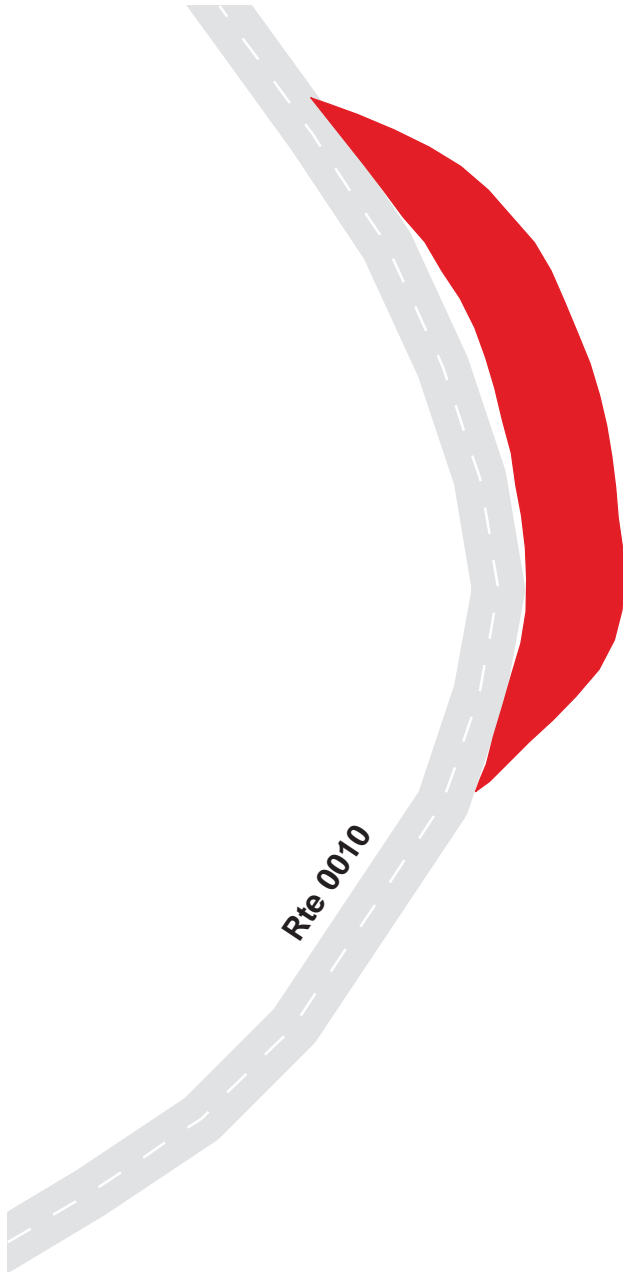
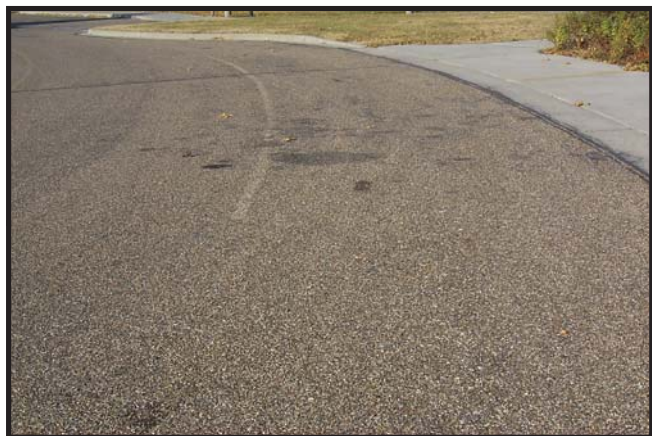
## Route 0900A

Route	Public / NonPublic	Date Visited	Area (sq ft)	Lane Miles *	Surface Type	Condition / PCR
0900A	Public	10/12/2002	916	0.02	NC	GOOD / 90

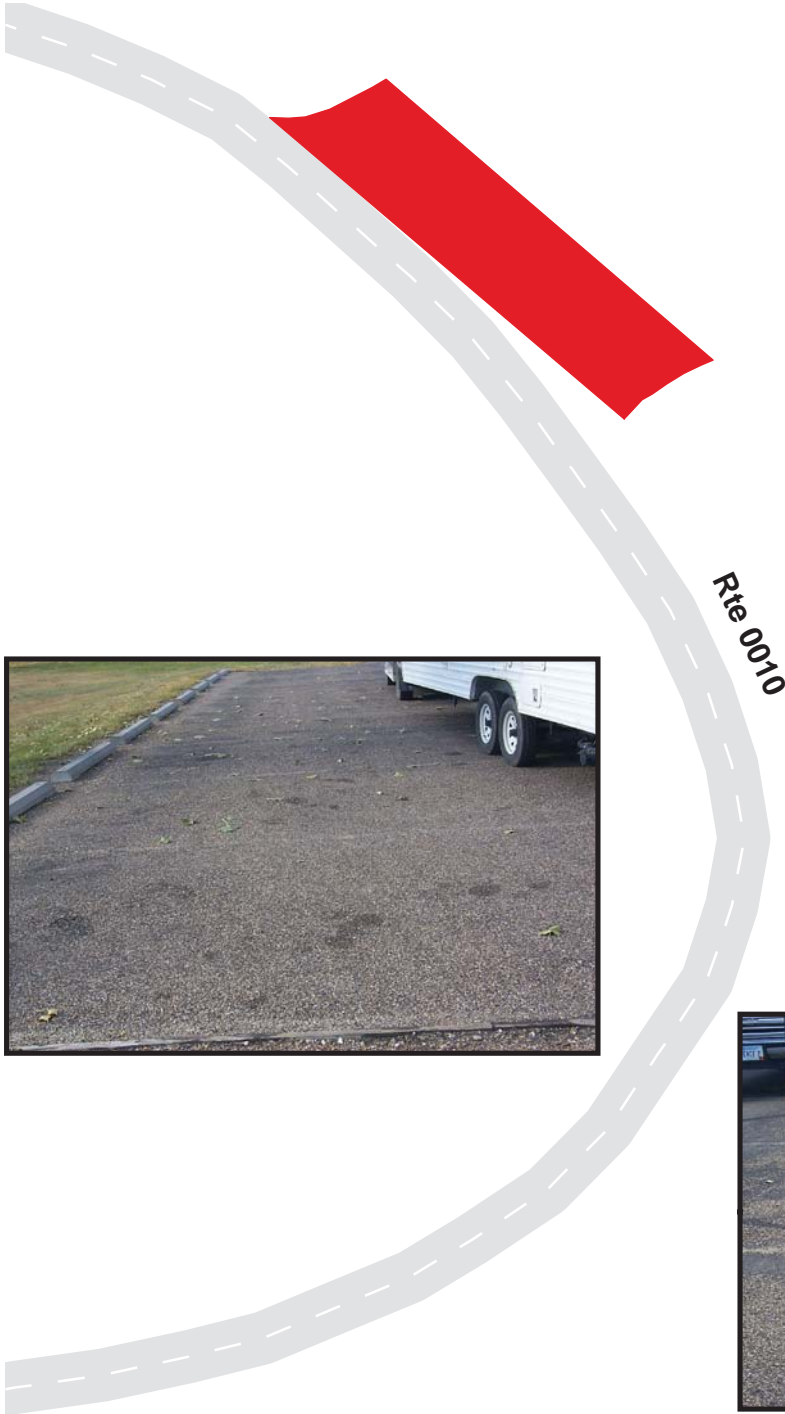
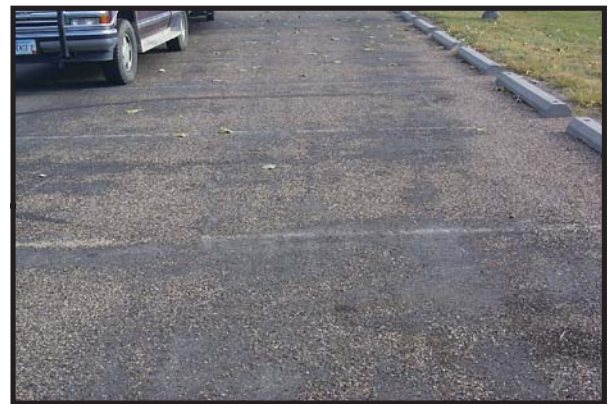
## Route 0900B

Route	Public / NonPublic	Date Visited	Area (sq ft)	Lane Miles *	Surface Type	Condition / PCR
0900B	Public	10/12/2002	1563	0.03	NC	GOOD / 90

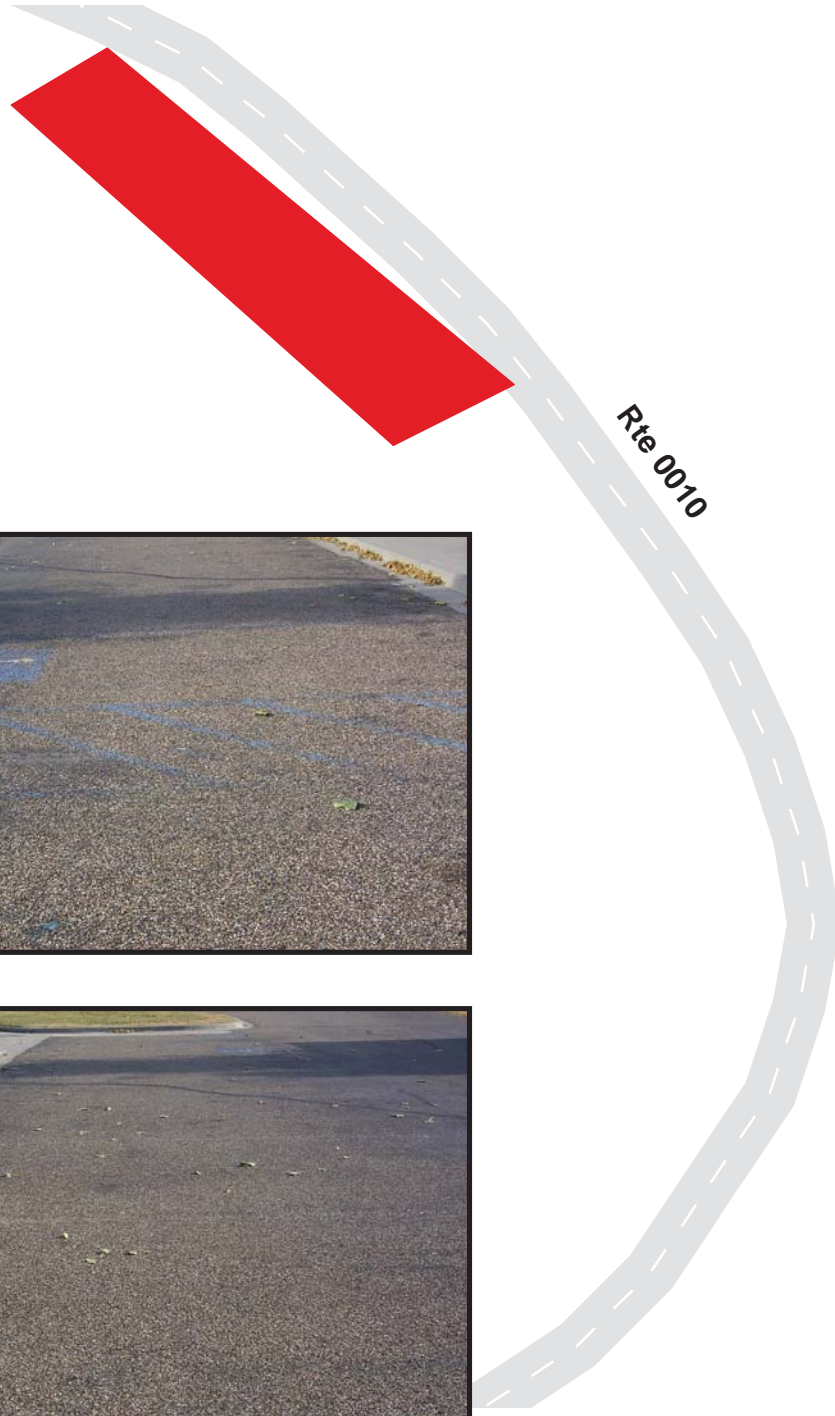
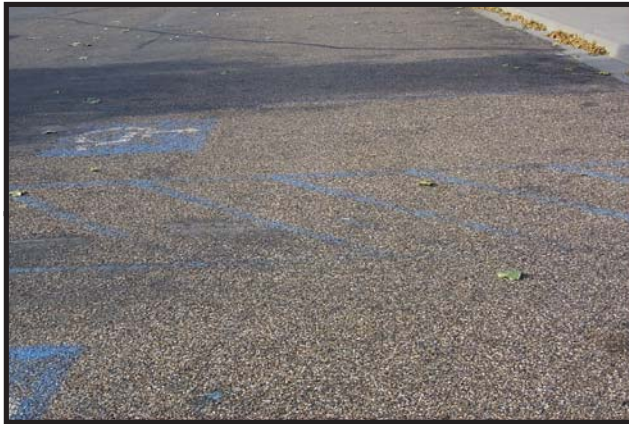
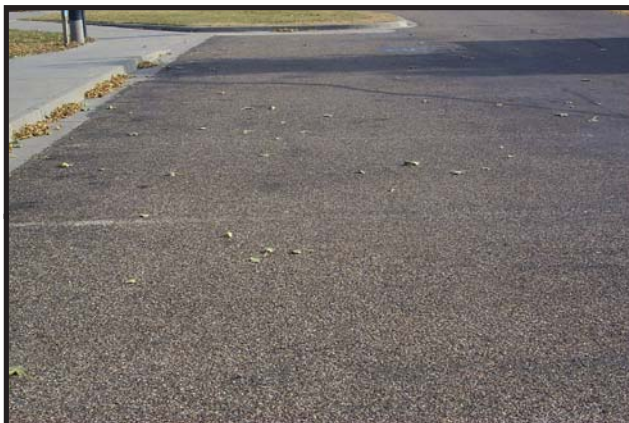
## Route 0900C

Route	Public / NonPublic	Date Visited	Area (sq ft)	Lane Miles *	Surface Type	Condition / PCR
0900C	Public	10/12/2002	1447	0.02	NC	GOOD / 90

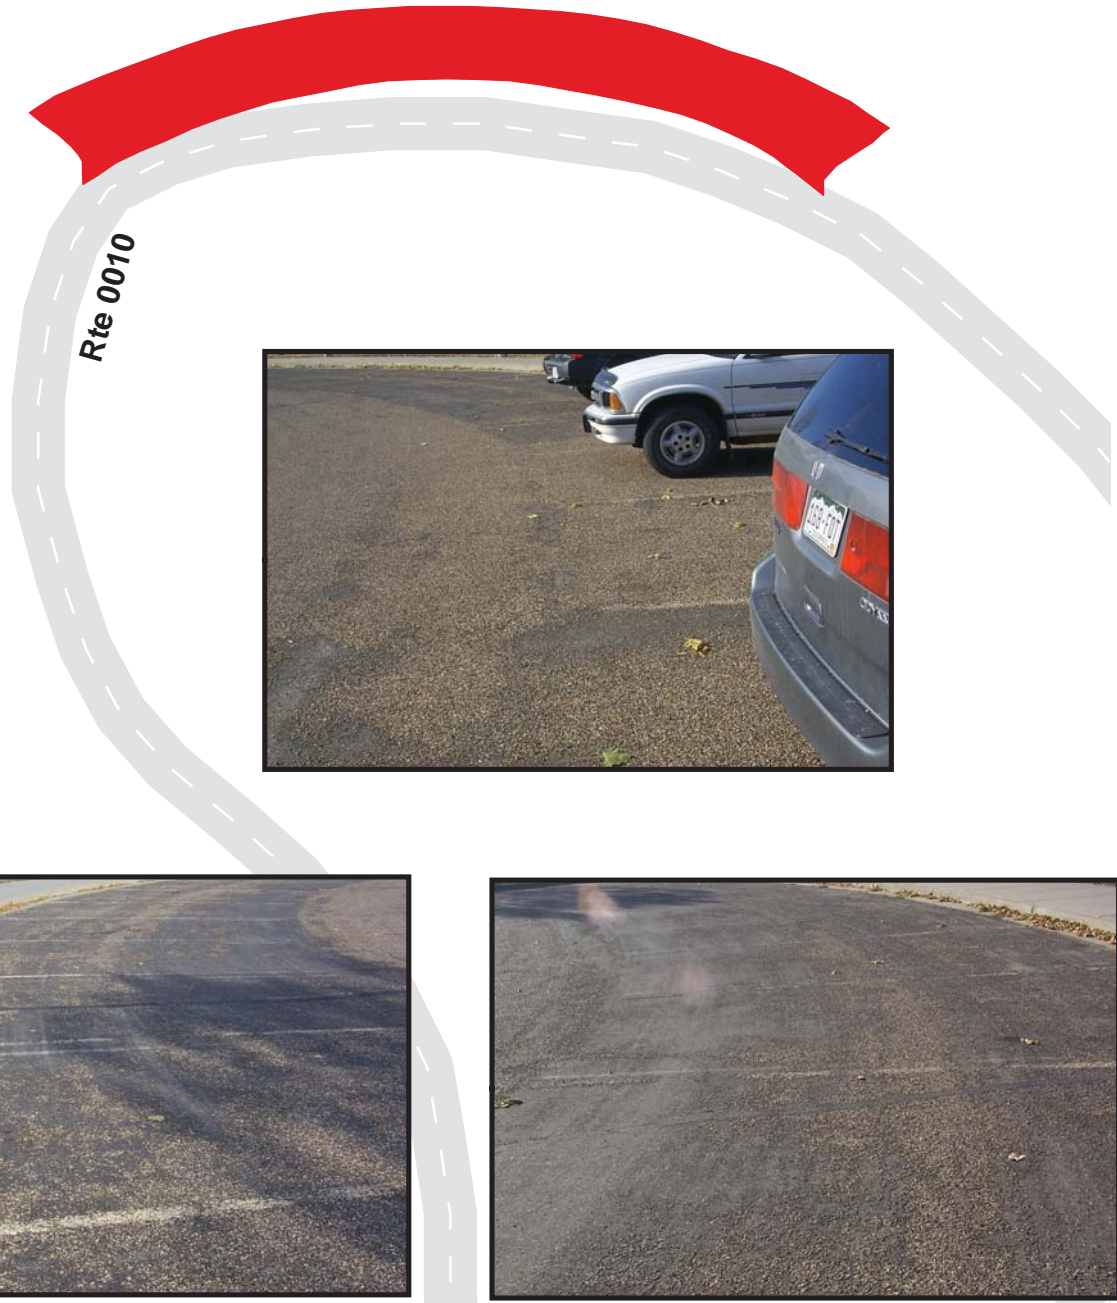
## Route 0900D

Route	Public / NonPublic	Date Visited	Area (sq ft)	Lane Miles *	Surface Type	Condition / PCR
0900D	Public	10/12/2002	2481	0.04	NC	GOOD / 90

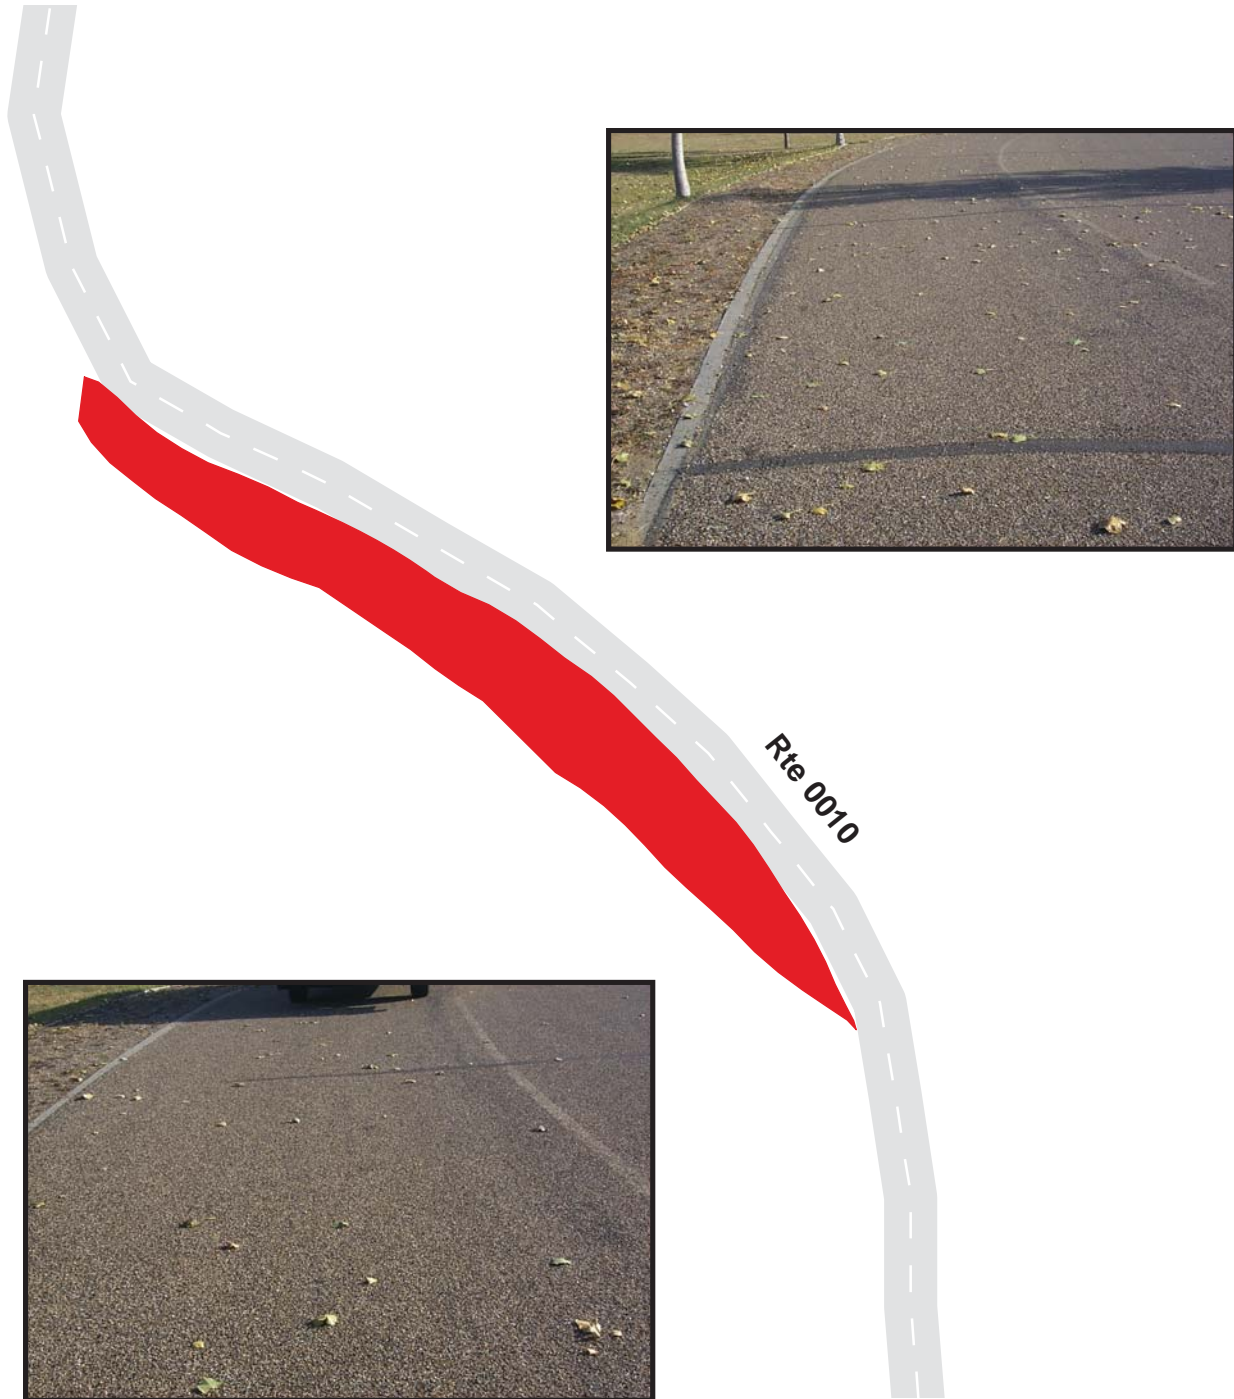
## Route 0900E

Route	Public / NonPublic	Date Visited	Area (sq ft)	Lane Miles *	Surface Type	Condition / PCR
0900E	Public	10/12/2002	1497	0.03	NC	GOOD / 90

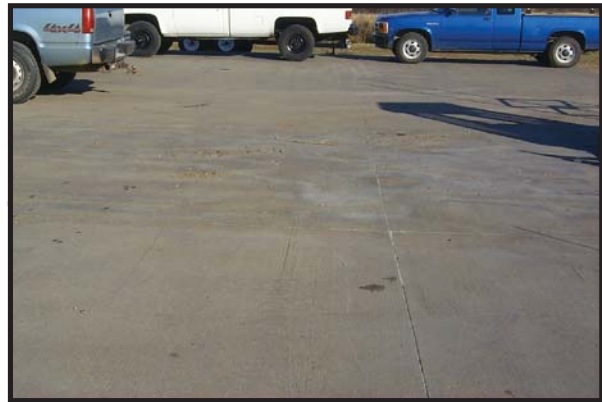
## Route 0903

Route	Public / NonPublic	Date Visited	Area (sq ft)	Lane Miles *	Surface Type	Condition / PCR
0903	NonPublic	10/12/2002	3246	0.06	CO	GOOD / 90

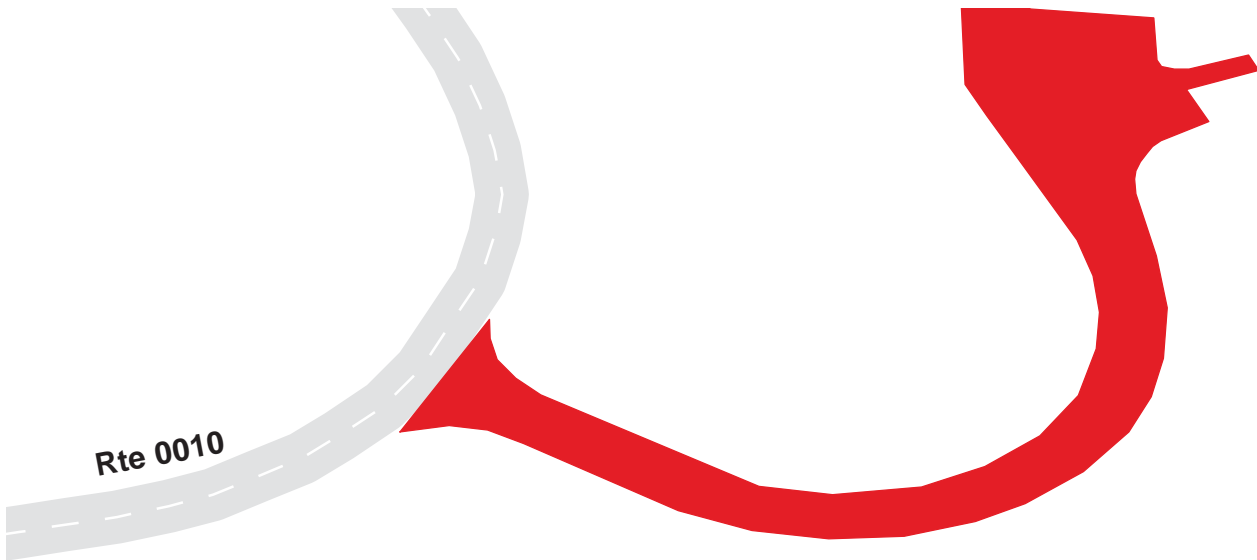
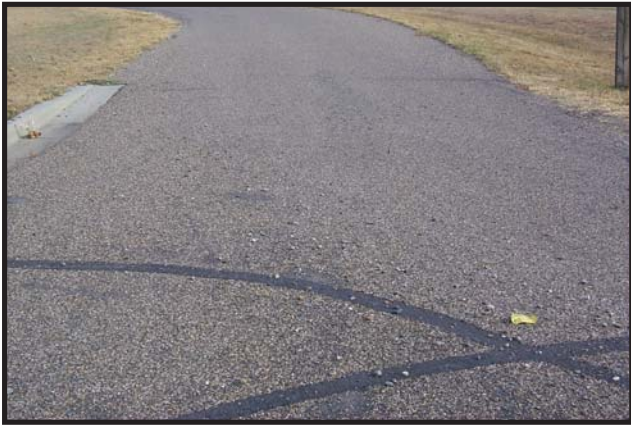
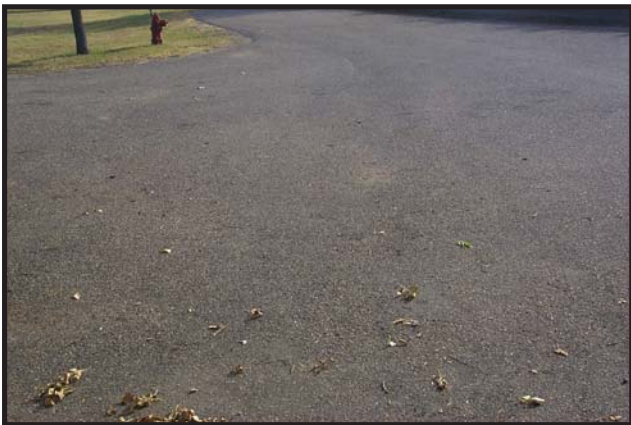
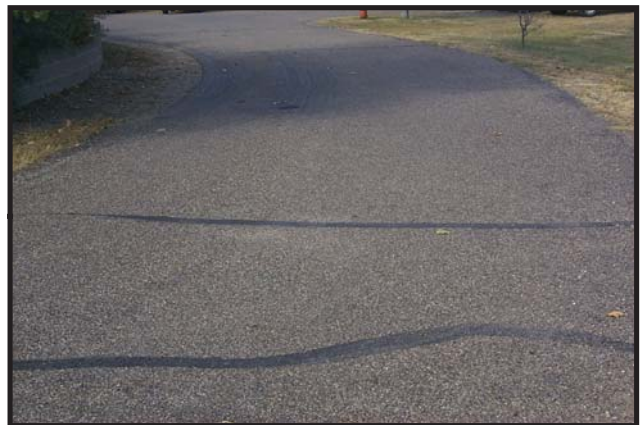
## Route 0906

Route	Public / NonPublic	Date Visited	Area (sq ft)	Lane Miles *	Surface Type	Condition / PCR
0906	NonPublic	10/9/2002	8519	0.15	NC	GOOD / 90
