# The Road Inventory of Lava Beds National Monument LABE - 8410

## Road Inventory Program

Prepared By:  
Federal Highway Administration  
Eastern Federal Lands Highway Division  
Cycle 3

# Lava Beds National Monument in California

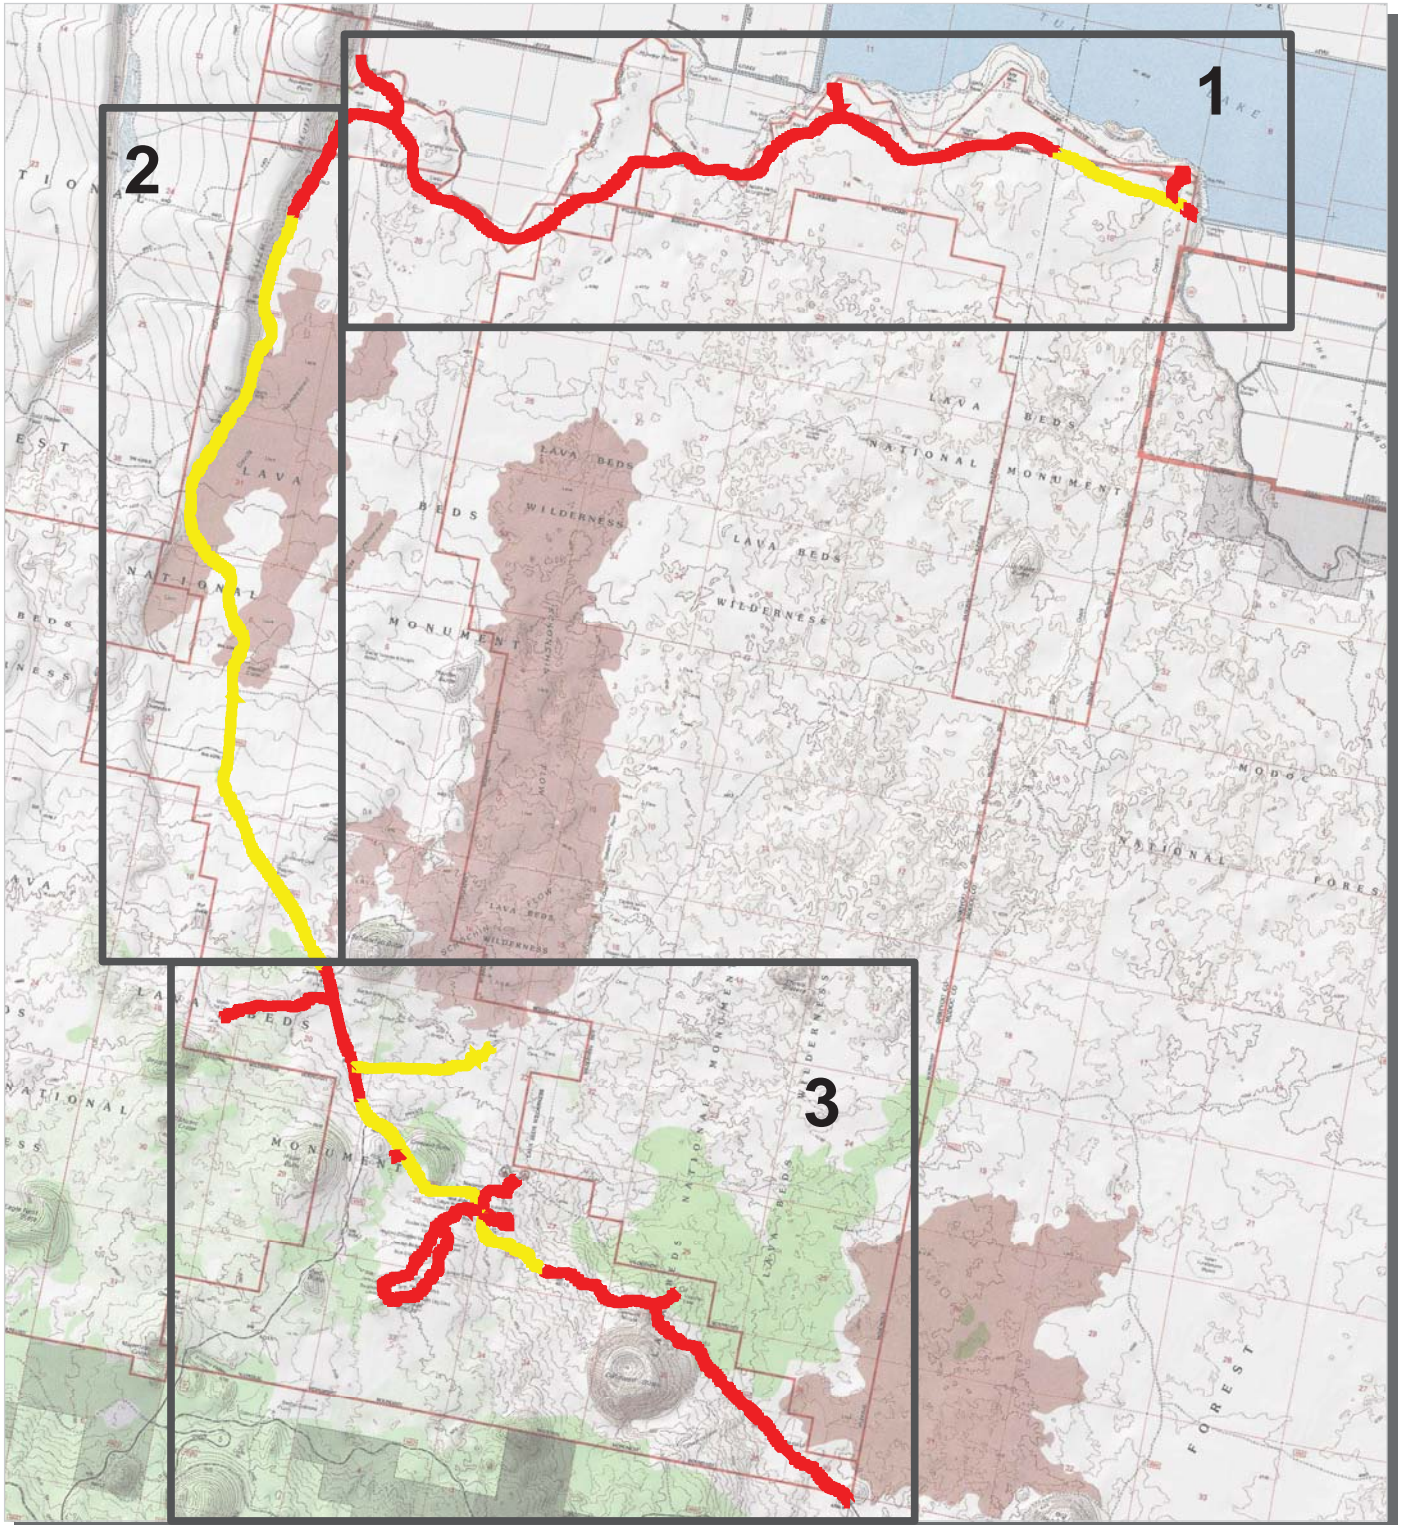
# Lava Beds National Monument Route Condition Key Map PCR - Mile by Mile

PCR	Poor		Fair		Good		Excellent	
		(<=60)		(61 - 84)		(85 - 94)		(95 - 100)

\* If the PCR rating is not available for a section, the SCR rating will be displayed. See appendix for definitions and formulas.

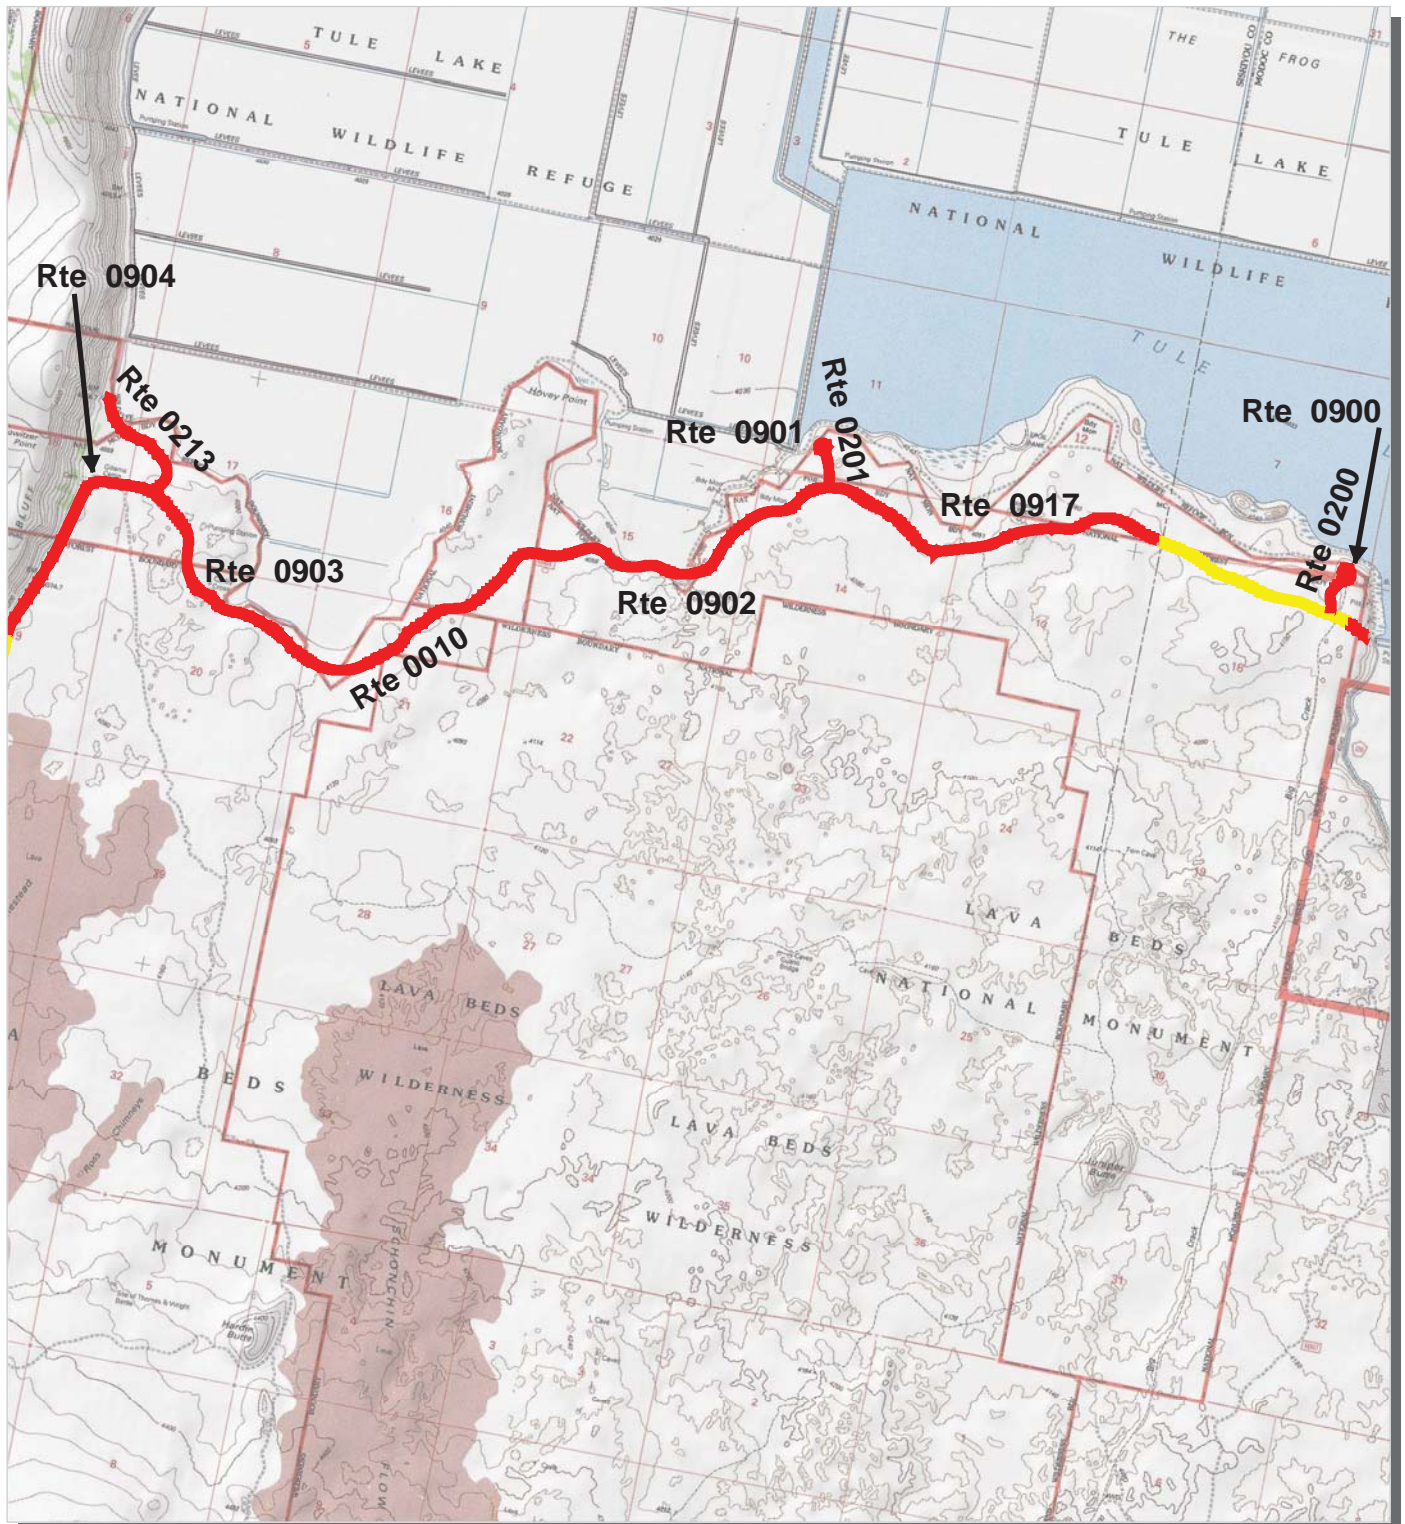
# Lava Beds National Monument Route Condition Area Map 1 PCR - Mile by Mile

PCR	Poor	<span style="display: inline-block; width: 20px; height: 10px; background-color: red; border: 1px solid black;"></span>	Fair	<span style="display: inline-block; width: 20px; height: 10px; background-color: yellow; border: 1px solid black;"></span>	Good	<span style="display: inline-block; width: 20px; height: 10px; background-color: green; border: 1px solid black;"></span>	Excellent	<span style="display: inline-block; width: 20px; height: 10px; background-color: blue; border: 1px solid black;"></span>
	(<=60)		(61 - 84)		(85 - 94)		(95 - 100)

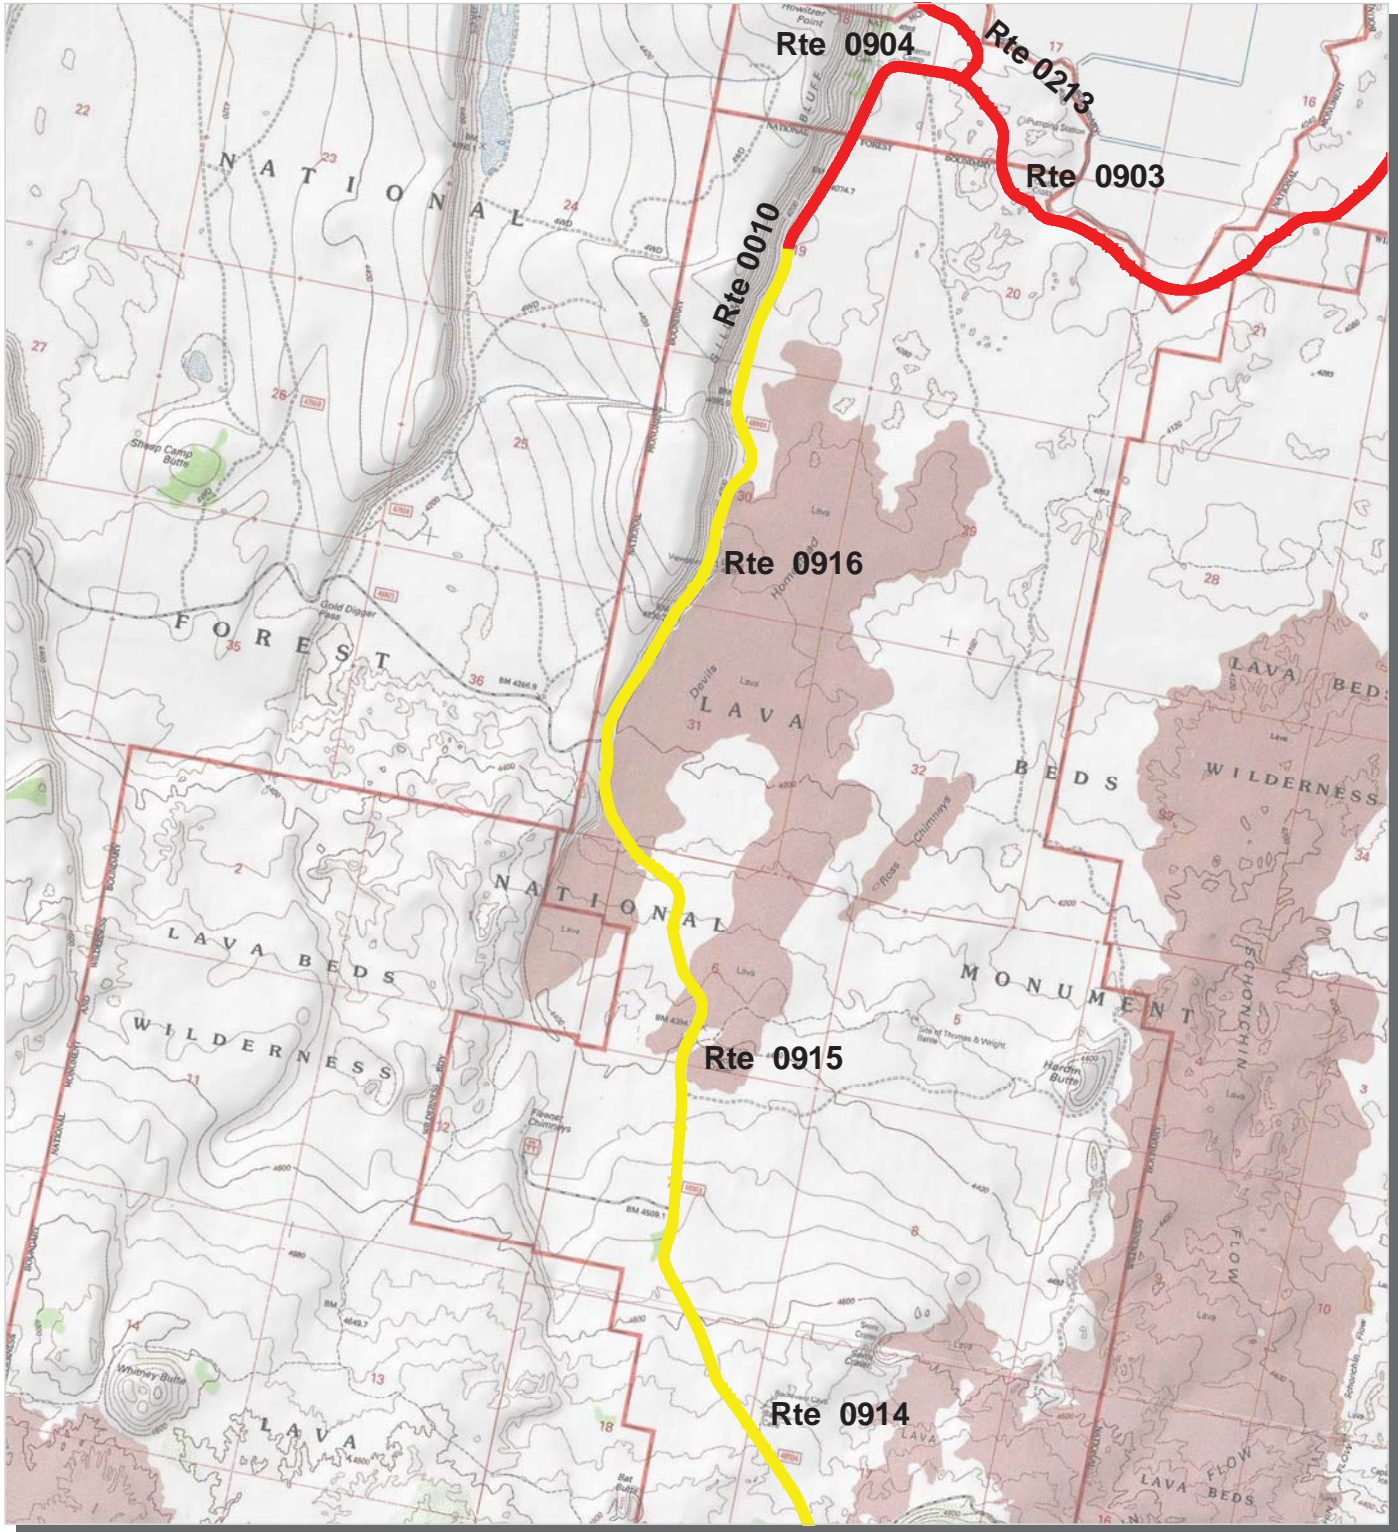
# Lava Beds National Monument Route Condition Area Map 2 PCR - Mile by Mile

PCR	Poor	<span style="display: inline-block; width: 20px; height: 10px; background-color: red; border: 1px solid black;"></span>	Fair	<span style="display: inline-block; width: 20px; height: 10px; background-color: yellow; border: 1px solid black;"></span>	Good	<span style="display: inline-block; width: 20px; height: 10px; background-color: green; border: 1px solid black;"></span>	Excellent	<span style="display: inline-block; width: 20px; height: 10px; background-color: blue; border: 1px solid black;"></span>
	(<=60)		(61 - 84)		(85 - 94)		(95 - 100)

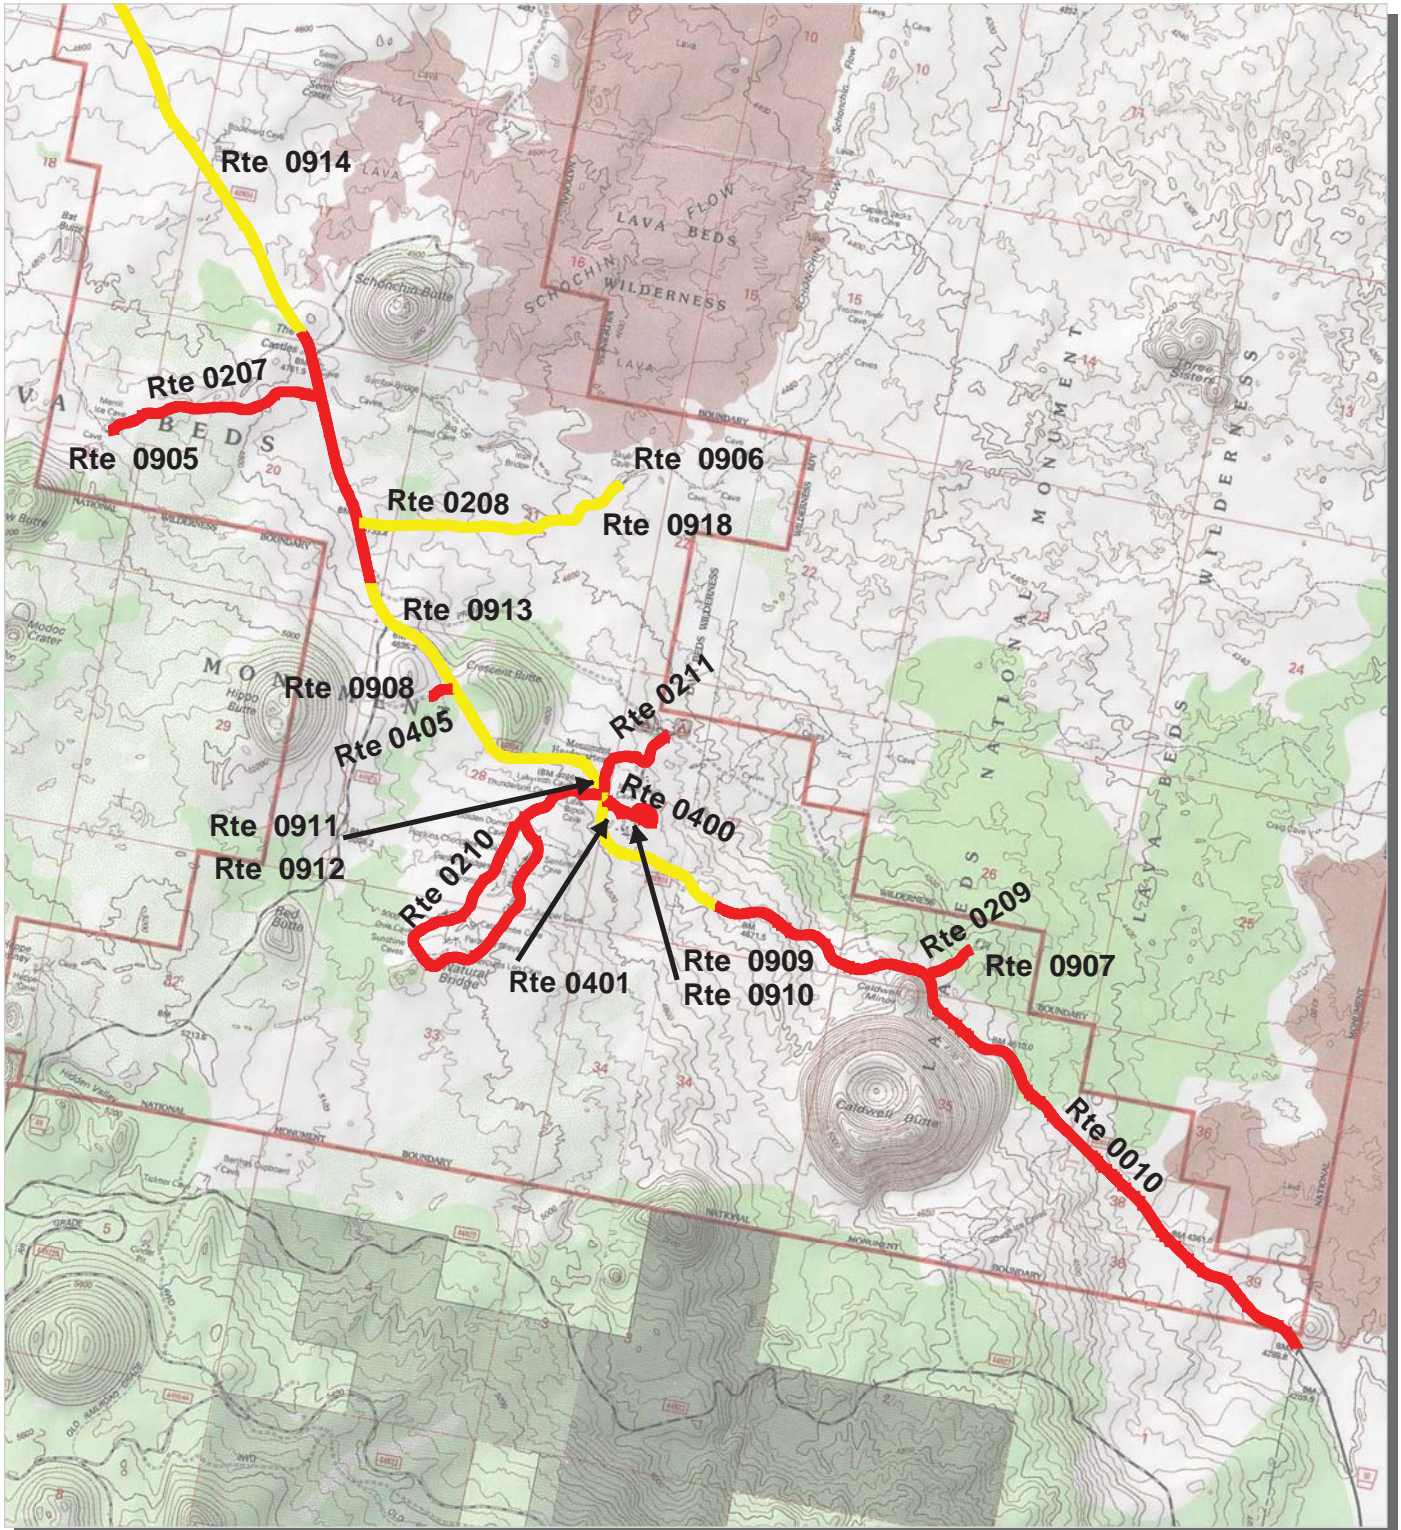
# Lava Beds National Monument Route Condition Area Map 3 PCR - Mile by Mile

PCR	Poor	<span style="display: inline-block; width: 20px; height: 10px; background-color: red; border: 1px solid black;"></span>	Fair	<span style="display: inline-block; width: 20px; height: 10px; background-color: yellow; border: 1px solid black;"></span>	Good	<span style="display: inline-block; width: 20px; height: 10px; background-color: green; border: 1px solid black;"></span>	Excellent	<span style="display: inline-block; width: 20px; height: 10px; background-color: blue; border: 1px solid black;"></span>
	(<=60)		(61 - 84)		(85 - 94)		(95 - 100)

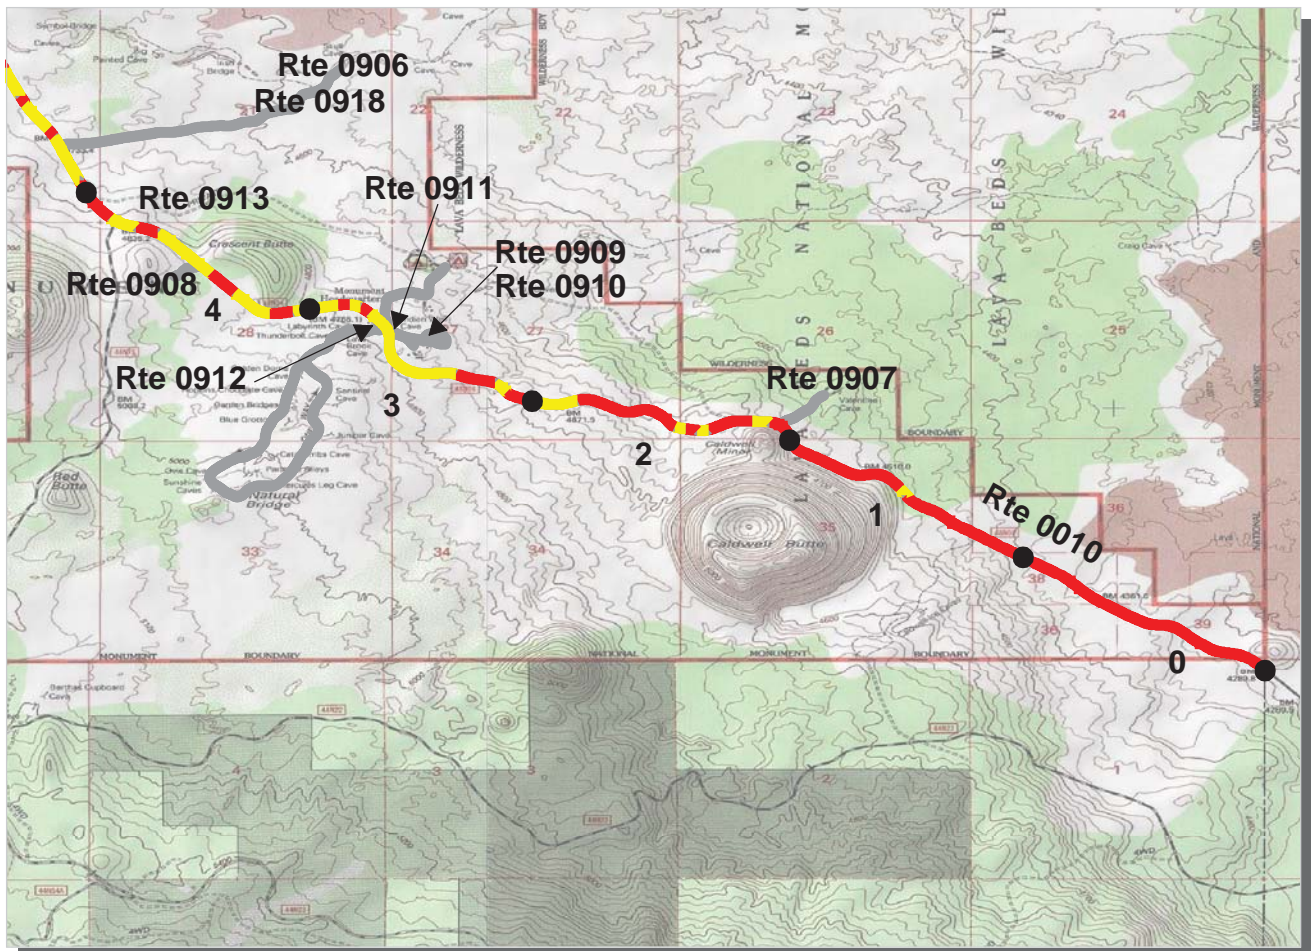
**ROUTE: 0010 North-South Highway**

Section Number	0	5	10	11	12
Section Length (mi)	1.00	1.00	1.00	1.00	1.00
AADT	**				
SADT	**				
ADT Date	**				
<b>Cross Section Information</b>					
Number of Lanes	2	2	2	2	2
Paved Width (ft)	22	25	25	25	25
Lane Width (ft)	11	13	12	12	12
Shoulder Width (ft)	6	3	4	5	4
<b>Roadway Condition Information</b>					
PCR (Pavement Condition Rating)	46	59	61	64	60
RCI (Roughness Condition Index)	65	82	94	95	86
SCR (Surface Condition Rating)	33	44	40	43	43
Alligator Cracking Index	99	100	100	100	100
Rutting Index	37	45	42	45	45
Patching Index	100	100	100	100	100
Transverse Cracking Index	96	99	98	97	98
Longitudinal Cracking Index	99	99	99	99	99
Shoulder Condition Rating	N/C	N/C	N/C	N/C	N/C
Drainage Condition Rating	GOOD	GOOD	GOOD	GOOD	GOOD

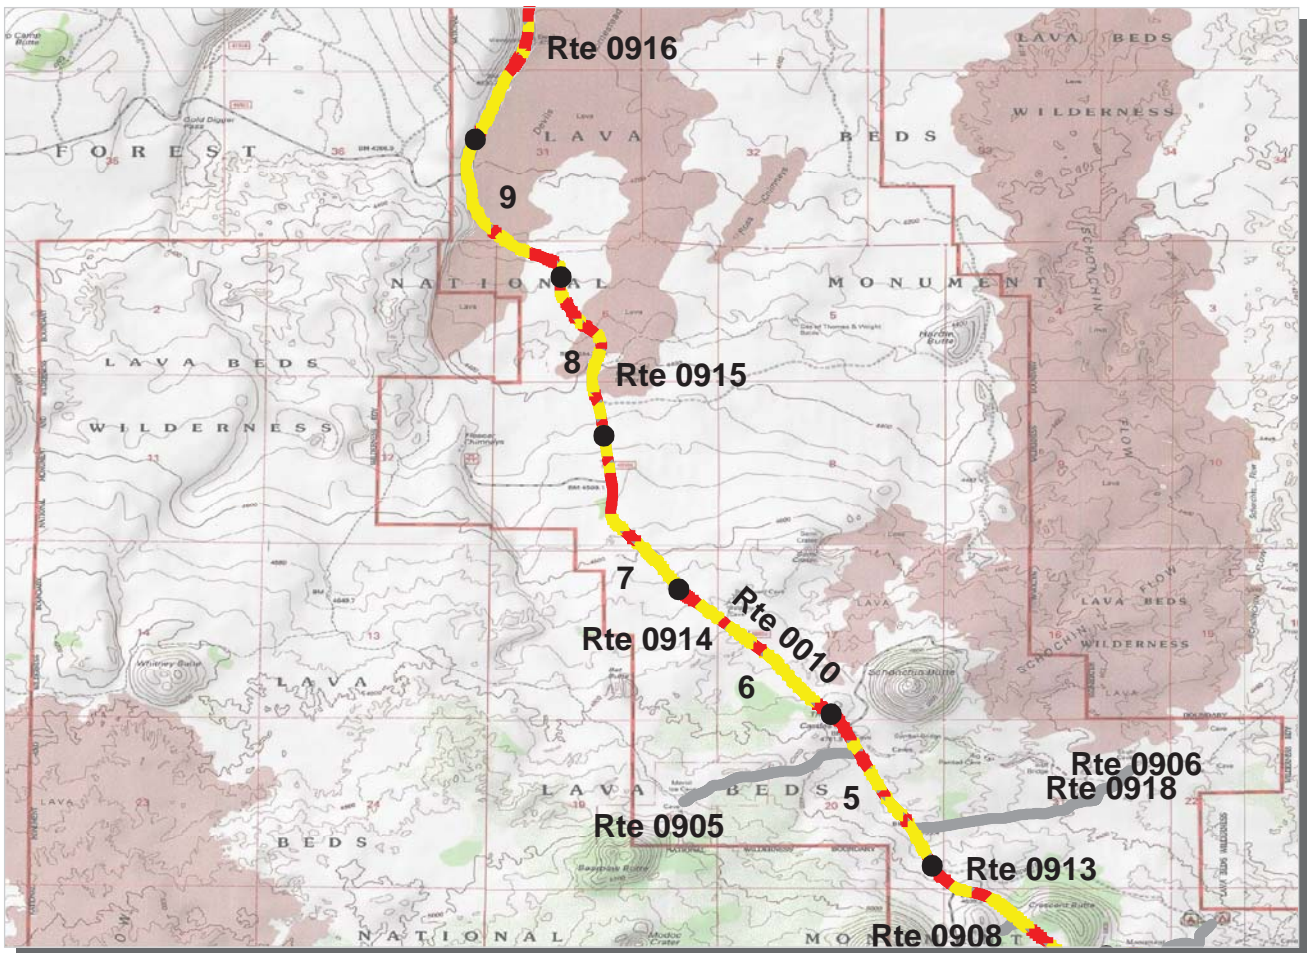
**ROUTE: 0010 North-South Highway** **TOTAL LENGTH: 20.14 Miles**

Section Number	5	6	7	8	9
Section Length (mi)	1.00	1.00	1.00	1.00	1.00
AADT	**				
SADT	**				
ADT Date	**				
<b>Cross Section Information</b>					
Number of Lanes	2	2	2	2	2
Paved Width (ft)	25	25	26	25	26
Lane Width (ft)	13	12	14	12	13
Shoulder Width (ft)	3	6	6	5	6
<b>Roadway Condition Information</b>					
PCR (Pavement Condition Rating)	59	62	62	61	65
RCI (Roughness Condition Index)	82	90	86	81	91
SCR (Surface Condition Rating)	44	43	45	48	49
Alligator Cracking Index	100	100	100	100	100
Rutting Index	45	43	46	48	52
Patching Index	100	100	100	100	100
Transverse Cracking Index	99	99	99	99	97
Longitudinal Cracking Index	99	99	99	100	99
Shoulder Condition Rating	N/C	N/C	N/C	N/C	N/C
Drainage Condition Rating	GOOD	GOOD	GOOD	GOOD	GOOD

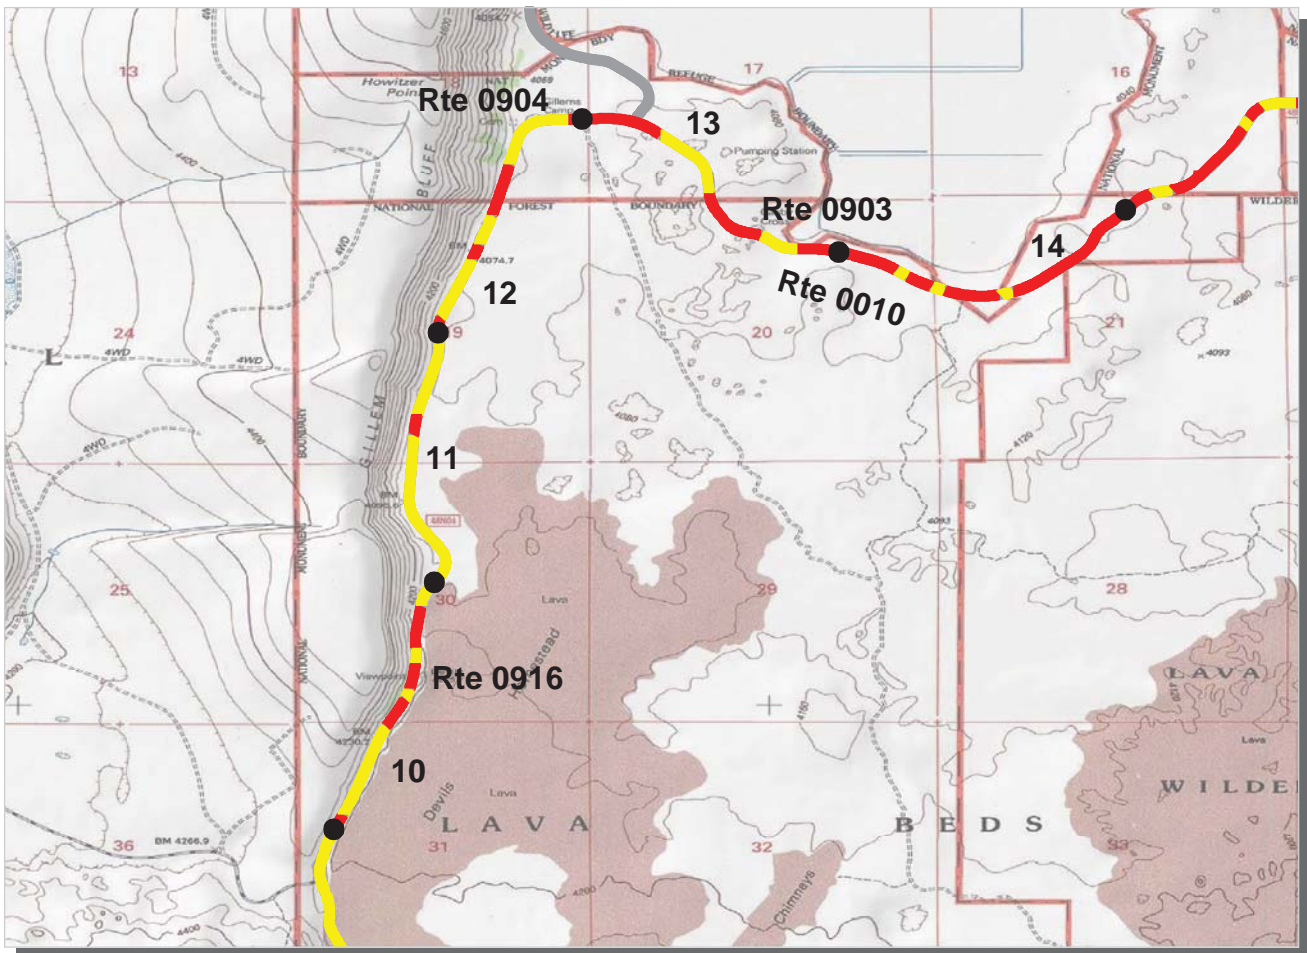
**ROUTE: 0010 North-South Highway** **TOTAL LENGTH: 20.14 Miles**

Section Number	10	11	12	13	14
Section Length (mi)	1.00	1.00	1.00	1.00	1.00
AADT	**				
SADT	**				
ADT Date	**				
<b>Cross Section Information</b>					
Number of Lanes	2	2	2	2	2
Paved Width (ft)	25	25	25	26	23
Lane Width (ft)	12	12	12	14	12
Shoulder Width (ft)	4	5	4	5	0
<b>Roadway Condition Information</b>					
PCR (Pavement Condition Rating)	61	64	60	58	52
RCI (Roughness Condition Index)	94	95	86	83	71
SCR (Surface Condition Rating)	40	43	43	42	40
Alligator Cracking Index	100	100	100	100	100
Rutting Index	42	45	45	43	41
Patching Index	100	100	100	100	100
Transverse Cracking Index	98	97	98	98	99
Longitudinal Cracking Index	99	99	99	99	99
Shoulder Condition Rating	N/C	N/C	N/C	N/C	N/A
Drainage Condition Rating	GOOD	GOOD	GOOD	GOOD	GOOD

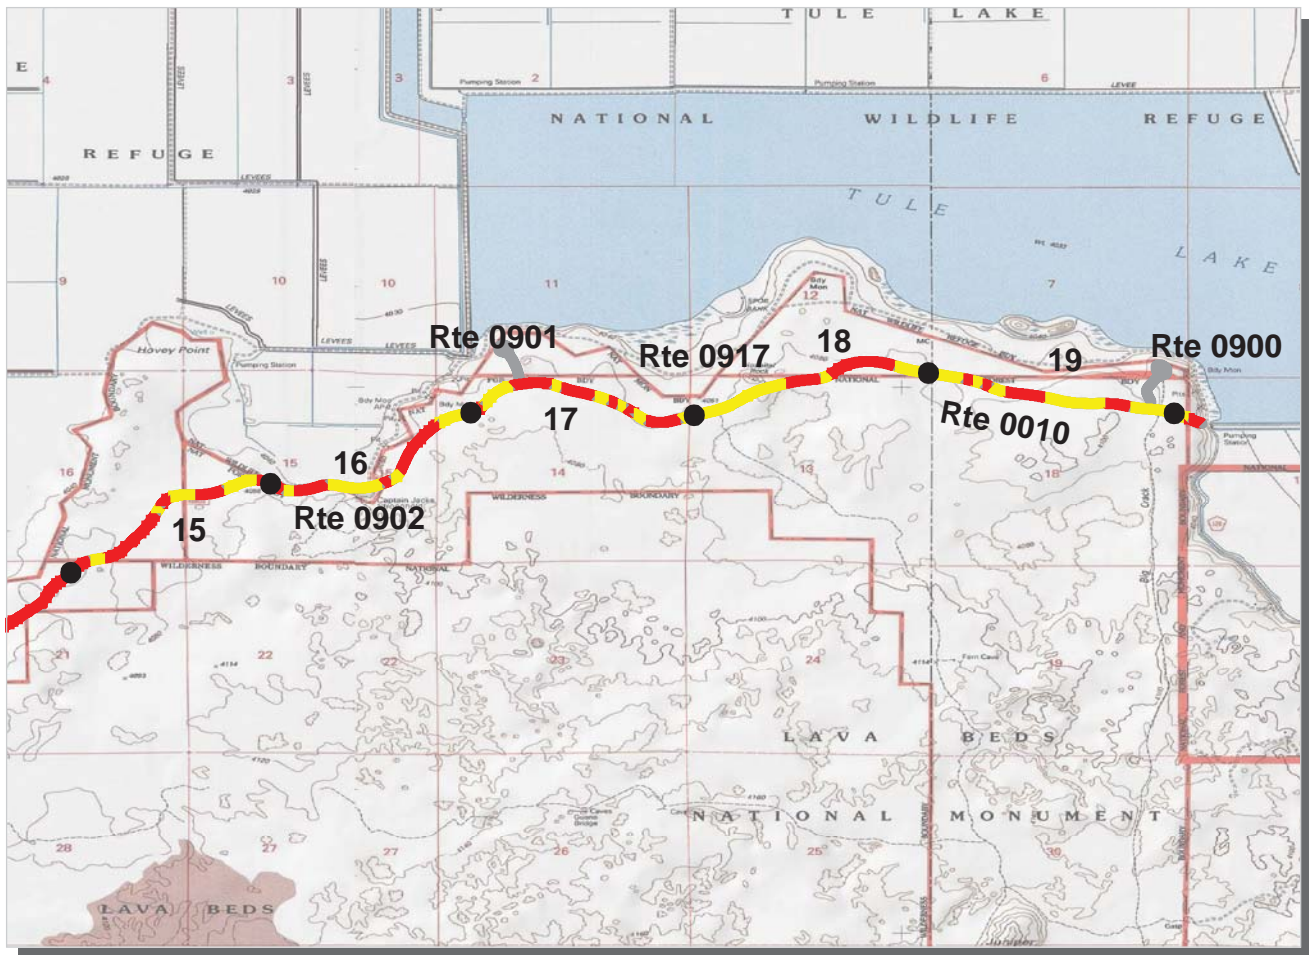
**ROUTE: 0010 North-South Highway** **TOTAL LENGTH: 20.14 Miles**

Section Number	15	16	17	18	19
Section Length (mi)	1.00	1.00	1.00	1.00	1.00
AADT	**				
SADT	**				
ADT Date	**				
<b>Cross Section Information</b>					
Number of Lanes	2	2	2	2	2
Paved Width (ft)	25	25	24	25	24
Lane Width (ft)	12	12	12	12	12
Shoulder Width (ft)	0	0	0	0	0
<b>Roadway Condition Information</b>					
PCR (Pavement Condition Rating)	57	59	59	60	62
RCI (Roughness Condition Index)	79	82	82	83	84
SCR (Surface Condition Rating)	42	44	44	44	48
Alligator Cracking Index	100	100	100	100	100
Rutting Index	42	45	45	46	50
Patching Index	100	100	100	100	100
Transverse Cracking Index	99	99	98	98	98
Longitudinal Cracking Index	99	99	99	99	99
Shoulder Condition Rating	N/A	N/A	N/A	N/A	N/A
Drainage Condition Rating	GOOD	GOOD	GOOD	GOOD	GOOD

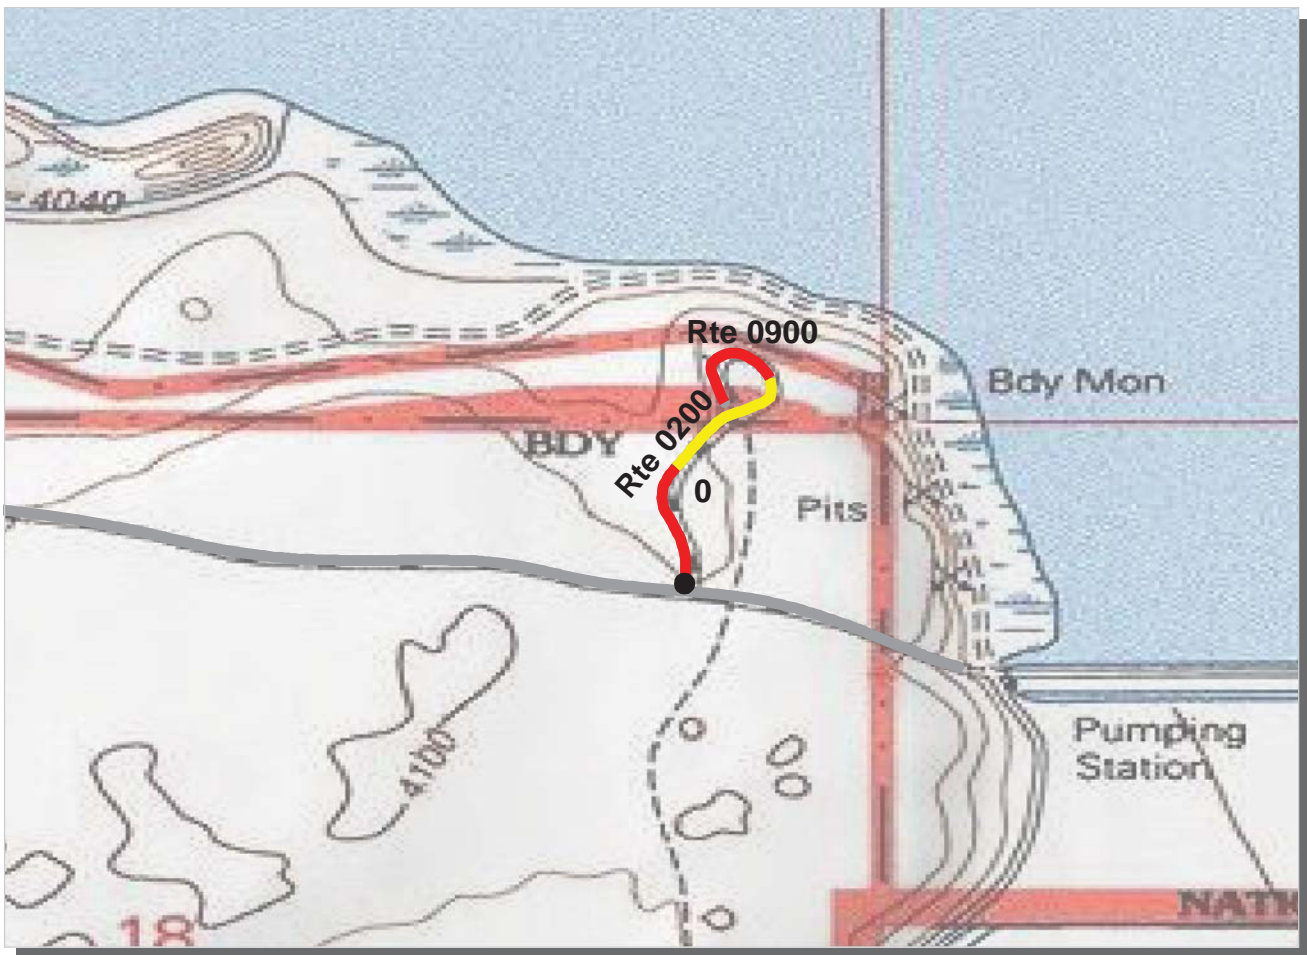
**ROUTE: 0200 East Wildlife Overlook Road** **TOTAL LENGTH: 0.36 Miles**

Section Number	0				
Section Length (mi)	0.36				
AADT	**				
SADT	**				
ADT Date	**				
<b>Cross Section Information</b>					
Number of Lanes	2				
Paved Width (ft)	17				
Lane Width (ft)	8				
Shoulder Width (ft)	6				
<b>Roadway Condition Information</b>					
PCR (Pavement Condition Rating)	51				
RCI (Roughness Condition Index)	64				
SCR (Surface Condition Rating)	45				
Alligator Cracking Index	100				
Rutting Index	48				
Patching Index	100				
Transverse Cracking Index	97				
Longitudinal Cracking Index	99				
Shoulder Condition Rating	N/C				
Drainage Condition Rating	POOR

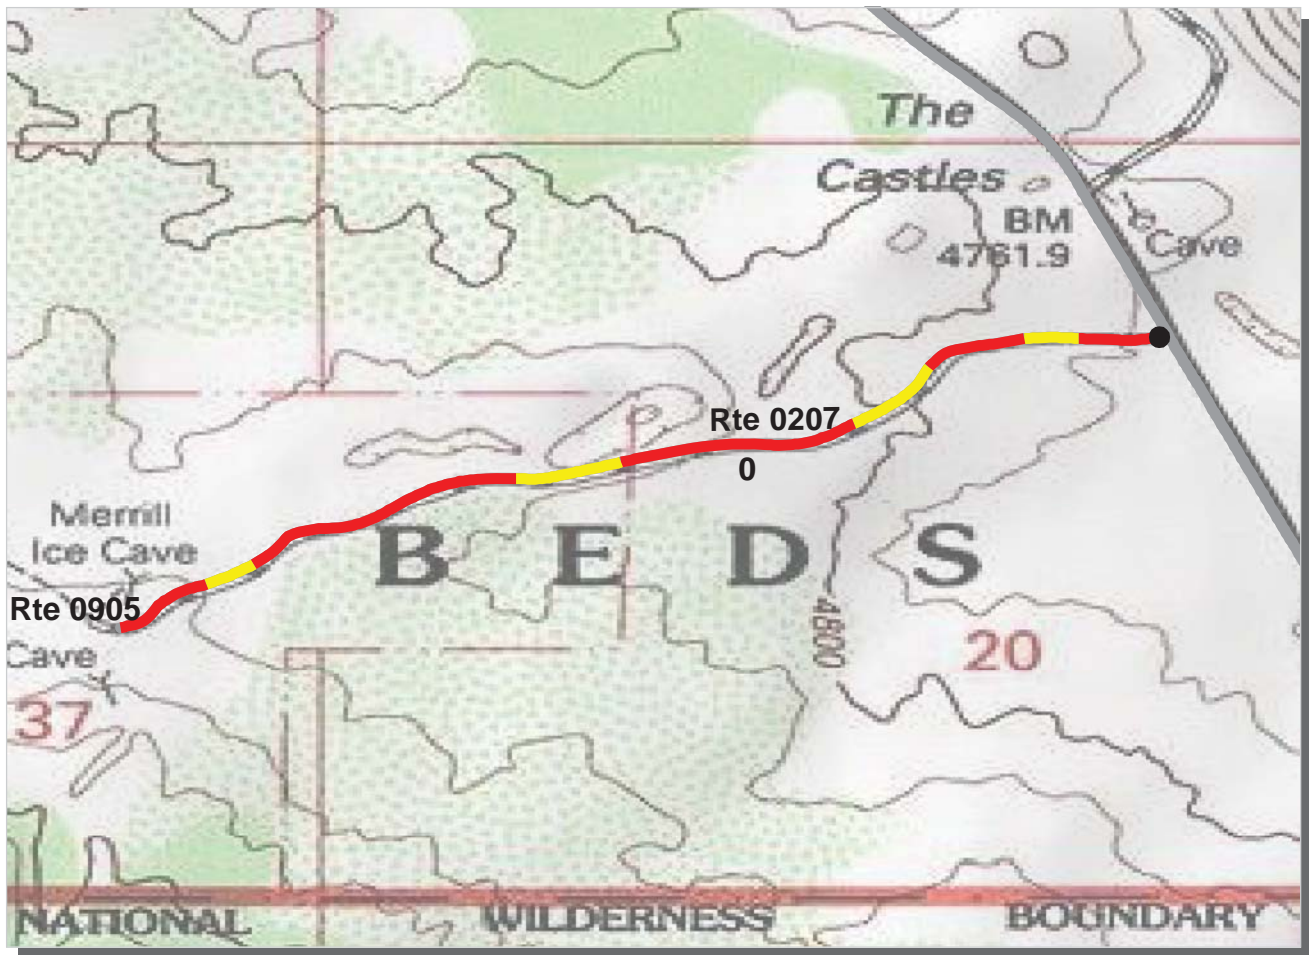
ROUTE: 0207 Merrill Ice Cave Road

Section Number	0				
Section Length (mi)	0.88				
AADT	**				
SADT	**				
ADT Date	**				
<b>Cross Section Information</b>					
Number of Lanes	2				
Paved Width (ft)	20				
Lane Width (ft)	9				
Shoulder Width (ft)	5				
<b>Roadway Condition Information</b>					
PCR (Pavement Condition Rating)	55				
RCI (Roughness Condition Index)	75				
SCR (Surface Condition Rating)	44				
Alligator Cracking Index	100				
Rutting Index	45				
Patching Index	100				
Transverse Cracking Index	99				
Longitudinal Cracking Index	99				
Shoulder Condition Rating	N/C				
Drainage Condition Rating	GOOD

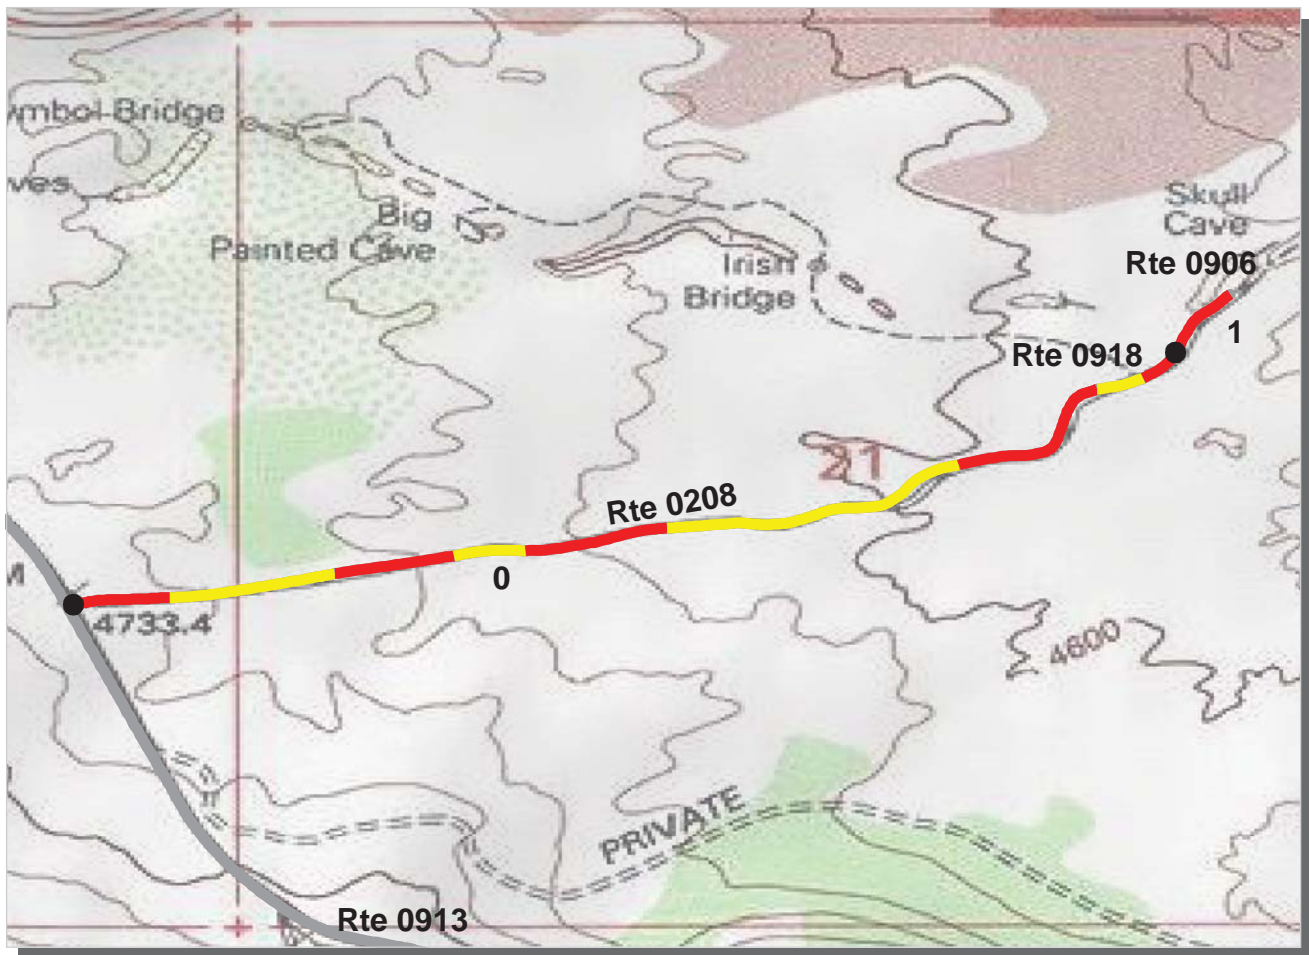
**ROUTE: 0208 Skull Cave Road**

Section Number	0	1			
Section Length (mi)	1.00	0.10			
AADT	**				
SADT	**				
ADT Date	**				
<b>Cross Section Information</b>					
Number of Lanes	2	2			
Paved Width (ft)	19	20			
Lane Width (ft)	10	10			
Shoulder Width (ft)	0	0			
<b>Roadway Condition Information</b>					
PCR (Pavement Condition Rating)	61	61			
RCI (Roughness Condition Index)	78	77			
SCR (Surface Condition Rating)	50	50			
Alligator Cracking Index	100	100			
Rutting Index	51	50			
Patching Index	100	100			
Transverse Cracking Index	99	99			
Longitudinal Cracking Index	100	100			
Shoulder Condition Rating	N/A	N/A			
Drainage Condition Rating	GOOD	GOOD

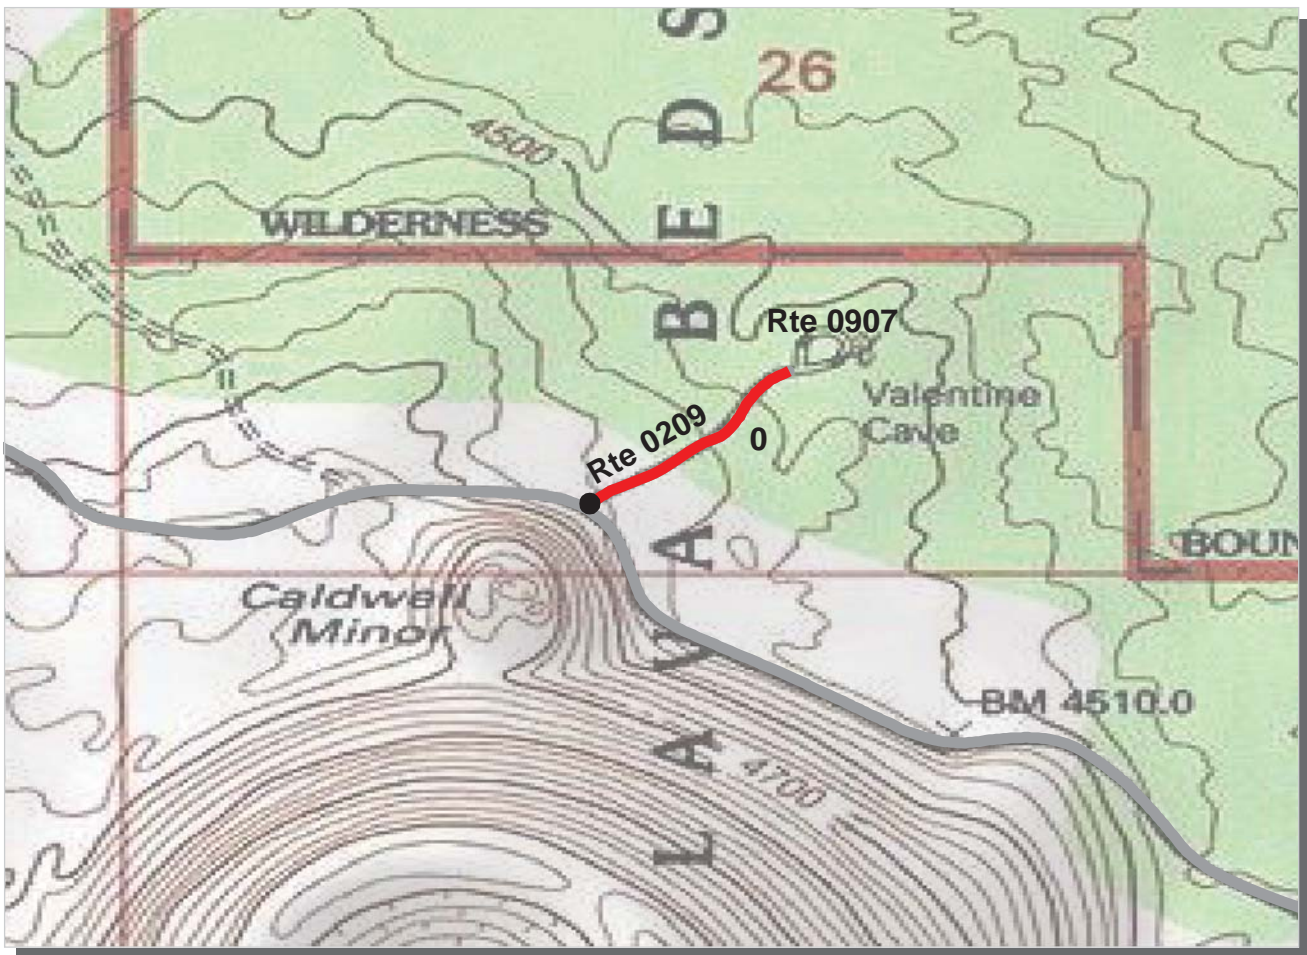
**ROUTE: 0209 Valentine Cave Road** **TOTAL LENGTH: 0.21 Miles**

Section Number	0				
Section Length (mi)	0.21				
AADT	**				
SADT	**				
ADT Date	**				
<b>Cross Section Information</b>					
Number of Lanes	2				
Paved Width (ft)	27				
Lane Width (ft)	12				
Shoulder Width (ft)	0				
<b>Roadway Condition Information</b>					
PCR (Pavement Condition Rating)	55				
RCI (Roughness Condition Index)	77				
SCR (Surface Condition Rating)	45				
Alligator Cracking Index	100				
Rutting Index	46				
Patching Index	100				
Transverse Cracking Index	99				
Longitudinal Cracking Index	100				
Shoulder Condition Rating	N/A				
Drainage Condition Rating	GOOD

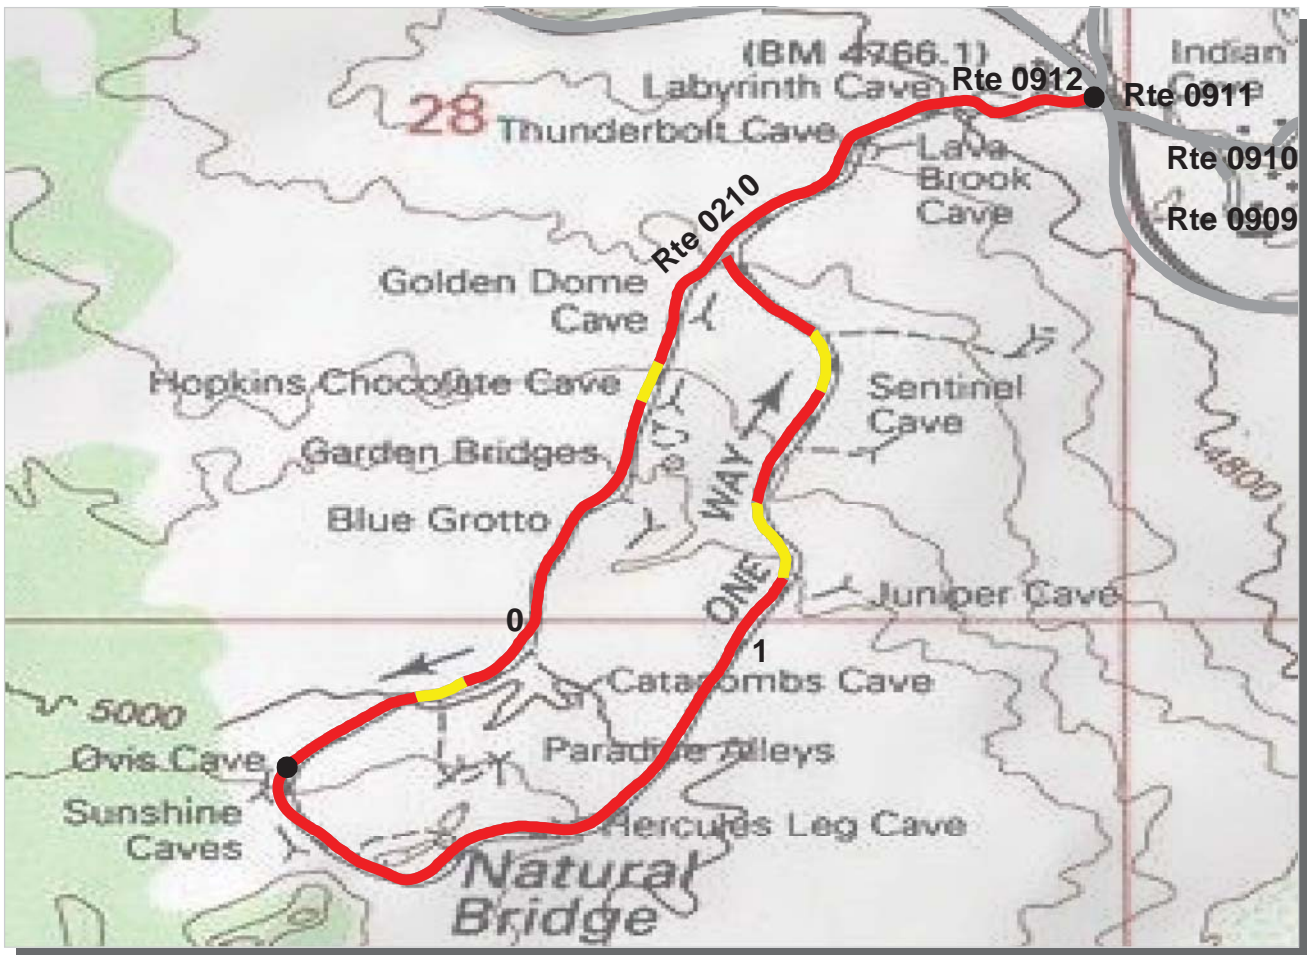
**ROUTE: 0210 Cave Loop Road** **TOTAL LENGTH: 1.98 Miles**

Section Number	0	1			
Section Length (mi)	1.00	0.98			
AADT	**				
SADT	**				
ADT Date	**				
<b>Cross Section Information</b>					
Number of Lanes	2	1			
Paved Width (ft)	24	12			
Lane Width (ft)	14	12			
Shoulder Width (ft)	0	0			
<b>Roadway Condition Information</b>					
PCR (Pavement Condition Rating)	52	56			
RCI (Roughness Condition Index)	65	68			
SCR (Surface Condition Rating)	46	48			
Alligator Cracking Index	100	100			
Rutting Index	49	48			
Patching Index	100	100			
Transverse Cracking Index	98	99			
Longitudinal Cracking Index	99	99			
Shoulder Condition Rating	N/A	N/A			
Drainage Condition Rating	GOOD	GOOD
