# The Road Inventory of Lava Beds National Monument LABE - 8410

## Road Inventory Program

Prepared By:  
Federal Highway Administration  
Eastern Federal Lands Highway Division  
Cycle 3

# Lava Beds National Monument in California

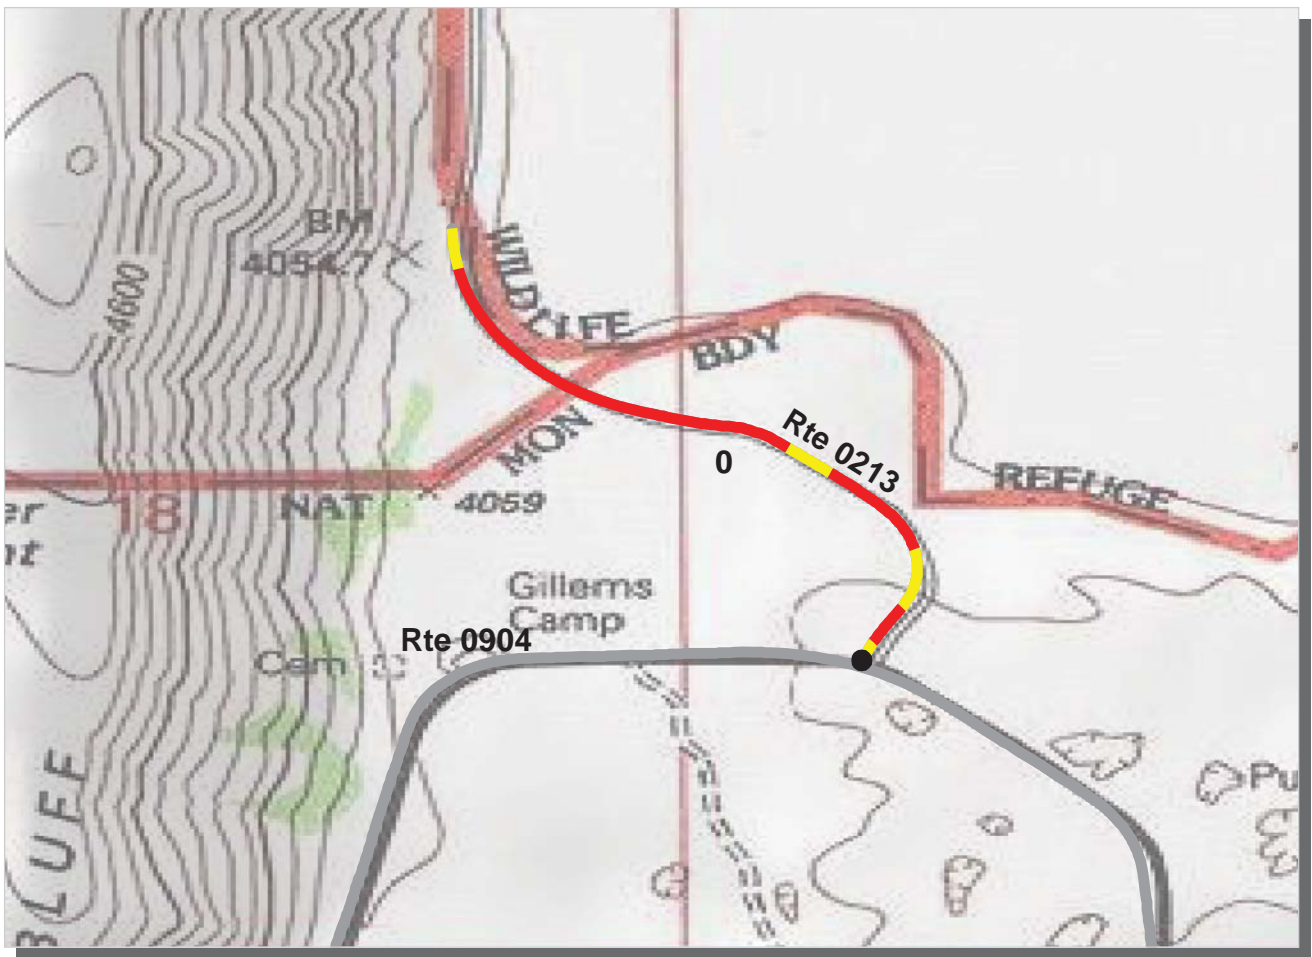
**ROUTE: 0213 US Fish and Wildlife Headquarters Road**      **TOTAL LENGTH: 0.64 Miles**

Section Number	0	0			
Section Length (mi)	0.64	0.34	0.06	0.12	
AADT	**				
SADT	**				
ADT Date	**				
<b>Cross Section Information</b>					
Number of Lanes	2	2			
Paved Width (ft)	18	19			
Lane Width (ft)	9	9			
Shoulder Width (ft)	6	5			
<b>Roadway Condition Information</b>					
PCR (Pavement Condition Rating)	53	44			
RCI (Roughness Condition Index)	79	53			
SCR (Surface Condition Rating)	38	43			
Alligator Cracking Index	100	100			
Rutting Index	39	43			
Patching Index	100	99			
Transverse Cracking Index	98	99			
Longitudinal Cracking Index	99	99			
Shoulder Condition Rating	N/C	N/C			
Drainage Condition Rating	GOOD	POOR

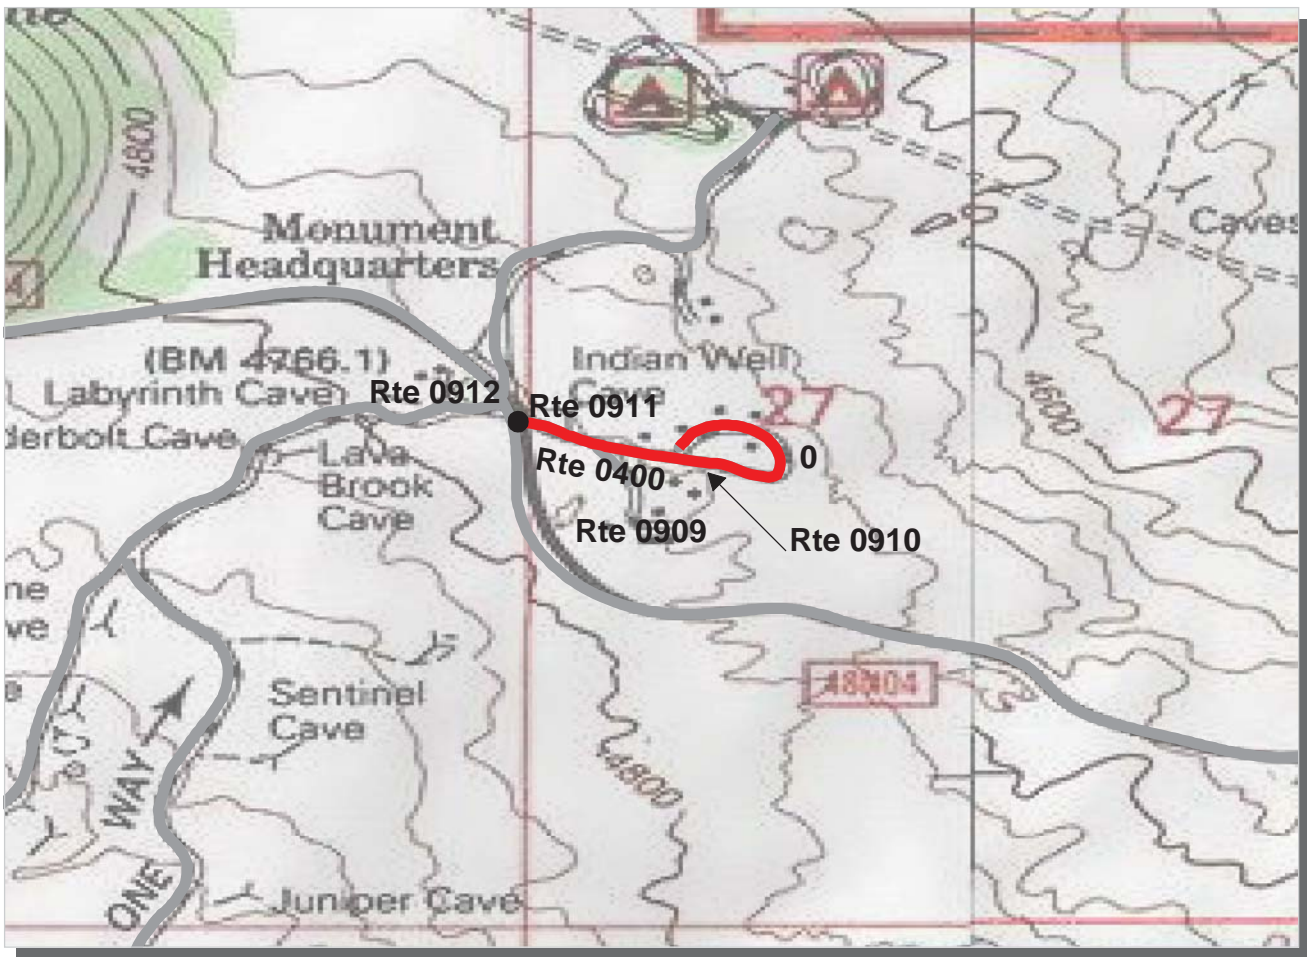
**ROUTE: 0400 Residence Spur** **TOTAL LENGTH: 0.34 Miles**

Section Number	0				
Section Length (mi)	0.34				
AADT	**				
SADT	**				
ADT Date	**				
<b>Cross Section Information</b>					
Number of Lanes	2				
Paved Width (ft)	19				
Lane Width (ft)	9				
Shoulder Width (ft)	5				
<b>Roadway Condition Information</b>					
PCR (Pavement Condition Rating)	44				
RCI (Roughness Condition Index)	53				
SCR (Surface Condition Rating)	43				
Alligator Cracking Index	100				
Rutting Index	43				
Patching Index	99				
Transverse Cracking Index	99				
Longitudinal Cracking Index	99				
Shoulder Condition Rating	N/C				
Drainage Condition Rating	POOR

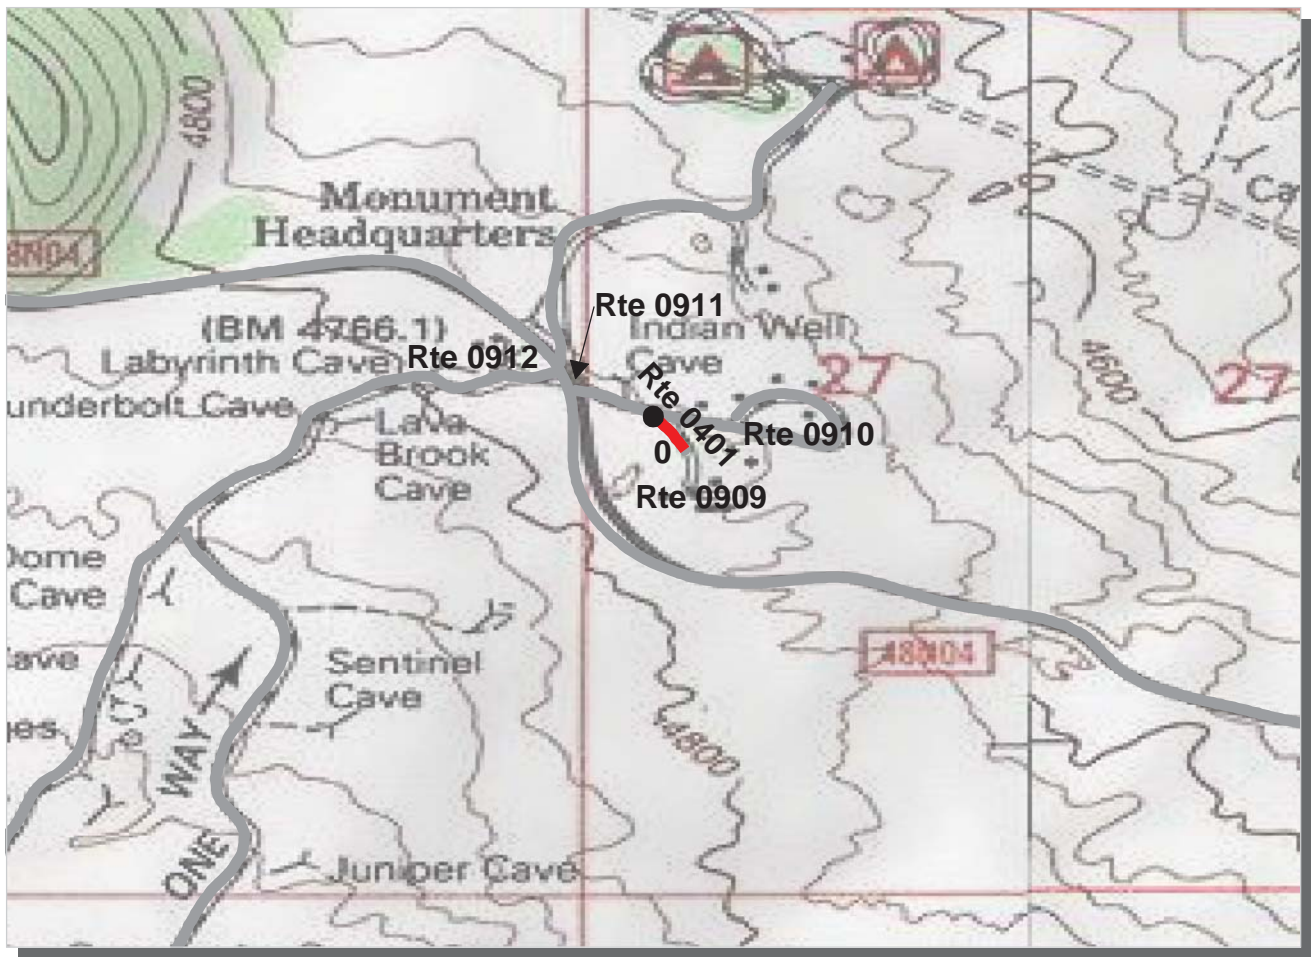
**ROUTE: 0401 Maintenance Spur** **TOTAL LENGTH: 0.06 Miles**

Section Number	0				
Section Length (mi)	0.06				
AADT	**				
SADT	**				
ADT Date	**				
<b>Cross Section Information</b>					
Number of Lanes	2				
Paved Width (ft)	17				
Lane Width (ft)	8				
Shoulder Width (ft)	0				
<b>Roadway Condition Information</b>					
PCR (Pavement Condition Rating)	51				
RCI (Roughness Condition Index)	35				
SCR (Surface Condition Rating)	53				
Alligator Cracking Index	100				
Rutting Index	54				
Patching Index	100				
Transverse Cracking Index	99				
Longitudinal Cracking Index	99				
Shoulder Condition Rating	N/A				
Drainage Condition Rating	POOR

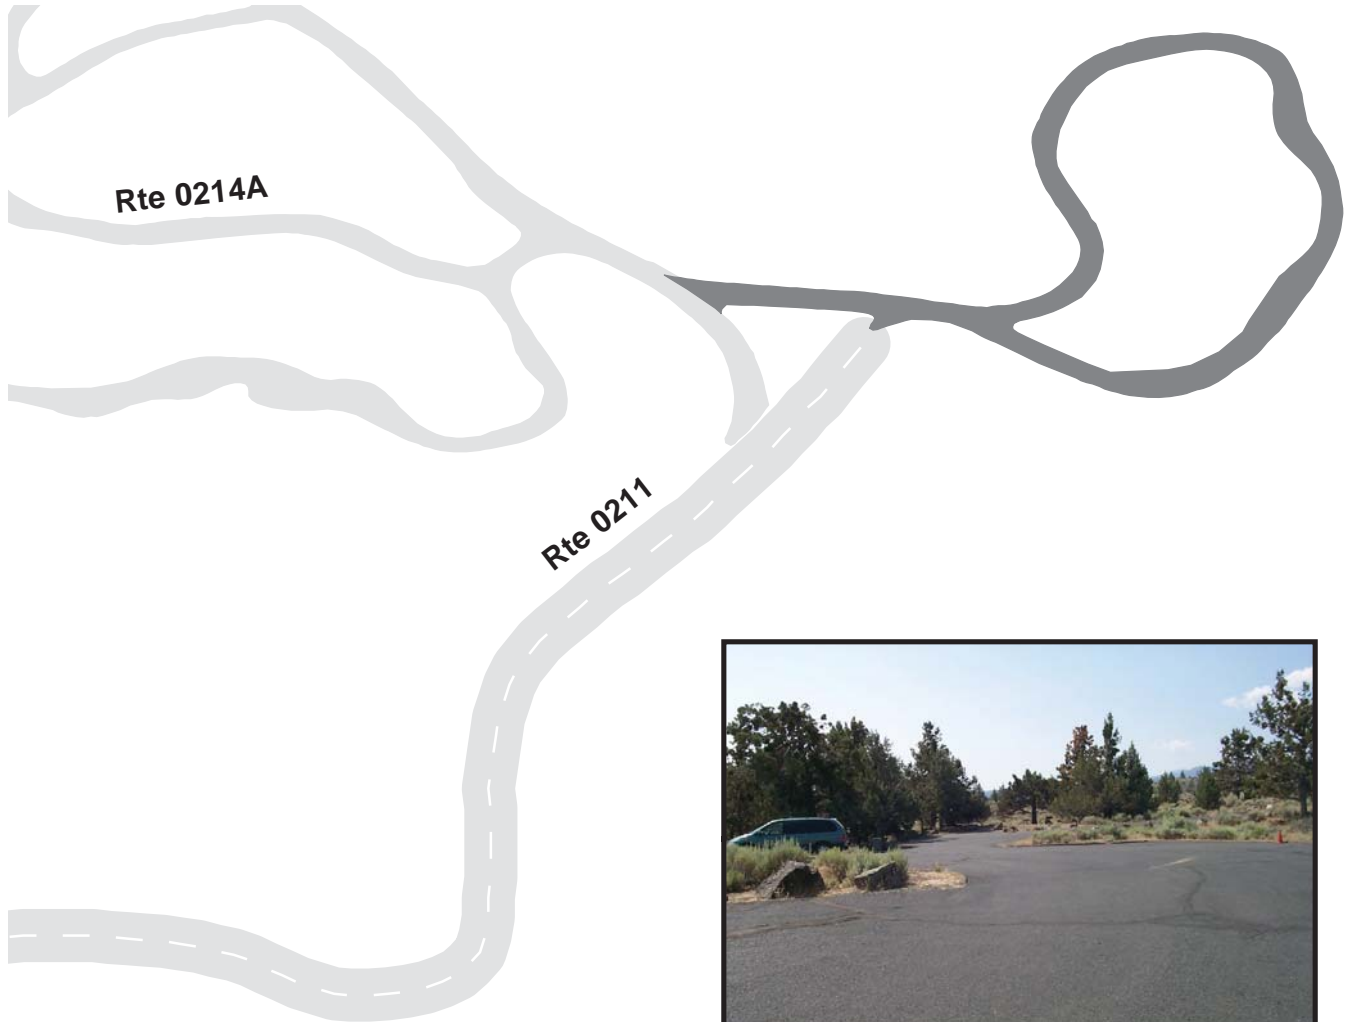
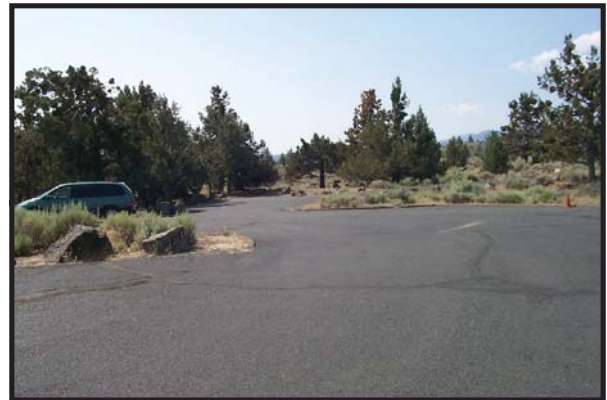
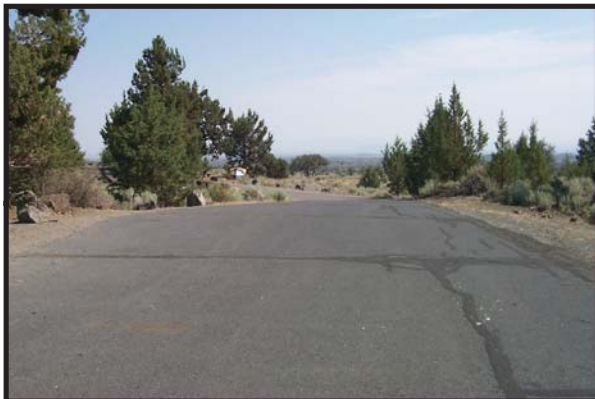
## Route 0402

Route	Length (mi)	Width (ft)	Area (sq ft)	Lane Miles *	Condition / PCR	Surface Type
0402	0.06	15.00	4831	0.08	EXCELLENT / 97	AS

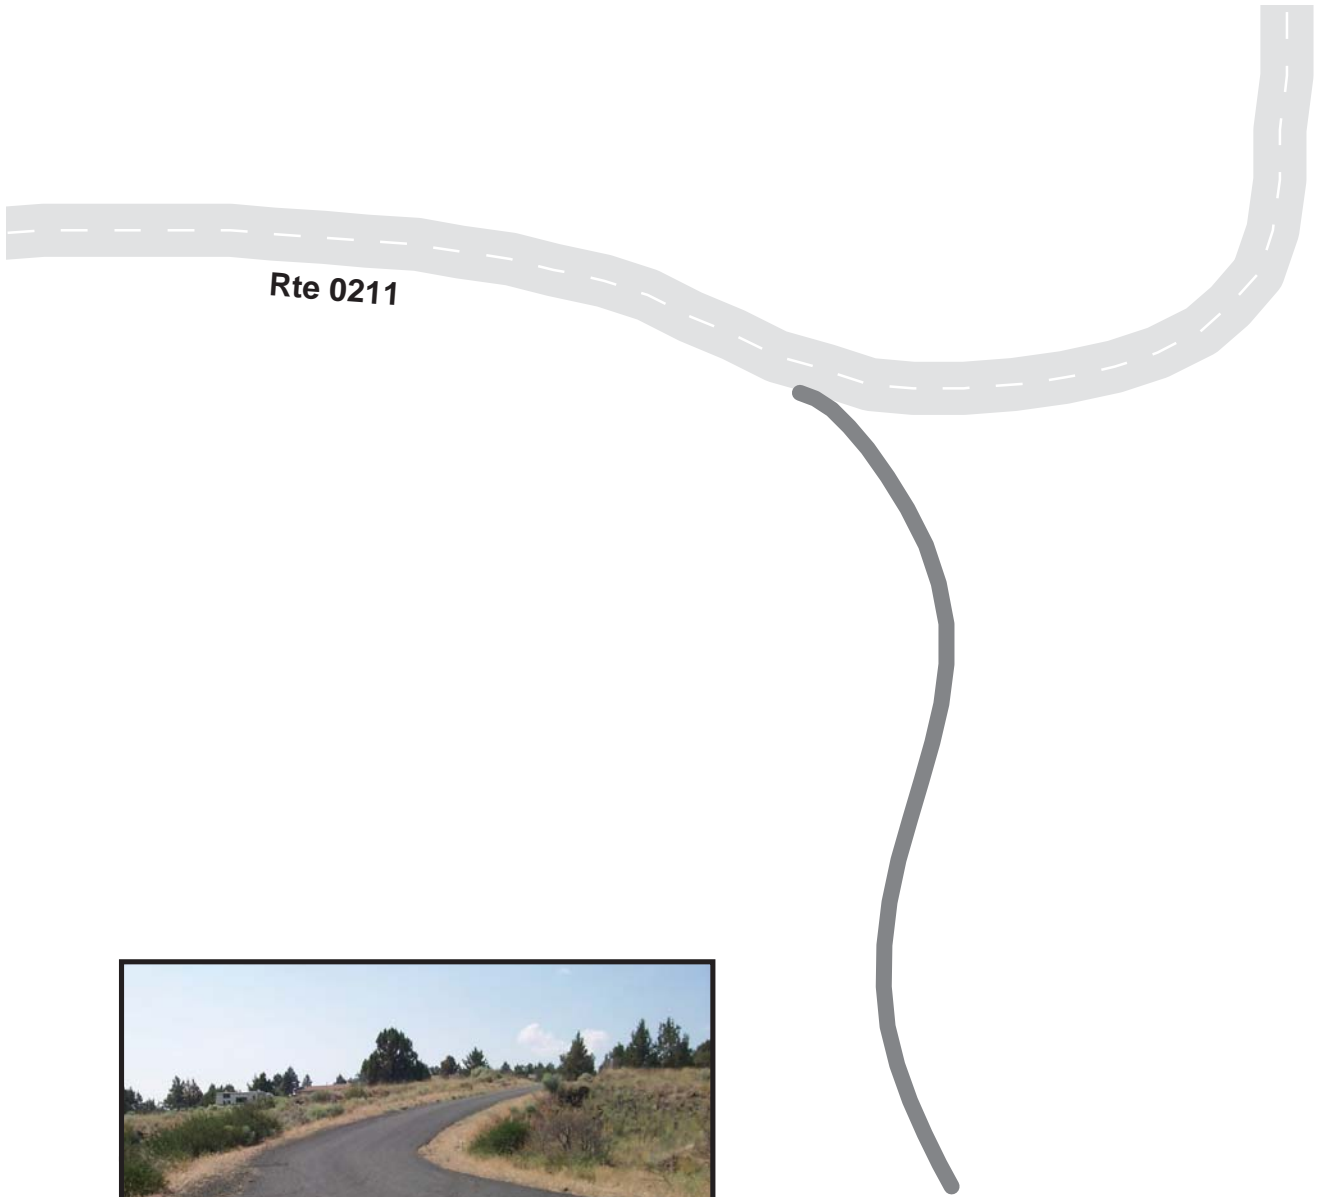
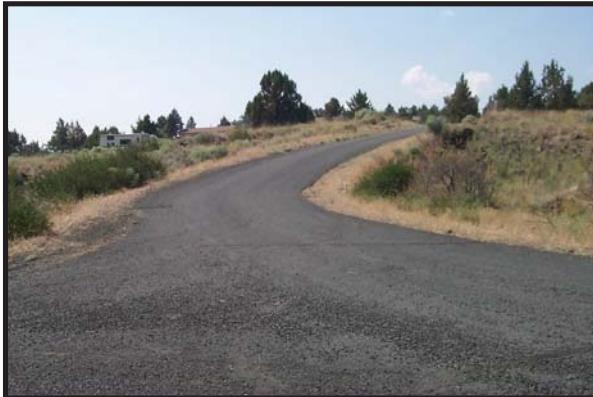
## Route 0403

Route	Length (mi)	Width (ft)	Area (sq ft)	Lane Miles *	Condition / PCR	Surface Type
0403	0.06	15.00	4673	0.08	EXCELLENT / 97	NC

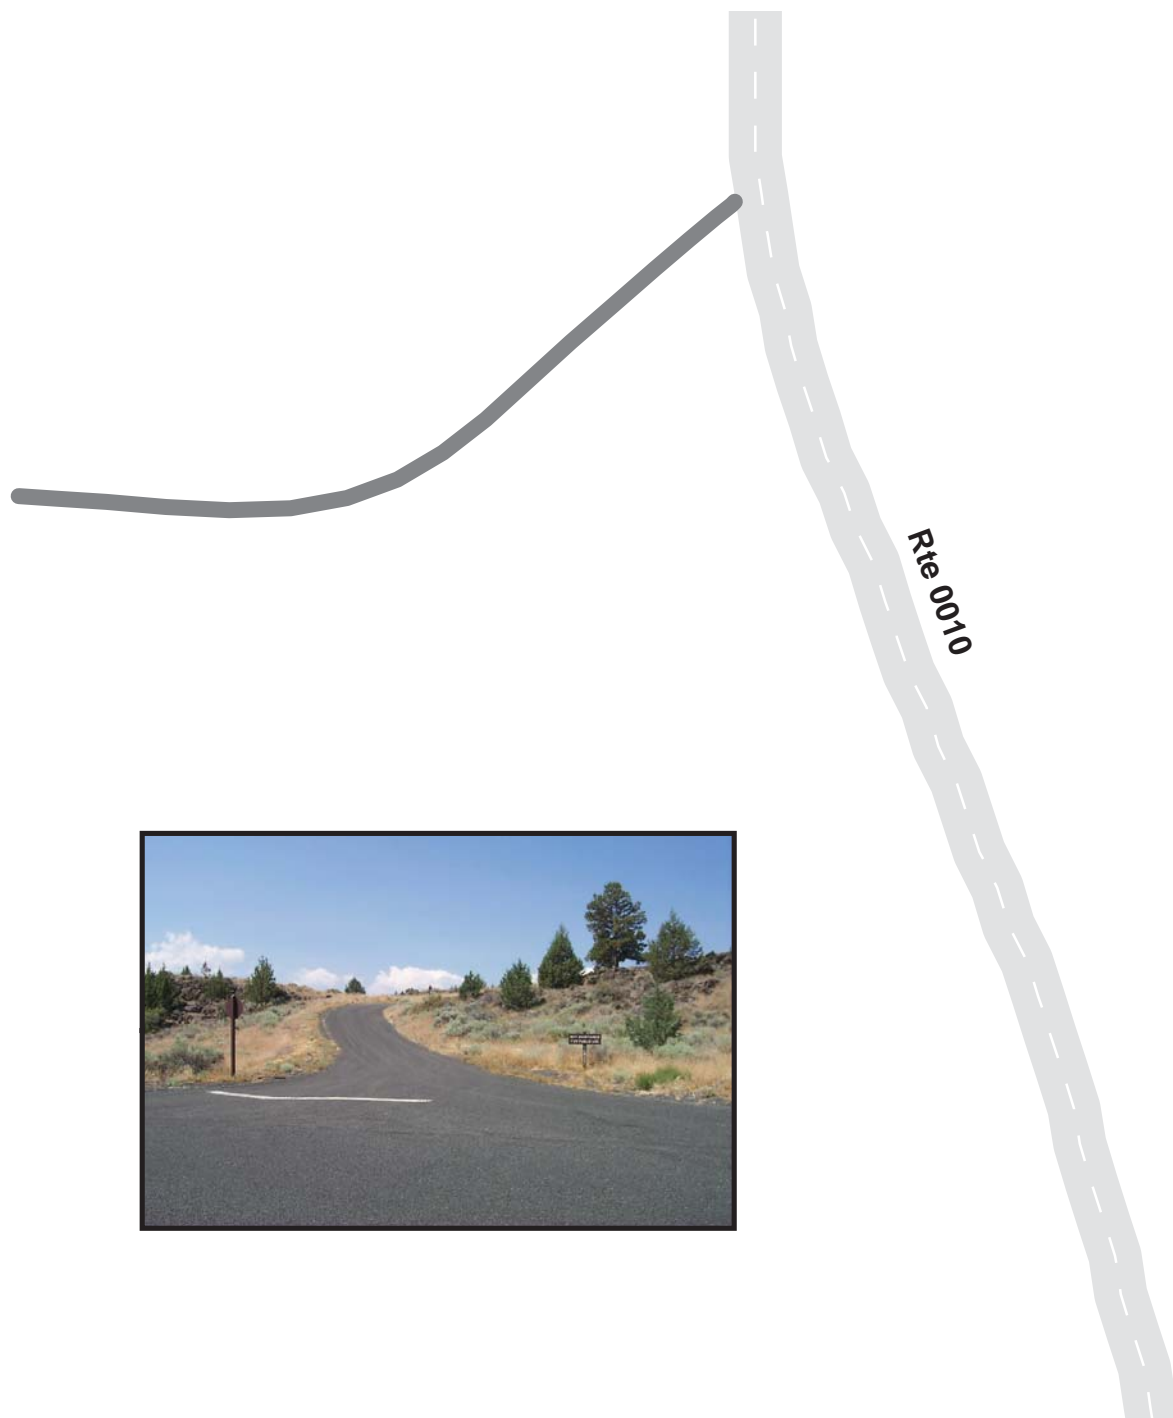
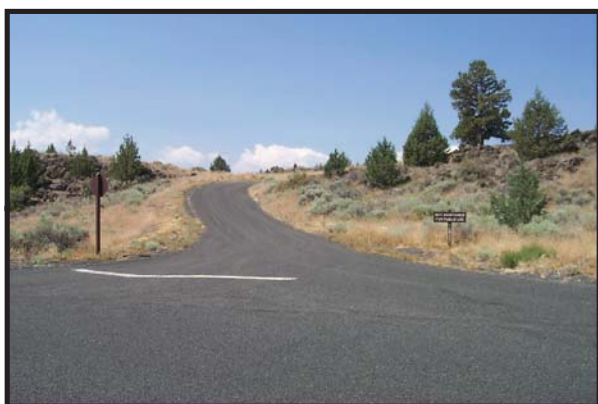
## Route 0900

Route	Public / NonPublic	Date Visited	Area (sq ft)	Lane Miles *	Surface Type	Condition / PCR
0900	Public	7/19/2002	6409	0.11	OC	FAIR / 73

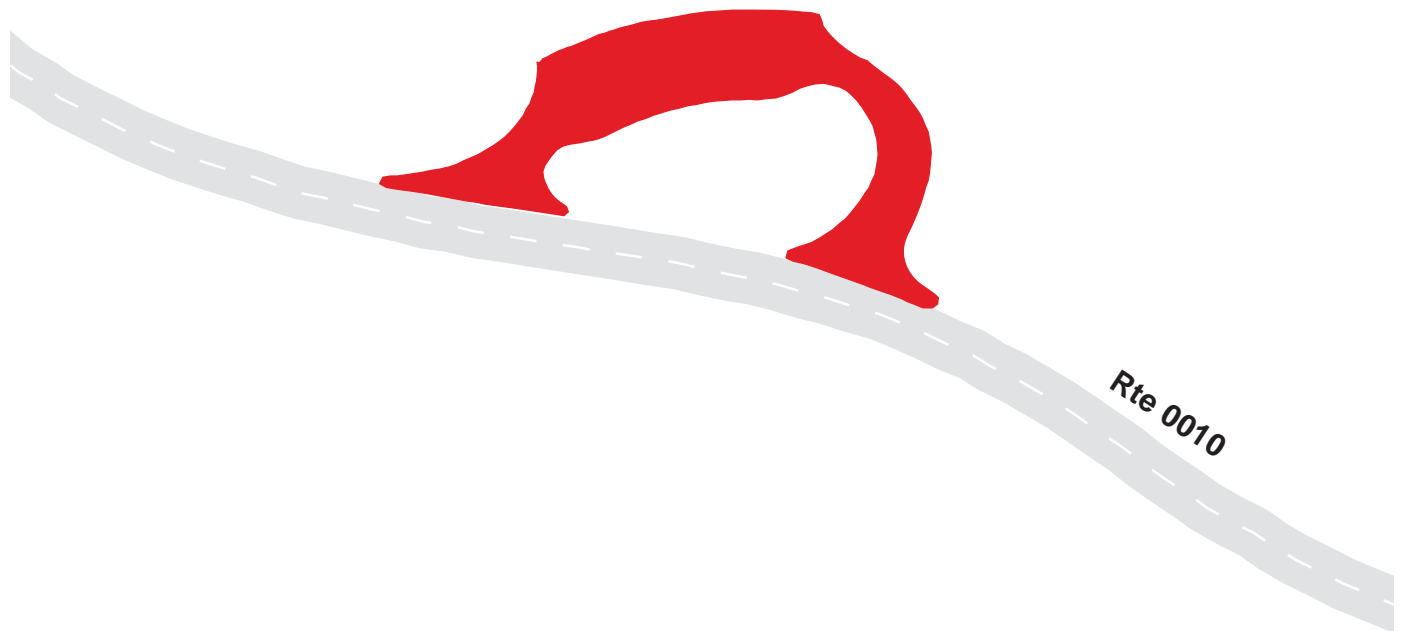
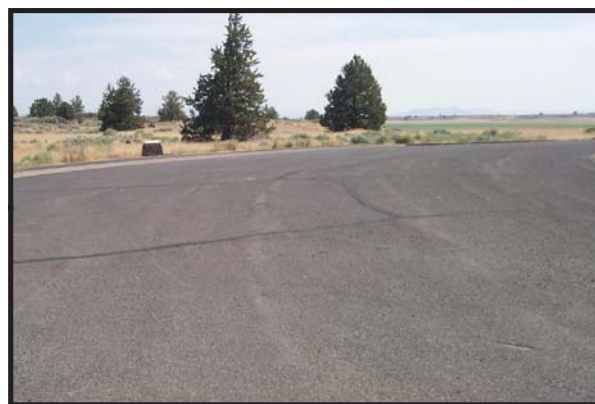
**Lava Beds National Monument**  
**Route 0904**  
 Gillems Camp Parking  
 Adjacent To Route 0010 at MP 12.9 on Left

Route	Public / NonPublic	Date Visited	Area (sq ft)	Lane Miles *	Surface Type	Condition / PCR
0904	Public	7/19/2002	23311	0.40	OC	FAIR / 73

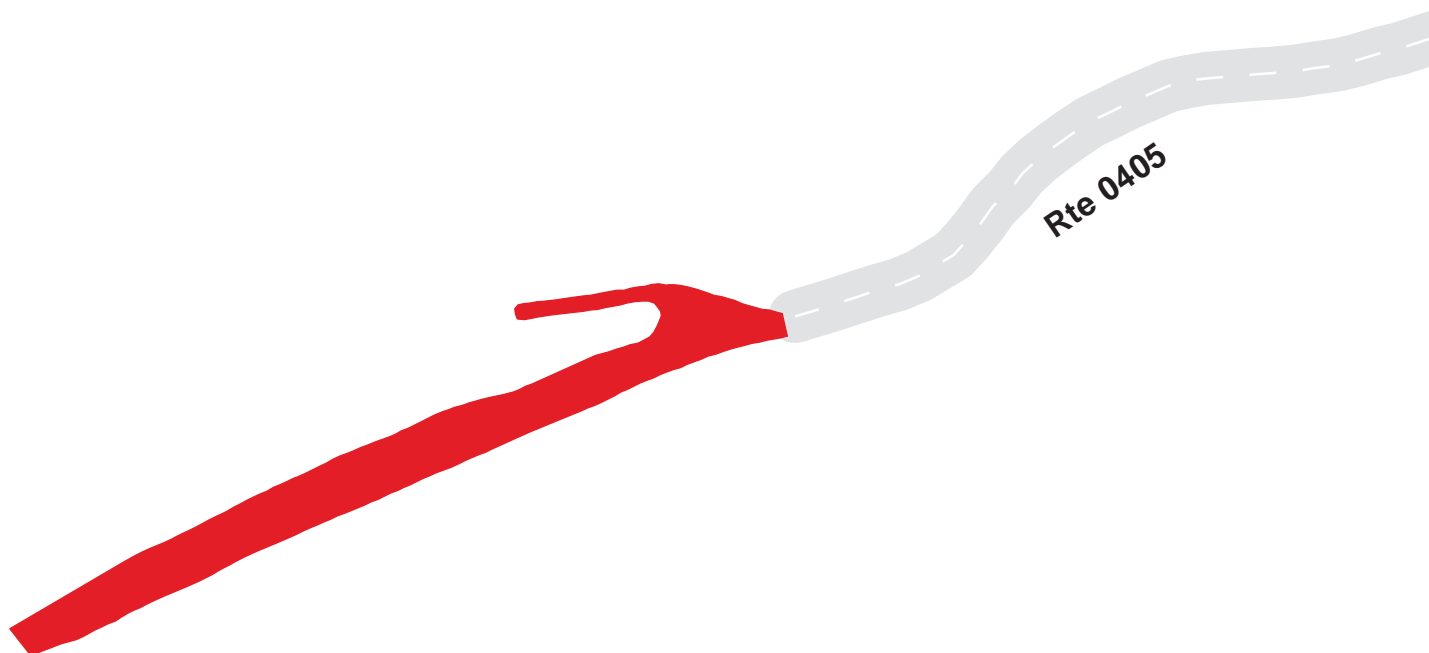
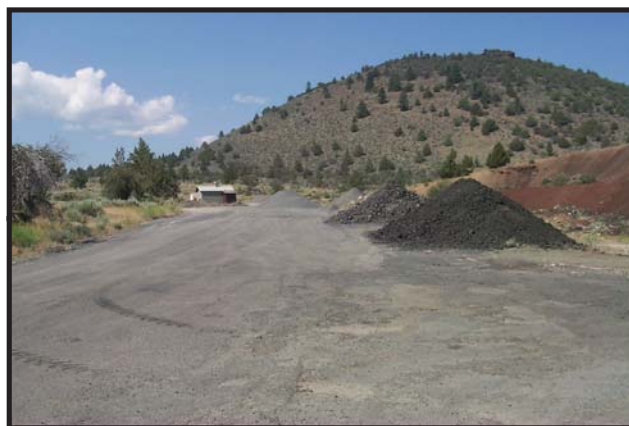
## Route 0908

Route	Public / NonPublic	Date Visited	Area (sq ft)	Lane Miles *	Surface Type	Condition / PCR
0908	NonPublic	7/19/2002	23482	0.40	AS	POOR / 45

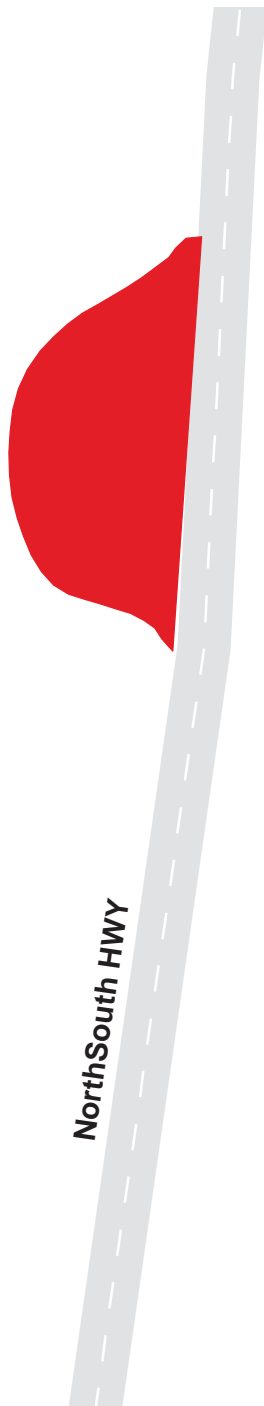
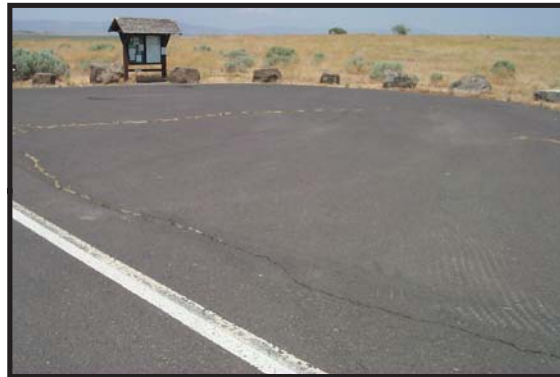
## Route 0919

Route	Public / NonPublic	Date Visited	Area (sq ft)	Lane Miles *	Surface Type	Condition / PCR
0919	Public	7/19/2002	3205	0.06	AS	POOR / 45
