The Road Inventory of Lake Meredith National Recreation Area LAMR - 7540

Prepared By:
Federal Highway Administration
Eastern Federal Lands Highway Division
Cycle 3

Lake Meredith National Recreation Area in Texas

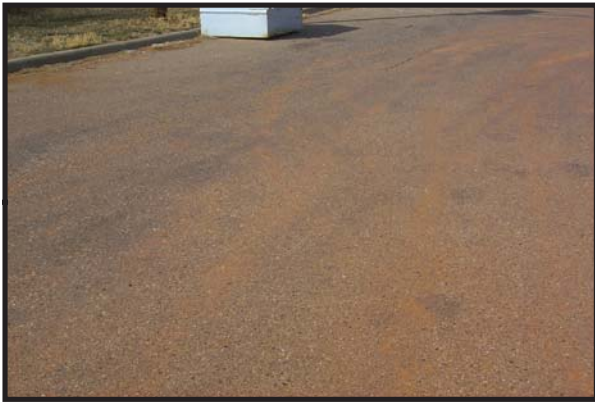
Route	Public / NonPublic	Date Visited	Area (sq ft)	Lane Miles *	Surface Type	Condition / PCR
0900A	Public	3/10/2003	3055	0.05	AS	GOOD / 90

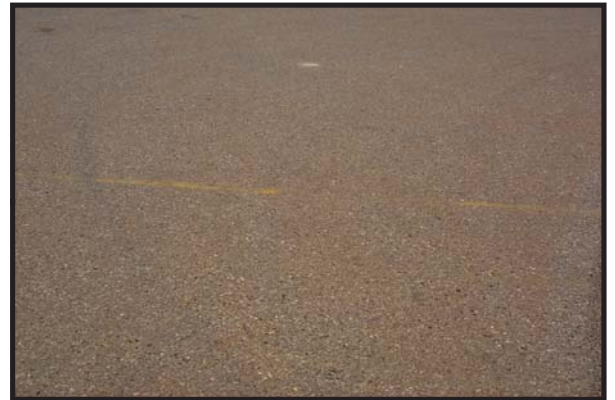
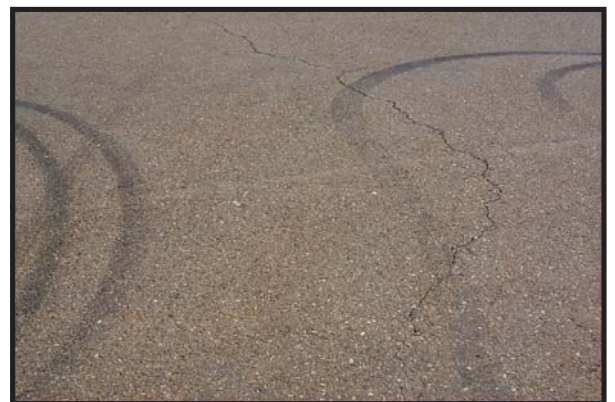
Route 0900B

Route	Public / NonPublic	Date Visited	Area (sq ft)	Lane Miles *	Surface Type	Condition / PCR
0900B	Public	3/10/2003	57247	0.99	AS	FAIR / 73

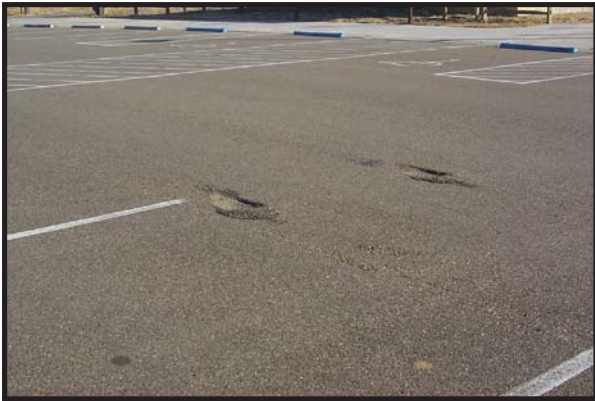
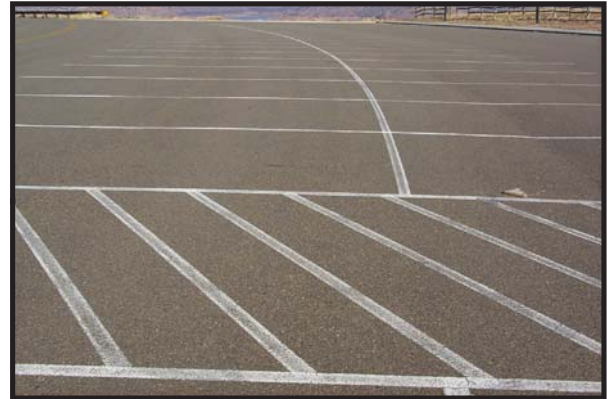
Route	Public / NonPublic	Date Visited	Area (sq ft)	Lane Miles *	Surface Type	Condition / PCR
0901	Public	3/10/2003	94140	1.62	AS	GOOD / 90

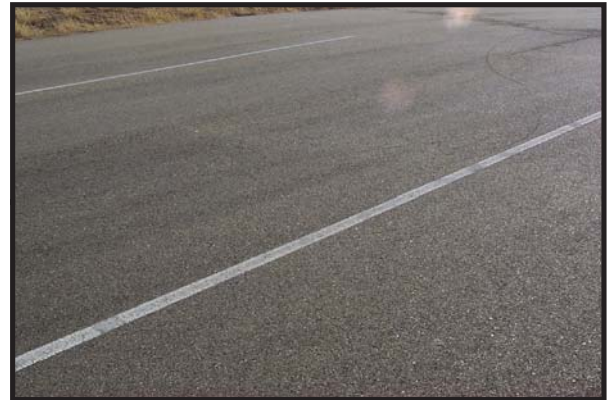
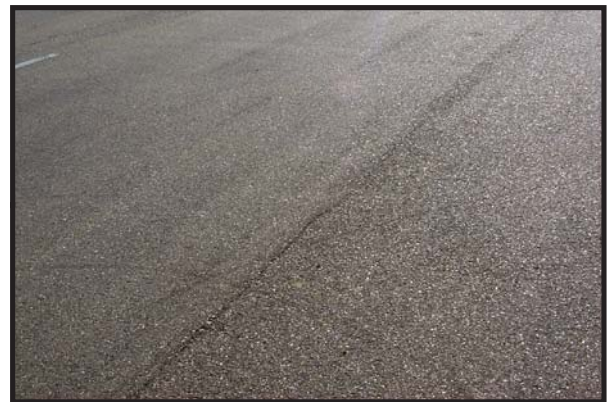
Route	Public / NonPublic	Date Visited	Area (sq ft)	Lane Miles *	Surface Type	Condition / PCR
0902	Public	3/10/2003	25528	0.44	AS	GOOD / 90

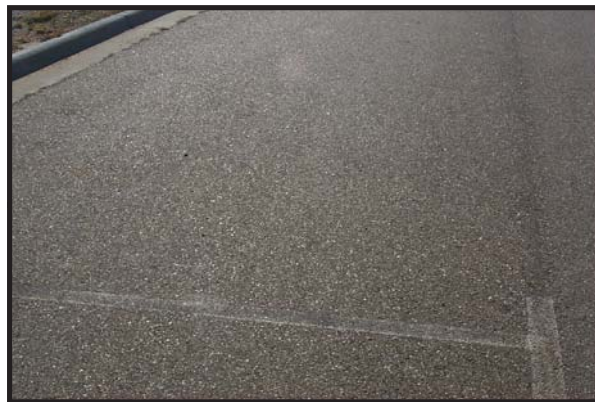
Route	Public / NonPublic	Date Visited	Area (sq ft)	Lane Miles *	Surface Type	Condition / PCR
0903A	Public	3/9/2003	1929	0.03	AS	FAIR / 73

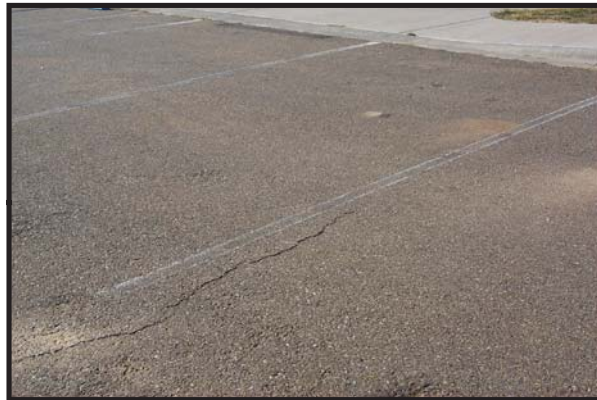
Route	Public / NonPublic	Date Visited	Area (sq ft)	Lane Miles *	Surface Type	Condition / PCR
0903B	Public	3/9/2003	2531	0.04	AS	FAIR / 73

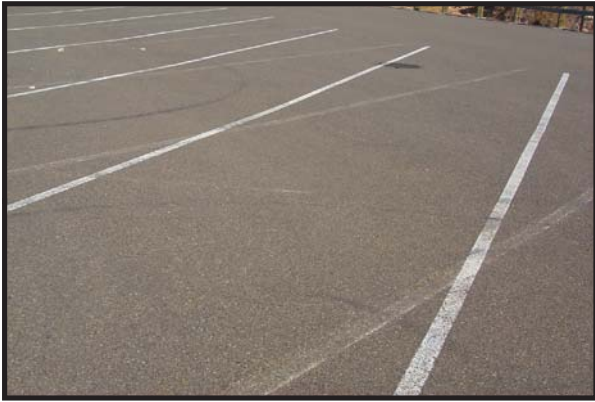
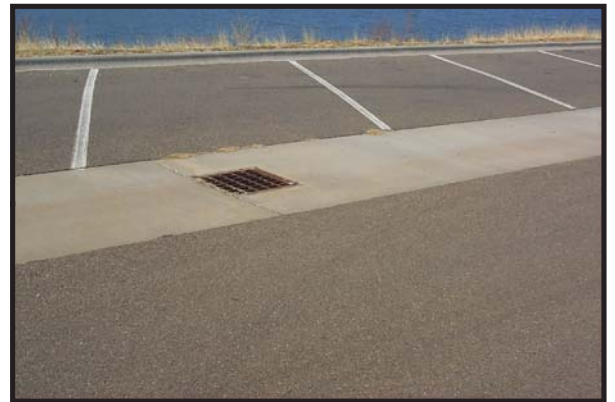
Route	Public / NonPublic	Date Visited	Area (sq ft)	Lane Miles *	Surface Type	Condition / PCR
0904	Public	3/9/2003	58597	1.01	AS	GOOD / 90

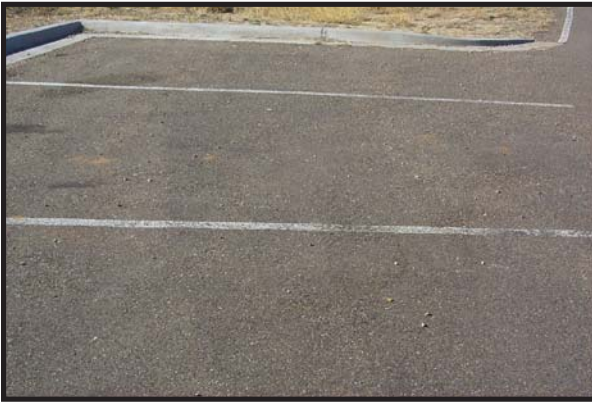
Route	Public / NonPublic	Date Visited	Area (sq ft)	Lane Miles *	Surface Type	Condition / PCR
0905A	Public	3/9/2003	1339	0.02	AS	GOOD / 90

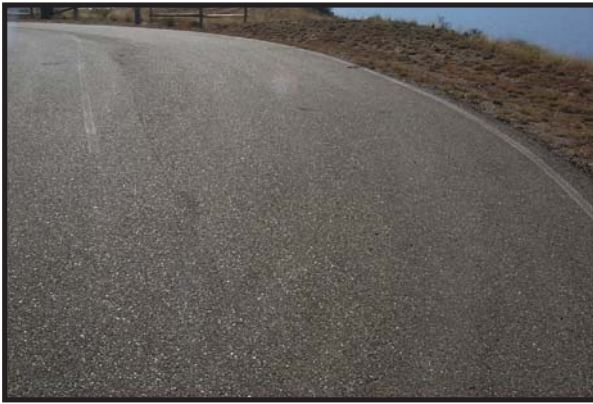
Route	Public / NonPublic	Date Visited	Area (sq ft)	Lane Miles *	Surface Type	Condition / PCR
0905B	Public	3/9/2003	1367	0.02	AS	GOOD / 90

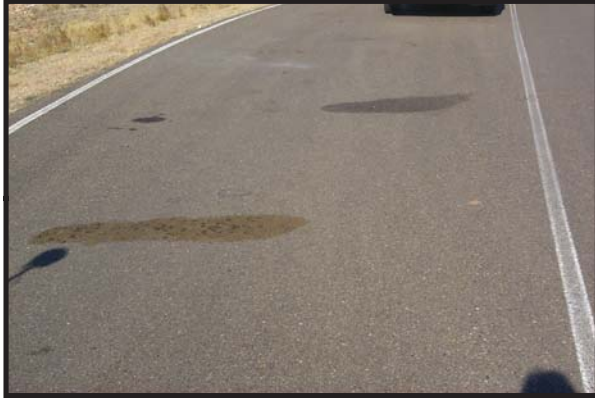
Route	Public / NonPublic	Date Visited	Area (sq ft)	Lane Miles *	Surface Type	Condition / PCR
0905C	Public	3/9/2003	1421	0.02	AS	GOOD / 90

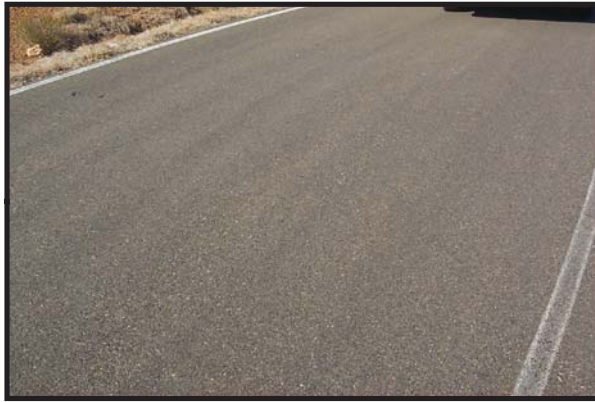
Route	Public / NonPublic	Date Visited	Area (sq ft)	Lane Miles *	Surface Type	Condition / PCR
0905D	Public	3/9/2003	956	0.02	AS	GOOD / 90

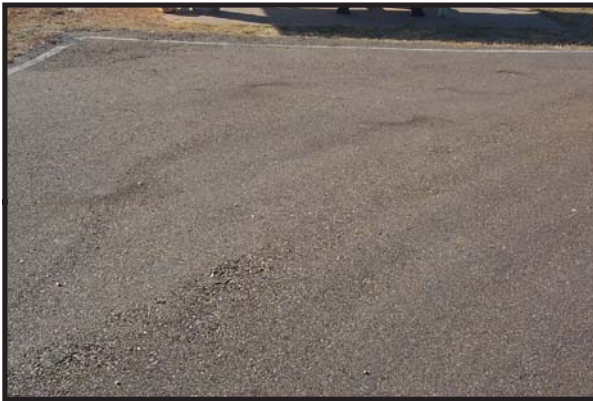
Route	Public / NonPublic	Date Visited	Area (sq ft)	Lane Miles *	Surface Type	Condition / PCR
0905E	Public	3/9/2003	1027	0.02	AS	GOOD / 90

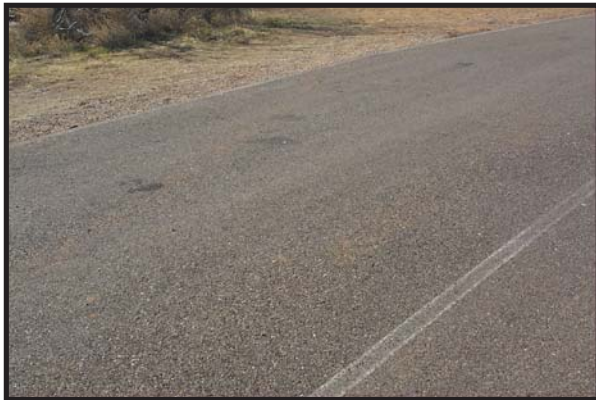
Route	Public / NonPublic	Date Visited	Area (sq ft)	Lane Miles *	Surface Type	Condition / PCR
0905F	Public	3/9/2003	1358	0.02	AS	GOOD / 90

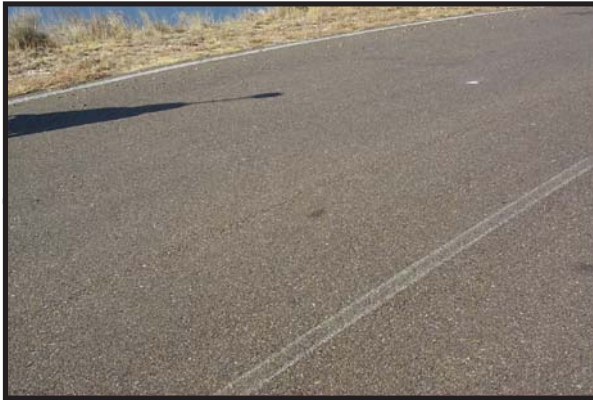
Route	Public / NonPublic	Date Visited	Area (sq ft)	Lane Miles *	Surface Type	Condition / PCR
0905G	Public	3/9/2003	1893	0.03	AS	GOOD / 90

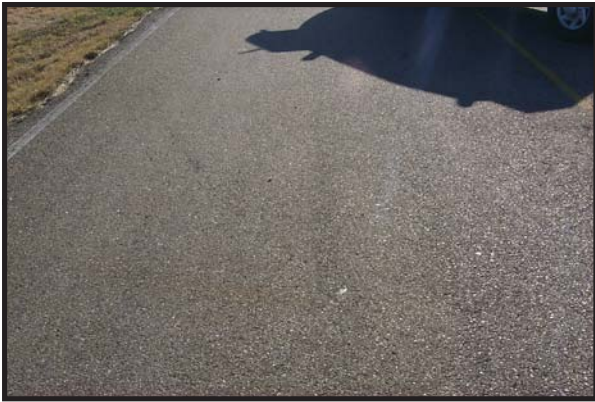
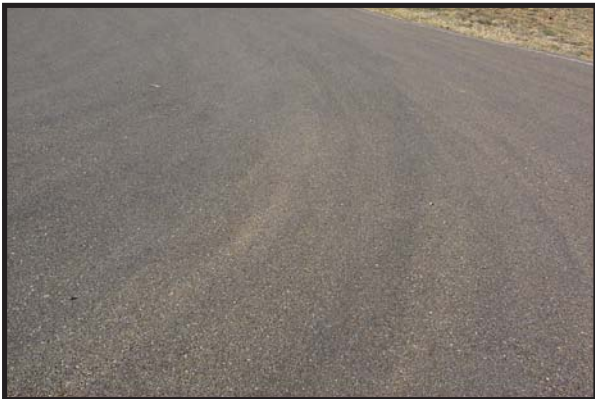
Route	Public / NonPublic	Date Visited	Area (sq ft)	Lane Miles *	Surface Type	Condition / PCR
0906	Public	3/9/2003	7912	0.14	AS	GOOD / 90

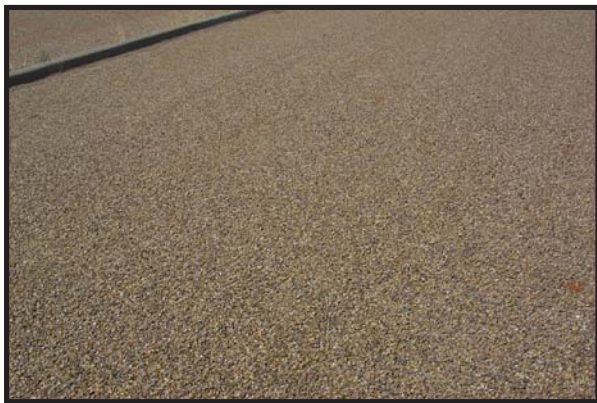
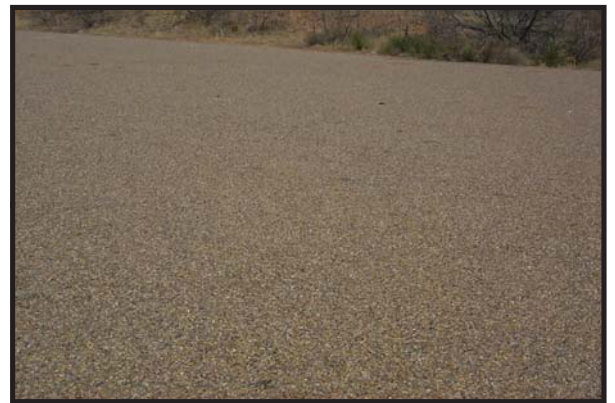
Route	Public / NonPublic	Date Visited	Area (sq ft)	Lane Miles *	Surface Type	Condition / PCR
0907	Public	3/10/2003	82807	1.43	NC	GOOD / 90

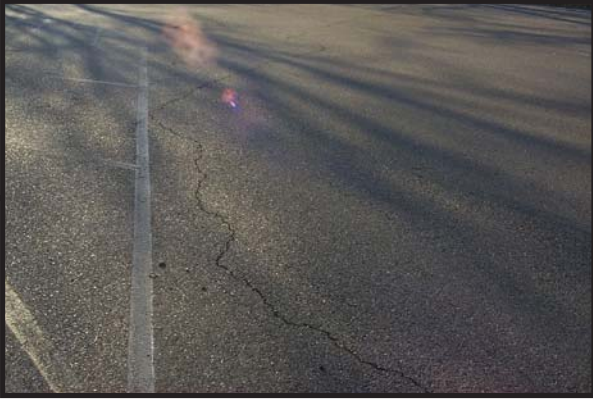
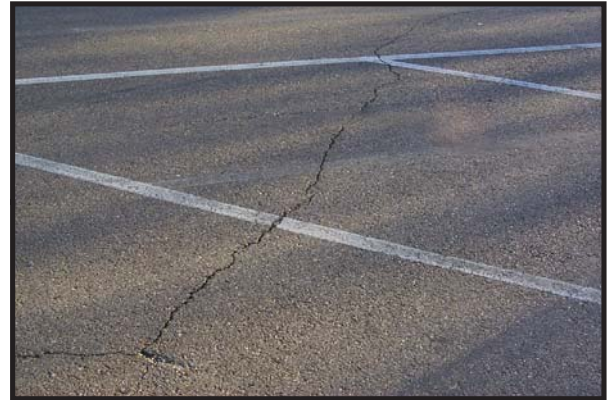
Route	Public / NonPublic	Date Visited	Area (sq ft)	Lane Miles *	Surface Type	Condition / PCR
0908	Public	3/9/2003	62404	1.07	AS	GOOD / 90

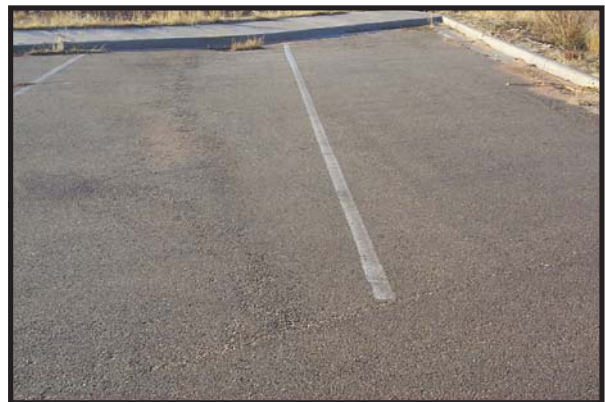
Route	Public / NonPublic	Date Visited	Area (sq ft)	Lane Miles *	Surface Type	Condition / PCR
0909	Public	3/9/2003	53049	0.91	AS	FAIR / 73

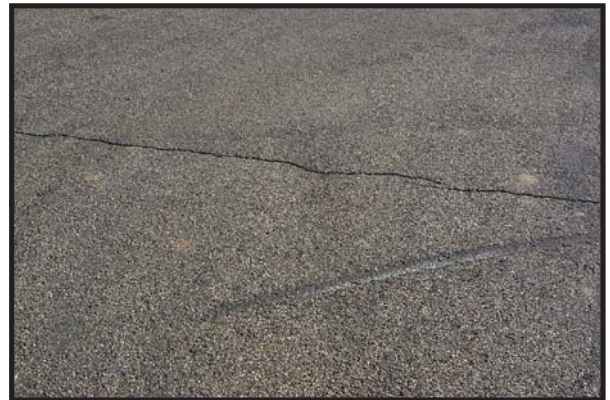
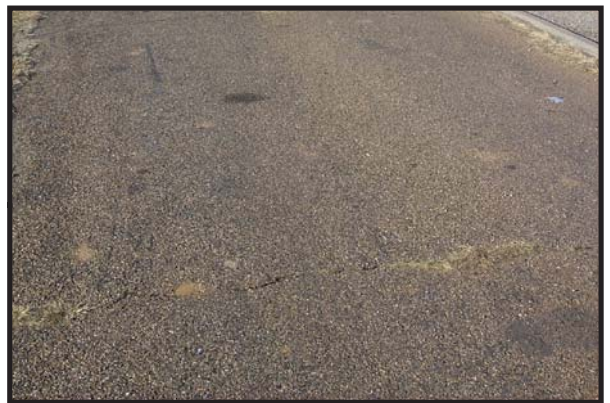
Route	Public / NonPublic	Date Visited	Area (sq ft)	Lane Miles *	Surface Type	Condition / PCR
0910	Public	3/9/2003	7997	0.14	AS	FAIR / 73

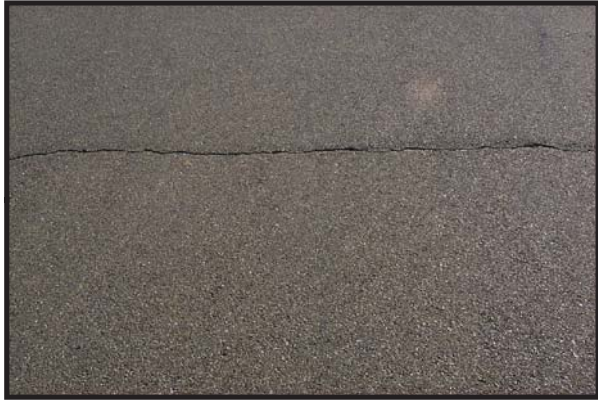
Route	Public / NonPublic	Date Visited	Area (sq ft)	Lane Miles *	Surface Type	Condition / PCR
0911	Public	3/9/2003	3684	0.06	AS	FAIR / 73

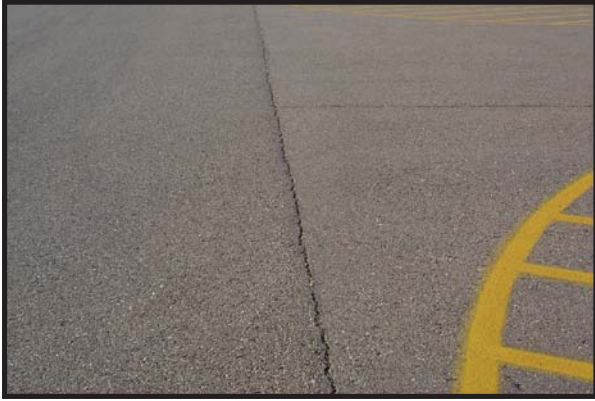
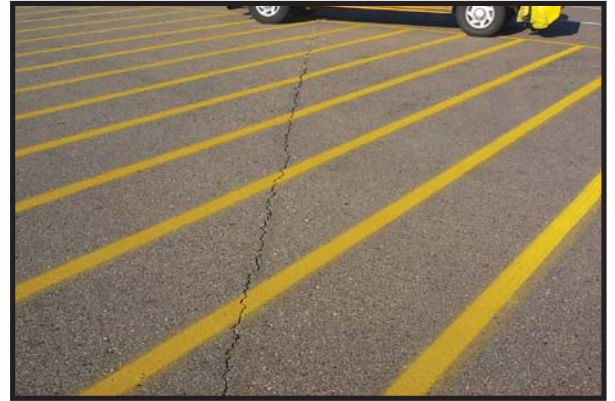
Route	Public / NonPublic	Date Visited	Area (sq ft)	Lane Miles *	Surface Type	Condition / PCR
0912	Public	3/9/2003	139770	2.41	AS	FAIR / 73

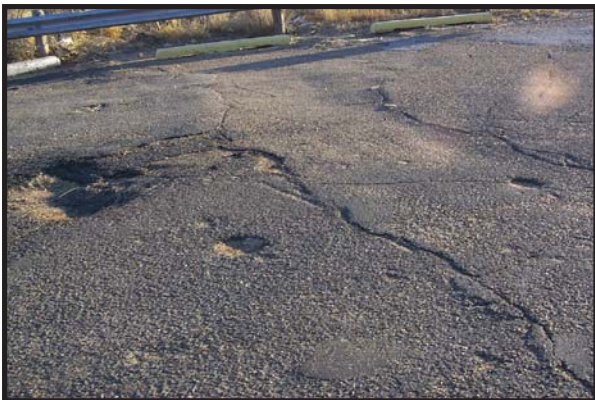
Route 0914

Route	Public / NonPublic	Date Visited	Area (sq ft)	Lane Miles *	Surface Type	Condition / PCR
0914	Public	3/9/2003	6642	0.11	AS	FAIR / 73

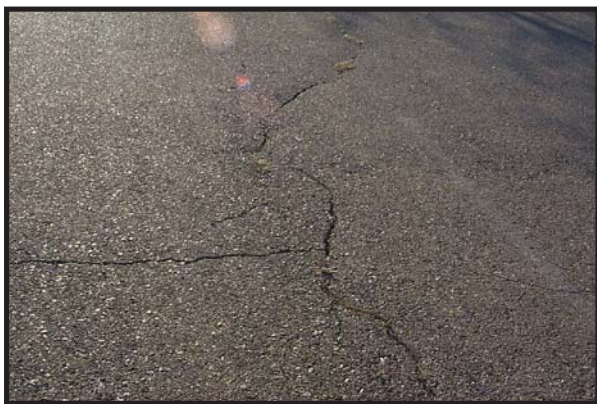
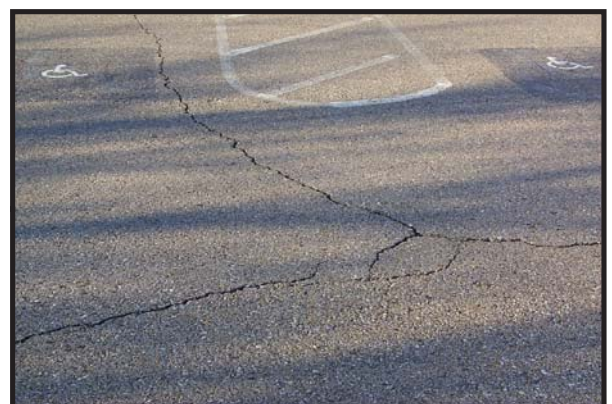
Route 0915A

Route	Public / NonPublic	Date Visited	Area (sq ft)	Lane Miles *	Surface Type	Condition / PCR
0915A	Public	3/9/2003	3095	0.05	AS	GOOD / 90

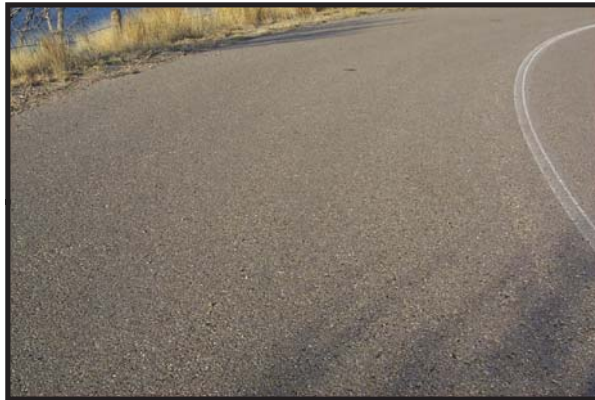
Route 0915B

Route	Public / NonPublic	Date Visited	Area (sq ft)	Lane Miles *	Surface Type	Condition / PCR
0915B	Public	3/9/2003	3577	0.06	AS	GOOD / 90

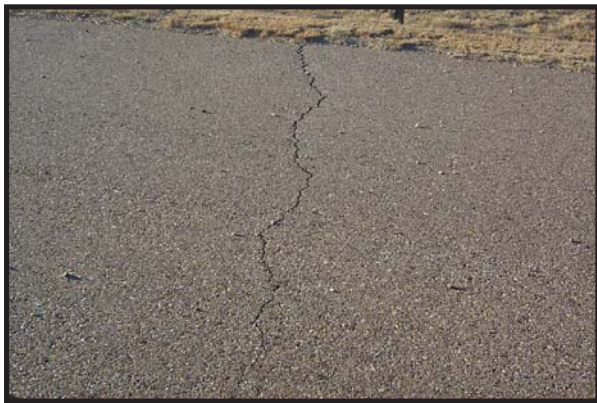
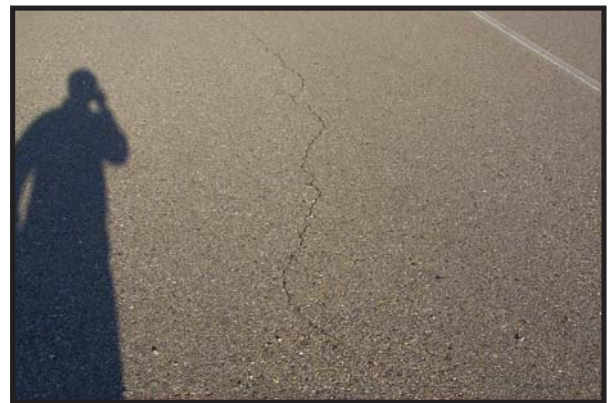
Route 0915C

Route	Public / NonPublic	Date Visited	Area (sq ft)	Lane Miles *	Surface Type	Condition / PCR
0915C	Public	3/9/2003	1174	0.02	AS	GOOD / 90

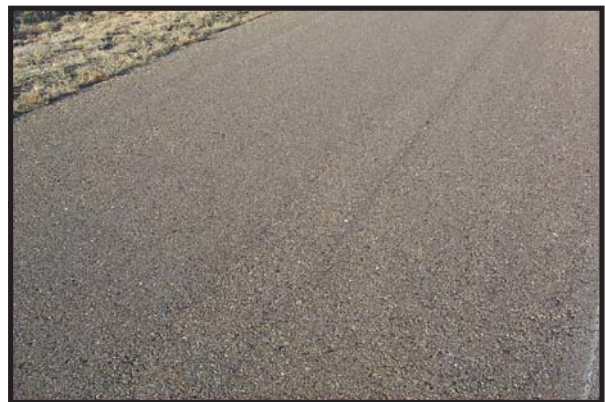
Route 0916

Route	Public / NonPublic	Date Visited	Area (sq ft)	Lane Miles *	Surface Type	Condition / PCR
0916	NonPublic	3/9/2003	32610	0.56	AS	POOR / 45

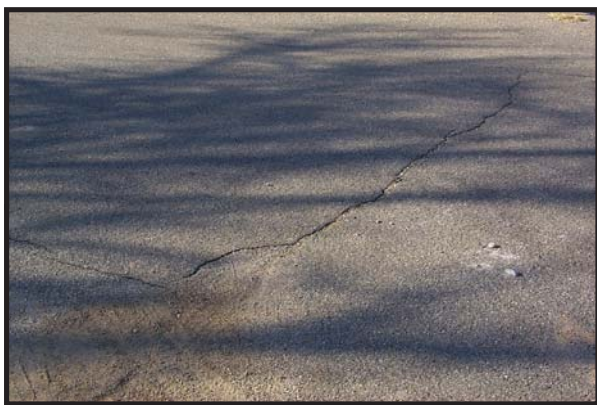
Route 0917

Route	Public / NonPublic	Date Visited	Area (sq ft)	Lane Miles *	Surface Type	Condition / PCR
0917	NonPublic	3/9/2003	41127	0.71	AS	POOR / 45

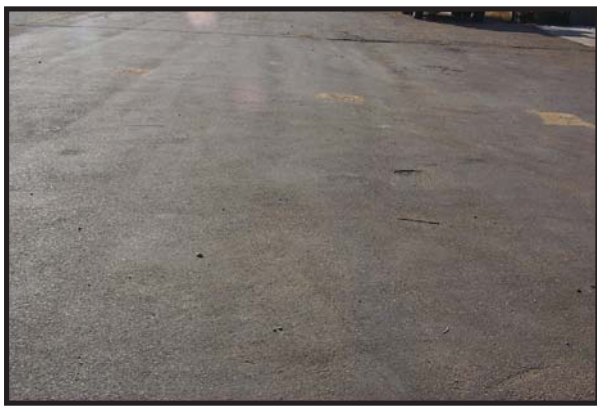
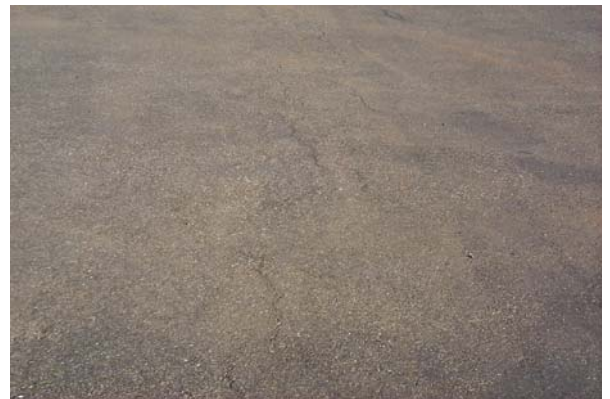
Route 0918A

Route	Public / NonPublic	Date Visited	Area (sq ft)	Lane Miles *	Surface Type	Condition / PCR
0918A	Public	3/9/2003	11878	0.20	AS	GOOD / 90

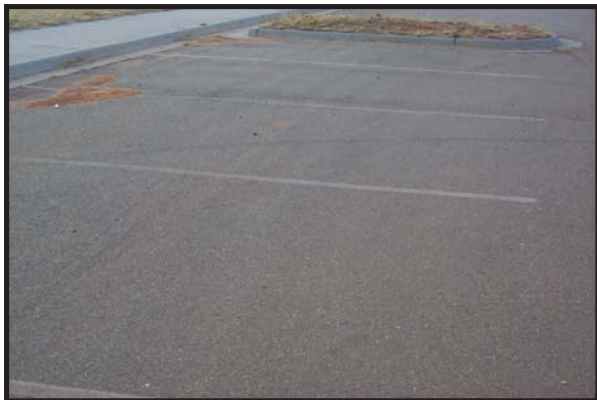
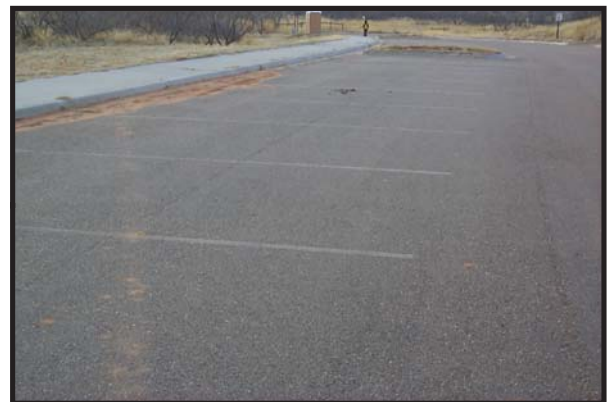
Route 0918B

Route	Public / NonPublic	Date Visited	Area (sq ft)	Lane Miles *	Surface Type	Condition / PCR
0918B	Public	3/9/2003	3207	0.06	AS	GOOD / 90

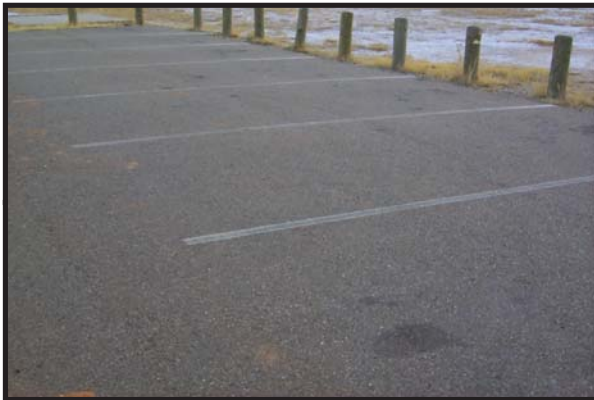
Route 0918D

Route	Public / NonPublic	Date Visited	Area (sq ft)	Lane Miles *	Surface Type	Condition / PCR
0918D	Public	3/9/2003	1860	0.03	AS	GOOD / 90

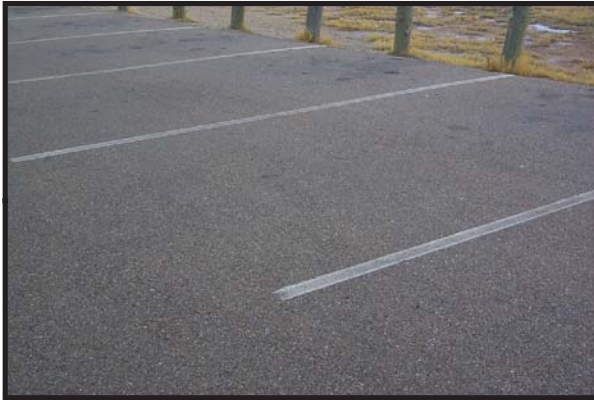
Route 0918E

Route	Public / NonPublic	Date Visited	Area (sq ft)	Lane Miles *	Surface Type	Condition / PCR
0918E	Public	3/9/2003	12796	0.22	AS	GOOD / 90

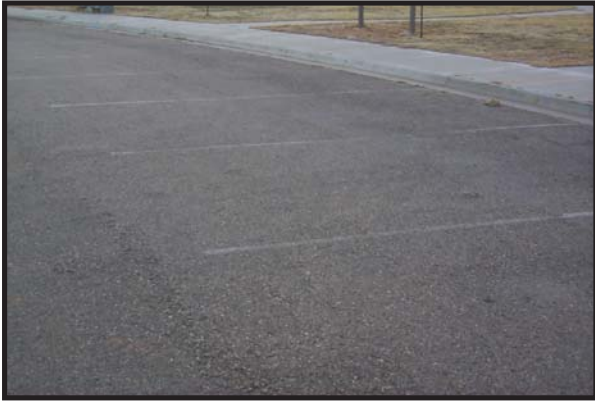
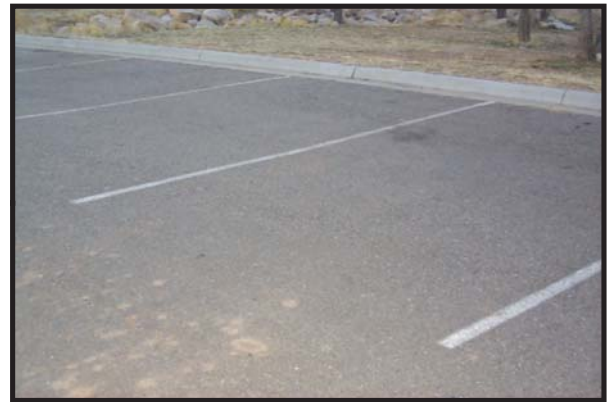
Route 0918F

Route	Public / NonPublic	Date Visited	Area (sq ft)	Lane Miles *	Surface Type	Condition / PCR
0918F	Public	3/9/2003	6385	0.11	AS	GOOD / 90

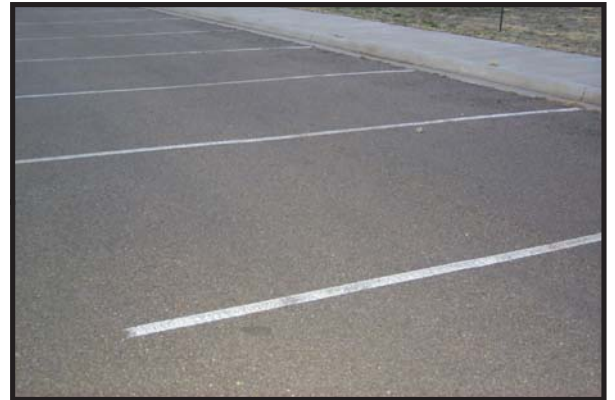
Route 0919

Route	Public / NonPublic	Date Visited	Area (sq ft)	Lane Miles *	Surface Type	Condition / PCR
0919	Public	3/9/2003	14184	0.24	AS	GOOD / 90

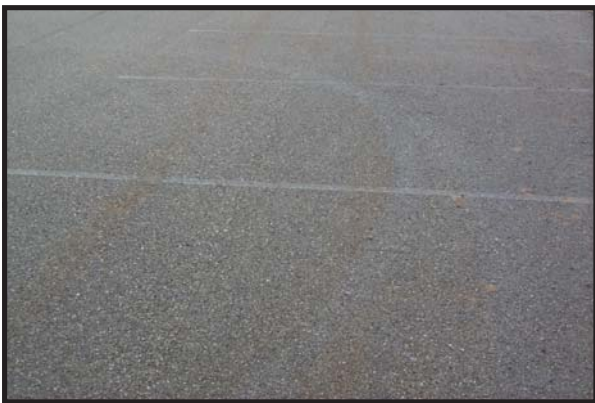
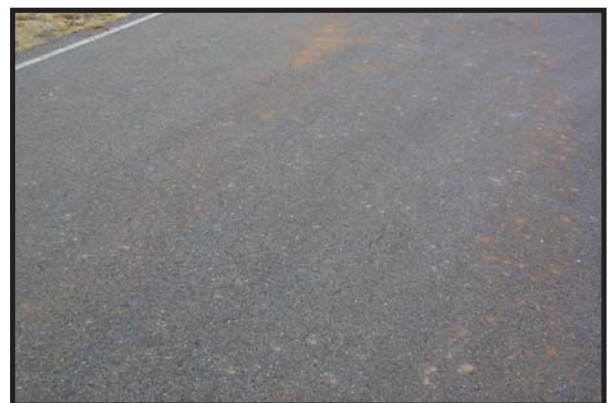
Route 0920

Route	Public / NonPublic	Date Visited	Area (sq ft)	Lane Miles *	Surface Type	Condition / PCR
0920	Public	3/10/2003	41389	0.71	AS	POOR / 45

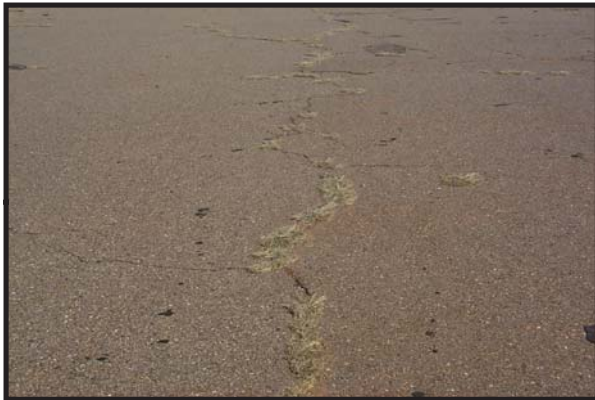
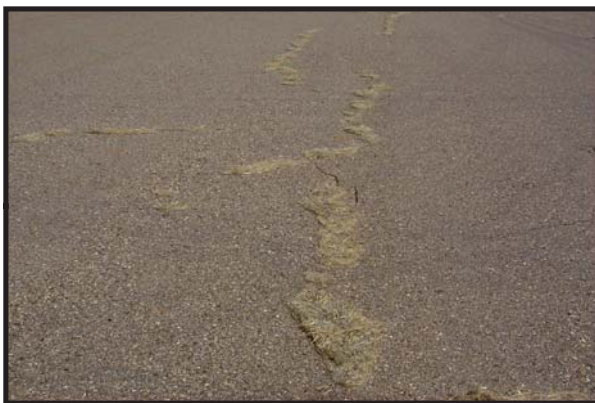
Route 0921

Route	Public / NonPublic	Date Visited	Area (sq ft)	Lane Miles *	Surface Type	Condition / PCR
0921	Public	3/10/2003	8881	0.15	AS	POOR / 45

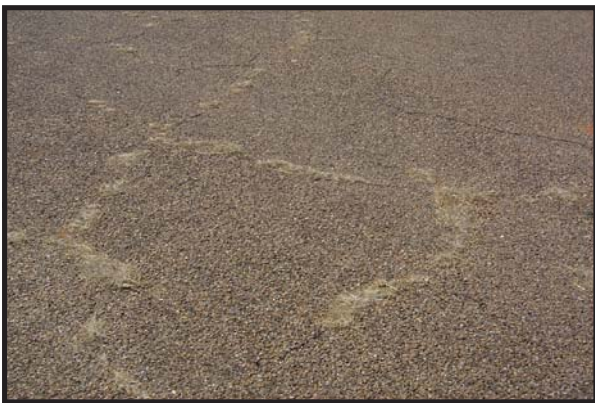
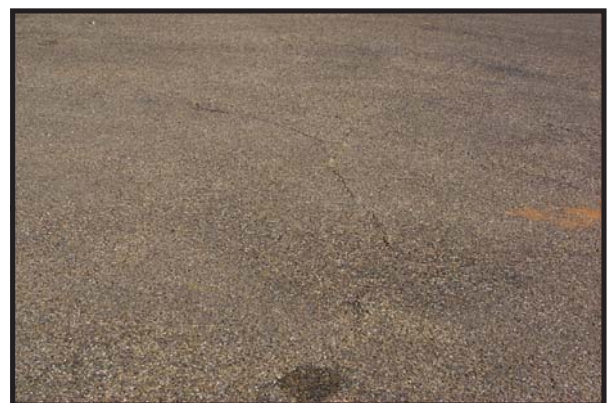
Route 0922

Route	Public / NonPublic	Date Visited	Area (sq ft)	Lane Miles *	Surface Type	Condition / PCR
0922	Public	3/10/2003	87589	1.51	NC	GOOD / 90

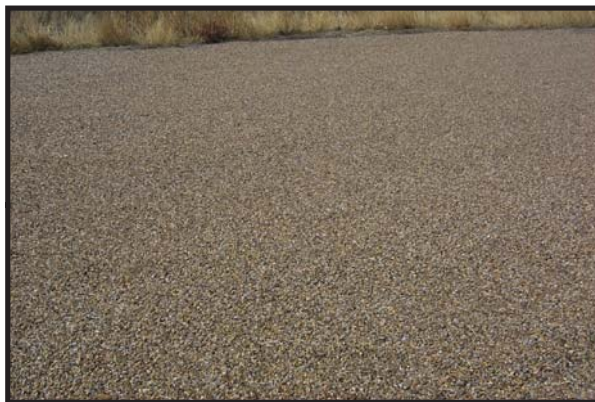
Route 0924

Route	Public / NonPublic	Date Visited	Area (sq ft)	Lane Miles *	Surface Type	Condition / PCR
0924	Public	3/10/2003	1070	0.02	AS	GOOD / 90

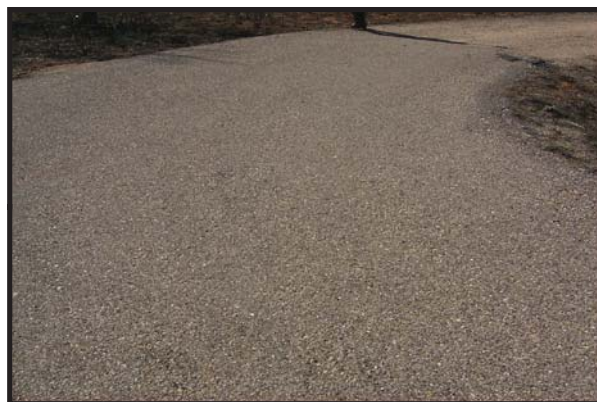
Route 0925

Route	Public / NonPublic	Date Visited	Area (sq ft)	Lane Miles *	Surface Type	Condition / PCR
0925	Public	3/10/2003	7860	0.14	AS	POOR / 45

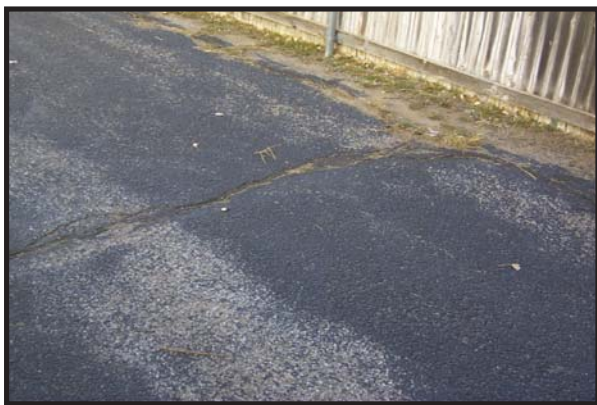
Route 0926

Route	Public / NonPublic	Date Visited	Area (sq ft)	Lane Miles *	Surface Type	Condition / PCR
0926	NonPublic	3/10/2003	12966	0.22	AS	POOR / 45

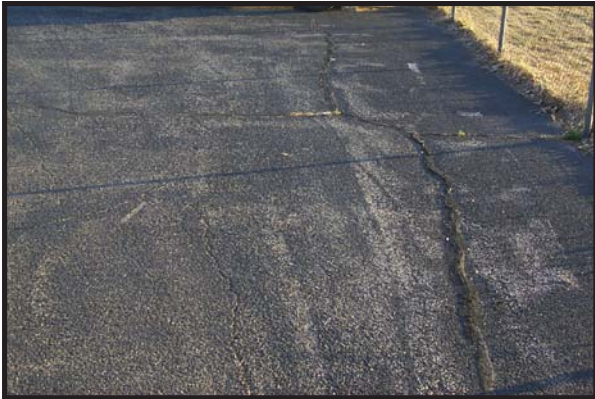
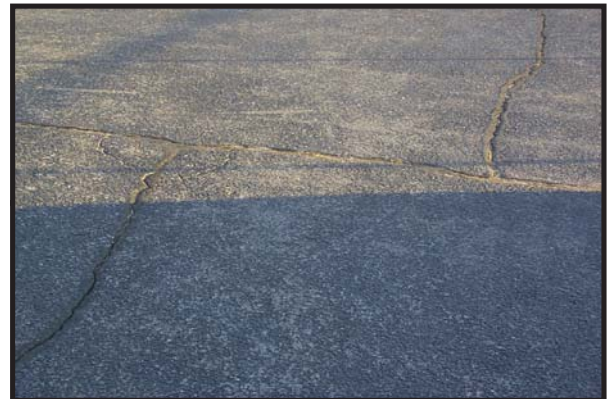
Route 0927

Route	Public / NonPublic	Date Visited	Area (sq ft)	Lane Miles *	Surface Type	Condition / PCR
0927	Public	3/10/2003	6973	0.12	AS	POOR / 45

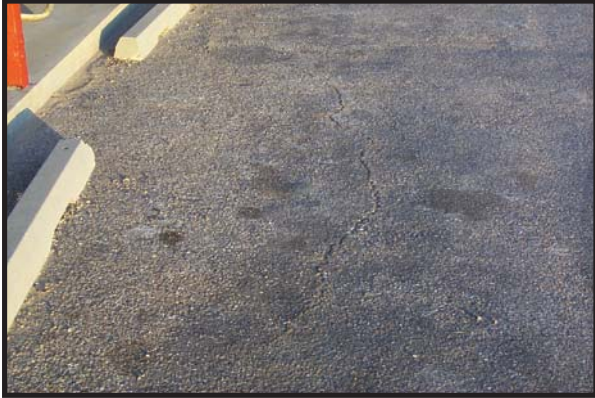
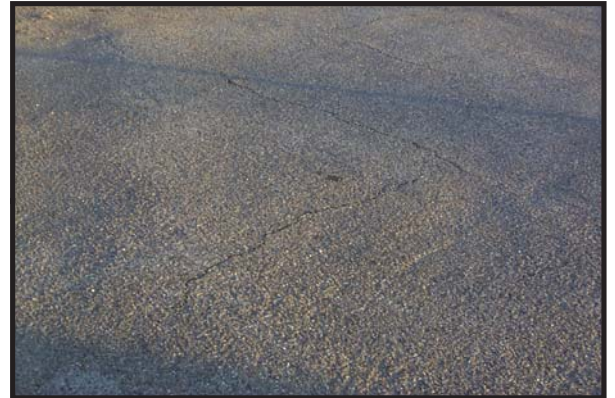
Route 0928

Route	Public / NonPublic	Date Visited	Area (sq ft)	Lane Miles *	Surface Type	Condition / PCR
0928	Public	3/10/2003	24289	0.42	AS	FAIR / 73

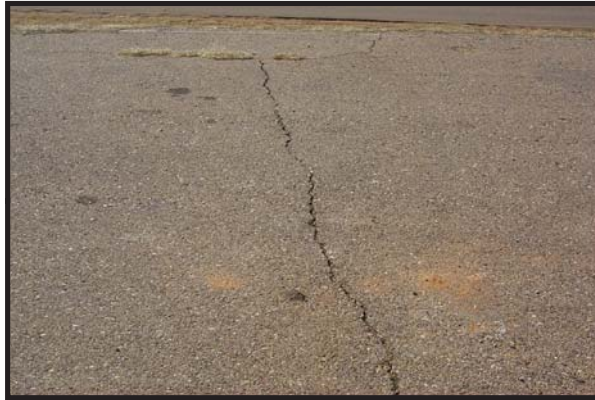
Route 0930

Route	Public / NonPublic	Date Visited	Area (sq ft)	Lane Miles *	Surface Type	Condition / PCR
0930	Public	3/10/2003	3915	0.07	AS	GOOD / 90
